A LEGACY SLOPE FAILURE IN PENLEE QUARRY - A WARNING TO OTHERS

McAllister, R., Walton, G., Coggan, J. and Wetherelt, A. 2013. A legacy slope failure in Penlee Quarry - a warning to others. *Geoscience in South-West England*, **13**, 183-190.

Penlee Quarry has a 90 m high slope which is 50-60 years old and is showing increasing signs of instability with two significant collapses in 2010 and 2011. The latter collapse gave rise to a possible flow slide at the toe and a significant air blast. This paper presents details of the underlying joints controlling ground movements, the investigation of these joints and proposals for remedial works. There are implications for other similar slopes elsewhere in England.

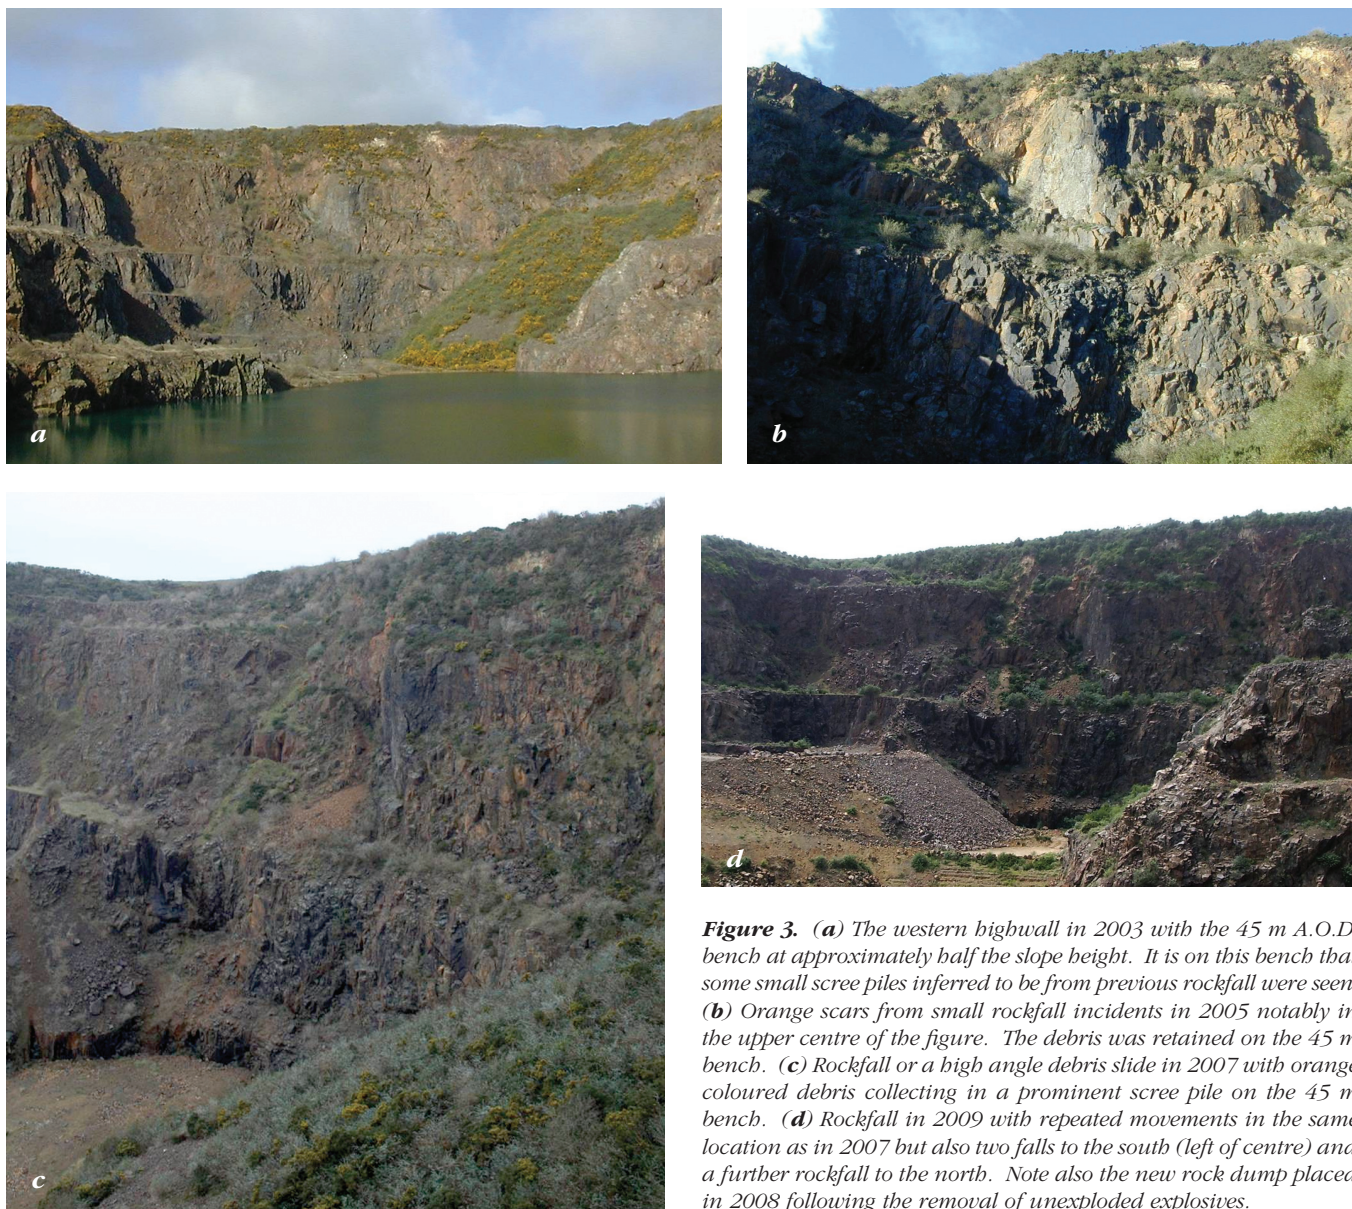
In 2003 in the absence of any quarry records and prior to any significant site works being undertaken for the proposed development, initial geotechnical inspections of the western highwall indicated that there may have been some previous rockfall although none had been reported. Rockfall was apparent from vegetated scree piles observed along sections of the narrow 45 m A.O.D. bench. As a consequence all access to the western face was prohibited and inner and outer barriers constructed. There was however no evidence of recent rockfalls (Figure 3a). In 2005 a rockfall occurred near the centre of the slope with a resulting pale coloured collapse scar and some debris collecting on the 45 m bench (Figure 3b). Further movement occurred in 2007 which could be described as a high angle debris slide (Figure 3c) and again in 2009 at four locations (Figure 3d) resulting in material choking the 45 metre bench.

Figure 3. (a) The western highwall in 2003 with the 45 m A.O.D. bench at approximately half the slope height. It is on this bench that some small scree piles inferred to be from previous rockfall were seen. (b) Orange scars from small rockfall incidents in 2005 notably in the upper centre of the figure. The debris was retained on the 45 m bench. (c) Rockfall or a high angle debris slide in 2007 with orange coloured debris collecting in a prominent scree pile on the 45 m bench. (d) Rockfall in 2009 with repeated movements in the same location as in 2007 but also two falls to the south (left of centre) and a further rockfall to the north. Note also the new rock dump placed in 2008 following the removal of unexploded explosives.

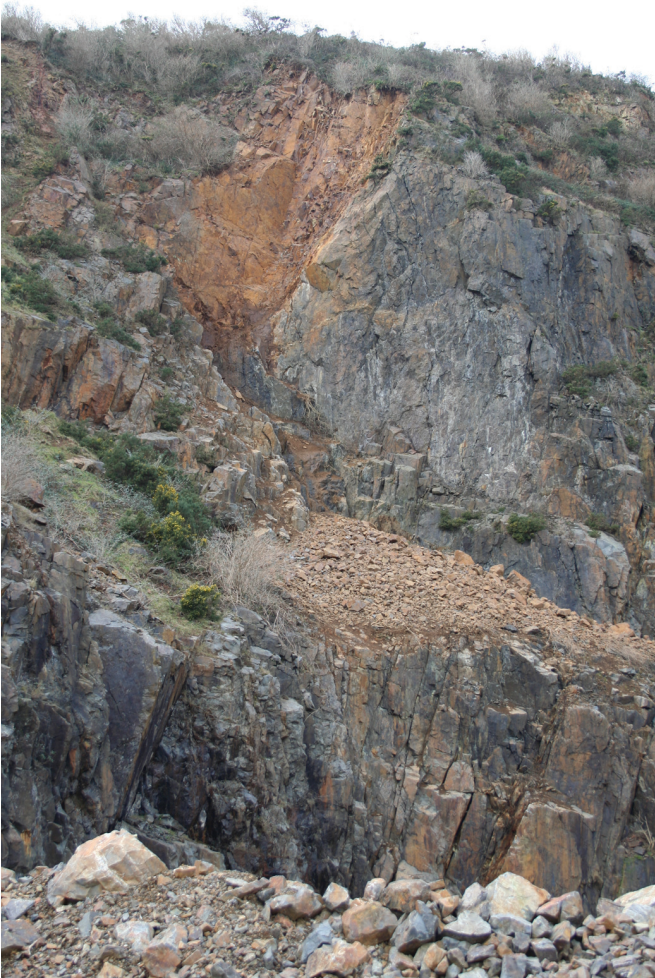
On 25 January 2010, a more significant failure occurred involving a high angle wedge of rock weighing approximately 2,000 t which fell from just below the crest of the highwall (Figure 4). Debris from the face choked the 45 m bench and then fell onto the quarry floor 35 m below. This material also formed a debris scree pile, but stayed within the inner exclusion zone demarcated by a 2 m high bund. Further precautionary measures were established since potential for distinct wedge and toppling failures was identified. However early the following year, a more significant collapse occurred.

Figure 4. The January 2010 wedge failure showing the scar below the crest of the highwall and debris clogging the 45 m bench, with some spillage onto the face below. The release surfaces creating this wedge have been identified using the stereoplot in Figure 10 as Set 2 and Set 4.

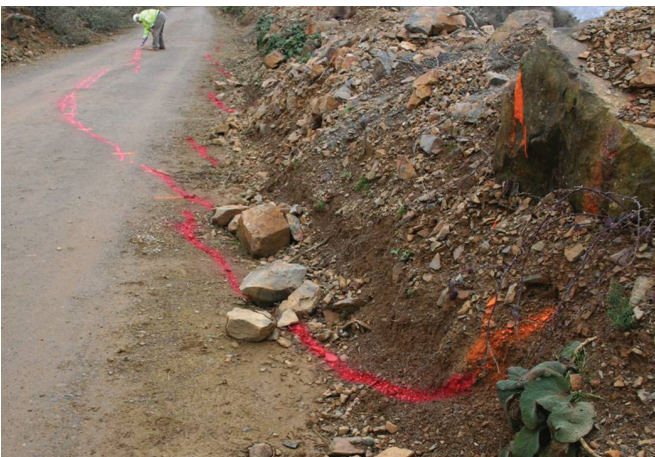
In January 2011 hairline cracking (0.5 mm wide) was identified during routine daily checks along the boundary road immediately behind the edge protection at the crest of the highwall. This cracking continued into February and lengthened to more than 85 metres (Figure 5). At 05:30 hours on 22 February 2011, a collapse of 7-8,000 t occurred leaving a large scar with several clear discontinuity surfaces (Figure 6a). The collapse may have been assisted by extensive freezing and thawing of the face over the winter, followed by heavy rainfall just prior to the collapse. Although the collapse was expected, the nature of the resulting ground movements was not. As noted, the slope toe was significantly less in length than the slope crest and the debris landed in a confined area at the 10 m level. From the resulting piles and spreads of material (Figure 6b) it is apparent that rock fragments and debris travelled large distances from the toe of the slope. A buoyancy aid on the crest of the slope down to the quarry pond, 90 m from the toe, had 5 mm fragments of rock embedded within it (Figure 6c) and the surrounding ground with an area of *c.* 1.0 ha up to a level of 35 m A.O.D., was covered in a thick layer of dust. Two distinct ridges of small rock debris (<10 kg) were formed on either side of what appears to have been a possible flow slide although there is little doubt that much of the finer debris was dispersed by the air blast.

Figure 5. Cracks in the western quarry access road being marked out in January 2011 to aid the identification of further movements.

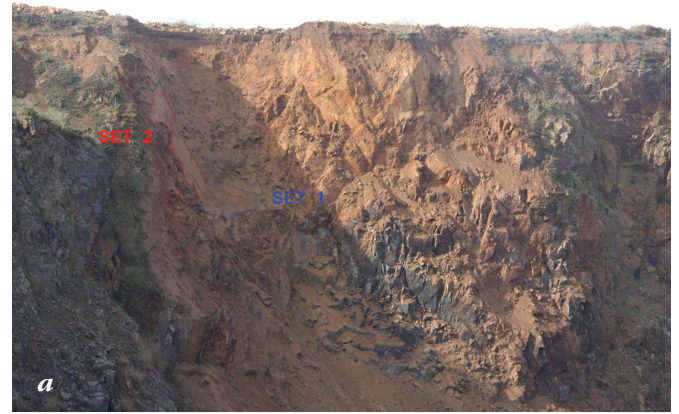
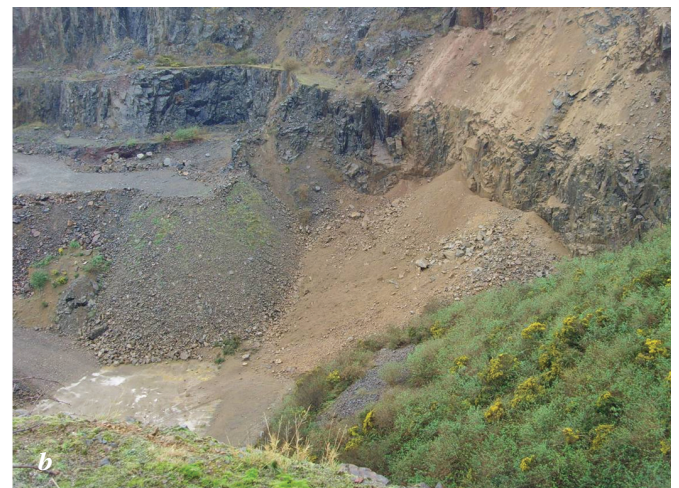
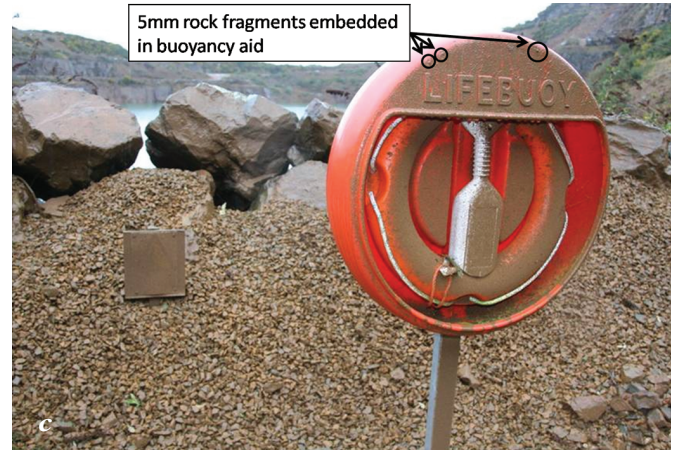
orientation data on a stereoplot four dominant joint sets were identified, as shown in Figure 10. Kinematic analysis of the data suggests that Joint Set 1 forms potential planar failure surfaces or basal planes for direct toppling, in addition to the potential wedge failure from intersections of joint sets identified previously. It is unclear whether the 2011 collapse was a result of planar failure (Set 1) or toppling failure (Sets 2

Figure 6. (a) Scar of collapse in February 2011 showing discontinuities inclined out of the highwall (Set 1) and release surfaces similar in alignment to those of the 2010 collapse (Set 2). Figure 10 shows the stereoplot derived from the laser scan of this face with allocation of the discontinuity sets. (b) The debris pile at the toe of the February 2011 collapse. Photograph taken from Laser scan position 3 (see Figure 8). (c) A buoyancy aid at a distance of 90 m from the toe of the highwall with 5 mm rock fragments embedded from the resulting air blast following the collapse. Figure 7 shows the location of the buoyancy aid in relation to the slope face.

and 3) or a combination of both (with Set 1 forming the basal plane); however the risk of further failure was apparent with movements extending beyond the site boundary behind the crest of the slope. The Split FX analysis primarily focussed on identifying the orientation characteristics of the discontinuities although it is also possible to establish other parameters such as persistence and spacing of the respective sets.

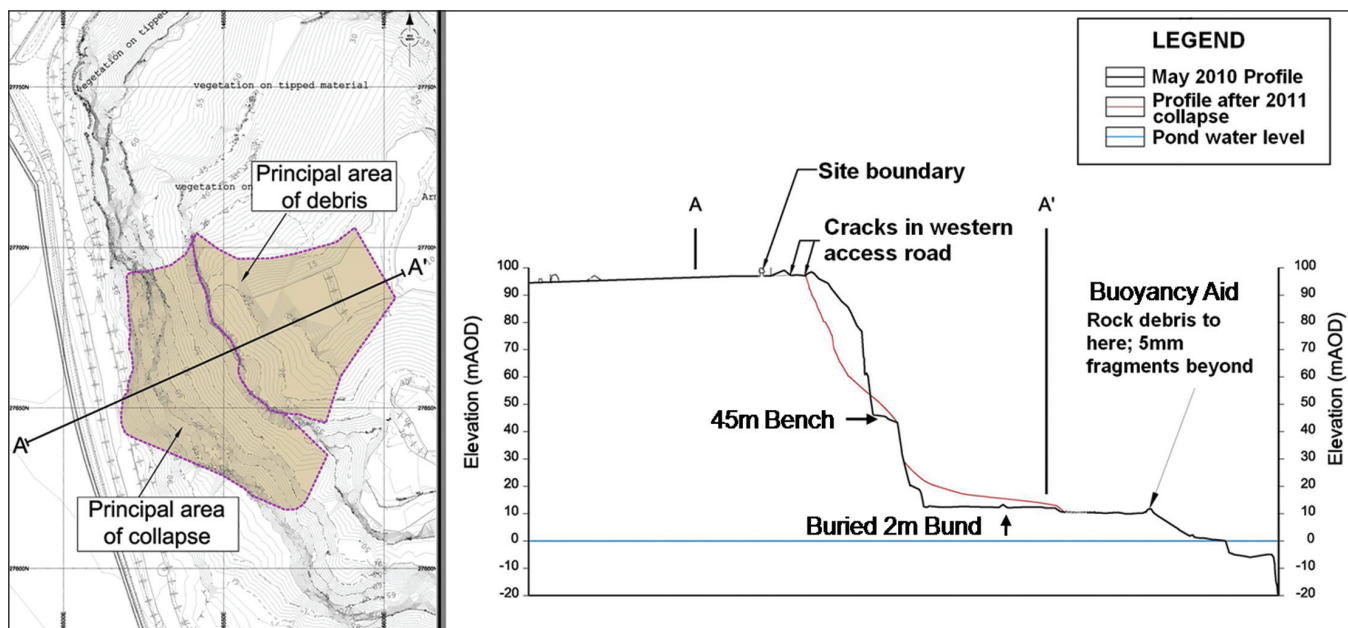
The plan and cross-section in Figure 7 show the extent of the collapse scar and debris pile, highlighting the debris pile with a shallow gradient of 7°. The positions of the choked 45 m bench, the buried inner exclusion barrier (2 m high bund) and position of the buoyancy aid are indicated. The collapse scar extended 35 m along the perimeter road, but the cracking extended more than 85 m along the road in places more than 10 m behind the crest of the slope. Subsequent calculations have shown that a further 40-60,000 t of rock could imminently collapse in relation to the discontinuity patterns that had become apparent. In the context of what occurred on the morning of 22 February there appeared to be some potential for even more significant flow slide/air blast phenomena and as such the event was reported under RIDDOR (Anon, 1996) as clearly this was a dangerous occurrence of relevance to this and other operations.

Figure 7. A plan and cross-section of the 2011 collapse showing movements in relation to the site boundary and the western quarry access road.

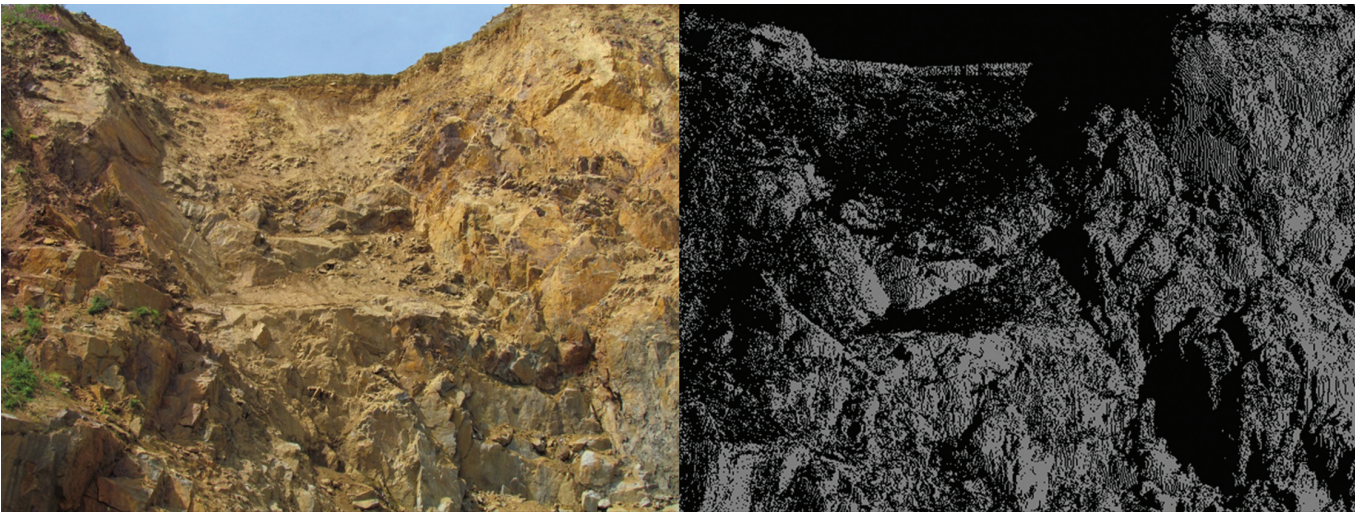
Figure 9 shows a photograph and point cloud image of the 2011 failure scar on the upper region of the western face. The point cloud data were analysed using Split FX to identify the dip and dip direction of identified surfaces that represent individual discontinuities within the rock mass. These surfaces or ‘patches’ were manually identified rather than relying on automated routines. This involved rotating the point cloud until it was perpendicular to the identified plane before the patch is inserted to ensure the correct orientation of the patch. It should be noted patches cannot be inserted on shadows on the point cloud as these areas have no points. By representing this

Figure 9. Split FX software point cloud image of the upper region of the western face from the 2011 scanning survey (right), and a photograph of the same slope (left). Figure 10 shows the stereoplot derived from the laser scanning of this face.

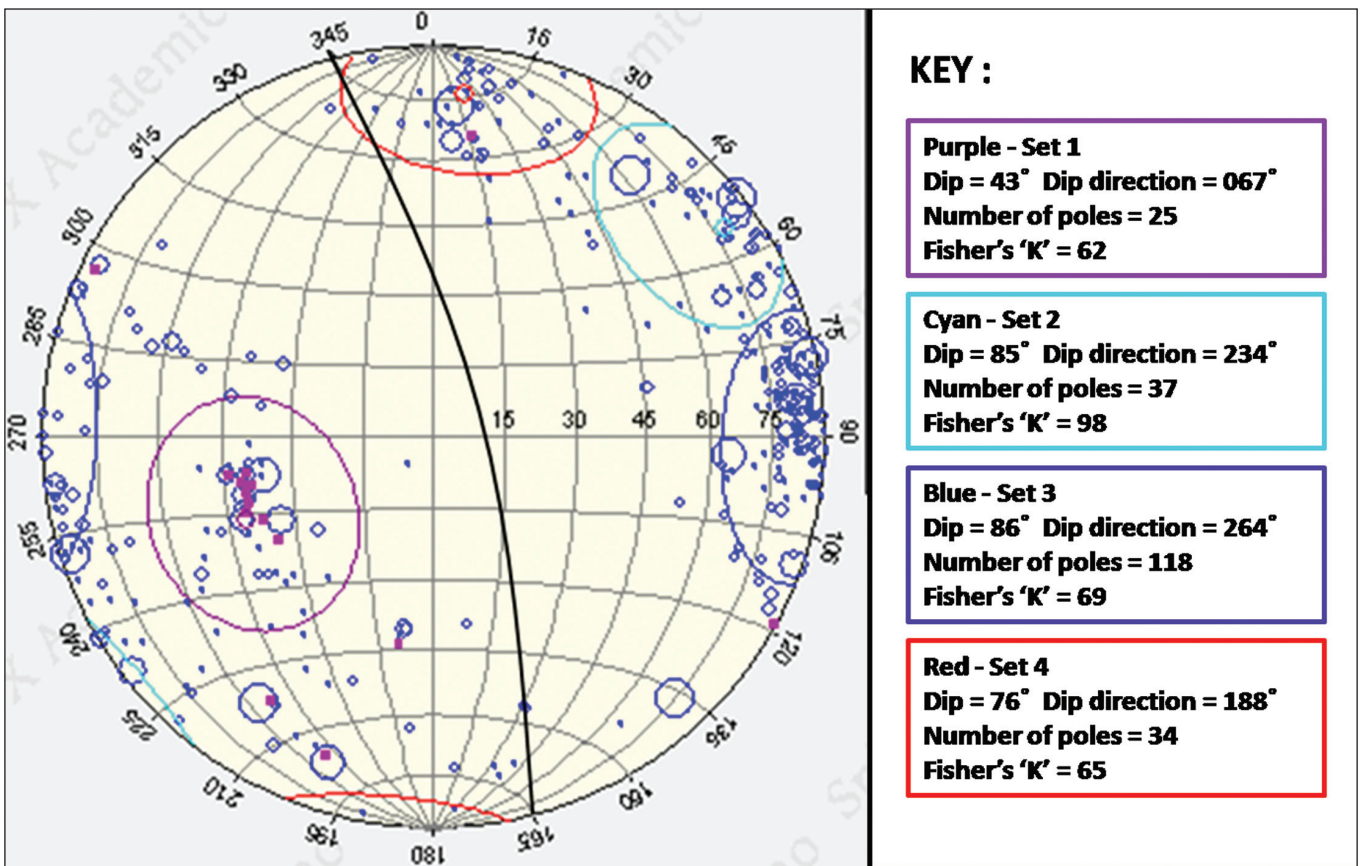
Figure 10. The stereoplot based on manually inserted 'patches' onto the point cloud image shown in Figure 9 for the 2011 collapse. Joint Set 1 with a general dip of 43° in the direction of 067° was found to be a significant structural element to be accommodated in the proposed remedial works.

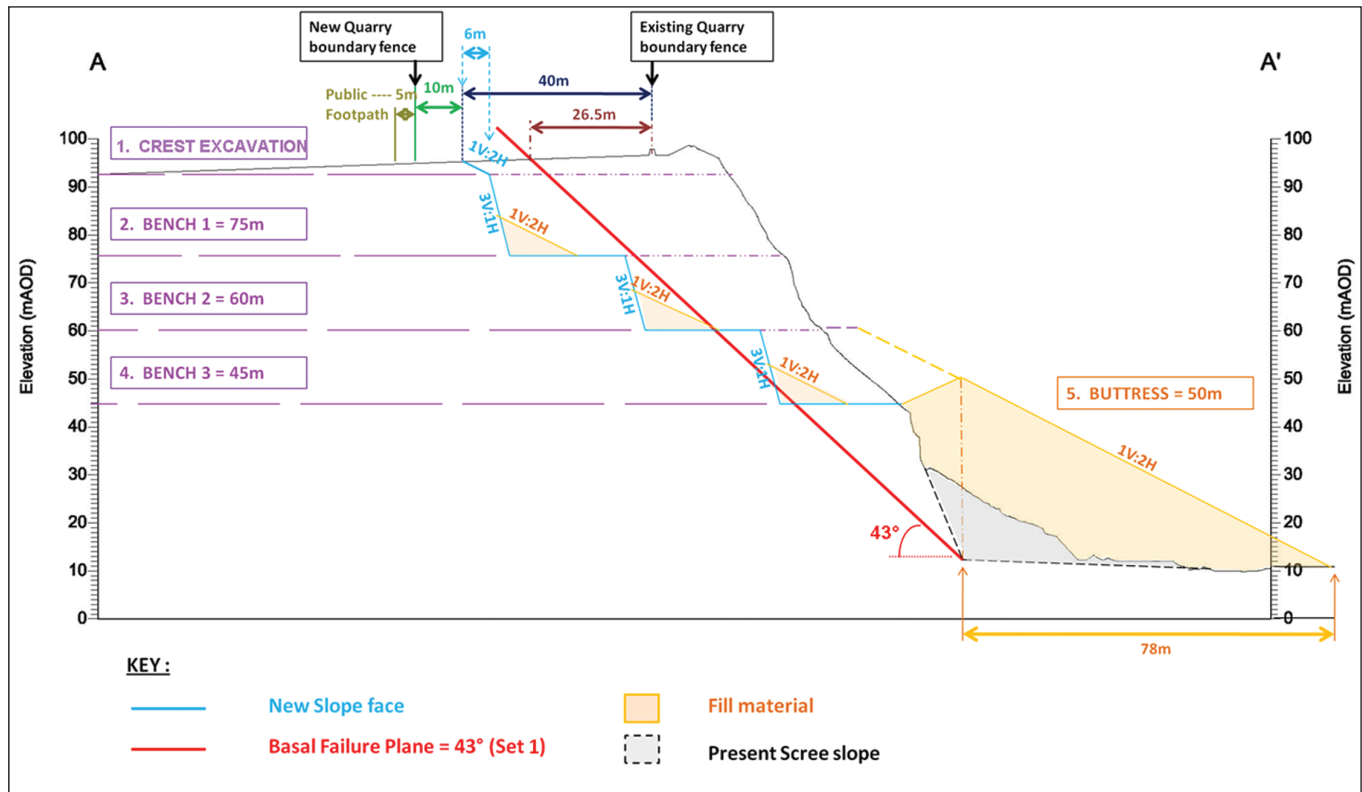
Projections of discontinuity Set 1, assuming a worst case scenario, as shown in Figure 11 indicate that movements could extend beyond the boundary of the quarry into the land to the west depending on the inferred discontinuity persistence. In

Figure 11. A cross-section showing the proposed stabilisation works using bench excavation and buttressing up to 45 m A.O.D. and buttressing of each excavated bench. (N.B. this cross-section is along line A-A' in Figure 12, but extends c. 90 m to the SW and c. 30 m to the NE).

Remedial work such as anchoring, bolting and face netting cannot be achieved safely within the context of the likely scale of any active movements and the only practical long-term solution within the context of the proposed site development was to flatten and buttress or reprofile the overall slope. The proposal was therefore to acquire the land to the west and to excavate a series of benches commencing with working to the rear of the landslip and raising a buttress at the toe of the slope using excavated material. A small part of this buttress has already been formed from material excavated during the removal of old unexploded explosives in 2008/9.

The proposed benching system comprises benches at the 45, 60 and 75 m A.O.D. levels and a minor 'rockhead bench' at 90 m A.O.D. The bench heights are 15 m and the basic bench widths nominally 25 m wide. This configuration ensures that the lowest angled adversely orientated discontinuities within

the rock mass, as identified in the investigations following the 2011 collapse, are only undercut at bench level and not by multiple benches. The levels and configurations of benching are modified at the northern and southern ends of the excavation to accommodate existing ground levels. Bench faces are assumed to be 1 to 3 (horizontal to vertical) but would be modified by face dressing, especially at the crest, and by debris placed at the toe of each bench reaching up to a third to half the bench height. Benches would have 2 m high outer edge protection and would be covered with roughly sorted material generally of less than 300 mm. Allowing for break-back and dressing slope crests, this would give a bench

between the edge protection and the buttress material of about 5 m for a 20 m-wide basic bench. Limited rock excavation would occur between the 60 m and the 45 m level, but a significant buttress bench would be formed of excavated material at the 45 m level. The total excavation volume of material to form the overall benching would be 346,000 m³.

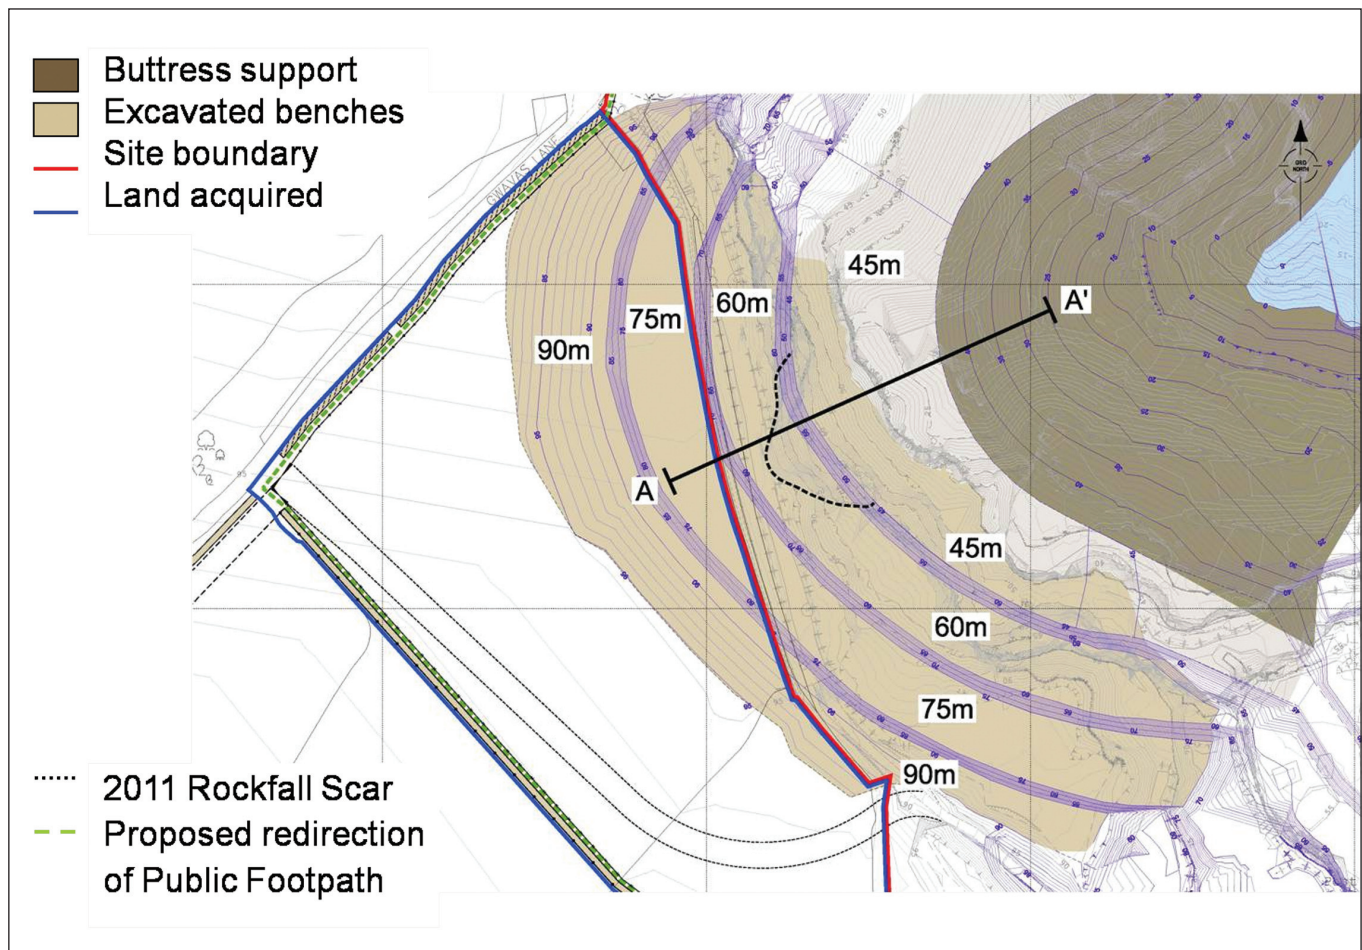
Figure 12. A plan showing the proposed excavation benching, buttressing and the likely diversion of the public footpath. (N.B. the cross-section for line A-A' is shown in Figure 7).

The excavation proposed shown in Figures 11 and 12 extends from the western limits of the proposed armourstone quarry in the south east to the northern end of the western highwall. This aims to provide access and space for ramps, a safe replacement road behind the landslip area and haul roads down to the proposed buttress area incorporating the existing buttress from the 2008/9 works.

As designed, this system of benching and buttressing allows for excavation to commence at the southern/south eastern end of the relevant area and to progress into and behind the landslip area where there is active cracking. Excavated material would be hauled via temporary ramps to the existing buttress, which would be progressively raised and extended to form the buttress shown in Figures 11 and 12.
