Large Steel Tank Fails and Rockets to Height of 30 meters - Rupture Disc Installed Incorrectly

Published in:
Safety and Health at Work

Publication date:
2016

**Vertical cylindrical 90 m³
steel tank operated at
"slight overpressure"
rockets to height of 30 m –
rupture disc overpressure
relief device inoperative,
installed upside down**

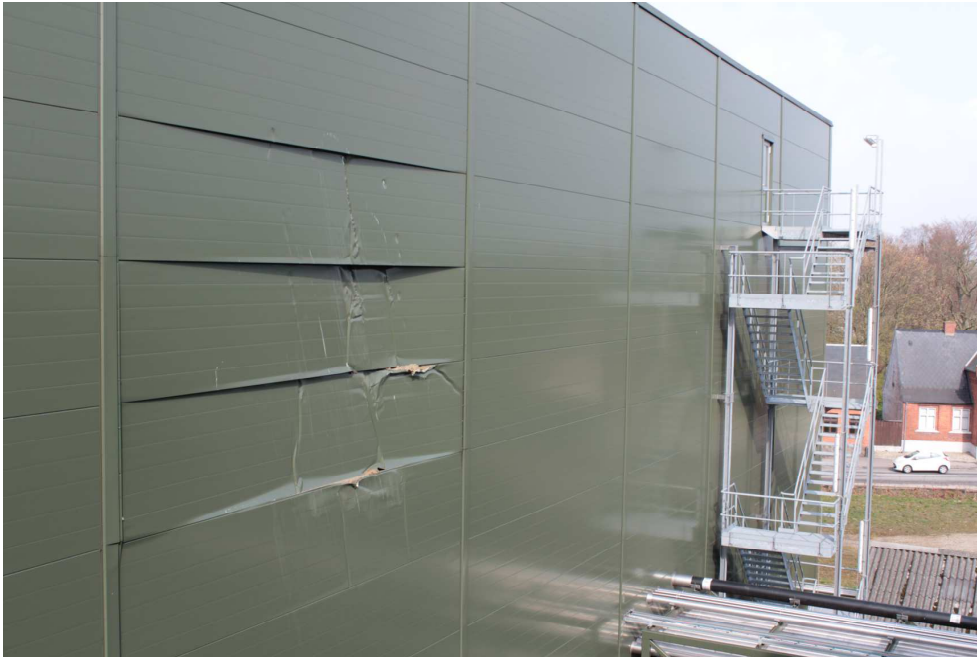
A specialist metallurgy company examined the failed tank, the supports and the welds. The tank shell skirt had been joined to the circumferential steel profile at the base of the supporting steel structure by 58 short welds each distanced about 0.15 m. The short welds were absent in two adjacent arc sections, each about 0.5 m length, which were identified as the probable point of failure initiation. The position of the two arc segments were opposite the tall green building, which would imply that the tank would tilt towards that building immediately before rocketing. This is consistent with impact damage to that building's exterior panels, when the tank descended (Figure 4).

Figure 4 The tank rose almost vertically in the air and the base of the tank rose higher than the 19 m tall green building. Whilst descending, the tank impacted and deformed the building's exterior wall panels (Photo courtesy: Frank H. Hedlund)

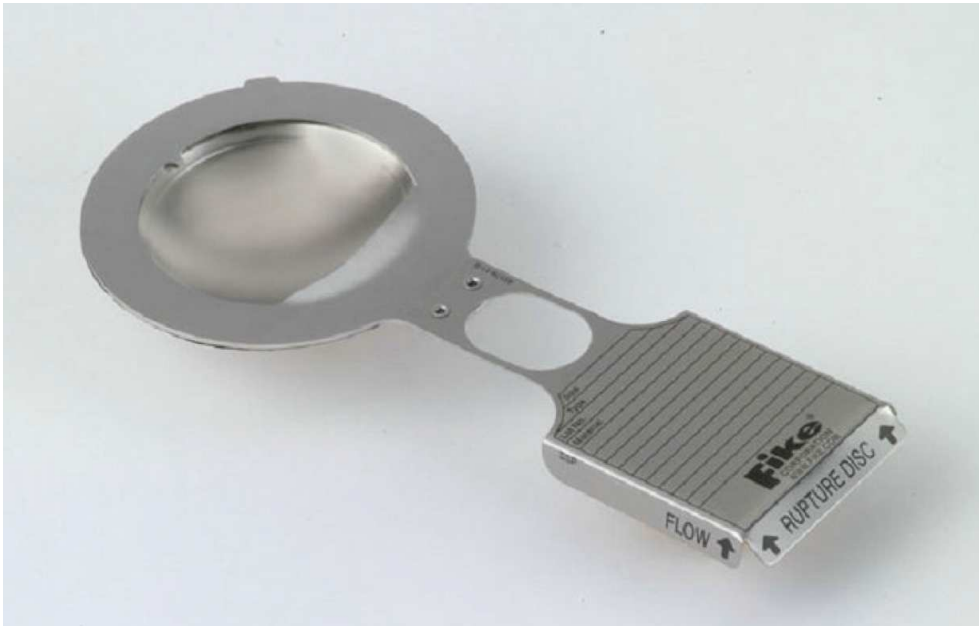
The rupture disc was intact. It was a reverse buckling type device that had been installed upside down (i.e. with the dome facing away from the tank). The vendor stated when asked, that the

rupture disc likely could withstand an overpressure of at least three times the stamped pressure (i.e. 150 kPa or more) before bursting, if installed upside down.

Reverse buckling discs may therefore be an attractive choice for low-pressure applications. Because buckling occurs at substantially lower stress level than rupture under tensile stress, correct installation is essential. If installed upside down the burst pressure is significantly higher. This property can be useful for overpressure protection of vessels in vacuum service because reverse buckling discs can easily withstand full vacuum in reverse direction.

Figure 5 Reverse buckling type rupture disc (dome points towards the fluid pressure) similar to the one installed on the incident storage tank. Proper flow direction of pressure release is marked on the nameplate (Photo courtesy: Fike®)

- The P&ID symbols in use for rupture discs may be a possible source of confusion during installation of reverse buckling type discs.
- The nameplate of a rupture discs clearly indicates the flow direction and allows simple visual verification of correct installation without interruption of production. Such inspections should be included in safety audits.
- The rupture disc seems to have been installed only to avoid being covered by the European Pressure Equipment Directive's arbitrary limit of 50 kPa(g). Had the tank failed at a slightly lower pressure than 50 kPa, the consequences would still have been dramatic. The burst pressure of the rupture disc could easily have been specified at a lower value for the tank in question, significantly reducing the hazard (provided that it had been correctly installed).
