Condition assessment of a Johannesburg skyscraper

Abstract. This paper presents a condition assessment conducted on a Johannesburg skyscraper. It had become apparent that concrete spalling occurred in areas of the top 11m of the Southern and Western facades of the reinforced concrete skyscraper constructed in the 1970's. However, the extent of the problem was unknown. The only information available were two photographs showing spalled concrete and severely corroded reinforcement bars. Some literature search pertaining to the structure was conducted after which, visual inspection and mapping of spalled areas and cracks were conducted. This was followed by a cover meter survey, a half-cell potential survey, and the removal of 20 (twenty) cores for laboratory testing. It was found that the typical problems associated with carbonation and insufficient cover resulted in the corrosion of reinforcement which then led to the spalling observed.

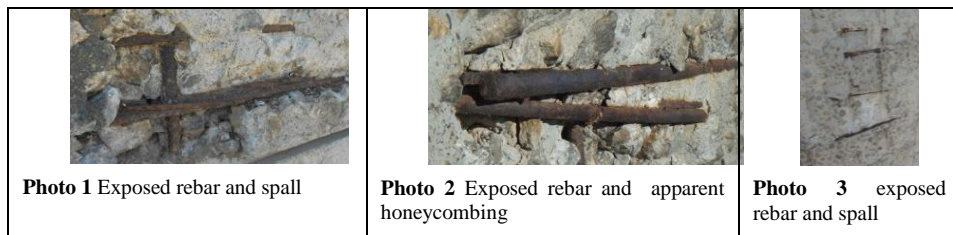
Photographic surveys, mapping of cracks wider than 0.3mm and mapping of areas of spalling were conducted. The surveys provided strong evidence that the problems were localized. **Photo 1** to **Photo 3** shows some of the problematic areas.

Site survey determined that the spalling was localized, in areas of very low cover. Carbonation attack was the mechanism identified to have caused corrosion of the reinforcement, which then resulted in spalling. In the 40 MPa concrete, carbonation had progressed to about 19.4 mm over the 40 years of the structure's lifetime. However, the cover in the façade varied significantly to the extent that the very low cover areas were severely affected by corrosion.

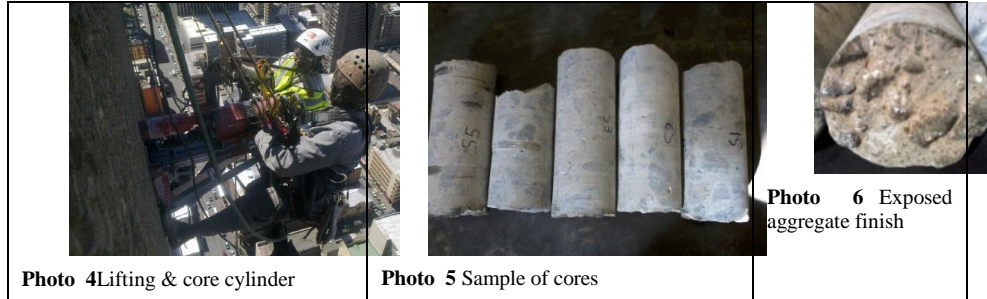
A total of 5 (five) cylindrical cores, from preselected locations, were extracted from each of the four facades. These 100mmdiameter cores of approximately 200mm length were sent for laboratory testing. **Photo 4** shows the coring process while **Photo 5** and **Photo 6** show some of the core samples.

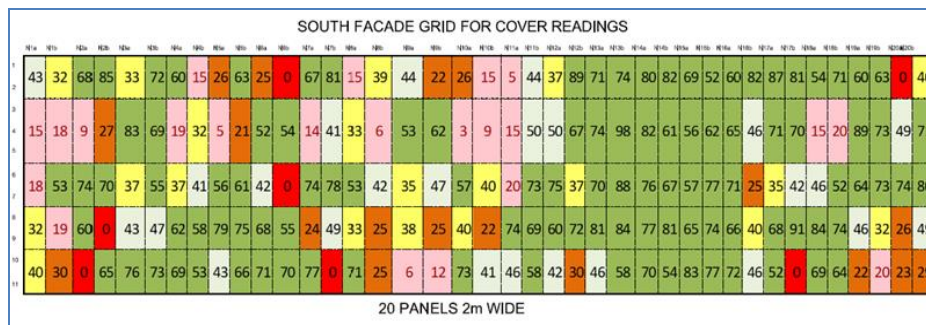
Figure 1. Minimum cover meter readings taken on the South Facade

The lowest cover reading for each block was recorded, thereby giving conservative measurements. The survey was able to identify areas that would require repair and maintenance in the short to medium term. The results of the South facade cover survey, which contained by far the most area of low cover, is shown in **Figure 1**.

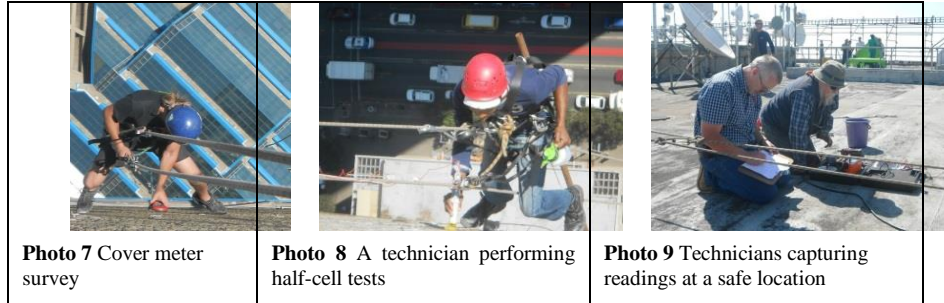
Half-cell potential measurements were conducted to assess the likely presence of corrosion activity, whether hidden or visible. Typically, readings of less than -350mV imply a 95% probability of corrosion occurring, whilst readings higher than -200 mV suggest less than 5% probability of any presence of corrosion[1-3]. Half-cell readings that were obtained, varied between -170mV to +180mV. The results indicated that no corrosion activity was occurring at the locations where measurements were taken[4]. **Photo 8** shows a technician performing the half-cell tests while the data was being captured at a safe location, as in **Photo 9**.

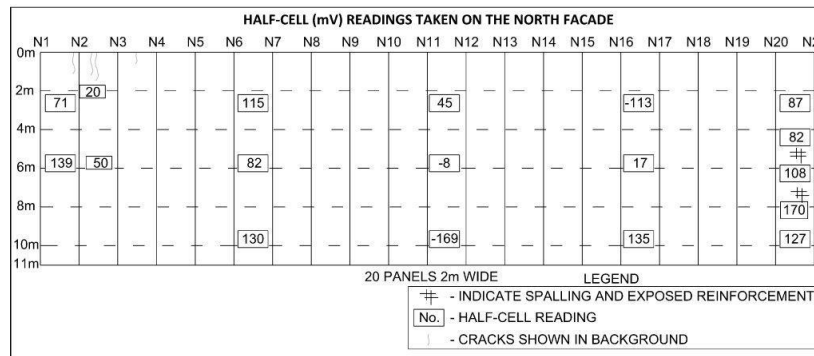
Figure 2. Half-cell potential measurements taken on the South facade

Half-cell readings were taken at random locations and also near cracks. **Figure 2** indicates the locations and readings of half-cell measurements taken on the South facade.

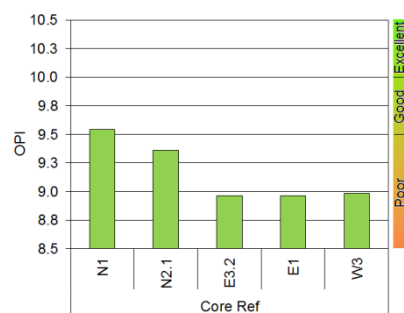
Figure 3. Oxygen permeability test results

Six core samples were selected for durability tests. Two durability index tests were conducted on the core samples namely, oxygen permeability and sorptivity tests [9]. The objective of conducting these tests was to obtain an indication of the potential performance of the concrete under mild exposure environment. The tests revealed generally poor durability performance, as shown in **Figures 3** and **4**. This was not surprising as the desk study revealed that no extenders were used in the concrete mix design[4]. However, the results should be examined in the context of the construction period of the 1970s when current understanding of the influence of extenders in concrete was not yet fully developed. Modern concrete technology usually requires the use of extenders in order to achieve good durability performance.

The concrete was intrinsically of excellent quality yet its durability characteristics were generally poor when evaluated based on durability indexes. This poor index performance is attributed to absence of extenders, whose use in concrete was not an established technology in the 1970's. No indication of chemical deterioration attack mechanism was found.

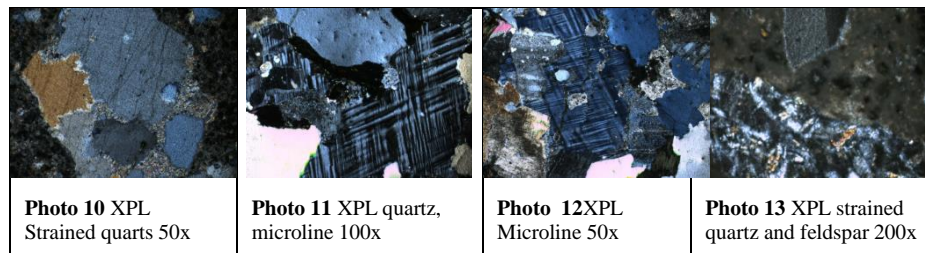
Detailed examination of the concrete was done using thin section optical microscopy. Thin sections were prepared from different concrete cores and cut longitudinally in a direction parallel to core axis. Microscopic examination showed the aggregates to be predominantly quartz, microline, feldspars and some opaque particles as shown in micrographs of **Photo 10** to **Photo 13**.

Strained particles such as seen in **Photo 10** and **Photo 13** may sometimes be associated with alkali aggregate reaction[4]. However, there was no evidence of any reactive phase(s) such as microcrystalline quartz commonly found in reactive aggregates in South Africa.
