Full-scale fire test on an earthquake-damaged reinforced concrete frame

Kamath, P, Sharma, UK, Kumar, V, Bhargava, P, Usmani, A, Singh, B, Singh, Y, Torero, J, Gillie, M & Pankaj, P 2015, 'Full-scale fire test on an earthquake-damaged reinforced concrete frame' Fire Safety Journal, vol. 73, pp. 1-19. DOI: 10.1016/j.firesaf.2015.02.013

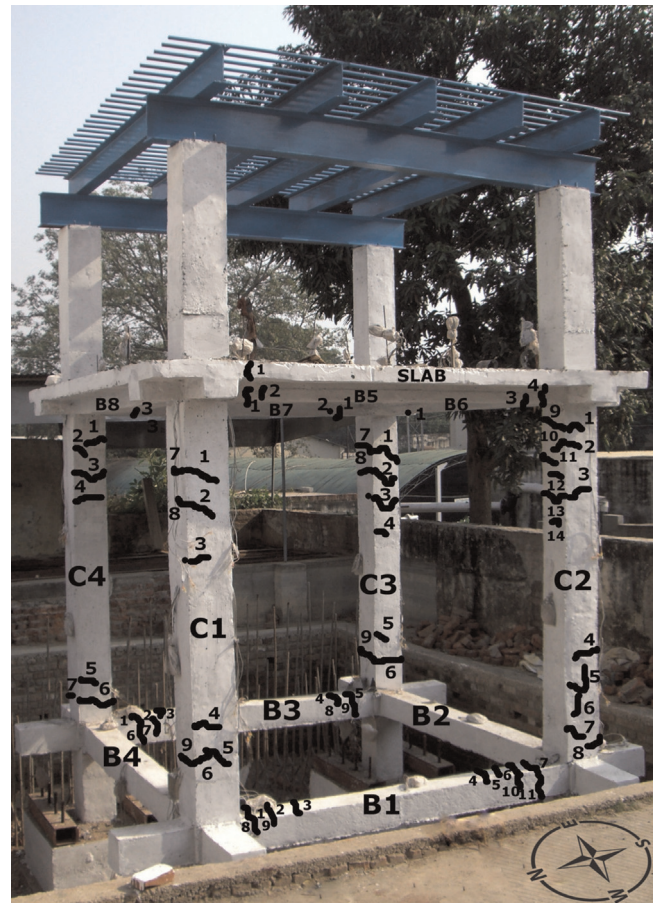
Fig. 8. Nomenclature for the identification of RC test frame members and schematic of cracks due to cyclic loading.

The nomenclature used to identify individual members of the RC test frame is shown in Fig. 8, also showing the north–south orientation of the frame. The test frame was inspected after each cycle of displacement to detect the formation of cracks and monitor their growth. No visually observable cracks were seen up to a lateral displacement of 20 mm corresponding to a roof drift ratio of 0.53%. The first set of cracks developed at the ends of the roof beams oriented along the N–S direction (beam B7) at a lateral displacement of 35 mm (roof drift ratio of 0.92%) corresponding to a base shear of 185 kN. The next set of cracks developed at the ends of the plinth beam B1 also in the N–S direction at the measured lateral displacement of 44 mm corresponding to a base shear of 212 kN. As expected, the flexural cracks occurred earlier and were more pronounced in the beams oriented in the direction parallel to the loading direction. Flexural cracking in the columns was first observed at the junction near the roof beams at a lateral displacement of 31 mm (roof drift ratio of 1.37%). Spalling of concrete was observed at the ends of the roof beams B5 and B7 at a roof drift ratio of about 2%. Widening of cracks was conspicuous in the columns and the plinth beams. It was attempted to maintain the hydraulic pressure in the loading jacks at a constant level when the displacement reached 80 mm (roof drift ratio of 2.11%) corresponding to a base shear of 267 kN (note that the intended displacement was 76 mm). However, due to the limitations of the load-controlled actuators, the actual value of the maximum

displacement reached was 95 mm. Flexural cracking, symptomatic of composite action between the RC slab and the roof beams spanning along the N–S direction was noted. After the final loading cycle, these flexural cracks on the roof slab propagated throughout the span from one end to the other in the direction parallel to the direction of loading. The formation of these flexural cracks indicates that a RC roof slab need not necessarily behave as a rigid diaphragm under in-plane loading [18]. Table 2 outlines the sequence of the occurrence of selected cracks in members of the frame that sustained the greatest damage during cycling loading. This table refers to crack locations shown schematically in Fig. 8. The base shear–roof displacement plot for the test frame depicted in Fig. 9 shows no deterioration in the lateral strength of the frame at life safety level of structural performance. Despite the observed inelastic excursions, the test frame did not suffer any significant

structural damage. Except for noticeable cracking, no major spalling (loss of big chunks) of concrete or loss of cover (exposing reinforcement) was observed at any location in the test frame at the desired level of mechanical pre-damage.

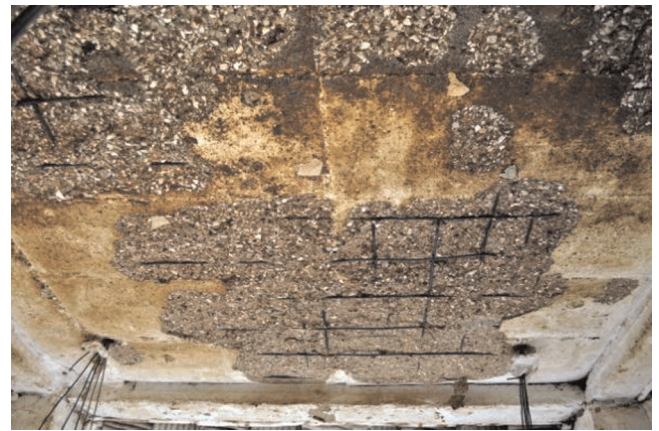
Fig. 12. Spalling in roof slab after fire.

The first major event to be observed, both visually and audibly, was the spalling (loss of cover concrete at the soffit) of concrete at the roof slab initiating 4–5 min after ignition and continuing for almost 15 min and resulting in the exposure of reinforcement. During this period the compartment temperatures near the roof slab were of the order of 300–400 °C in the front and close to 1000 °C at the back of the compartment where the worst of the spalling was observed, suggesting that a high temperature gradient produces more severe spalling (see Fig. 12). Fire induced spalling is often linked to temperature gradients causing rapid development of pore-pressure in concrete exceeding its tensile strength [19–21], especially in regions of higher compressive stresses. Furthermore, the portions of the roof slab already

damaged during the lateral load test were more vulnerable to spalling compared to the undamaged portions. The loud fire-cracker like sounds which indicated the initiation of spalling suggested that the spalling was of an explosive nature resulting from high pore pressures exacerbated by the fact that the frame had entrapped moisture from the rain earlier in the week before the test. Bazant [22], Ulm [23,24] and Zukov [25] suggest that spalling occurs due to prevented thermal expansion. Careful observation of spalled soffit of the slab suggests high compressive forces were induced in the bottom layers of the roof slab concrete due to the rotational restraint offered by the peripheral beams against thermal bowing (resulting in hogging bending moments across the whole exposed face of the slab). Further high compressive stresses are induced in the layers of concrete near the exposed face which are restrained from expanding thermally by the cooler layers above and ultimately also by the lateral restraint from the peripheral beams. The lack of the spalling around the service holes (made for anchoring thermocouple trees) also indicates that spalling may be influenced by high compressive. Even though compressive stresses exacerbate the severity of spalling, they were also likely to be beneficial to the integrity of the roof slab by aiding compressive membrane resistance (action similar to prestressing). However, spalling remains a very complex phenomenon dependent on parameters such as porosity, permeability, differential thermal expansion between cement paste and aggregate, high moisture content, heating rate and external loads [26] and is not the key focus of the current study. The lack of collapse of the roof slab even after severe spalling means that the effect of thermally assisted compressive membrane action can considerably enhance the load-carrying capacity of the roof slab considerably beyond the calculated flexural resistance. In the later stages of test, i.e., during the growth stage, spalling of concrete and

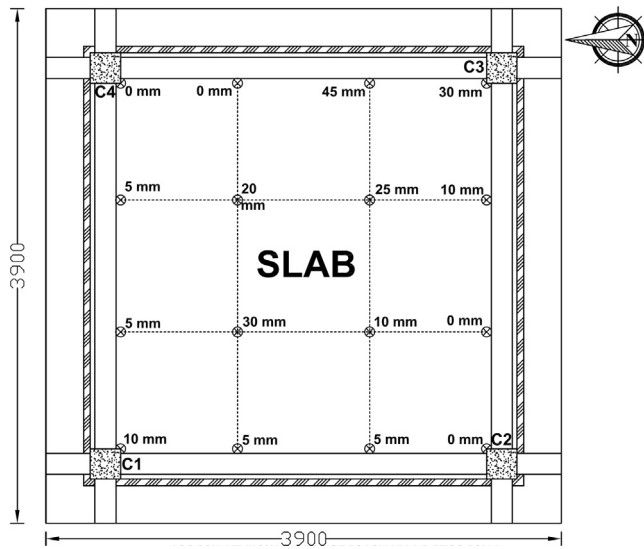
Fig. 13. Vertical residual displacements in roof slab.

roof slab at the centre of the span. Temperatures of more than 1200 °C were also noted at depths more than 60 mm from the exposed face in the N–E quarter, but this can be attributed to the loss of concrete and exposure of thermocouples. The temperature variation in the depth of slab is shown in Fig. 14(a–e) at the five plan locations embedded with thermocouples. It was observed that the north half portion of the slab at the rear experienced higher temperatures than the southern half of the slab. Furthermore, in the north half portion, the east side quarter portion had higher temperatures than the western quarter portion. The thermal data and the observations from the visual inspection indicate that the roof slab of the test frame underwent major deterioration under fire in comparison with the other structural components. Despite the considerable damage, no collapse of slab was observed. The slab continued carrying the superimposed loads.
