# INVESTIGATION OF THE FUNDAMENTAL RELIABILITY UNIT FOR CU DUAL-DAMASCENE METALLIZATION

## ABSTRACT

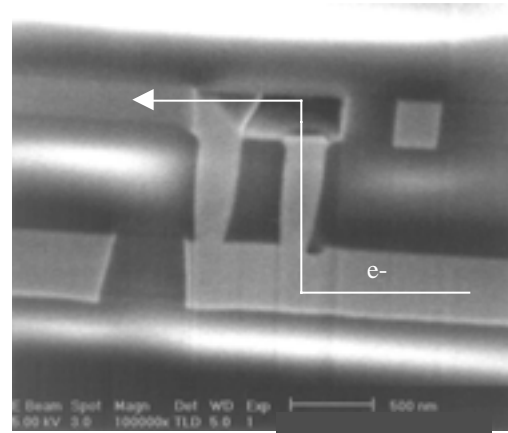
imaging using ion-induced secondary electrons, as well as transmission-electron-microscopy (TEM) for investigation of the integrity of the Ta liner after testing. Figure 3(a) shows an FIB image of the cathode end of a M2 structure that terminated with 4 vias. The length and width of the structure is 800 $\mu\text{m}$  and 0.28 $\mu\text{m}$ , respectively. The sample was stressed at 350 $^{\circ}\text{C}$  and 3.6 MA/cm $^2$  until it failed as an open circuit. The void formed at the top surface of the M2 line and grew in length (along the line) as well as thickness. Figure 3(b) shows the anode end of a different 4-via M2 structure. This test line was 800 $\mu\text{m}$  long and 0.28 $\mu\text{m}$  wide and was also stressed at 350 $^{\circ}\text{C}$  and 3.6 MA/cm $^2$ . However, in this case failure took a much longer time and it can be seen that voids formed in the much wider metal 1 connector at the anode end of the M2 test line, where the tensile stress was very large *in the M1 connector*. As can be seen from these figures, the voids tend to form at the Cu/Si $_3$ N $_4$  interface even in the wider connector lines held at much lower current densities.

Fig. 3: (a) FIB image of voids formed at the surface at the cathode end of a 800µm-long, 0.28µm-wide 4-via M2 line in a M2 test structure. (b) Cross sectional view of voids at the surface of a wide M1 connector to a 800µm-long, 0.28-µm wide 4-via M2 line in a M2 test structure. Voiding occurred at the cathode of the M1 connector and the anode of the M2 test line. Samples were stressed at  $T = 350^{\circ}\text{C}$  and  $j = 3.6 \text{ MA}/\text{cm}^2$ . The arrows indicate the direction of electron flow.

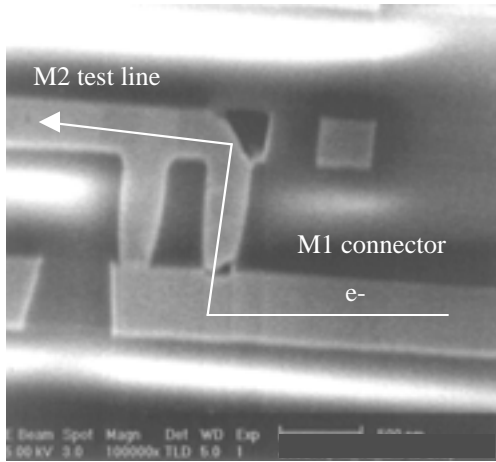
characterization, some voids were detected in the via instead of in the line. Figure 4 shows competing failure mechanisms as observed in a 800 $\mu\text{m}$ -long, 1.0 $\mu\text{m}$ -wide 4-via-terminated M2 structure. Voids are seen both at the bottom of a via and in the M2 Cu line. A TEM image of one of the vias showed that void nucleation started from the side of the via at the bottom, where the Ta liner was virtually absent (Figure 5).

Figure 4: FIB image of voids in both the M2 line and bottom of a via at the cathode end of a 800µm-long, 1.0µm-wide 4-via M2 test structure. The sample was stressed at  $T = 350^{\circ}\text{C}$  and  $j = 3.6 \text{ MA}/\text{cm}^2$ .

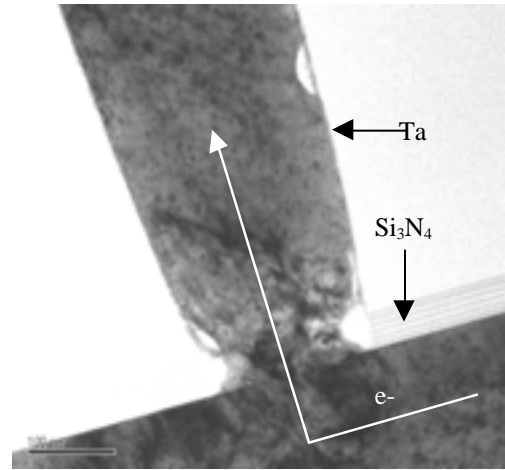
Figure 5: TEM image of voids nucleated at the sides of the bottom of a via, at the Cu/Si<sub>3</sub>N<sub>4</sub> interface.

Ogawa *et al.* [15] have also reported the observation of voids in vias of lines that had failed early. They attributed this phenomenon to processing defects. From our TEM analysis of the lines that failed very early, poor sidewall coverage in the high aspect-ratio via (~10%) during Ta sputter deposition may cause insufficient sidewall coverage in some of the vias, possibly resulting in Cu being in direct contact with the Si<sub>3</sub>N<sub>4</sub> layer. Moreover, as the tensile stress at the bottom of the via at the cathode end of a M2 line is maximum, the sidewall liner of a “weak” via may rupture under electromigration stress. With the Cu/Si<sub>3</sub>N<sub>4</sub> as the preferential void nucleation interface, a void may form rapidly. This mechanism may occur simultaneously with the normal void formation at the Cu/Si<sub>3</sub>N<sub>4</sub> interface at the surface of the M2 line as observed in Figure 4. Since a much smaller volume of Cu is needed to block the current in a via than in the line, the time-to-failure will also be much shorter of voiding that occurs in the via due to insufficient sidewall coverage of the via by the Ta. This may be the reason that voids are observed in the vias of lines that failed early.

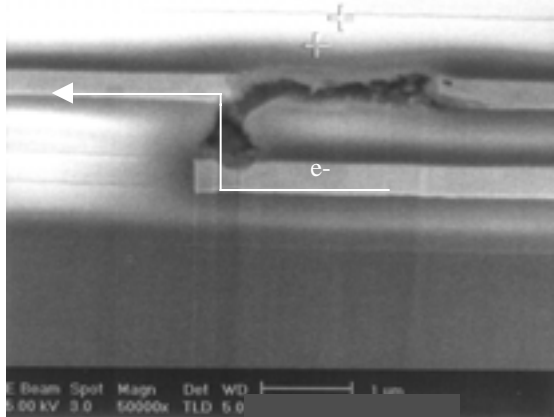
configurations (ii) and (v) respectively, as indicated in Figure 6(a). Figure 7(a) shows that the electrons flow from M1 into the left segment of M2 only. However, a void had formed in the via and extended into the *right* limb, where no current was flowing during stress. In Figure 7(b), the void that had formed in the middle via, extended into both the left and right segments above the via. In this case, the electrons were flowing from M1 through the middle via into both M2 limbs. However, in both cases, the voids have resulted in an open failure of the test structure.

Fig.7: FIB images of voids in the middle via of a representative failed dotted-I for (a) test condition (ii) and (b) test condition (v). Samples were stressed at  $T = 350^{\circ}\text{C}$  and  $j = 2.5 \text{ MA/cm}^2$  in each M2 segment.

In case (ii), the right limb had no current during test and was therefore a “passive” reservoir that acted as a source of Cu atoms for the middle via. This slowed the build-up of tensile stress, increasing the lifetime of the structure compared to cases (v) and (iv). However, the  $t_{50}$  for this configuration was lower than that of the left segment in case (iii). In case (iii), we saw that the right segment was acting as an active source for Cu atoms, and therefore suppressed the build-up of tensile stress in the central via even more effectively than in case (ii). As observed from the failure analysis shown in Figure 7(b), a void had formed in the via and extended into the right limb. As a tensile stress develops under the central via, Cu from the “unstressed” right segment diffuses towards the central via because of the resulting stress gradient. The void therefore grows into the right segment.

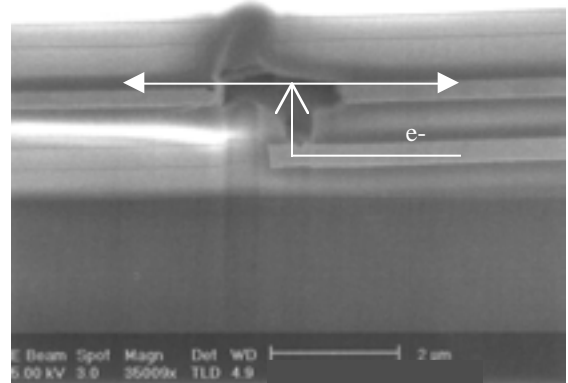
(b)

For configuration (v), electrons moved from the middle via to the two outer vias, with the same electron current density in both segments and twice the electron current density in the middle via. With the Ta liners at the bottom of the vias acting as sites for atomic flux divergence, a tensile hydrostatic stress builds up rapidly in the central via until void nucleation occurs. As observed in Figure 7(b), a void had formed in the middle via and in the line just above the middle via where the tensile stress was largest, resulting in simultaneous failure of both the right and left segments.
