XRD ANALYSIS IN FRONT OF A CORROSION CRACK TIP

C. GHEORGHIEȘ, S. LEVCOVICI, V. PĂUNOIU, L. GHEORGHIEȘ,
C. OANCEA, I. OSTACHE, P. ALEXANDRU

During exploitation of the heat exchangers some damages can appear in the contact region between the gaskets and the stainless steel walls. The studies upon the material were performed using SEM microscopy, X-ray diffractometry and the finite element method. The obtained data allow the explanation of the complex damage mechanism of the heat exchanger wall. Following our research, the manufacturing technology of the heat exchangers was changed and this way the rebuts were eliminated. The performed research is based upon physical methods and the damage mechanism of the heat exchanger plates is explained by means of the physical phenomena that appear and develop during working conditions.

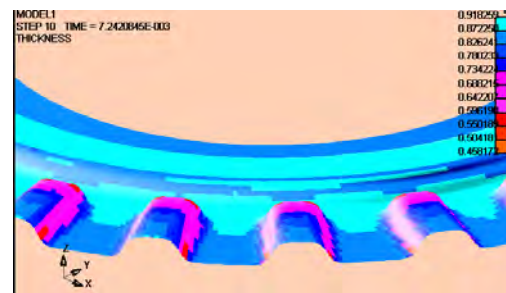
Fig. 2. The thickness variation of the material

In figure 2 we can see the lack of uniformity of the thickness of our processed material. Even so, the thickness variations are rather small.

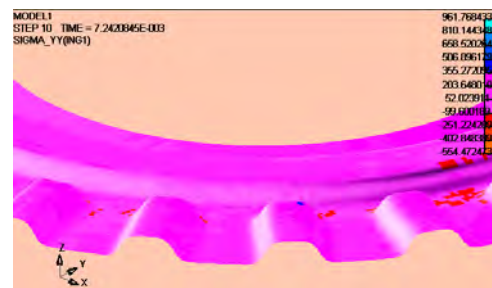
Fig.3. The variation of the radial tension

The variation of the radial tension is presented in figure 3.

According to the values obtained for the radiate tensions, disposed perpendicular to the cracks, we could conclude that as it is normal, stretching tensions around 300 MPa appear at the edge of the gaskets' area, close to the outlet, in the middle of the material. In the lower part, the tensions are also of stretching type, with the same kind of values. In the upper part we have compression tensions, so that a bending effect emerges. The normal circumferential tensions are compression-type on the entire thickness and breadth of the fixing gaskets' area.

with a tangential tension close to the modulus of radiate and circumferential tensions. So, there is a possibility that cracks appear in a zigzag shape, such as we could really notice at a close exam of the affected areas.

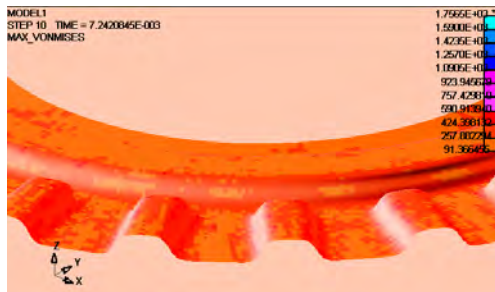
Fig. 4. The distribution of the Von Mises flow tensions

The distribution of the Von Mises flow tensions is presented in figure 4, according to the Von Mises flow criterion, when the plastic state is attained if the value of the flow resistance surpasses the value given by the next formula:

From this last simulation it was concluded that the tensions that appear during the deformation process cannot represent a real cause for cracking of the heat exchanger plates [2, 4].

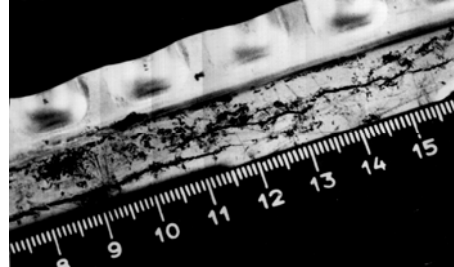
Fig. 6. A cracked area of the heat exchanger

It is interesting to notice that cracks appear every time at the inlet area of the hot thermal agent (the hottest area) and also on the plane portion of the rib

We can see clear corrosion traces of the piece's surface on the cracked area. These traces do not appear on the rest on the surface, which is also in contact with the same working fluid.

Taking into account the processing and the functioning conditions of the material, we consider that it would have been better to use for the heat exchanger plates a stainless steel with stabilized structure, by adding molybdenum. Such steel is 316 AISI, which contains 2 – 3 % Mo (molybdenum).

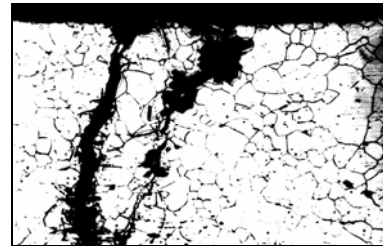
Fig. 9. Transcrystalline crack (attacked sample; 500 ×)

The electrolytically attacked samples have a microstructure made of thin austenitic grains with 8-point granularity, according to STAS 5490-80, with thin inter-grain precipitates of carbides (See fig. 9 and 10).

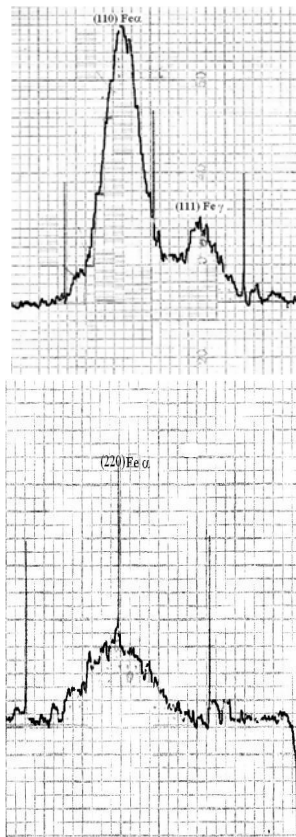
Fig. 13. X-ray diffraction spectra fragment according to the scheme from fig. 12a

The diffraction spectra of the material from the area unaffected by cracks are presented in figures 13 (according to the scheme from fig. 12a).

These spectra fragments inform about the structural states and the tension states from the superficial layer, with a depth of approximately 80 μm

The presented diffraction spectra show the change of form of the diffraction lines for the martensitic and austenitic phases because of the action of the tensions from the areas near the tip of the crack. Their shape proves the existence of a $Fe_{\gamma} \rightarrow Fe_{\alpha}$ type of transformation because of the action of the internal tensions. Thus, we concluded that the material is unstable from the structural point of view and this is why the pitting-type of corrosion is favored in the stretched areas of the ply where the fittings are placed. Also, we deduced that the material is inhomogeneous from the texturing degree point of view, thus being favored the structural instabilities at the crystalline grain level, having negative consequences on the corrosion behavior of the heat exchanger plates.

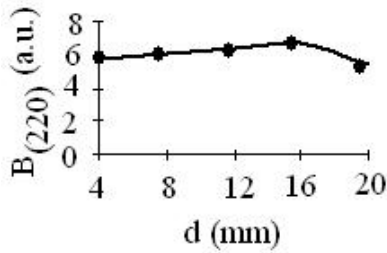
Fig. 14. The distribution of B (220) size

1) The B_{211} magnitude (see fig. 14) is directly proportional with the level of the 2nd degree internal tensions. From the obtained data we could see that B_{211} increases towards the tip of the crack, thus showing the existence of a tensional inhomogeneity of the material at the level of the mosaic block. This aspect induces the beginning of the pitting corrosion (narrow spaces).

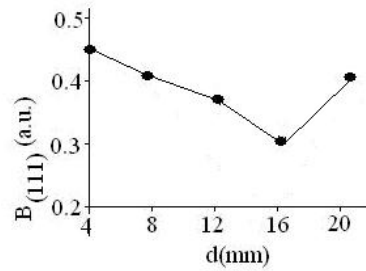
Fig. 17. The distribution of $B_{(111)}$ size

4) The B_{111} magnitude (see fig. 17) is directly proportional with the breaking tension of the austenitic phase. From the data we concluded that towards the tip of the crack the breaking tension decreases, fact that also favors the beginning of the breaking of the material.

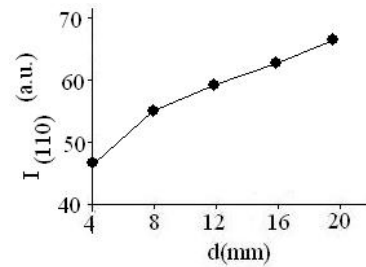
Fig. 18. The distribution of the integral intensity $I_{(110)}$

5) The I_{110} integral intensity magnitude (see fig. 18) is directly proportional with the quantity of the martensitic phase. This magnitude increases towards the tip of the crack as a consequence of the instability of the martensitic phase caused by the 1st and 2nd degree internal tensions. Thus, the martensitic phase appears, it is metastable and it creates supplementary tensions into the material.

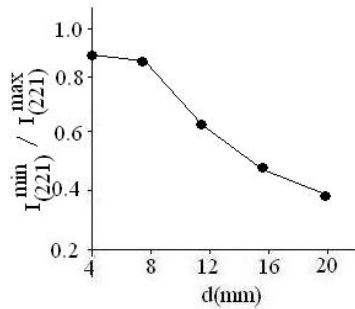
Fig. 20. The distribution of the $I_{211}^{\min} / I_{211}^{\max}$ ratio

7) The $I_{211}^{\min} / I_{211}^{\max}$ ratio magnitude (see fig. 20) is proportional with the density of dislocations from the martensitic phase. The decrease of the density of dislocations leads to the decrease of the plasticity properties of the martensitic phase towards the tip of the crack, thus having negative effects over the answer of the material to mechanical stress (stretching or compressing).
