CERN - PS DIVISION

PS/RF/ Note 2002-042

MODIFICATION OF PSB FAST PHASE SHIFTER FOR 2002

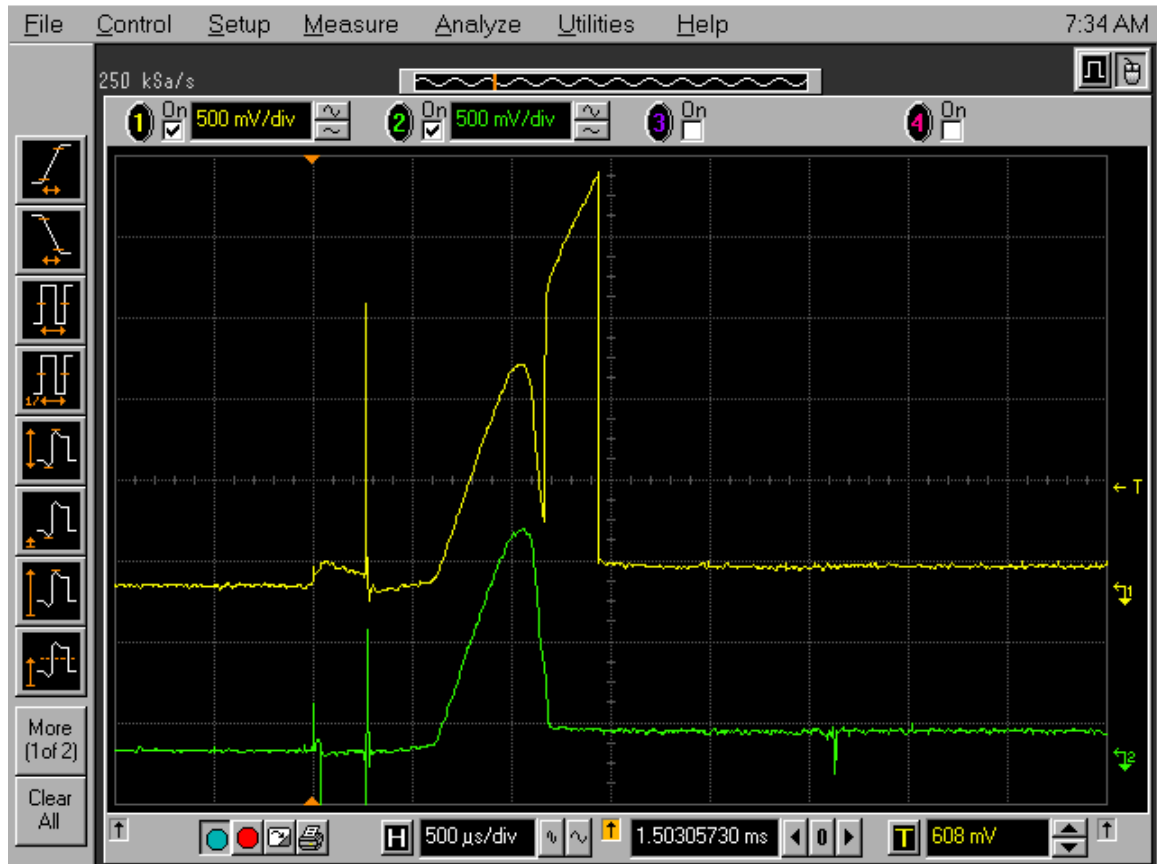
Figure 2

When the output of the flip-flop that performs the clocking of the latched input data was observed, the difference between the 2 units became obvious. It could be seen that initial clock generated at power up by the flip-flop on a bad unit, was 300 μ s shorter and only 1.25V instead of 2.5V.

Observing pin 9 of IC 11 or IC 34 on an oscilloscope as shown in fig. 2, we can see that Channel 2 (green) demonstrates a pulse at power up that is too short and too low to clock the input data into the latches. Channel 1 demonstrates the response of a good unit at power up giving time for all data bits to be clocked high.

The simplest solution seemed to be to use the available 8 MHz clock that was connected to pin 11 of IC11 (see fig.1) to permanently strobe or clock the latches of the unused input. Soldering a connection between pin 11 and pin 3 of IC 11 achieved just this.

The second problem required that the clock generated by pin 9 of IC 11, which also goes to pin 5 of IC 30, be disconnected, so as to make sure that the Data Loaded LED

flashes only when phase input 1 is strobed. It was necessary to ground pin 5 of IC30 after the clock was disconnected to ensure the OR operation of IC 30.
