CERN TE-Note-YYYY-000

EDMS No. 1054648

Summary of QRL 7-8 repair and re-installation leak test results.

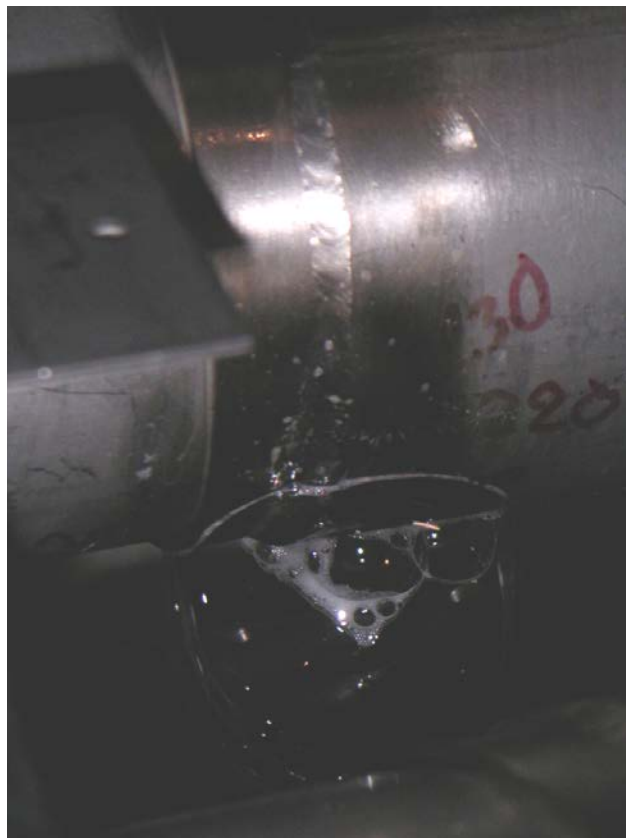
In case of very large leaks, when the obtainable vacuum was not good enough to perform an under vacuum localisation, the volume concerned was slightly pressurised with dry compressed air and the leak localised with bubble spray. Figure 5 shows an example.

Figure 5 – Localisation with bubble spray of a large leak in the interconnection weld of a process line.

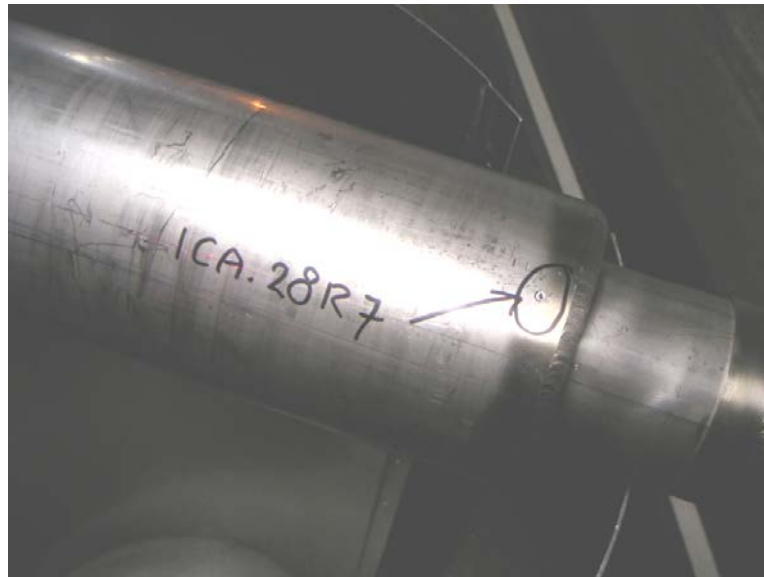
By pumping the leaking process line from both ends with two turbomolecular pumps, both backed by a leak detector, the amplitude of the leak signals as seen by both detectors gave an indication of the longitudinal position of the leak. Following opening of the vacuum envelope at the suspect interconnection, a drilled hole was found in the outer sleeve of the line F compensator.

shells of the thermal shield have their pop-riveted joint at the bottom position where line F is also located.

Figure 10 – Accidentally drilled and pop-riveted F line compensator.

A subsequent modification in the interconnection closing procedure (no in-situ drilling allowed) made sure that such incidents did not happen anymore.
