1 **The Saint-Jude landslide of May 10th, 2010, Quebec, Canada:**
2 **Investigation and characterisation of the landslide and**
3 **its failure mechanism**

38 Abstract

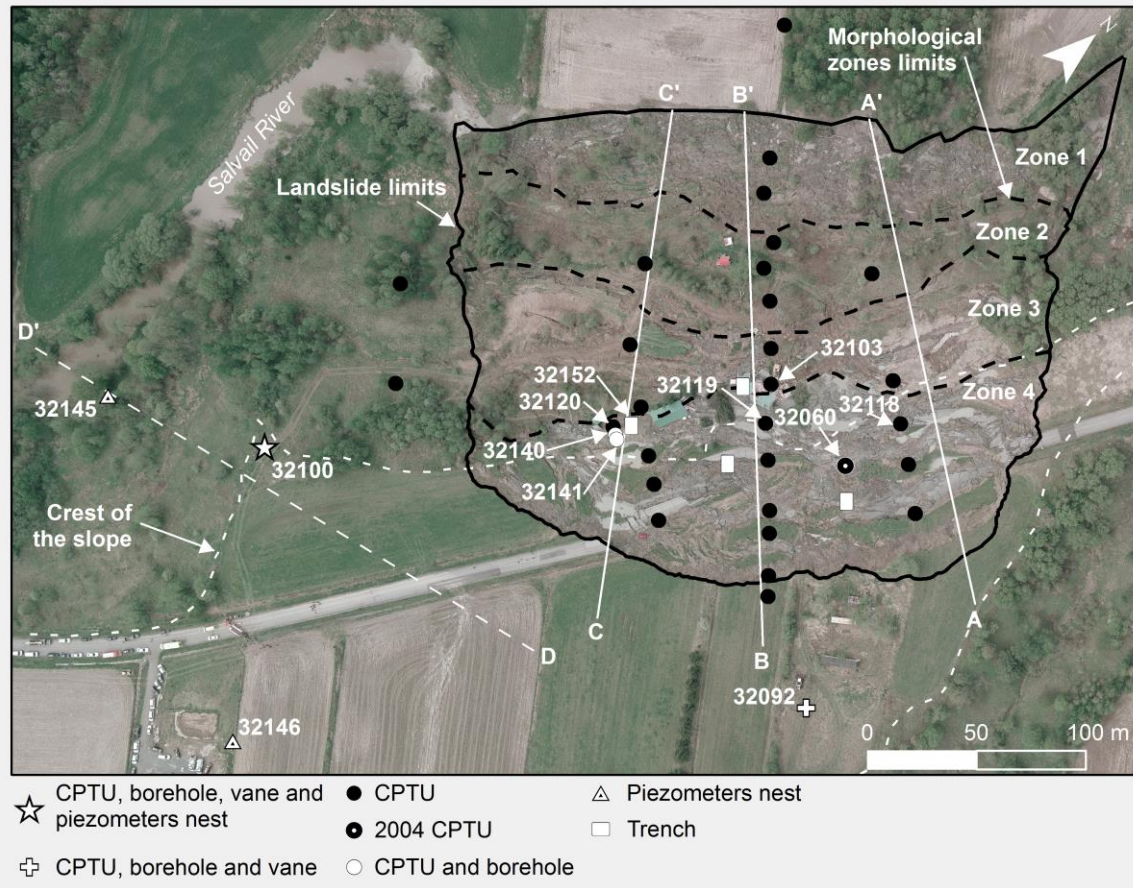
143 Aerial photographs of the site were taken on May 11th 2010, a few hours after the event
144 while excavation works were ongoing near the house (Figure 3). Comparing these aerial
145 photographs to previous ones allowed the identification several targets and the
146 measurement of their displacement due to ground movement. This gives valuable
147 information on the kinematic of failure.

880 Figure 3 : Aerial view of the landslide at Saint-Jude taken on May 11th 2010, the day after
 881 the landslide while excavation work were going on near the house (Courtesy of
 882 MTMDET). Location of the soundings, delimitations of the landslide and its morphological
 883 zones as well as the crest of the slope are shown. Note that the crest of the slope inside the
 884 landslide footprint is the estimated crest of the slope location before the landslide.
 885 Movement direction of the debris is toward the Salvail River, at the top of the photograph.

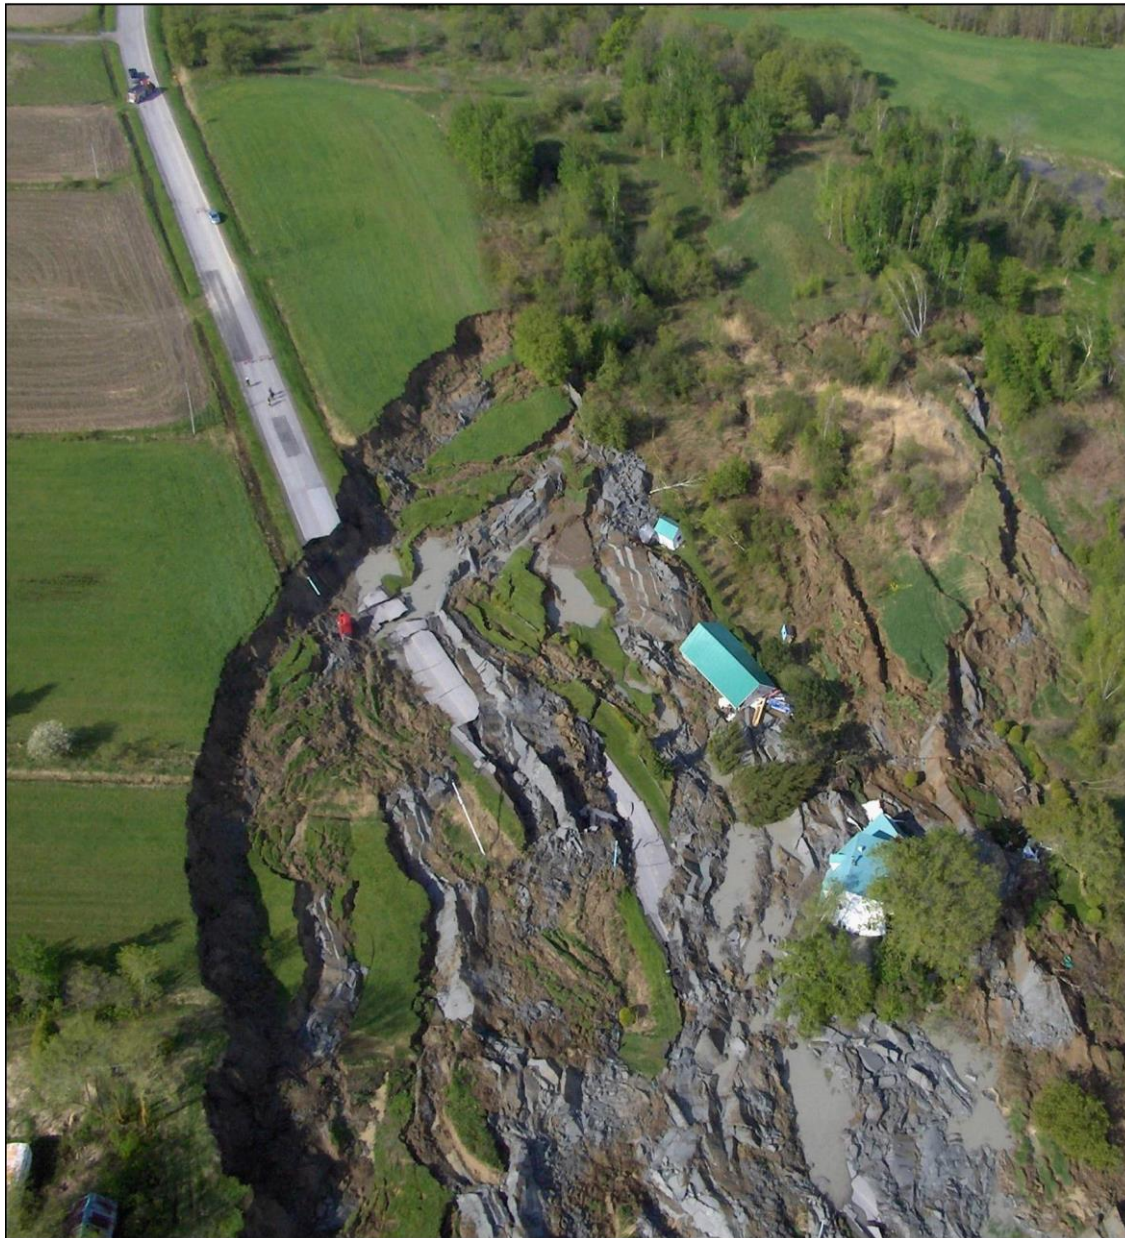
424 Zone 3 is a highly fissured area where the ground dislocated in several blocks. A part of
425 this zone can be observed on the upper left of Figure 4. Some of the blocks in this zone
426 have flat tops covered with intact vegetation and other blocks are prisms with tips pointing
427 upward. As explained above, these blocks are respectively called grabens and horsts.
428 Figure 6 presents a photograph of a horst and a graben at the boundary between zones 3
429 and 4, near the house. As can be observed on Figures 8 and 9, spacing and inclination of
430 fissured as well as the presence of vegetation on top of some horsts in zone 3 make it
431 difficult to distinguish horsts from grabens in this zone. Stratigraphy in these blocks is
432 generally close to the horizontal, indicating that they did not rotate during the landslide.
433 These blocks moved over a distance of 20 to 40 m towards the Salvail River and subsided

887 Figure 4: General photograph of the south part of the landslide taken on May 11th 2010,
888 the morning after the landslide. Movement direction is toward the top left of the photograph
889 (Courtesy of MTMDET).

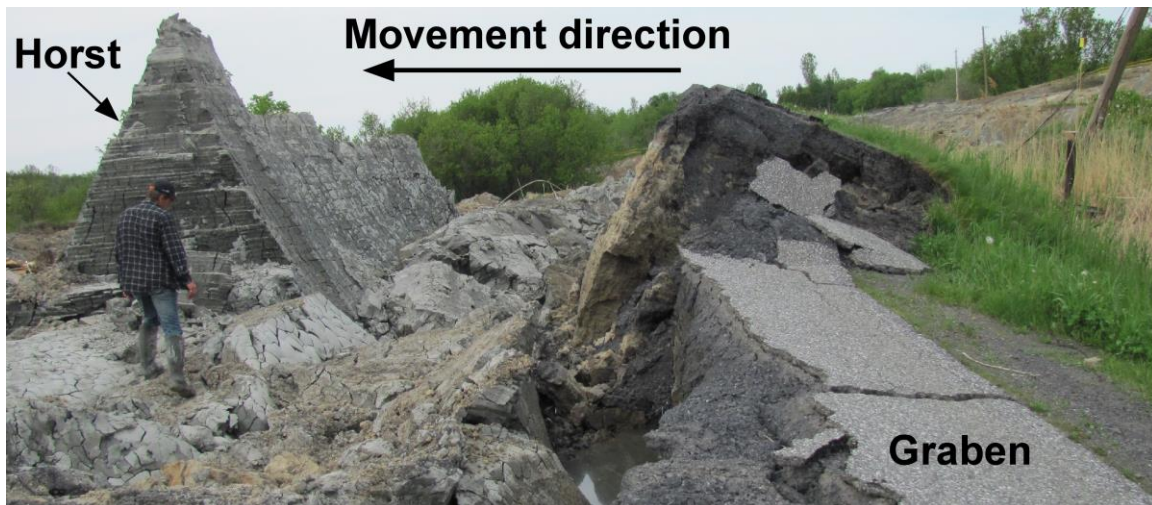
130 road or grass. Note the electric pole still standing on the right of the photograph on Figure
131 5 and trees standing in the debris after the landslide on Figure 6. Horsts and grabens are
132 typical of spreads (Cruden and Varnes 1996; Hungr et al. 2014) occurring in sensitive clays
133 and were described by Odenstad (1951), Carson (1979a, b), Tavenas (1984), Grondin and
134 Demers (1996), Demers et al. (2000), Locat et al. (2008), and Locat et al. (2011a). In
135 addition to horsts and grabens, inclined slices were observed in the debris. Figure 7 presents
136 a photograph of these inclined sliced located in the south part of the landslide.

891 Figure 5 : Photograph of a horst and a graben close to section B-B' (see Figure 3), taken
 892 on May 18th 2010, eight days after the landslide (modified from Locat et al. 2012a).

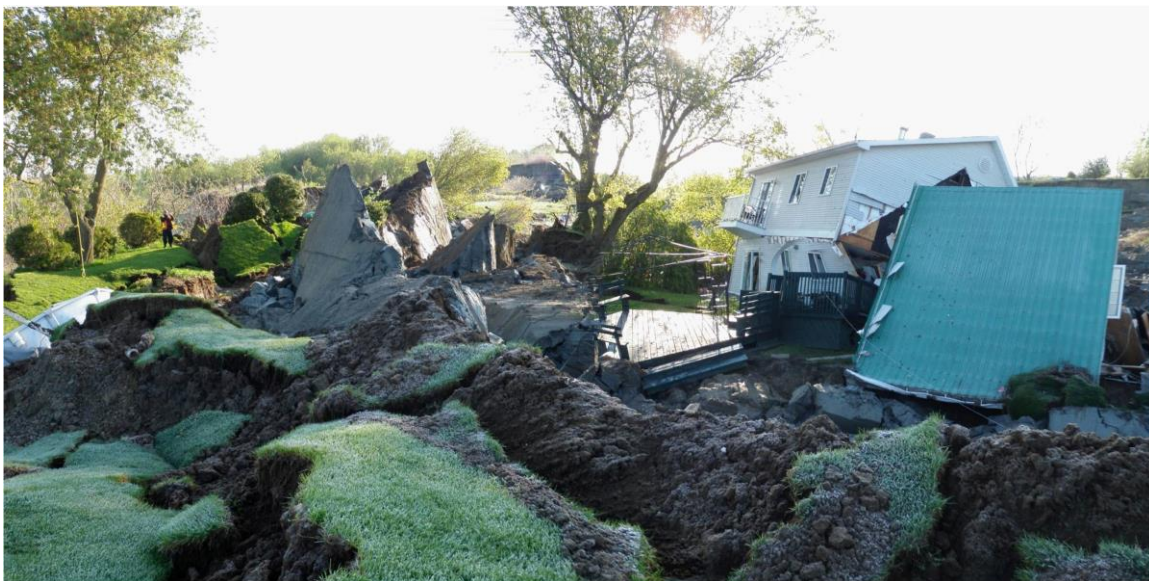
894 Figure 6: View of a graben and a horst behind the house, close to section B-B' (see Figure
 895 3) taken on May 11th 2010, the morning after the landslide (Courtesy of MTMDET).
 896 Movement direction is toward the left of the photograph.

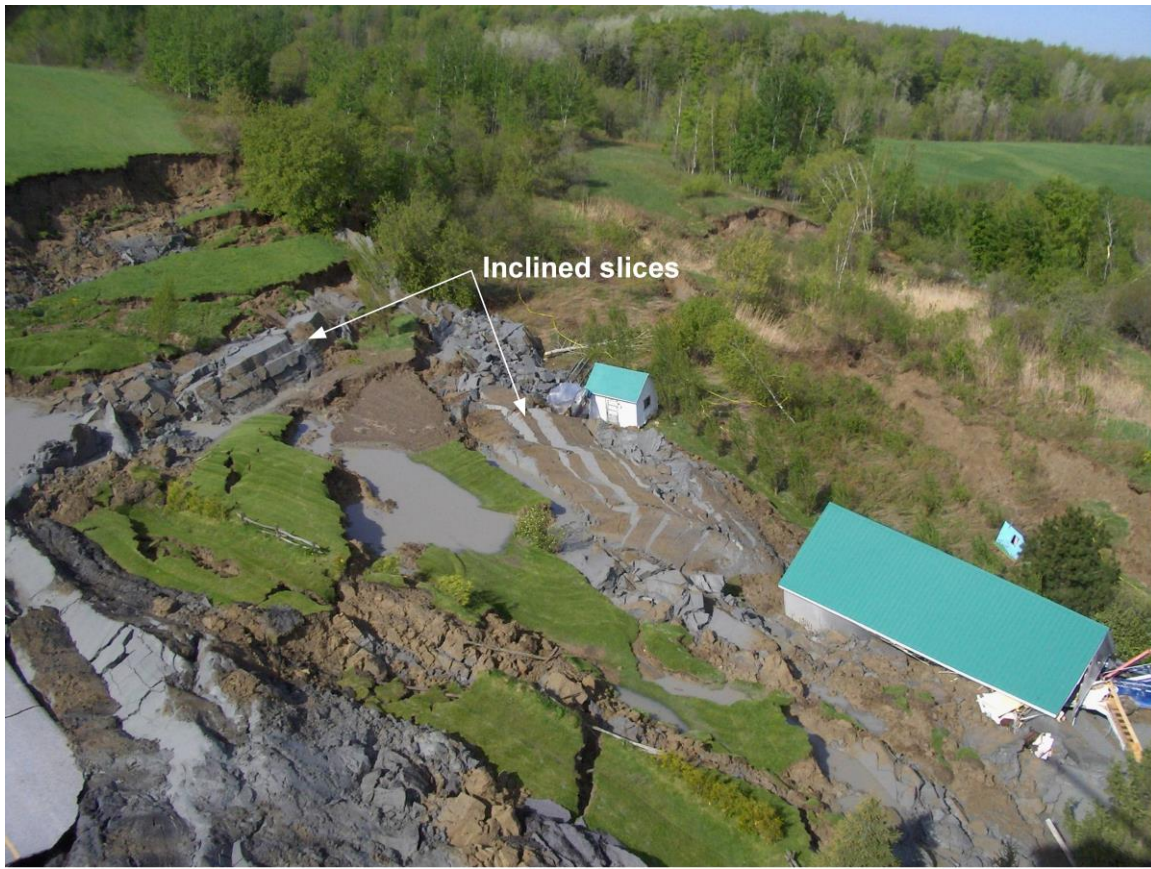
437 Zone 4 is an area formed of soil that was dislocated into horsts and grabens forming sub-
438 parallel stripes oriented perpendicular to the direction of the landslide movement. Part of
439 this zone located in the south part of the landslide is presented on the left of Figure 4. In
440 this zone, grabens are well defined by their flat tops covered with vegetation or pieces of
441 the road. Horsts form ridges of clay with sides inclined at around 60° (varying between 45
442 and 80°). Figure 5 shows a good example of a horst and a graben from zone 4. As can be
443 observed on the horst on Figure 5, stratifications inside horsts were inclined between 0 and
444 17° with the horizontal (see also Figures 8a and 9a), indicating that these blocks did not
445 rotate much during the movement. It was also observed that the downstream side of some
446 horsts was covered with brown soil, thus coming from the sandy crust and contrasting with

898 Figure 7: Closer view of the south part of the landslide, close to section C-C' (see Figure
899 3), showing inclined slices (Courtesy of MTMDET). Movement direction is toward the
900 right of the figure. Photograph taken on May 11th 2010, the morning after the landslide.

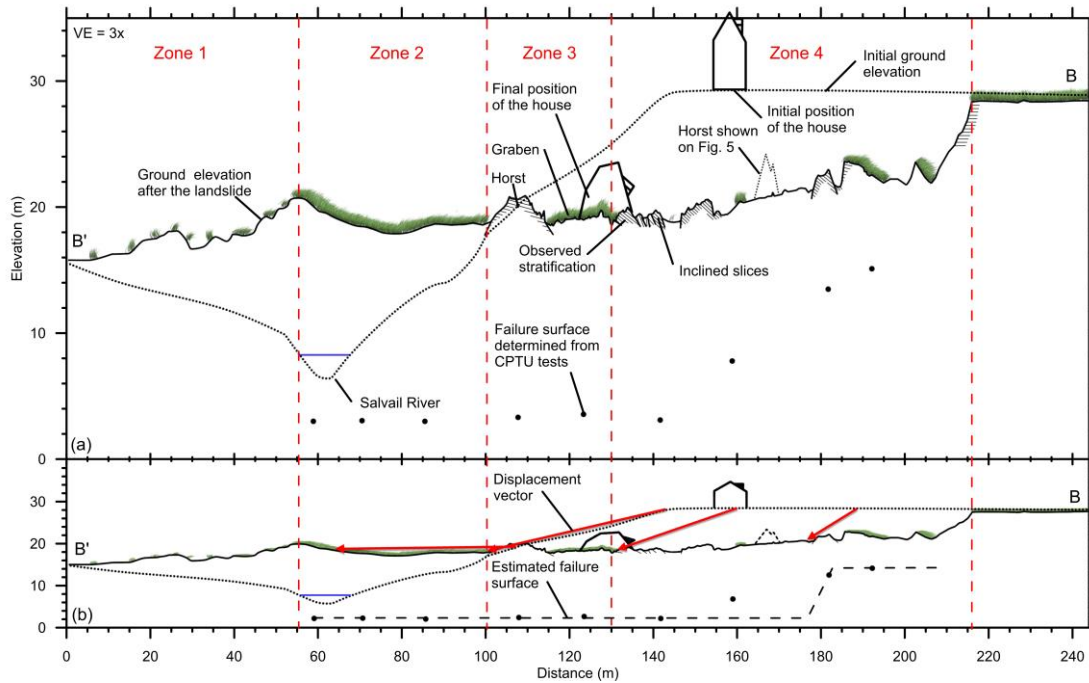
327 Figures 8 and 9 show that the failure surface is located at an elevation of about 3.5 m near
328 the toe of the initial slope. This is about 2.5 m below the elevation of the Salvail River bed
329 observed on the north of the 2010 landslide, when its course was blocked by debris. At the

330 locations of cross-section B-B' (Figure 8), the failure surface is horizontal over a length of
331 about 115 m, away from the initial river location, and then rises up suddenly to an elevation
332 of around 14 m before reaching the backscarp of the landslide. Along cross-section C-C'
333 (Figure 9) the failure surface is at about elevation 3.5 m for about 125 m inside the deposit
334 and comes up to an elevation of about 14 m. Along cross-section A-A', the main failure
335 surface has a length of about 80 m before jumping to about an elevation of 14 m (see section
336 Discussion on the landslide failure mechanism).

902 Figure 8 : Cross-section B-B'. (a) 3 times vertical exaggeration and (b) to scale (see Figure
 903 3 for location of cross-section, modified from Locat et al. 2012b).

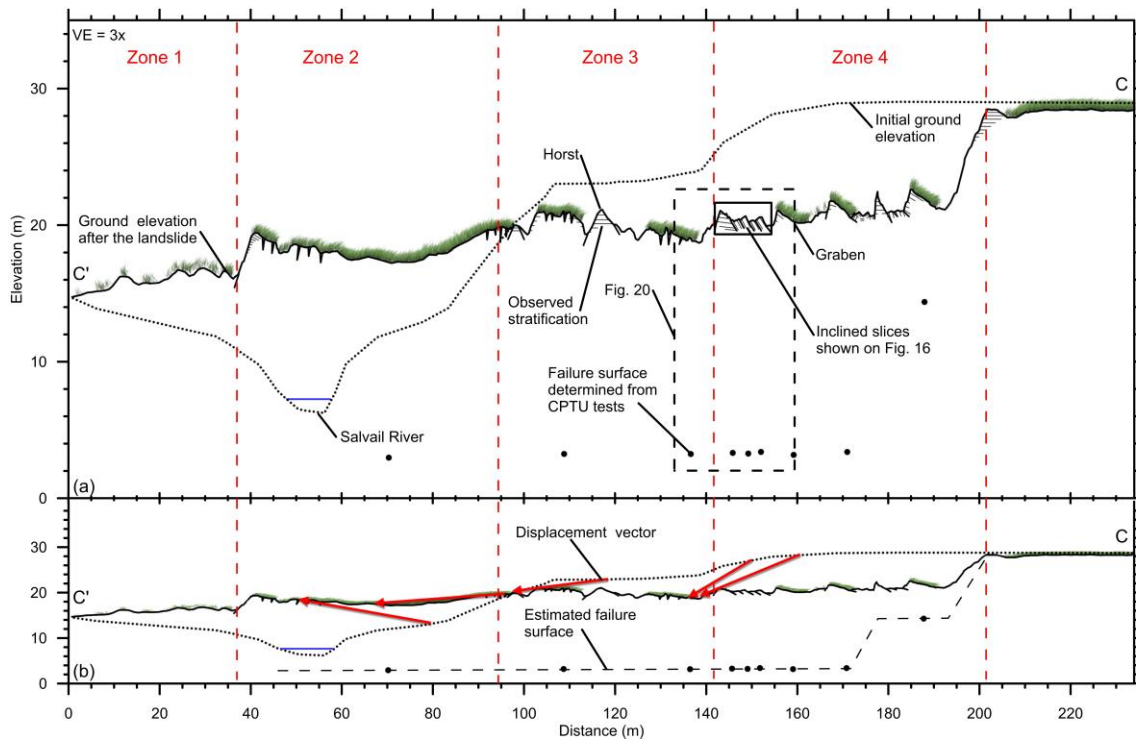
311 Figures 8 and 9 show cross-sections B-B' and C-C' of the topography before and after the
312 landslide (dashed and full black lines, respectively), location of the interpreted failure
313 surface (black dots), and displacement vectors of some debris (red arrows). Locations of
314 these cross-sections is shown on Figure 3. In this section, only cross-sections B-B' and C-
315 C' are presented. Cross-section A-A' will be discussed later in section Discussion on the
316 landslide failure mechanism. On Figures 8 and 9, the topography after the landslide was
317 obtained from a DEM made by combining aerial and terrestrial LIDAR surveys performed
318 a few days after the landslide. The failure surface was defined using the difference in shear
319 strength of the intact soil and the above remoulded debris from the 26 CPTUs performed
320 inside the scar and located on Figure 3. An example is shown on Figure 14 where, the

582 as seen on Figures 8 and 9. The presence of high artesian pressure could have influenced
583 the location of the failure surface, located 2.5 m below the river bed. However, the exact
584 influence of such hydraulic conditions on the failure mechanism is still not clear and should
585 be studied further in relation to spreads. These observations indicate that, most probably,
586 the 2010 landslide seems to be of natural origin and triggered by erosion near the toe of the
587 slope with high artesian pressures under the river, and deepening of the river with time with
588 a process similar to that described by Lefebvre (1986).

905 Figure 9 : Cross-section C-C'. (a) 3 times vertical exaggeration and (b) to scale (see Figure
 906 3 for location of cross-section, modified from Locat et al. 2012a).

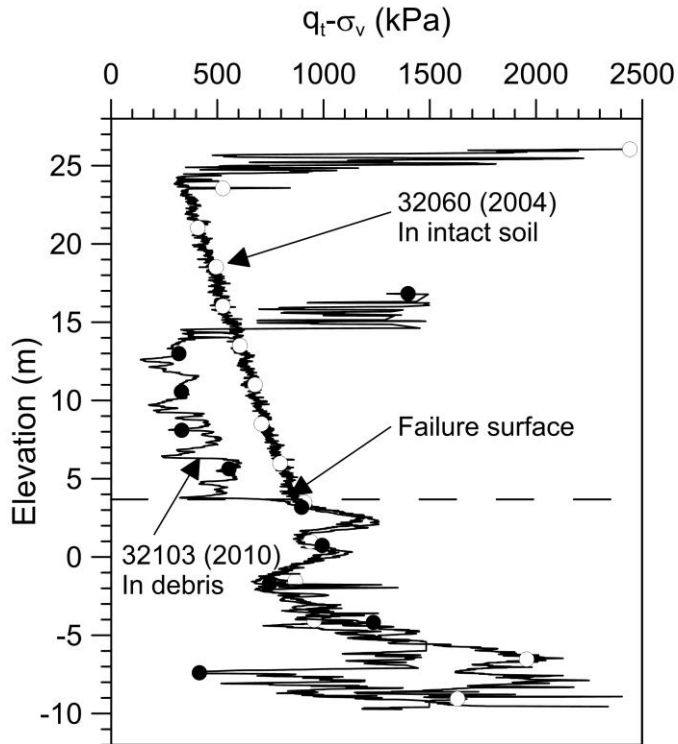
321 CPTU carried out at location 32060 in 2004, before the landslide, shows the intact strength
322 profile of the soil and the CPTU at location 32103 shows the strength profile of the debris
323 following landslide deformation. The difference between both profiles delimits the debris
324 thickness having lower strength than the intact soil. The point where the strength of the soil
325 in the debris becomes equal to the intact strength defines the elevation of the failure surface
326 (Figure 14).

926 Figure 14 : Failure surface identified by CPTU (see Figure 3 for location of CPTUs).

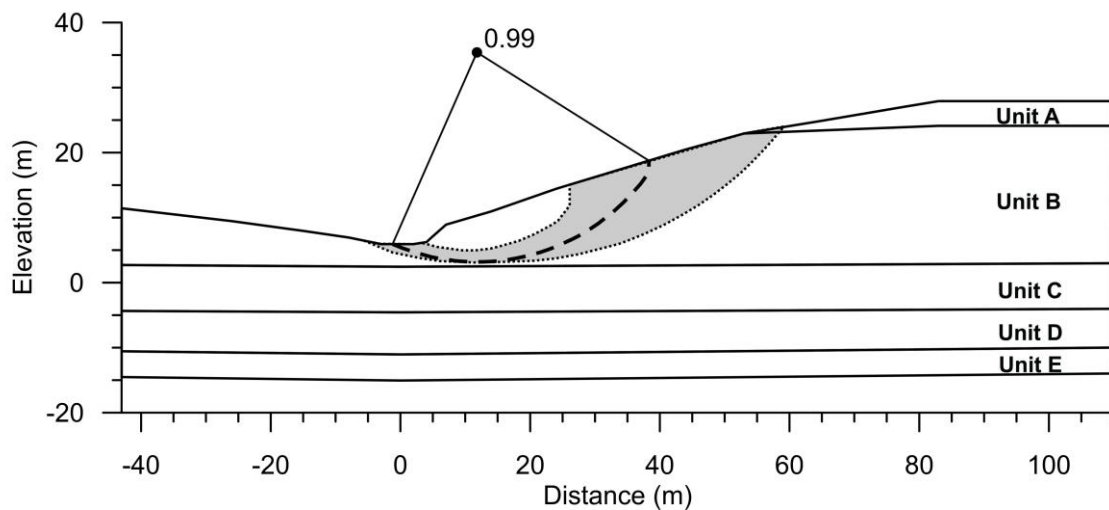
367 The shear strength parameters used in the drained stability analysis are based on
368 preconsolidation pressure, as suggested by Lefebvre (1981). Cohesion and friction angle
369 values used for each unit are presented on Table 1. The grid and radius method was used
370 in SLOPE/W to determine the critical failure surface in drained conditions that gives an
371 indication of the long term stability of the slope. The critical failure surface and its
372 corresponding safety factor are presented on Figure 15. It can be seen that the critical failure

568 Based on the 2010 Saint-Jude landslide investigation presented above, and as shown in
569 Figure 15, the bottom half of the slope was marginally stable, which is in accordance with
570 the observed ground movements on aerial photograph of the site taken in august 2009 (see
571 section The landslide and its regional context). Debris of these movements were probably

928 Figure 15 : Result of the drained stability analysis showing the critical failure surface
 929 (dashed line) and grey zone locating failure surfaces giving a safety factor lower than 1.05.

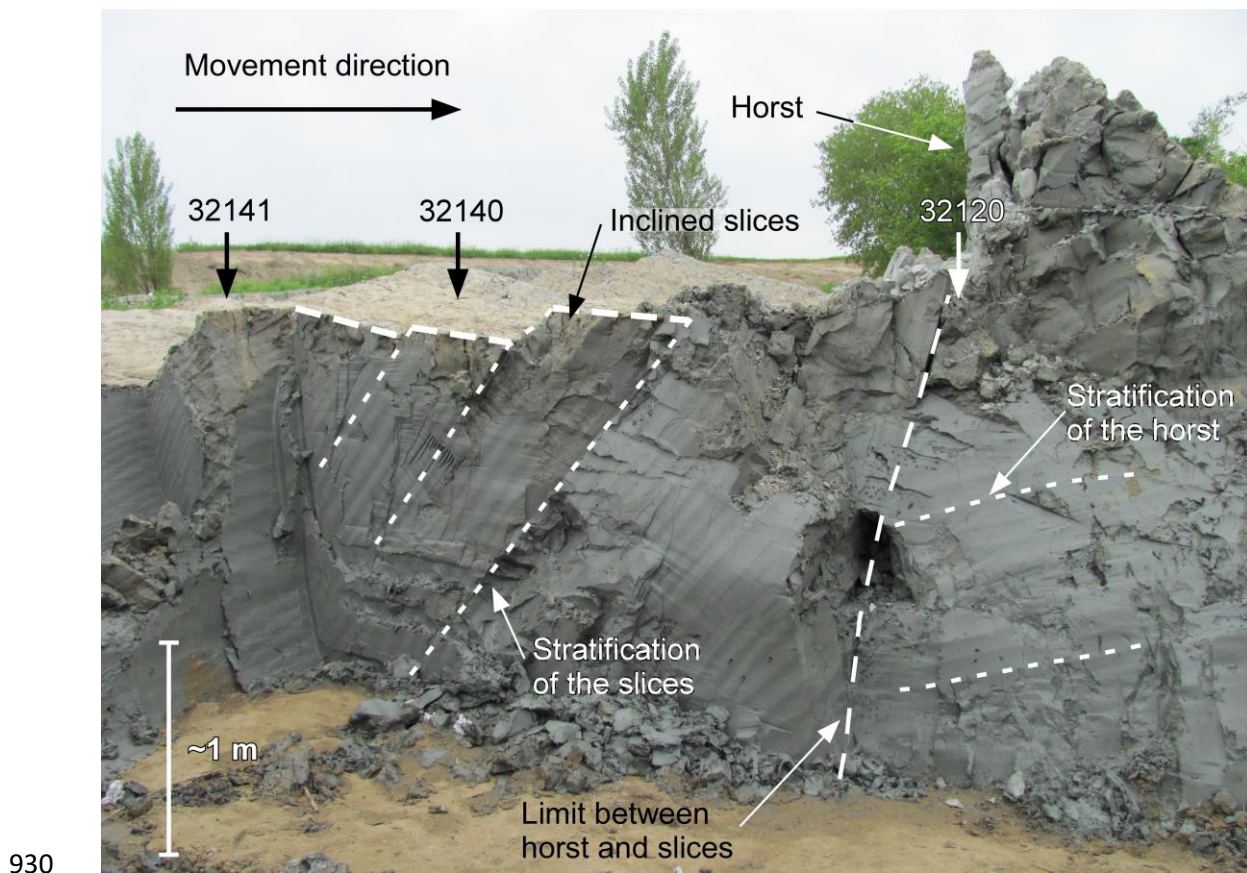
460 Four trenches were dug into horsts and inclined slices in order to observe their
461 stratifications and understand their formation (see Figure 3 for location). Figure 16 shows
462 a photograph of the trench at location 32152, close to cross-section C-C' (see Figures 3 and
463 9a for location) and inclined slices shown on Figure 7, that has been observed in details. It
464 can be seen that the trench has exposed close 3 m of the top of these inclined slices (on the
465 left side of Figure 16) and a horst (on the right side of Figure 16) in the direction
466 perpendicular to the general ground movement. The two types of structure are easily
467 differentiated by the inclination of their stratifications. The stratifications of the horst are
468 inclined of about 10° to the horizontal whereas the stratifications of the slices are inclined
469 close to 50° to the horizontal. The contact between the horst and the slices has an angle of

Figure 16 : View toward the south-west of the trench 32152 and approximate location of sites 32120, 32140 and 32141 (see Figures 3 and 9 for location). The picture was taken on June 16th 2010, about a month after the landslide (modified from Locat et al. 2012a).

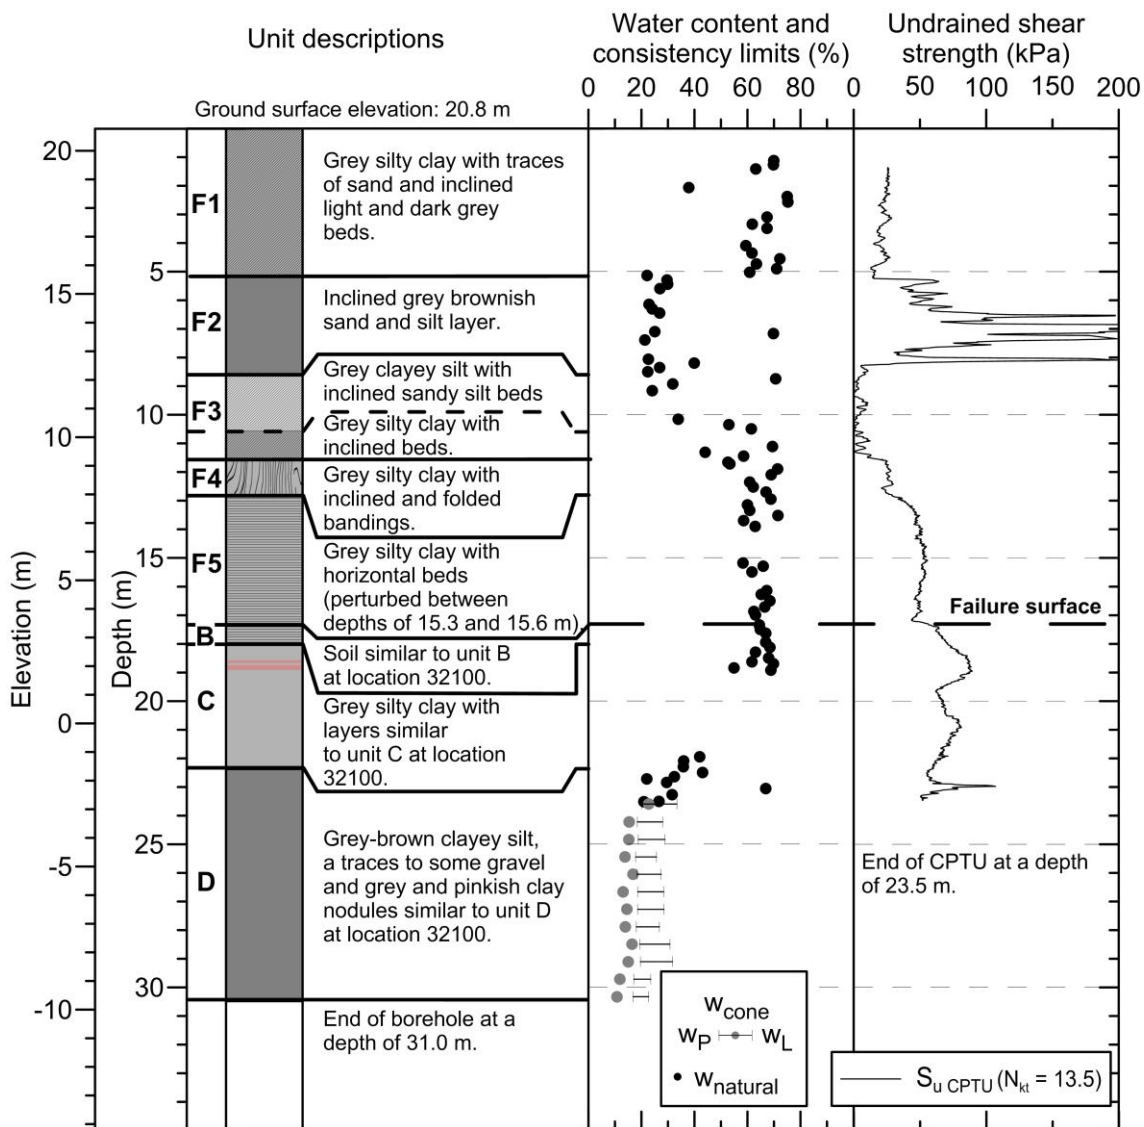
483 Results from location 32140 (Figure 17) show that the failure surface is located at a depth
484 of 17.3 m (elevation 3.5 m). Debris at this location are represented by unit F subdivided
485 into 5 subunits: F1, F2, F3, F4, and F5. Subunit F1 (from the ground surface down to a
486 depth of 5.1 m) is a soft silty clay with stratifications inclined at about 45° to the horizontal.
487 The average water content of this subunit is about 65%, typical of unit B on Figure 10, and
488 the shear strength varies from 16 to 27 kPa with depth. This subunit corresponds to the
489 inclined slices observed from the ground surface (see figure 13). From a depth of 5.1 m
490 down to a depth of 8.6 m, a stiff grey-brown sandy and silty layer is observed (subunit F2).
491 CAT scan shows that stratification in this subunit is slightly inclined. The average water
492 content is 29% and shear strength has values between 50 to 200 kPa. These characteristics

493 are typical of the sandy crust observed in intact soil (unit A on Figure 10). Underneath, lays
494 a very soft grey clayey silt having inclined stratifications from depths 8.6 to 11.6 m,
495 becoming more clayey at a depth of 11 m (subunit F3). The water content of this subunit
496 varies from 24 to 70% and the shear strength is around 3 kPa. A soft grey silty clay with
497 inclined and folded stratification was found from depths of 11.6 to 12.8 m (subunit F4).
498 The average water content is 62% and shear strength varies from 24 to 30 kPa with depth.
499 Geotechnical properties of this subunit indicate that it is soil from unit B that was sheared
500 during the landslide. Stiff grey silty clay with horizontal stratifications (subunit F5) is found
501 below a depth of 12.8 m down to the failure surface observed at a depth of 17.3 m. The
502 water content in this subunit is generally constant with an average value of 65%. The shear

503 strength varies from 45 to 65 kPa with depth. These characteristics are typical of the soil
504 from unit B on Figure 10 that was involved in the landslide. Below the failure surface units
505 B, C, and D, also detected in the intact deposit (Figure 10), are observed. They exhibit

935 Figure 17 : Geotechnical profile at location 32140 in the debris (see Figure 3 for location).

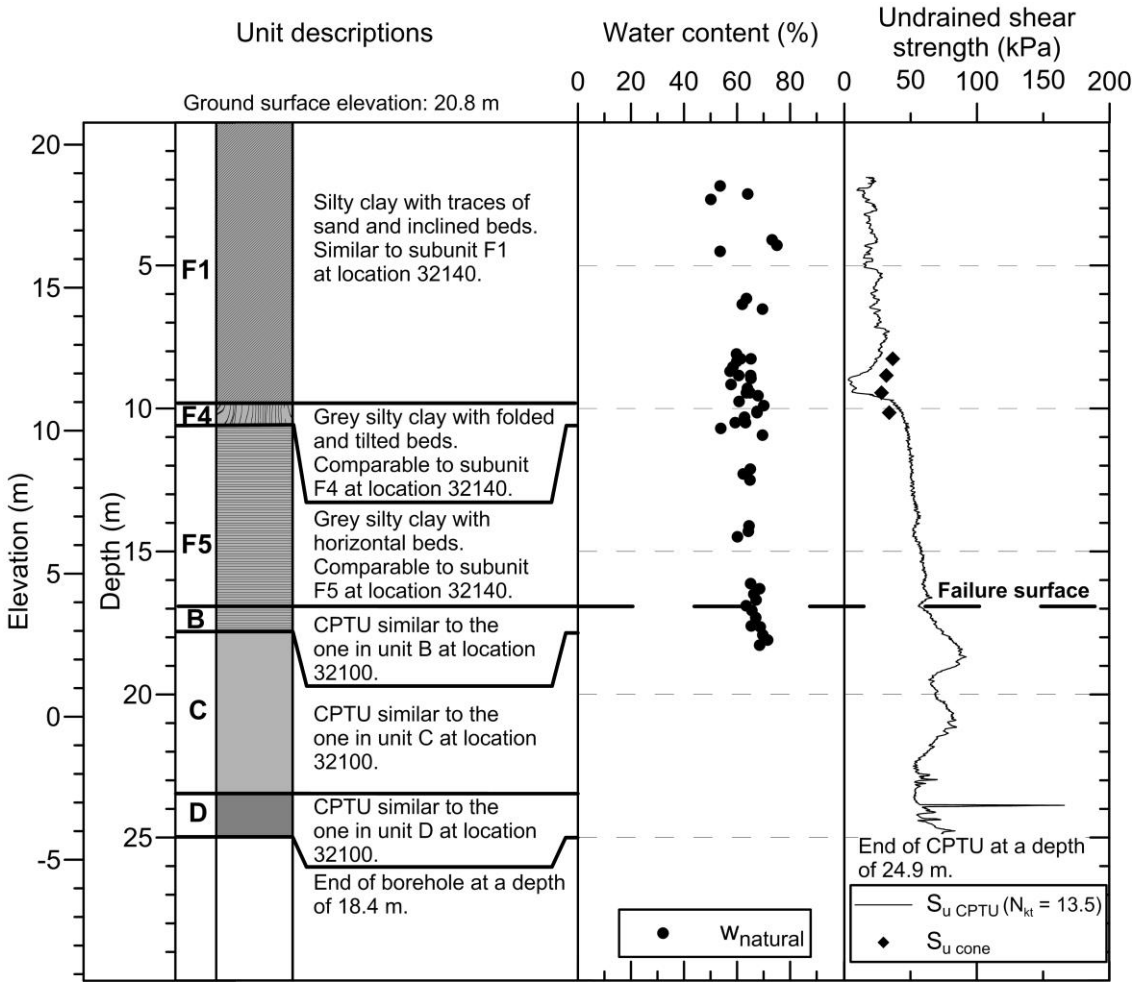
508 Results from location 32141 (Figure 18) show that the failure surface is located at a depth
509 of 16.9 m (elevation 3.7 m). Debris (unit F) at this location can be divided in three subunits:
510 F1, F4 and F5 (Figure 18). A soft grey silty clay with stratification inclined at about 45° to
511 the horizontal is observed from the ground surface down to a depth of 9.8 m. Its water
512 content is 62% in average and the shear strength varies from 17 to 39 kPa. Around a depth
513 of 9 m, the shear strength decreases down to about 3 kPa. This subunit presents similar
514 properties with subunit F1 at location 32140 (Figure 17) and originates from unit B. It
515 corresponds to inclined slices observed at the ground surface. Grey stiff soft silty clay with
516 folded and disturbed stratifications is observed from a depth of 9.8 m to a depth of 10.6 m.
517 A sample from this subunit shows almost vertical stratifications. The average water content

518 is 65% and the shear strength of the soil varies from 40 to 50 kPa. The properties of this
519 subunit correspond to soil from unit B (Figure 10) that was sheared during the landslide
520 and are comparable with subunit F4 from location 32140 (Figure 17). From 10.6 m down
521 to the failure surface, at a depth of 16.9 m, a stiff grey silty clay with horizontal
522 stratifications is observed. The average water content of this subunit is 65% and its shear
523 strength varies from 50 to 70 kPa with depth. The properties of this subunit are similar to
524 those observed for unit B (Figure 10), involved in the landslide and are similar to those of
525 subunit F5 (Figure 17). Below the failure surface Units B, C and D have been observed and
526 represent the intact soil under the landslide body.

937 Figure 18 : Geotechnical profile at location 32141 in the debris (see Figure 3 for location).

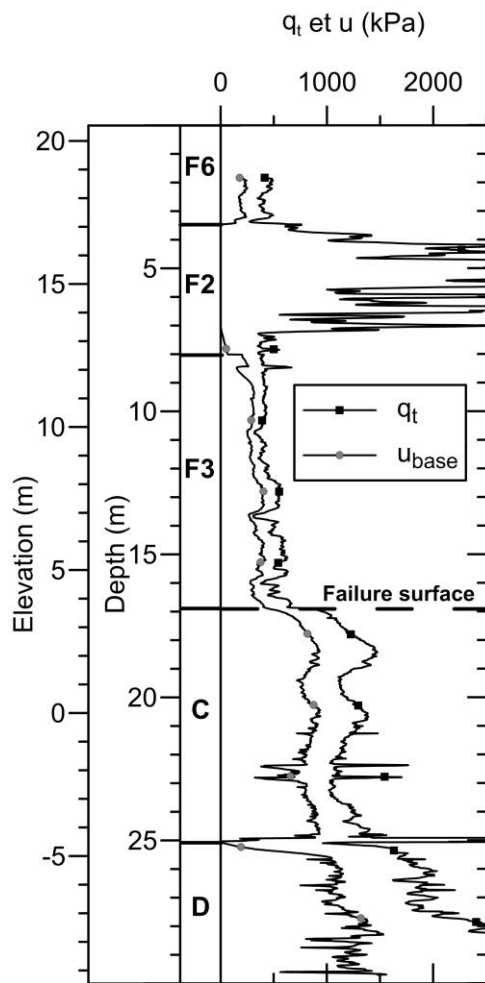
527 CPTU 32120 was performed through the horst exposed by trench at location 32152 and
528 shown on Figure 16, near location 32140 (see Figure 3). Figure 19 shows the results of this
529 in situ test. At this location, the failure surface is at a depth of 16.8 m (elevation 3.8 m) and
530 the debris (unit F) can be divided in three subunits: F6, F2 and F3. It can be seen that for
531 the first 3 m, the corrected tip resistance and the pore pressure are about 400 kPa and 200
532 kPa respectively, indicating a clayey soft layer. This indicates that this subunit F6
533 corresponds to the horst observed at the ground surface (Figure 16). From a depth of 3 m
534 to a depth of 8 m, the corrected tip resistance varies from 550 kPa to more than 3000 kPa
535 and the pore pressure is closed to 0 kPa. This indicates a stiff coarse layer very similar to
536 the sandy crust observed at location 32140 (subunit F3 on Figure 17). From a depth of 8 m

537 down to a depth of 16.8 m (depth of the failure surface), the soil is a grey silty clay and the
538 corrected tip resistance varies between 300 to 600 kPa. Under the failure surface the intact
539 soil, observed at location 32100 (Figure 10) is also detected and corresponds to units B, C
540 and D as observed at location 32100.

939 Figure 19 : CPTU profile at location 32120 in the debris and corresponding units as
 940 described on Figures 17 and 18 (see Figure 3 for location).

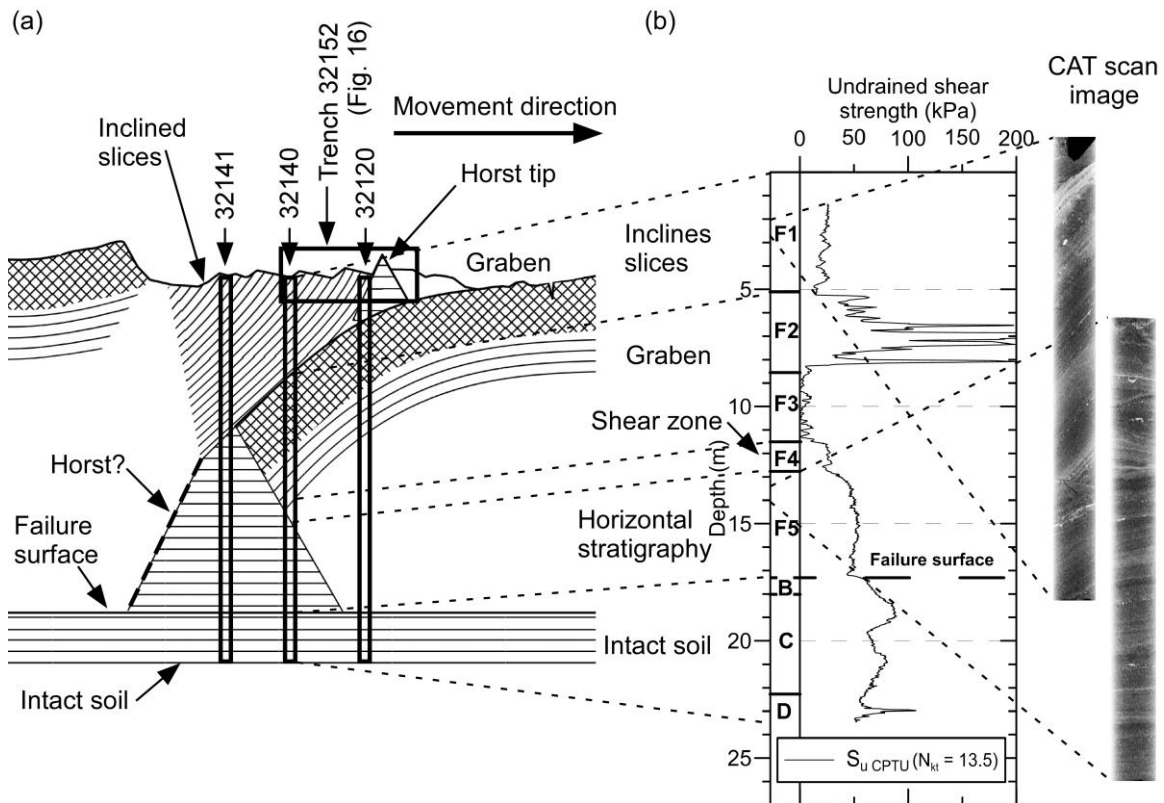
541 Figure 20 shows location of profiles 32120, 32140 and 32141 (Figures 17 to 19) on part of
542 cross-section C-C' (see Figure 9), and examples of CPTU and CAT scan images obtained
543 at location 32140. A schematic cross-section of the trench and location of these soundings
544 is also shown in figure 20. Extrapolating the subunits observed at locations 32120, 32140
545 and 32141 it is possible to get an approximate interpretation of the stratigraphy near these
546 three soundings. The top soft silty clay layer (subunit F1 on Figures 17 and 18) represents
547 inclined slices observed at trench 32152, on Figure 16 and is originating from unit B
548 (Figure 7). Unfortunately, this latter unit is so homogeneous in terms of water content that
549 it is not possible to specify the original elevation of that subunit. The stiff sandy layer

550 (subunit F2 on Figures 17 and 19) seen on profiles 32140 and 32120 represents the sandy
551 crust of a graben (graben on the right on figure 20a). Subunit F3, observed at locations
552 32140 and 32120 (Figures 17 and 19), would correspond to soil below this sandy crust
553 forming the bottom of this graben. Units F5 (Figures 17 and 18) show horizontal
554 stratification above the failure surface that seems to correspond to the lower base of the
555 horst. Subunit F4 (Figures 17 and 18) would correspond to a shear zone forming between
556 the base of the inclined slices and the horst sides during the movement. The tip of that horst
557 (observed on Figure 16 and corresponding to subunit F6 on Figure 19) could have been
558 swept away on top of the graben by the inclined slices, creating the observed morphology.

942 Figure 20 : a) Approximate interpretation of the stratigraphy near trench 32152 (Figures 9
 943 and 16), view toward the south-west, including location of soundings and b) example of
 944 CPTU and CAT scan results at location 32140 (see Figures 3 and 9 for location, modified
 945 from Locat et al. 2012a).

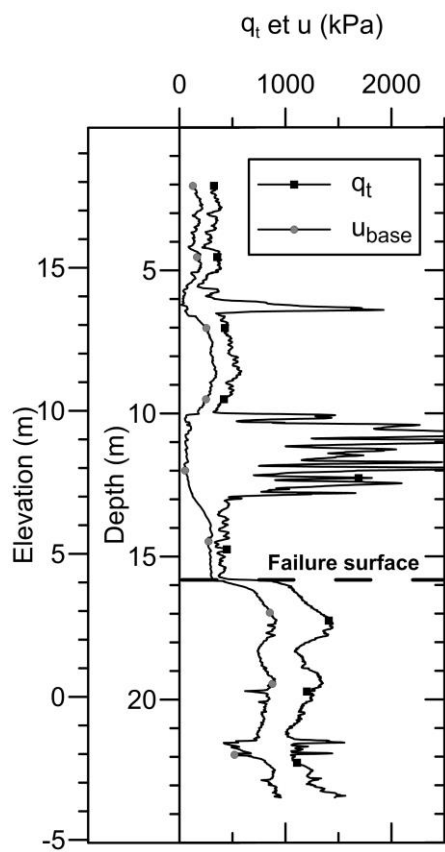
559 Another CPTU, performed at location 32118 in the debris (see figure 3 for location) shown
560 on Figure 21, presents a sandy crust (unit A as presented on figure 7) located a depth of 10
561 m in the debris and covered by what can be identified as a silty clay layer. This indicates
562 that, at this location, the sandy crust, originally located at the ground surface, subsided from
563 an elevation of 28 m down to an elevation of 10 m and was covered by other debris. This
564 is considered to be the lowest elevation where the sandy crust is found in the debris. This
565 detailed study shows the complexity of soil movements that occurred during the 2010
566 Saint-Jude spread.

947 Figure 21: CPTU profile at location 32118 in the debris showing the sandy crust,
 948 introduced on figure 10, buried at a depth 10 m under a layer of silty clay (see Figure 3
 949 for location).
