## Thermographic non-destructive evaluation of carbon fiber-reinforced polymer plates after tensile testing

Henrique Fernandes · Clemente  
Ibarra-Castanedo · Hai Zhang · Xavier  
Maldague

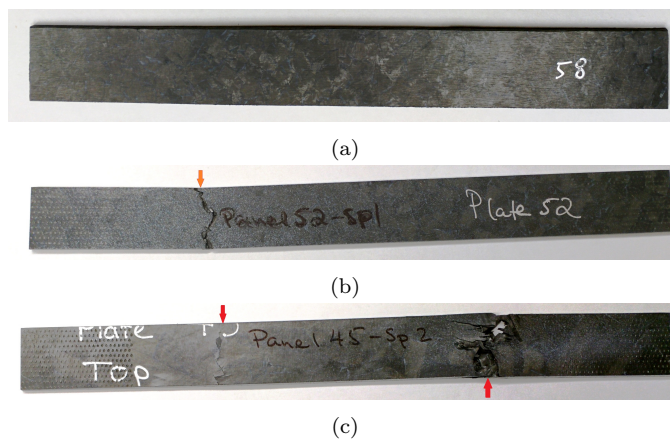
for tensile testing, i.e. they were subjected to a controlled tension until failure. Crashed samples were then inspected using IT techniques in order to identify cracks that occurred after the failure. By visually examining the samples the region of failure was concentrated in one or two regions, however smaller cracks may have occurred in other regions of the panels and these smaller cracks are the focus of the IT inspections in this paper. Figure 6 shows ROS samples inspected in this paper. Figure 6a shows a short strand sound sample while Figure 6b shows a short strand sample after failure due to tensile testing. Figure 6c shows a long strand sample after failure due to tensile testing. Failures in Figure 6b and Figure 6c can be visually seen.

Fig. 6: ROS samples inspected. Arrows indicate the main region of failure. (a) Short strand sound sample, (b) short strand sample after failure due to tensile testing, and (c) long strand sample after failure due to tensile testing.

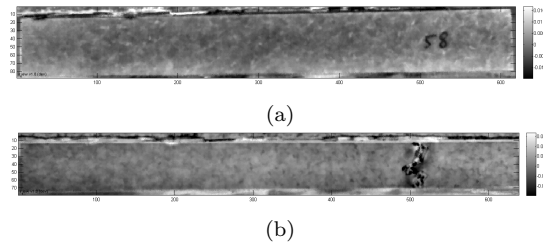
Figure 8 shows the fourth EOF image obtained with PCT for a pulsed thermography inspection of two short strand samples. Figure 9 shows the fourth EOF image obtained with PCT for a line scan inspection of the same samples inspected in Figure 8 (both samples in Figure 9 were tested simultaneously). Figure 8a and 9a show results of an inspection of an untested sample while Figure 8b and 9b show results of a tested sample, i.e. after failure due to a tensile test previously performed.

Both pulsed thermography and line scan were able to reveal some of the strand/resin structure on the surface of the sample. However, it was not possible to detect micro cracks on the samples, only the large crack which is visible

to the naked eye. With pulsed thermography it was possible, however, to identify more resin-rich areas than when using line scan. On the other hand, line scan highlighted only some particular strands on the surface of the sample which are not related to cracks or resin-rich areas.

Fig. 8: Pulsed Thermography. PCT results (EOF 4) of short strands samples. (a) Untested sample and (b) after tensile test.

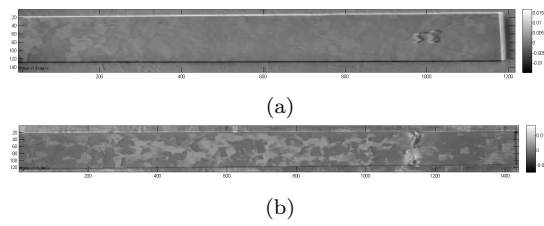
Fig. 9: Line Scan Thermography. PCT results (EOF 4) of short strands samples. (a) Untested sample and (b) after tensile test.

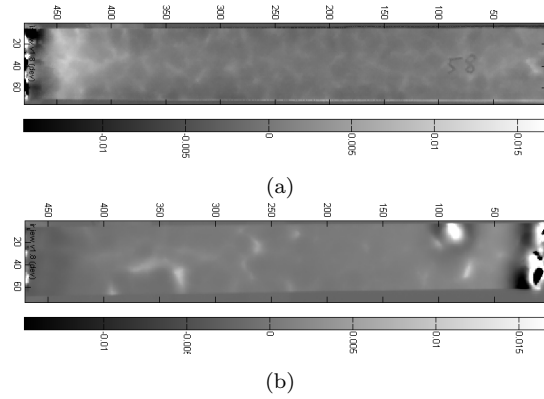
Fig. 10: Vibrothermography. PCT results (EOF 4) of short strands samples (same inspected in Figure 11). (a) Untested sample and (b) after tensile test.

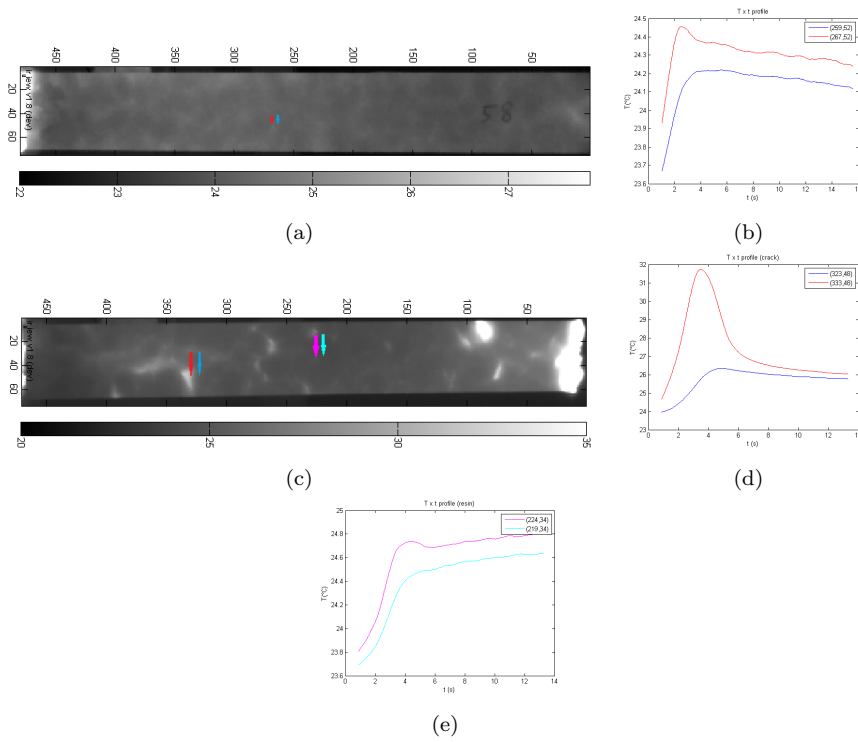
On the other hand, with vibrothermography inspection, it was possible to detect the small cracks spread throughout the sample. Figure 11 shows the unprocessed temperature images for the case of both untested sample (Figure 11a) and tested sample (Figure 11c). Also, temperature profiles of some pixels are presented to illustrate the difference between a resin-rich area (Figure 11b and Figure 11e) and a crack (Figure 11d). The regions corresponding to the temperature plots are marked on the images with small color arrows (it is possible to see the colors on the electronic version of the paper). While in a resin-rich spot the temperature increase was less than  $1^{\circ}\text{C}$ , in a small crack spot the temperature increase was almost  $10^{\circ}\text{C}$ . Figure 10 shows the result of the same inspections processed with PCT. Figure 10a shows PCT result image of untested sample and Figure 10b shows PCT result image a sample after tensile test. Since the large failure of the crashed sample (Figure 10b) separated the sample into two parts, only results from the larger part are presented (which corresponds to more than 80% of the sample size).

If one compares the vibrothermography results obtained from short and long strands some differences can be noticed. First, short strand samples presented more widespread damage after failure when compared with long strand samples. In the case of long strand samples, the region of failure was concentrated to one or two major cracks and no small cracks were detected in other regions of the sample. Also, very few resin-rich areas were detected. On the other hand, in the case of small strand samples, several small cracks were detected on the samples as well as the presence of several resin-rich areas. Second, it is possible to distinguish between large and small cracks and also resin-rich areas based on their temperature profiles. For large cracks, the temperature increase could be greater than  $30^{\circ}\text{C}$  (see Figure 12a and Figure 12b), for smaller cracks the temperature increase is around  $10^{\circ}\text{C}$  and for resin-rich areas the increase is less than  $1^{\circ}\text{C}$ .

Fig. 11: Unprocessed temperature images of vibrothermography inspection of short strand samples. (a) Untested (sound) sample at 3.3 s, no cracks are detected, (b) temperature profiles of a resin-rich area and a sound area are present, (c) sample after tensile test at 2.6 s, (d): temperature profiles of a crack and a sound area are present, and (e) temperature profiles of a resin-rich area and a sound area are present.

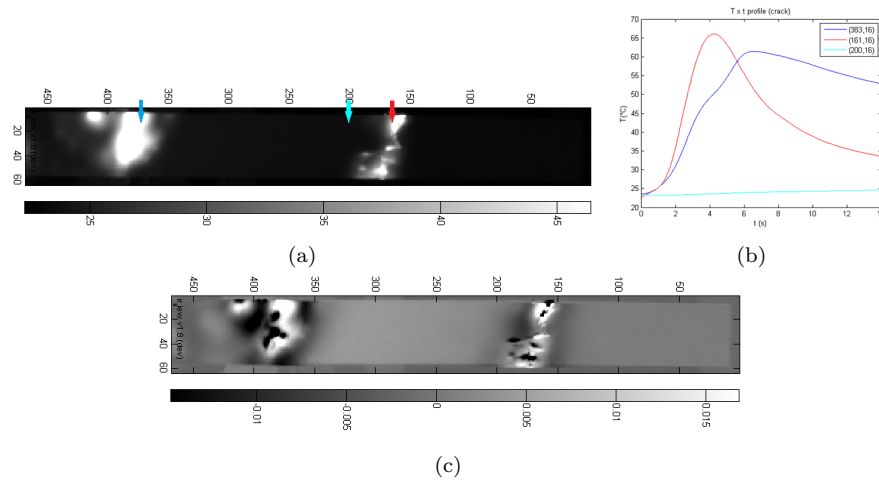
The results of inspections of long strand samples with pulsed thermography and line scan were similar to the ones achieved in the short strand samples case, i.e. only the large cracks were detected. Hence, they are not presented here. Figure 12 shows the results of a vibrothermography inspection of a long strand sample. An unprocessed temperature image is shown in Figure 12a and Figure 12b shows temperature profiles of a sound area and two cracks. Also, an EOF image obtained with PCT applied to the same inspection is shown in Figure 12c.

Fig. 12: Vibrothermography results of long strand samples. (a) Unprocessed temperature image, (b) temperature plot of three points: (383,16) crack #1 which was closer to ultrasound horn coupling region, (200,16) a sound area and (161,16) crack #2 which was the region of main failure in the tensile test, and (c) PCT result (EOF 4) of the same sample.

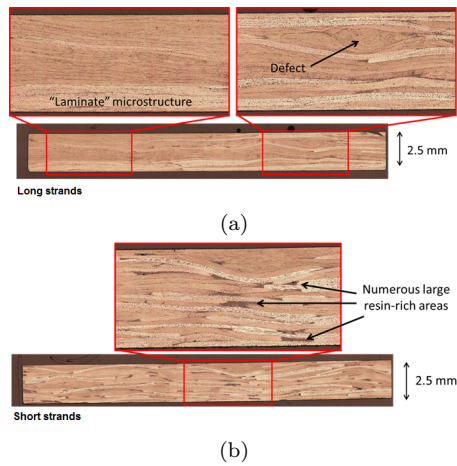
Preliminary comparisons were performed with microscopy and  $\mu\text{CT}$  images. In both cases, the images support the results obtained with vibrothermography. While long strands samples show very few void/resin-rich areas, the short strand samples display a high percentage of voids/resin-rich area content. This could explain the fact that more small cracks were found in the short strand samples in the vibrothermography tests. Figure 13 shows exam-

Fig. 13: Microscopy images. (a) Long strand samples display very few voids and resin-rich-areas while (b) short strand samples display a much higher content of resin-rich areas.

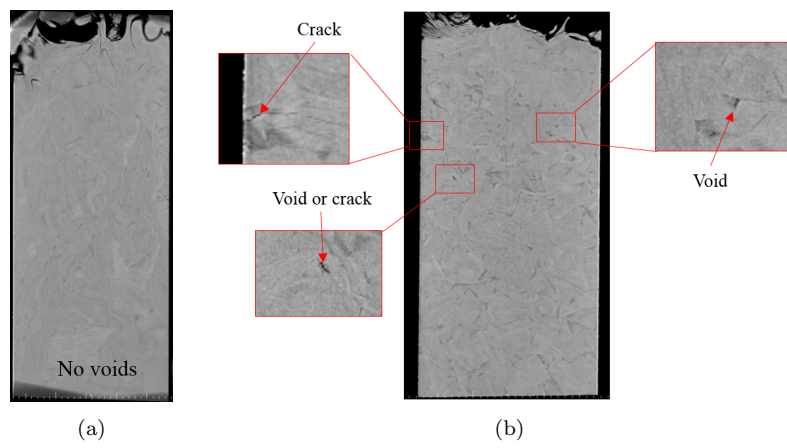
Fig. 14:  $\mu$ CT images. (a) Long strands and (b) short strands. The second presents a higher content of voids and resin-rich areas.
