# Reconstruction of the Grenfell Tower Fire—Thermomechanical Analysis of Window Failure During the Grenfell Tower Disaster

*Maxime Koohkan, Virginie Dréan, Bertrand Girardin\*, Eric Guillaume and Xavier Duponchel, Efectis France, route de l'Orme Des Merisiers, 91193 Saint Aubin Cedex, France*

**Abstract.** Observations and numerical studies have allowed an understanding of the fire development inside apartments and over the façade during the Grenfell Tower fire. During these analyses, the highlighted need was for a deeper investigation into the failure of windows during the fire. This detailed and complex model for window failure validates the thermal breakage criteria used in fire simulations of the whole Grenfell Tower fire. However, the present investigation is dedicated to a single pathway for the influx of fire and toxic smoke. Other pathways from the façade to the apartments, such as the melting of elements surrounding the window frame, are not addressed here. To analyse window behaviour during fire, Finite Element Method thermomechanical modelling is used. First, a heat transfer analysis is performed for windows subjected to the external flames from the identified façade f

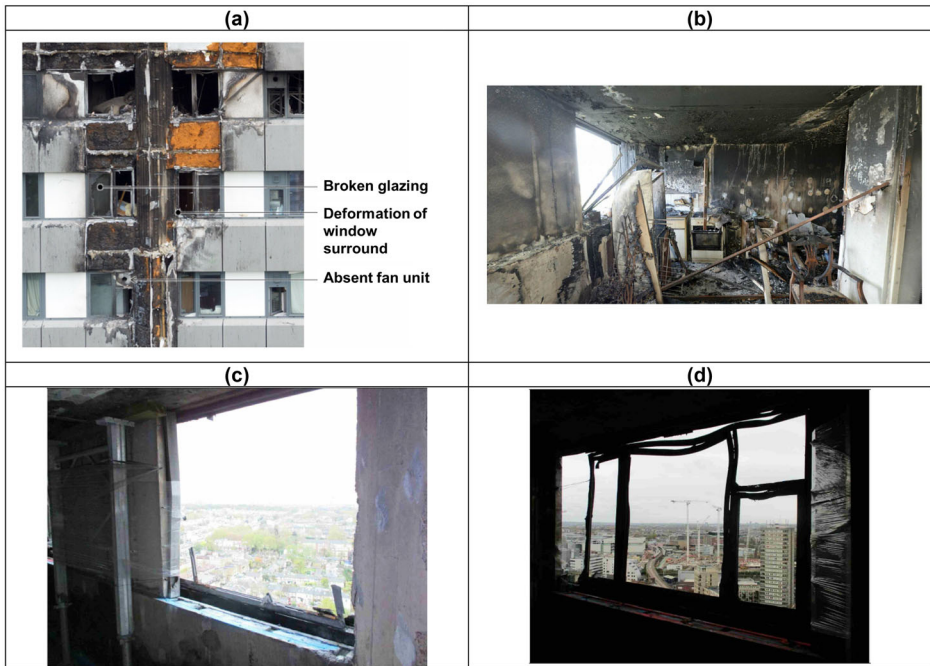
Post-fire observations have shown different failure modes for the windows: inward fallout, outward fallout and partial failure exist at several locations on the Tower. Examples of inward and outward fallout of windows are visible in Fig. 3. However, all the failure modes are quite binary since we observe either a window still in place or no more window.

The failure of the window can also be due, at first, to the softening and/or melting of the uPVC reveal liner, between the window and the concrete structure, when exposed to heat from the external cladding fire, or to thermally induced breakage of the window glazing. Thus, window fallout was probably not the only way of flame exit and re-entry during the Grenfell disaster. However, the failure

**Figure 3. a Failure mode of window frame, L. Bisby's expert report [30], Fig. 11, p. 166, b Inward failure of window frame, J. Torero's expert report [32], Fig. 54, p. 91, c Outward failure of window frame, B. Lane's expert report, Appendix C [31], Table 11C, p. 94, d Partial failure of window frame, B. Lane's expert report, Appendix C [31], Table 11C, p. 95.**

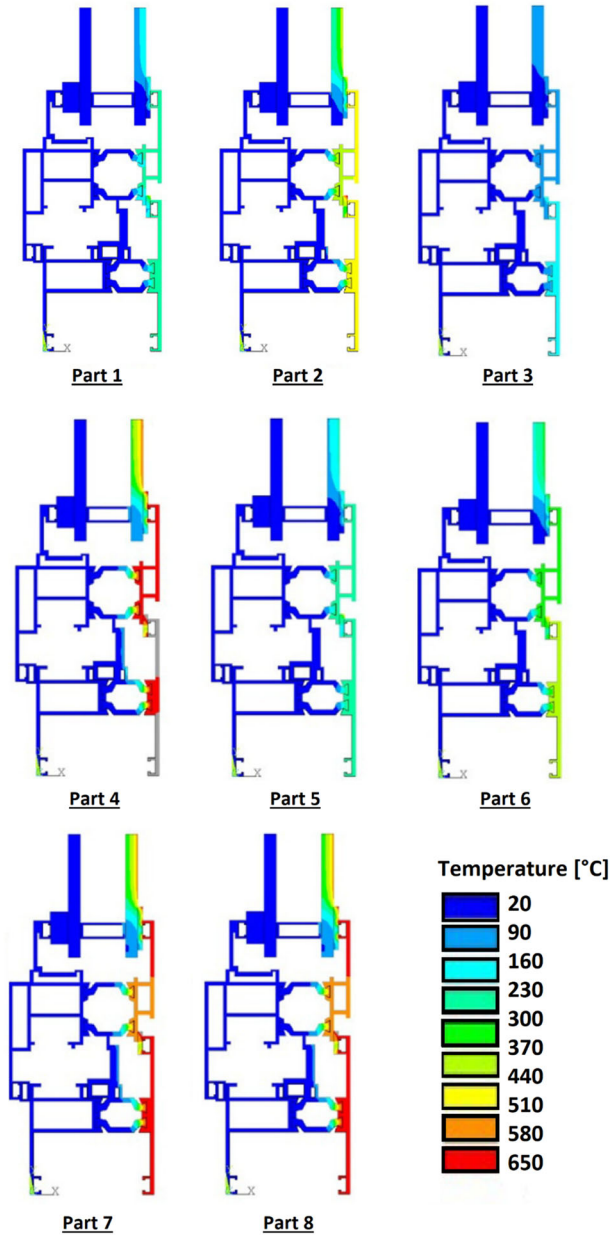
The thermal fields at all sides of the window frame at 180 s (3 min) of fire exposure are addressed in Fig. 13. The temperature is at about the melting point ( $650 \text{ }^\circ\text{C}$ ) at the exposed side of Parts 4, 7 and 8. The results show also that the

exposed side of the window has been melted at all parts except Part 3 before about 4 min.

◀ **Figure 13. Temperature fields for different locations in the window frame at 180 s of fire exposure.**

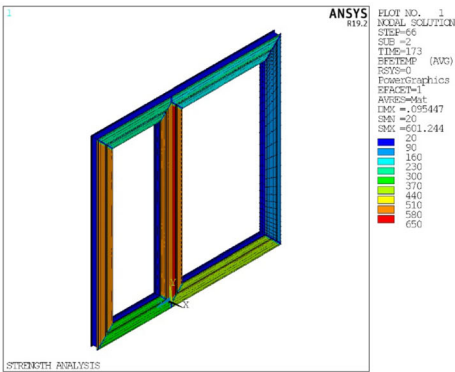
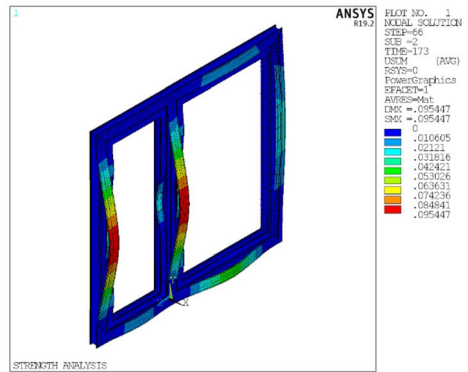
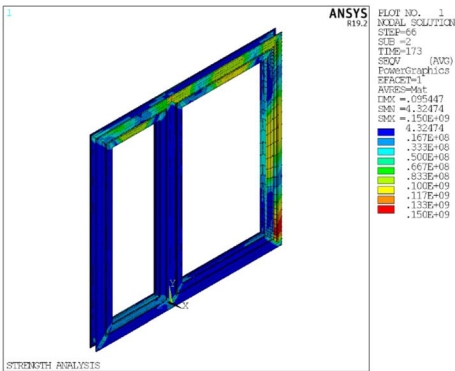
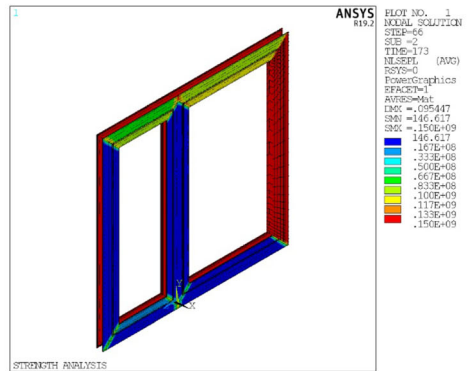
The thermomechanical modelling shows high deformation of the external profile of the window at about 3 min (173 s).

**Figure 18. Frame temperature (a), deformation (b), Von Mises stress (c) and plastic equivalent stress (d) before the failure of the outer frame at 173 s of fire exposure for the closed window configuration.**

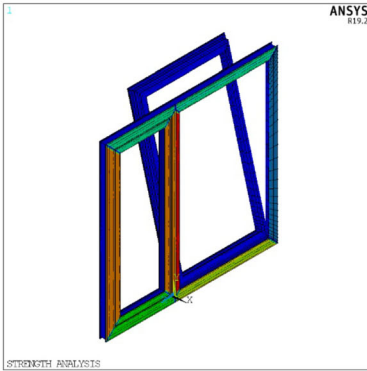
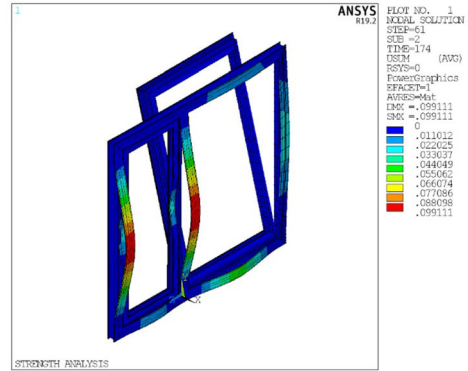
Temperature loads are applied to all Parts of the window except the tilted casement. The outer profile detaches from the rest of the window and falls outward after approximately 3 min (174 s) of fire exposure. The failure mode of the outer profile of the tilted-in configuration is the same as that of the closed window configuration. The maximum temperature at failure time is about 610 °C on the central vertical frame Parts (Parts 4 & 7). Figure 20 shows that the vertical frame Parts are deformed and may be detached from the rest of the structure because of the large deflections. The left side of the exposed frame plasticised because of the thermal stress. However, the failure of the outer profile of the window does not cause the failure toward outside because the weight of the tilted-in casement stabi-

**Figure 20. Frame temperature (a) and deformation (b) before failure of outer frame at 174 s of fire exposure for the in-tilt window configuration.**

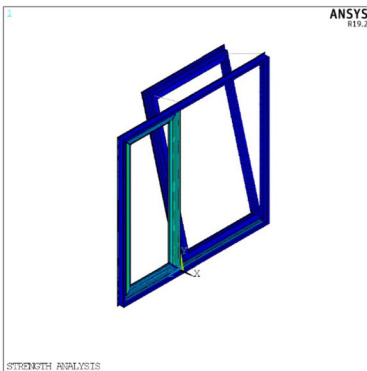
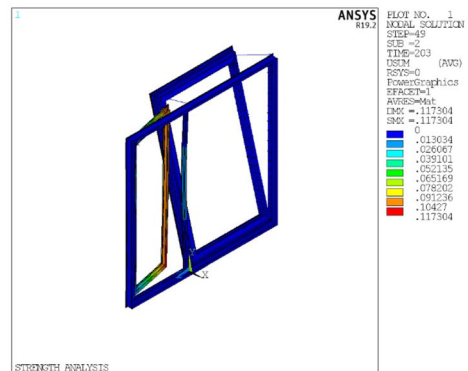
**Figure 21. Frame temperature (a) and deformation (b) before failure of outer frame at 203 s of fire exposure for the tilted-in window configuration.**

moment is not too high (about 270 °C) and the aluminium will still resist the loads. In that case, the complete collapse of the window occurs at the melting point of the window frame, at about 4 min.

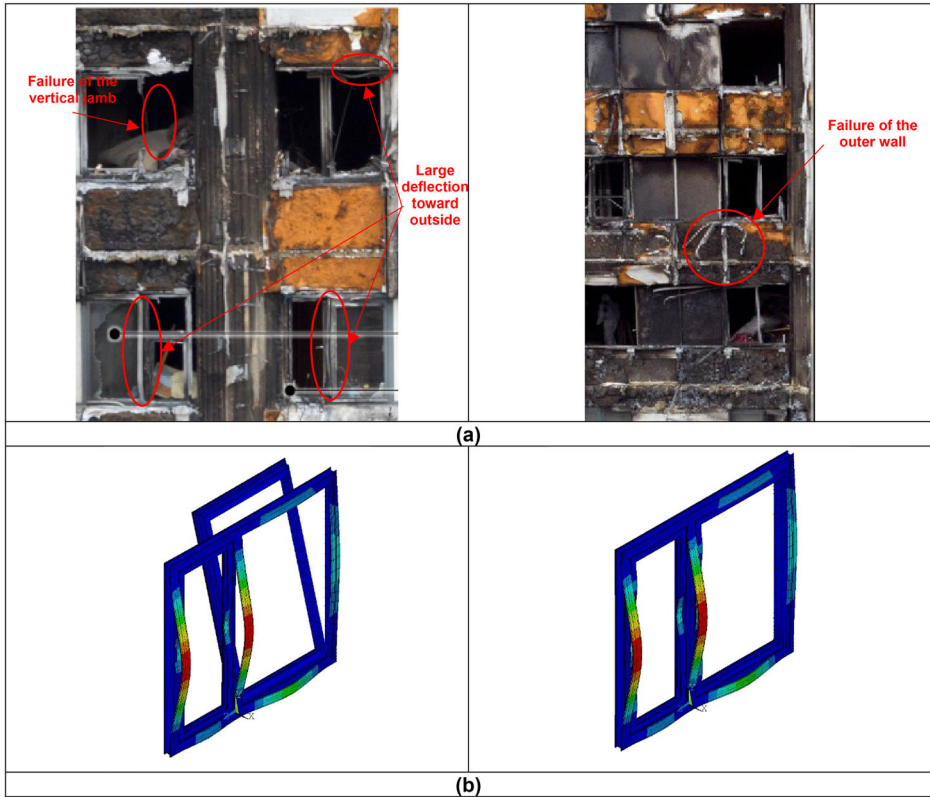
**Figure 22. (a) Failure of window frame with outward fallout of the external frame of windows, L. Bisby’s expert report [30], Fig. 109 and 110, p. 166, (b) outward failure of window frame evaluated numerically for two opening configurations.**

The numerically modelled thermomechanical deformation of the window frames are compared with observations after the real fire in Fig. 22. Partial failures of windows are visible, with the external part of the frame detached from the window and falling outward. Large deflections of vertical or horizontal Parts of the frame occurred during the Grenfell Tower disaster. The numerical model yields the same behaviour, whatever the opening configuration of the window.

The results of the thermomechanical analysis for the window failure times are collated in Table 4. The first failure of the window frame is observed after 3 min of fire exposure and the frame falls toward the exterior. The complete failure of window occurs at about 4 min. The last failure may be at about 5 min as the heating is delayed about 1 min for some of the external profiles. However, even if
