1 **Causes of scaling on bush-hammered heritage ashlar. A case study: Plaza Mayor of**  
2 **Madrid (Spain).**

3 D.M. Freire-Lista <sup>(1, 2)</sup> and R. Fort <sup>(1, 2)</sup>

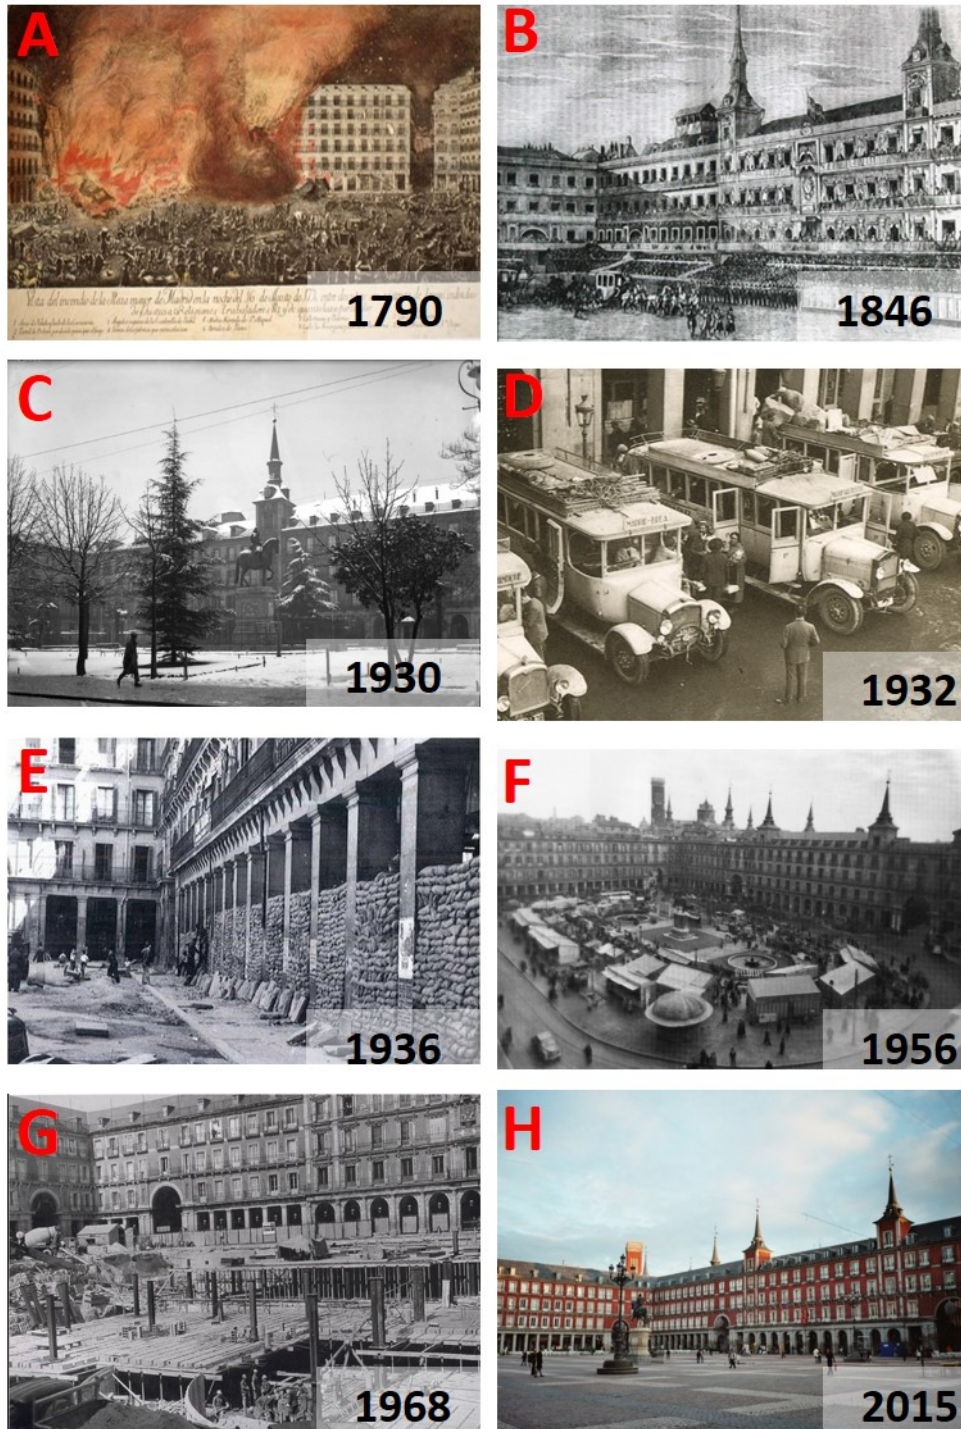
4 Figure 1. A: engraving of the 1790 fire; B: engraving of a bull fight in the square, 1846; C: after  
 5 a snowstorm, 1930; D: bus stop, 1932; E: during the Spanish Civil War, 1936; F: open-air  
 6 market, 1956; G: construction of underground car park, 1968; H: the square in 2015.  
 7  
 8

9 Decay was most intense on the north portico columns, the ones traditionally subject to greatest  
10 use, with the installation, for instance, of boxes and stages for theatrical performances or open-  
11 air markets that called for more aggressive pavement hosing at the end of the day. Moreover, as  
12 this portico once housed a bus stop (Figure 1D), the stone was exposed to the particles emitted  
13 by gasoline and gas-oil engines (Simão et al., 2006). All these uses favoured scaling. In  
14 contrast, war-induced damage is not representative, thanks to the measures adopted to mitigate  
15 the effects of the Spanish Civil War on the columns in the Plaza Mayor (Figure 1E).

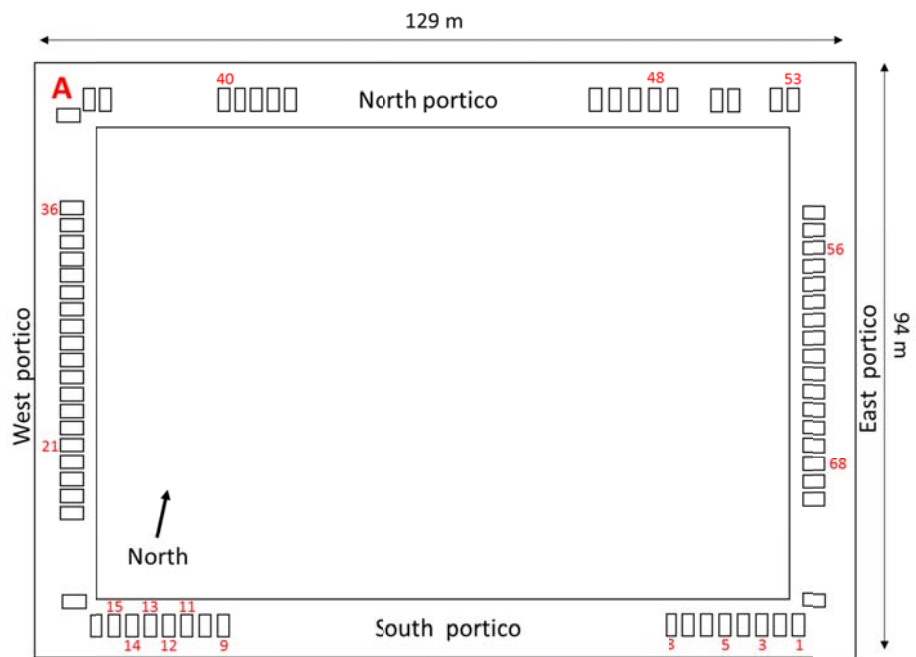
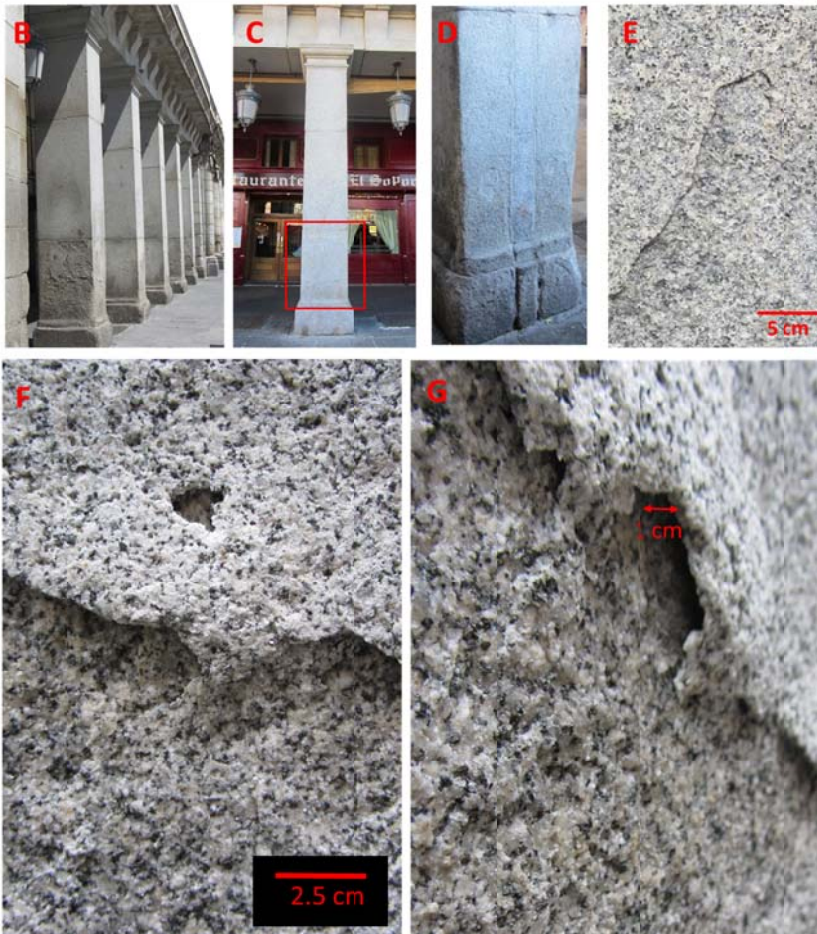
11 The bottom ashlar in the 71 orthohedral column shafts on Madrid's Plaza Mayor (Figures 2B,  
12 2C and 2D) were mapped to determine scaling orientation and height-wise distribution as well  
13 as the percentage of the area affected. Mapping was conducted in situ on a total of 284  
14 photographs (four sides of 71 columns). The decay mapping results were processed with  
15 UTHSCSA ImageTool 3.0 software to calculate the area of the ashlar affected by scaling. The  
16 bottom ashlar was chosen because while not significantly decayed, they exhibited the the most  
17 intense scaling.

1 Figure 2. A: line drawing of Madrid's Plaza Mayor, showing the orthohedral columns on the  
2 inner side of the north, south, east and west porticos; B: columns in the north portico; C: column  
3 62; D: column 1; E: scaling on column 48; F and G: details of scaling on column.  
4  
5 Three 30  $\mu\text{m}$  thick,  $30 \times 20 \pm 3$  mm thin sections were cut parallel to the cleft plane of the step at  
6 depths of 2, 10 and 30 mm, and one section was removed from the hard-way plane (Figure 3B).  
7 Sectioning was performed at 120 rpm to prevent additional damage and the original orientation  
8 was labelled.  
9 All thin sections were impregnated with fluoresceine (Silva et al., 1993, Chigira, 2001) and  
10 characterised under an Olympus BX 51 polarised light microscope (PM) fitted with DP 12-  
11 coupled (6 V/2.5  $\text{\AA}$ ) Olympus digital micrography and Olympus DP-Soft software (version 3.2).

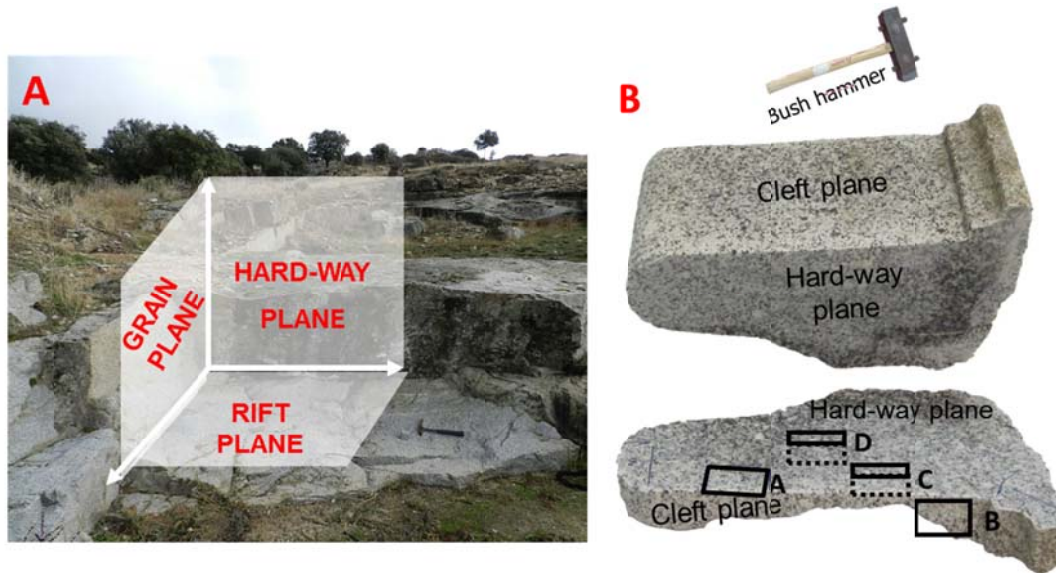
8  
9 Figure 3. A: distribution of cutting planes in the historic quarry where the granite was mined; B:  
10 position of thin sections removed from the granite step found at the Alpedrete quarry.

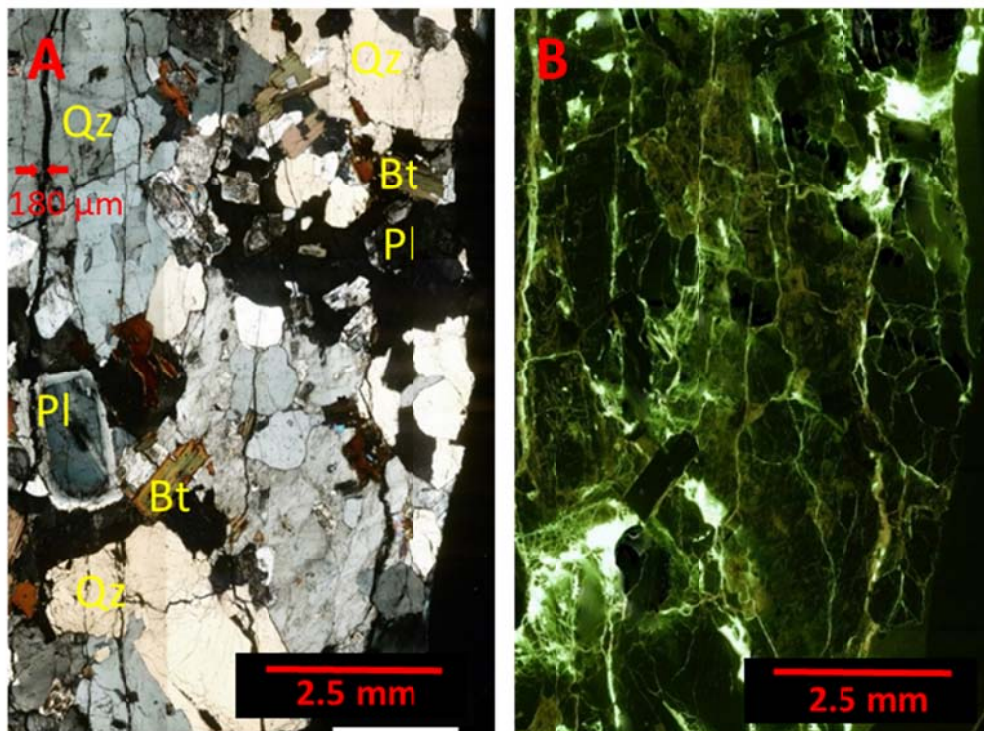
6 Figure 4. Thin section removed from column 36 perpendicular to the cleft plane (right side); A:  
7 cross-Nicol micrograph mosaic; B: fluorescence micrograph mosaic showing biotite (Bi),  
8 plagioclase (Pl) and quartz (Qz) affected by microcracking.

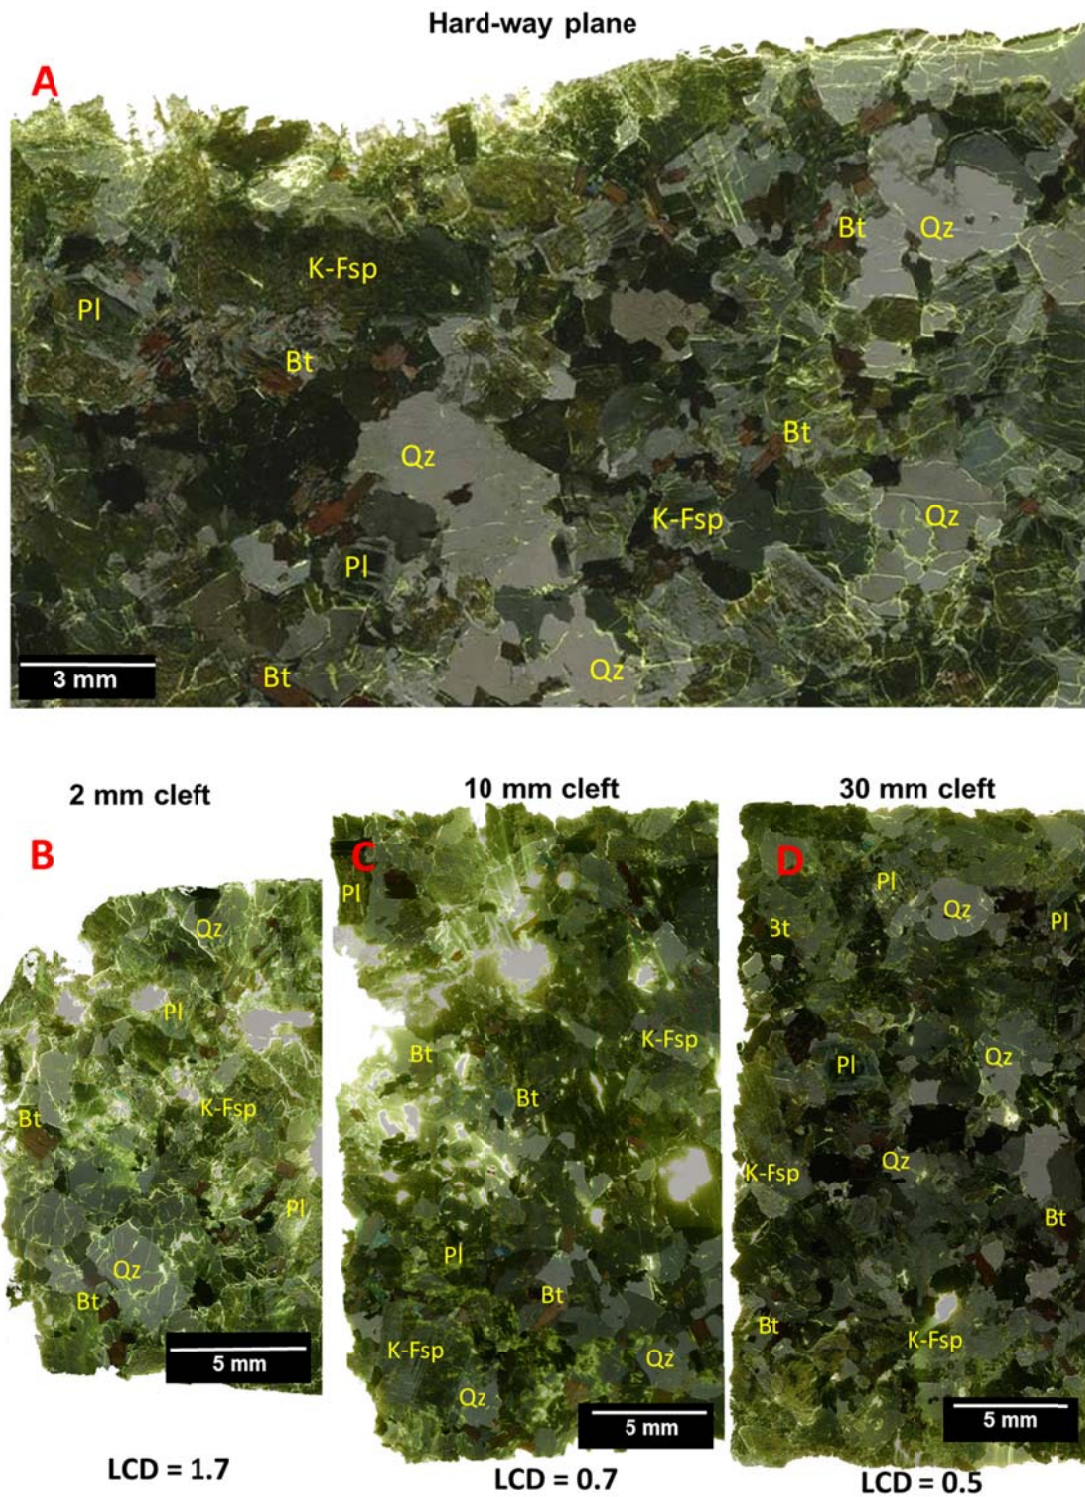
10 Figure 5A shows the micromosaic for the thin section removed from the hard-way plane on the  
11 Alpedrete stair step. LCD and crack spacing by distance from the surface are given in Table 3  
12 for each half of the thin section. Two types of surface decay are visible in Figure 5A: crystal  
13 loss on the left and coalescence on the right. Coalescence was greater and exfoliation  
14 microcrack spacing narrower in the upper 2.5 millimetres from the bush-hammered surface  
15 (Table 3). A plane of weakness was observed at approximately 1 mm from the surface,  
16 generating an area of connectivity parallel to the cleft plane.

15 Figures 5B, 5C and 5D depict the thin sections taken along the cleft plane at various distances  
16 from the bush-hammered surface of the stair step. The crack count yielded LCDs of 1.7  
17 microcracks per millimetre for the thin section taken at 2 mm from the bush-hammered surface,  
18 0.7 for the sample sectioned at 10 mm and 0.5 for the one removed at 30 mm. The number of  
19 microcracks intersecting with the lattice is given in Table 4.

2  
7 Figure 5. Fluorescence micrograph mosaic overlaid on polarised light micrograph mosaic  
8 showing biotite (Bi); K-feldspar (K-Fsp), plagioclase (Pl) and quartz (Qz) affected by  
9 microcracking; A: FM micromosaic for thin section removed along the hard-way plane of a  
10 granite stair step; B, C and D: micromosaics for thin sections removed along the cleft plane of  
11 the same step at 2, 10 and 30 mm from the bush-hammered surface.

17 Zhou (2005) proposed a model for crack growth in brittle rocks based on micro-mechanics.  
18 According to that author, one-way pressure on ashlar generated by hewing induces coalescence  
19 in the pre-existing exfoliation microcracks. Yin et al. (2014) later wielded similar arguments.  
20 The impact inherent in bush-hammering causes surface decay. Two types of surface decay are  
21 visible in Figure 5A. The crystal loss in the outermost millimetres on the left was induced by the  
22 impact waves of the bush hammer as they rebounded against a layer of potassium feldspar  
23 oriented parallel to the cleft plane. The exfoliation microcracks underneath this feldspar, with  
24 widths of approximately 50  $\mu\text{m}$ , exhibit barely any coalescence. In other words, the potassium  
25 feldspar obstructs wave propagation, ‘shielding’ the area below. The coalescing exfoliation  
26 microcracks on the right in Figure 5A generate planes of weakness. This same type of

1 At greater depths, the microcracks are spaced more widely and are no wider than approximately  
2 65  $\mu\text{m}$ . The intracrystalline cracks in Figure 5A are straight and parallel, whereas the  
3 intracrystalline cracks in Figures 5B and 5C are ramified and run in no prevalent direction. In  
4 other words, bush-hammering generates exfoliation microcrack coalescence parallel to the cleft  
5 plane and generates more microcracks running in several directions to a depth of at least 1 cm.  
6 Table 2 shows that bush-hammering generates intracrystalline cracks and furthers the  
7 development of the intercrystalline sort. Hence, the intra/inter-crystalline microcrack ratio  
8 declines as the distance from the hewn surface rises. Taken together, these microcracks result in  
9 a heavily microcracked surface (Figure 5) to a depth of 1 cm, where water and other agents of  
10 decay may readily penetrate. That accelerates scaling due to the existence of planes parallel to

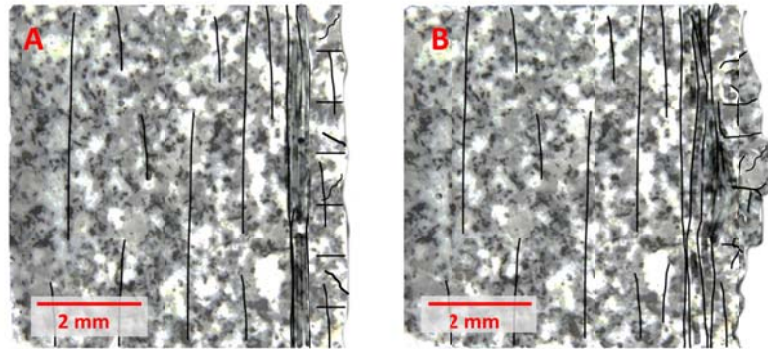
21 The diagram in Figure 6 shows a cross-section perpendicular to the cleft plane on a traditionally  
22 hammered ashlar. The bush-hammered surface exhibits scores of variously oriented microcracks  
23 (right). The area with high microcrack connectivity visible at a depth of approximately 1 mm  
24 from the surface would facilitate capillary ingress and the resulting decay, ultimately causing  
25 detachment of this plane and the concomitant scaling. The microcracks deeper into the ashlar  
26 exhibit coalescence.

Figure 6. Scaling on a vertical cleft plane (profile): A, baseline condition of a bush-hammered granite ashlar; B, scaling with detachment at a depth of approximately 1 mm from the bush-hammered surface.

1 The direction of exfoliation microcracks should be taken into consideration when applying  
2 conservation treatments on sculptures or ashlars. The surface parallel to such microcracks, the  
3 one most vulnerable to decay, is where treatments penetrate least deeply due to the low  
4 capillarity in the perpendicular direction. Conversely, the surface perpendicular to the  
5 microcracks is the one least vulnerable and most permeable to conservation treatments.
