# Remote assessment of tsunami damage in Japan by means of Google Street View images

## Project Report

Jessica Miles and Alan G. Bloodworth

University of Southampton

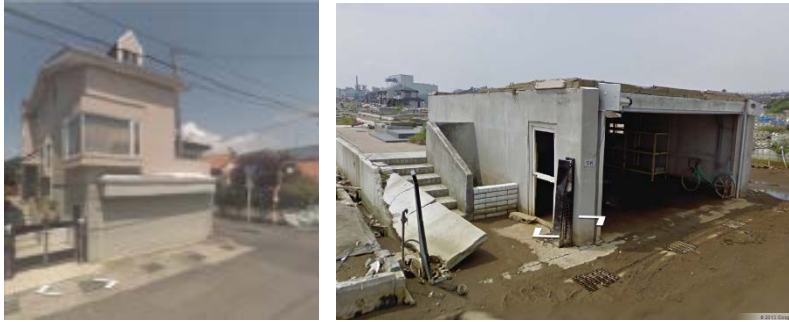
**Dual Frame Construction** is a noticeable design feature of housing in Ishinomaki, where a number of buildings remained standing with an RC or steel-framed ground floor and timber-framed construction for the upper floors (Fig. 10). The ground floor was often used as a garage, or sometimes commercial space in a mixed-use structure. In Ishinomaki, the inundation height was equivalent to two storeys and in the majority of cases observed, the RC/steel ground floor survived virtually undamaged, while the timber upper floors were heavily damaged or washed away (suggesting insufficient strength or connection to the ground floor frame). These buildings performed better overall than pure timber frames that were either completely destroyed or suffered collapse of the ground floor. This was also noted by EEFIT (2011, p101), referring to them as ‘raised dwellings’.

**Figure 10** Dual frame construction building A25 in Ishinomaki ‘Before’ (GSV, 2013d) (left) and ‘After’ (GSV, 2013c) (right)

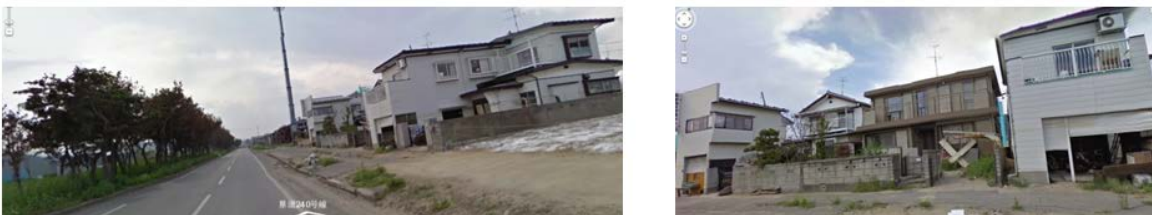
**Sheltering by trees.** A group of small commercial and residential structures of light frame construction (probably timber) were identified with damage rating D1, 435m from the shoreline in Area B (Fig. 11). Behind and to the right when viewed from the shore, very few buildings were left standing or not heavily damaged. The only clear reason for this group of buildings’ survival is sheltering from a line of trees still standing directly in front of them, between the residential area and the port. These trees relied in turn on a degree of sheltering from the port area buildings, as trees at other locations along the shorefront were uplifted from their roots and did not survive the tsunami.

**Figure 11** Buildings in Area B behind the port in Ishinomaki showing evidence of sheltering by trees (GSV, 2013c)

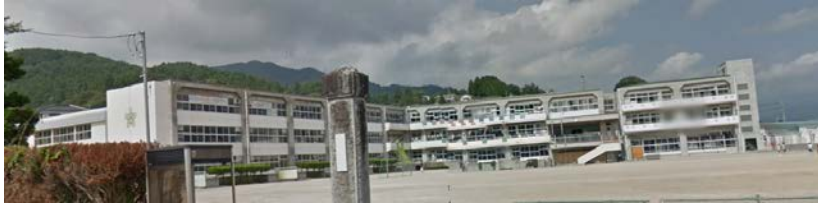
Ofunato Elementary School is a three storey RC structure (Figure 13), located 490m from the shoreline with damage level D0. The school is well positioned on higher ground to serve as a shelter. Schools are commonly designated as VE shelters in Japan because they are built to high seismic standards and have capacity for large numbers of evacuees.

**Figure 13** Potential VE Shelter: Ofunato Elementary School (GSV, 2013b)

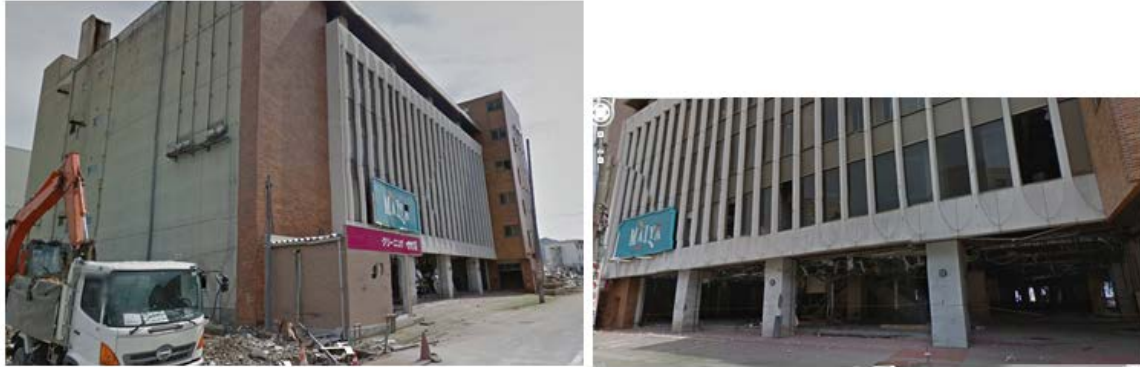
The five-storey steel-framed Maiya Shopping Centre was at the forefront of the tsunami, 100m from the coastline, yet survived with damage level D2 (Figure 14) despite inundation to third floor level (9m). Under FEMA guidelines, it had sufficient height to serve as a shelter. The ground floor is relatively open (serving as a customer car park), allowing water to pass through. This was also the case with an open plan construction car park directly in front of the shopping centre that suffered damage D1.

**Figure 14** Potential VE Shelter, Ofunato: Maiya Shopping Centre (GSV, 2013b)

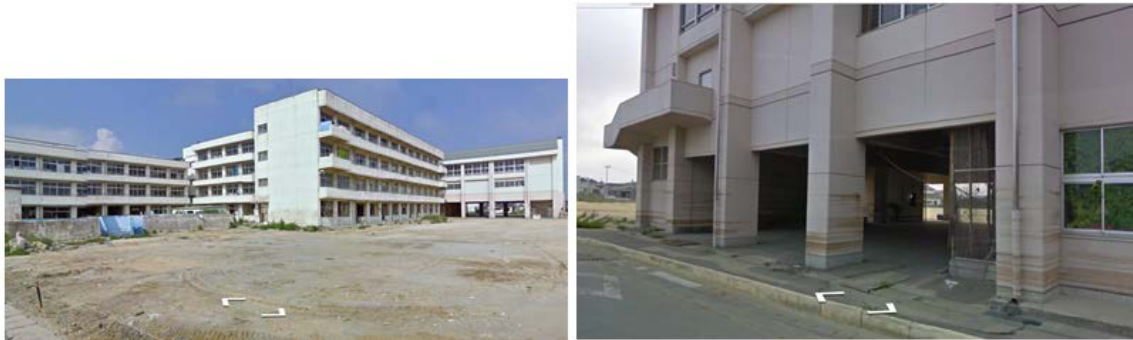
Minati Junior High School is located 750m from the shore and suffered damage D1. The size of the structural columns suggests the school is RC construction (Figure 15). Parts of the ground floor are open plan, used for car parking, and the school has a number of external staircases (possibly fire escape routes) to the uppermost floors that would enable evacuees in the surrounding houses readily to use it as a VE Shelter.

**Figure 15** Potential VE Shelter, Ishinomaki: Minati Junior High School (GSV, 2013c)
