A correlation between damage and intensity on old masonry churches in Colima, Mexico by the 2003 M7.5 earthquake

Preciado, Adolfo; Orduña, Agustín

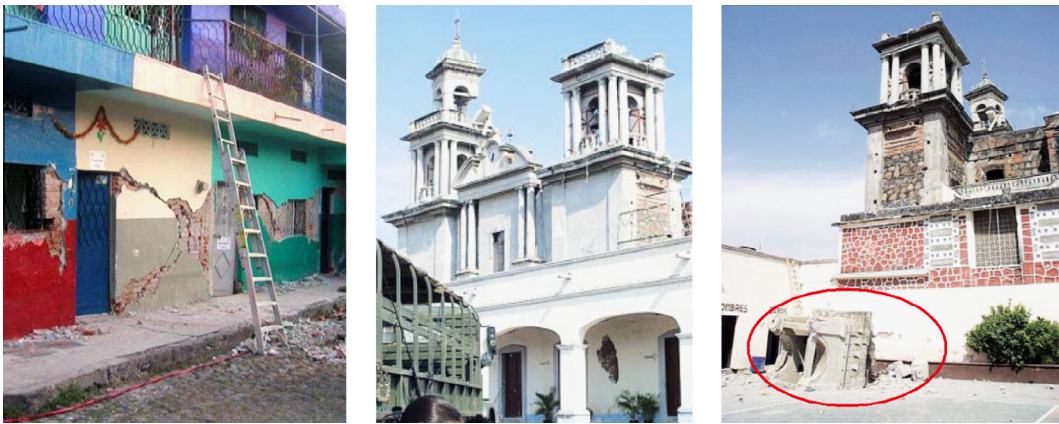
Fig. 2. Observed damages on churches after the 2003 M7.5 Colima, Mexico EQ.
