# Experimental investigation on the fire resistance of cast-in-situ hollow core concrete slabs constructed using filler boxes and an assembly box system

Lyu, J, Wang, Y, Van Coile, R, Huang, Z & Huang, Y 2019, 'Experimental investigation on the fire resistance of cast-in-situ hollow core concrete slabs constructed using filler boxes and an assembly box system', *Structural concrete*, vol. 20, no. 1, pp. 144-163. <https://doi.org/10.1002/suco.201800060>

**Experimental investigation on the fire resistance of cast-in-situ hollow core concrete slabs constructed using filler boxes and an assembly box system**

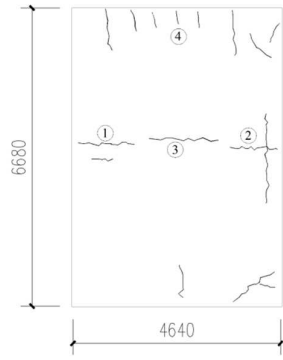
(a) Top surface in Test 1

Cracking of the simply supported hollow slab (Test 1) was observed during the test, as shown in Fig.11 (a). As expected, several minutes after ignition, its four corners gradually curled due to the unclamped corners and diagonal cracks could be seen at the corners of the top surface. At approximately 30 min, several cracks (denoted ①, ② and ③) formed on the top surface of the hollow slab. Meanwhile, water and steam started to seep through the cracks. As the test continued, a large amount of water simultaneously seeped through these cracks and accumulated, after which a large amount of steam was driven off. In addition, the crack (denoted ④) across the section of the edge beams gradually appeared in the test. At 1

1  
2  
3 hour and 50 min, the puddle of water on the top surface of the slab dried up. Finally, the  
4 cracking pattern appears on the unheated surface of the slab, as shown in Fig. 11 (a). It can be  
5 seen that the central crack (①, ② and ③) tended to be formed across the transverse  
6 direction of the slab, this crack pattern was similar to the crack which appears on the  
7 conventional simply-supported concrete slabs (Lim and Wade, 2002; Wang and Dong, 2009).

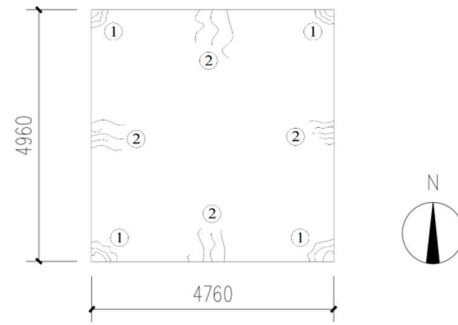
(b) Top surface in Test 2

8  
9  
10  
11 Fig. 11(b) shows the cracking pattern on the top of the column-supported hollow slab.  
12 Twenty minutes after ignition, many diagonal cracks (denoted ①) rapidly formed at the  
13 corners of the slab adjacent to the columns. Clearly, this behavior is due to the restraint of the  
14 column against the curling of the heated slabs. Similarly, water and steam started to seep  
15 through the cracks. As the test continues, several major cracks (denoted ②) developed  
16 perpendicular to the edge beams. Finally, the crack pattern observed in the slab is shown in  
17 Fig. 11(b). Clearly, the cracking pattern in Test 2 was different from that observed in Test 1,  
18 and fewer cracks were observed on the central region of the top surface in Test 2. Thus, the  
19 comparisons of the cracking patterns for the two slabs indicate that the boundary condition  
20 has an important effect on the number and direction of the cracking within the hollow slabs.

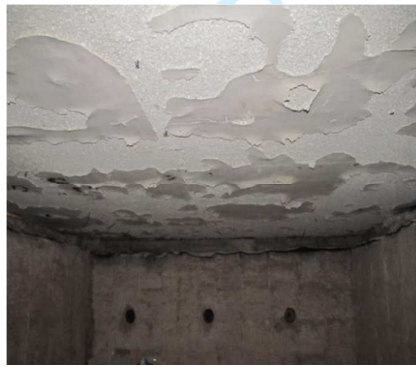
(c) Bottom surface in Test 1

28  
29 Failure mode on the bottom surface of two hollow slabs (Tests 1 and 2) was observed after  
30 the test, as shown in Figs. 11 (c) and 11(d). Serious spalling did not occur in the two tests,  
31 and thus the two slabs with plastic filler boxes had good fire resistance performance and  
32 structural stiffness.  
33  
34

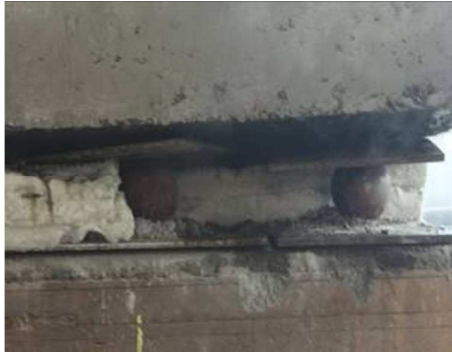
1  
2  
3 The following phenomena were observed during the testing of the simply-supported slab in  
4 Test 3. Several minutes after ignition, through the viewing ports, the water was seen on the  
5 bottom surface of the slab, falling to the ground of the furnace. After that, some noise was  
6 heard due to the spalling of the concrete assembly boxes. At approximately 20 min, the  
7 bottom failure of several assembly boxes occurred due to the spalling, and thus the bottom  
8 reinforcing steel was also observed. It is noted that the very loud noise (spalling) was heard,  
9 and the vibration of the slab was observed at the same time. At approximately 25 min, water  
10 and steam started to seep through the cracks (on the top surface). Meanwhile, four corners of  
11 the slab gradually curled due to the unclamped corners, as shown in Fig. 12 (a). As the test  
12 continued, a large amount of water simultaneously seeped through these cracks and

(a) Curled corner

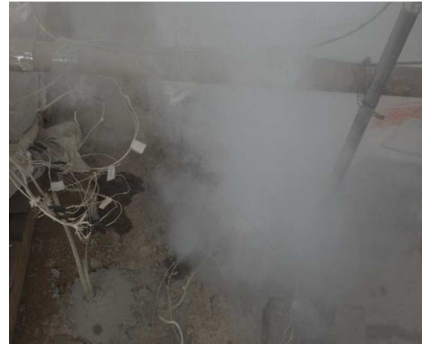
13 accumulated, after which a large amount of steam was driven off, as shown in Fig. 12(b). At  
14 that point, the cracking on the unheated surface of the slab could not be observed due to the  
15 steam. At 69 min, as shown in Fig. 12(c), one hole was observed on the top surface of the  
16 concrete assembly box, and then a flame was observed. Hence, the integrity failure of the  
17 slab occurred due to the spalling of the concrete assembly box. At 80 min, three further holes  
18 were observed on the top surface of the slab due to the spalling of the assembly boxes  
19 (bottom plates), so the hot gases escaped through the holes. At 90 min, the test was stopped  
20 in consideration of the safety.

(b) Water on the top surface

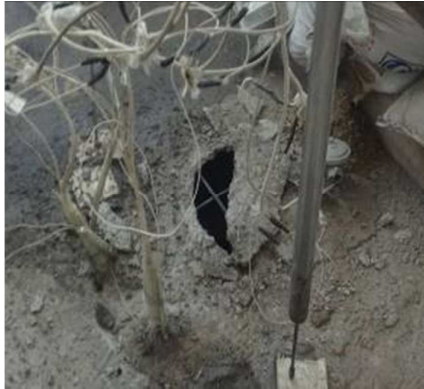
(c) One hole on the top surface

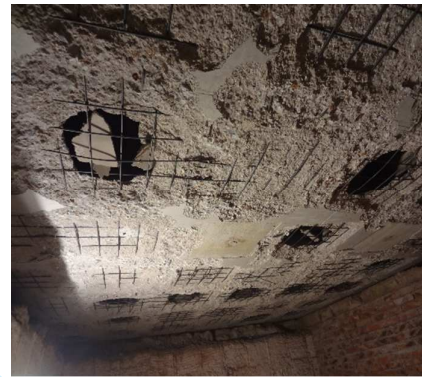
21  
22  
23  
24  
25  
26  
27  
28  
29  
30  
31  
32 After test, the heated surfaces of the slab were observed, as shown in Fig. 12(d). Clearly,  
33 there was serious spalling of the assembly boxes (bottom plates), and several holes at  
34 different locations could be seen as well as the bottom reinforcing steels. In other words, the  
35 assembly boxes could be resulting in more spalling locally, presumably because they limit  
36 the movement of water vapor to the interior of the concrete. In addition, as shown in Fig.  
37 12(e), the steel fracture in the assembly box occurred, and the spalling also appeared on the  
38 top plate. However, it is interesting to note that all the ribbed beams did not show the signs of  
39 serious spalling.

(d) Bottom surface after fire test

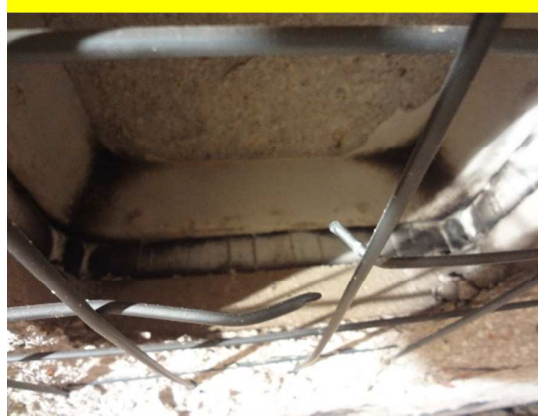
(e) Steel fracture and spalling of the assembly box

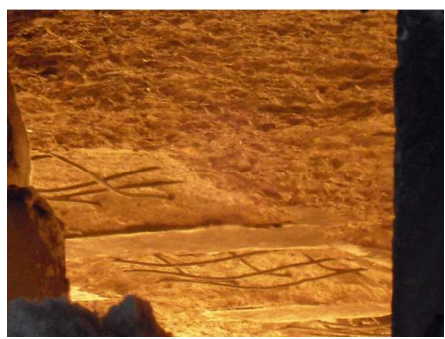
40  
41  
42  
43  
44  
45  
46 For Test 4, several minutes after ignition, the noise was heard due to the concrete spalling,  
47 and the reinforcing steel could be seen through the viewing port, as shown in Fig. 13(a). It is  
48 noted that the concrete spalling, the noise and the vibration lasted until about 40 min.  
49 Meanwhile, similar to that of Test 3, water and steam could be seen on the top surface of the  
50 slab. At about 40 min, four corners of the slab gradually curled. In addition, the test was  
51 stopped from 46 min to 51 min due to the malfunction of the fan. As shown in Fig. 13(b),  
52 through the viewing ports, the bottom surfaces of many assembly boxes (bottom plates)

(a) Concrete spalling of the bottom plate

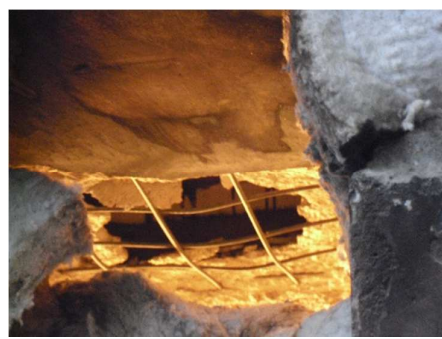
(b) Spalling of assembly box

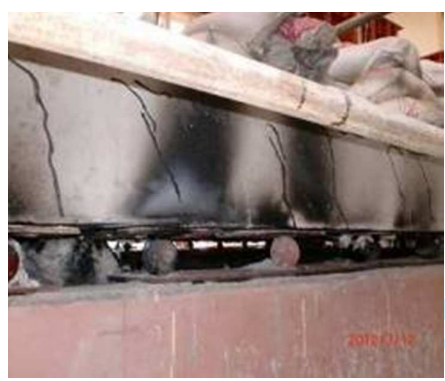
(c) Inclined cracks on the edge beam

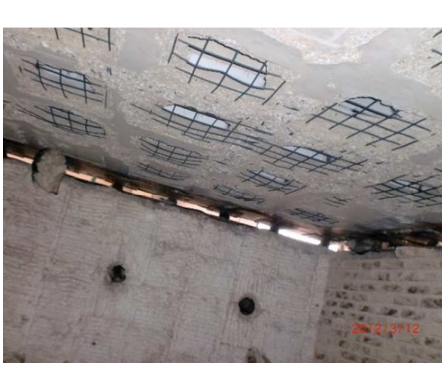
1  
2  
3 showed signs of serious spalling. At about **70 min**, a large amount of water simultaneously  
4 seeped through the cracks (top surface) and accumulated, and steam was driven off.  
5 Meanwhile, water appeared on the edge beams of the slab, and some inclined cracks (spacing  
6 of **300 mm**) were observed, as shown in Fig. 13(c). At **292 min**, due to the spalling (bottom  
7 surfaces) of many assembly concrete boxes, the test was ended. However, different from that  
8 of Test 3, no hole was found on the top surface of Test 4 during the heating phase. Hence, the  
9 upper cast-in-situ concrete was beneficial to enhance the fire-resistant performance of the  
10 hollow slab, particularly the integrity. **Similar to that of Test 3, due to the serious spalling, a  
11 lot of concrete on the bottom surface had fallen off, and thus the steel bars exposed, as shown  
12 in Figs. 13(d) and 13(e). Hence, some methods should be used to reduce the risk of the

(d) Bottom surface of the slab

13 explosive spalling in the unexposed or exposed assembly boxes. For example, the section  
14 shape or section size can be improved and the steel or polypropylene fibers added in the  
15 concrete mixes (Majorana et al., 2010).** In addition, the slight spalling occurred on the bottom  
16 surfaces of the ribbed beams, but no reinforcing steels were observed on the ribbed beams.

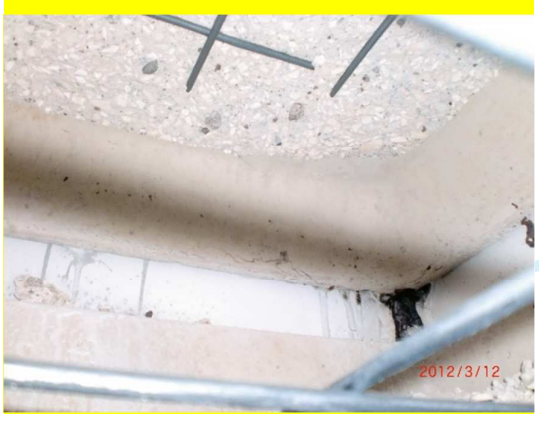
(e) Spalling on the top plate of the assembly box
