Evaluation of Moisture Barriers for Fire Fighting Turnout Gear Assessment of Product Failure and Test Method Development Predicting Failure Modes

Chastity Danielle Newsome
University of Kentucky, Chastity.Adkins@propexglobal.com

The purpose of this study was to investigate the failures seen in the moisture barrier of fire fighting turnout gear. Moisture barriers taken from garments in field were evaluated to establish a baseline for comparison. Moisture barriers were exposed as part of a three-piece ensemble and as a single layer moisture barrier to instrumental light exposure in a Carbon Arc Fade-ometer and natural sunlight exposure according to AATCC and ASTM test methods. After exposure, moisture barriers were visually examined using stereo and compound microscopes. A performance measurement was conducted on the exposed moisture barriers using a modified NFPA Hydrostatic Water Penetration Resistance Test. Results of the instrumental and natural sunlight exposures were compared to the failed garments from the field.

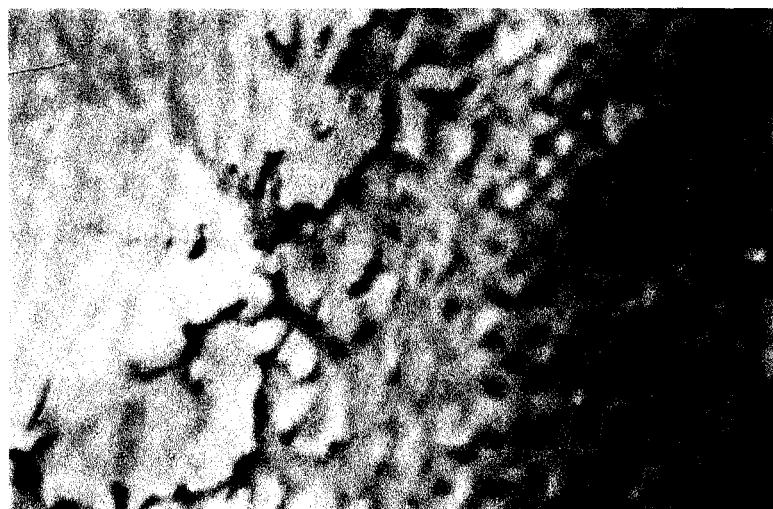
Figure 4.1: Degradation Observed in Failed Garments from the Field

Light degradation was thought to be a major factor in the damage seen in the moisture barriers but damage had been seen in garments exposed to limited sunlight but exposed to indoor or filtered light during storage. The result of the preliminary examination of product failure led to the selection of two light exposure treatments, instrument ultraviolet and natural sunlight. Figure 4.1 illustrates the damage seen in the moisture barrier.

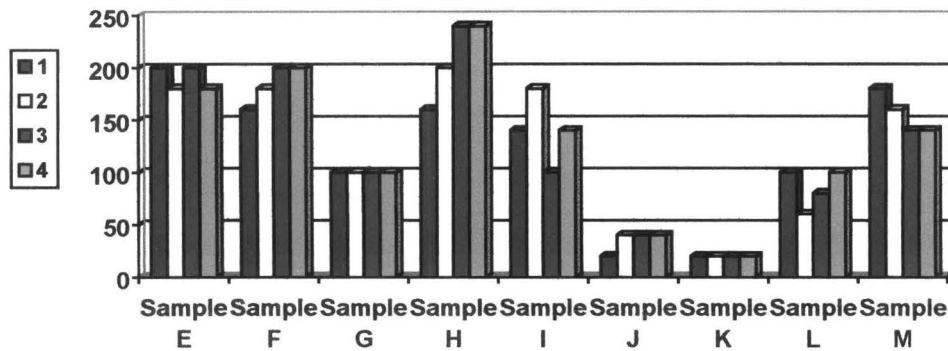
Figure 4.2 Hydrostatic Water Penetration Resistance Test Results for Carbon Arc Exposure - Group 3

Penetration Resistance Test to Carbon Arc exposure for Group 3 are presented in Figure 4.1 and detailed descriptions of the results are presented in Appendix B.

In the initial evaluation of Samples E and F, craters were apparent in the film layer, but the samples passed the Hydrostatic Water Penetration Resistance Test and leakage did not occur until more than 185 hours of exposure. Craters were also observed during the initial screening of Sample G, H, I but the craters did not result in failure. At the time of failure all replications for Sample G, H, and I showed cracking of the film side of the moisture barrier. The appearance of cracking did not always predict failure, for example in some samples cracking appeared but additional exposure time was needed before the sample failed the water penetration test. One could assume that cracks were beginning to form but they were not deep enough to allow water to penetrate the film. As exposure continued, the cracks became longer and deeper and/or more cracking occurred.

Samples J, K, L and M moisture barriers generally did not show the presence of craters during the initial visual evaluations, except for one replication of Sample L in which one small crater was present. Moisture barrier M developed some craters after 40 hours of exposure. Samples J, K, L and M did not exhibit the presence of cracking of the films at the time of failure to the Hydrostatic Water penetration test.
