Borehole Rehabilitation: A Case Study in the Dunkwa Mining Town*

¹A. Ewusi and ¹J. Seidu

¹University of Mines and Technology, P.O. Box 237, Tarkwa, Ghana

Ewusi, A. and Seidu, J. (2020), "Borehole Rehabilitation: A Case Study in the Dunkwa Mining Town", *Ghana Mining Journal*, Vol. 20, No. 2, pp. 11-17.

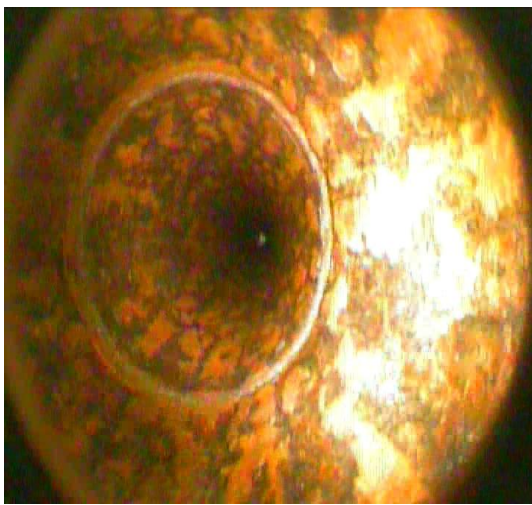
The camera inspection of the Dunkwa BH 1 borehole indicated an open borehole with 10" steel casing up to 32 m. The internal surface of the steel casing is rusted (Fig. 3). No major fractures were identified in the camera inspection. The borehole has a current depth of 75 m. Water was turbid and mud-laden. The borehole required rehabilitation by redevelopment as the silted zone may have sealed the aquifer zones.

Fig. 3 Rusted Casing Material at BH1

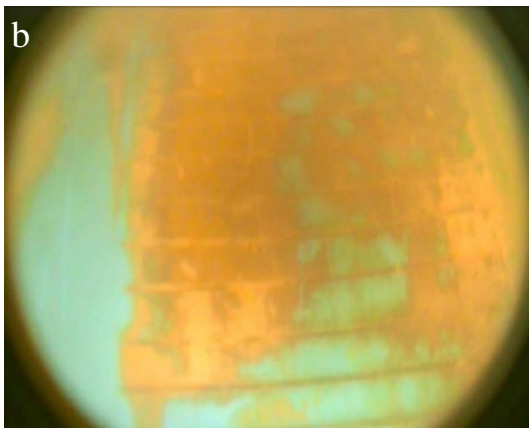
The camera inspection of the Dunkwa BH 3 borehole indicated a composite borehole design with screen positions located between 9 - 21 m, 27 -30 m and 39 - 43 m, and plain PVC elsewhere over a borehole of 45 m depth. The diameter of the borehole is 6". Biofilming was observed on portions of the screen and plain (Fig. 4). Water was slightly sand-laden. The PVC as observed from the inspection showed no indication of compromised integrity.

Fig. 4 Biofilming of the Borehole (BH3)
