## TYPICAL PERFORMANCE REDUCTIONS IN PV MODULES SUBJECT TO SOILING IN A TROPICAL CLIMATE

### ABSTRACT

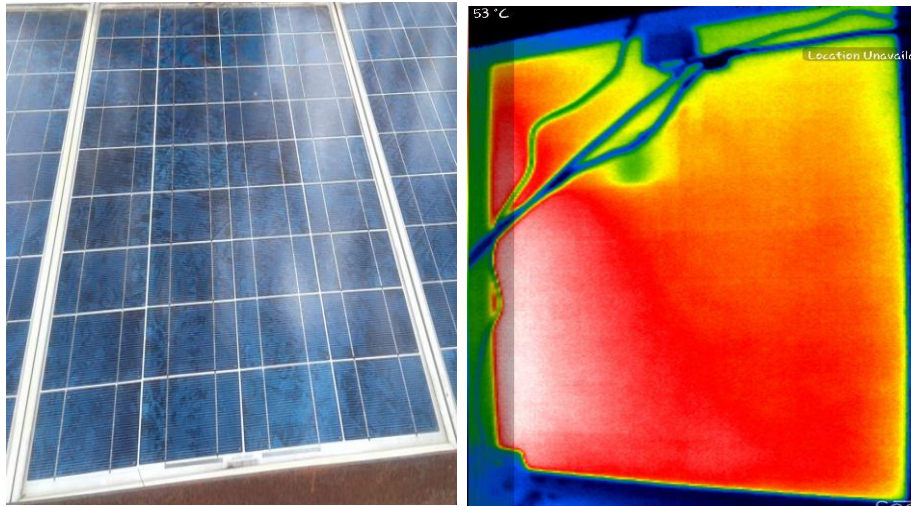
After the PV modules were cleaned, normal images of the modules were captured. One of such is shown on the left of Fig. 2. The extent of soiling before the

Fig. 2: Normal (left) and IR (right) images obtained after cleaning an NCERD PV module surface.

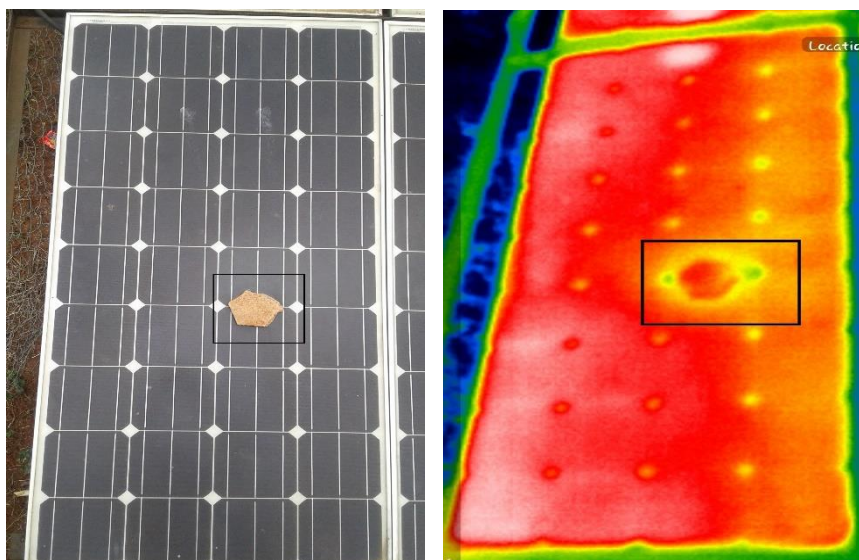
The IR image on the right of Fig. 3 shows the distortion in the module temperature distribution created by the stone resting on the soiled module surface. Generation of current by the PV cell beneath the stone was impaired by the shade cast on it by the stone, causing a cooling of the cell junctions adjacent to the stone (which appear greenish). This significantly impacted on current generation on the right side of the module. This is shown by the brighter coloration of the module's right side in the thermogram. Images of another module in the PV array at the USPS are depicted in Fig. 4. This module is also soiled with dust, and has stone and nail droppings on it. The thermal effects of these objects are clearly visible in the IR image on the right of the figure.

Fig. 3: Normal (left) and IR (right) images obtained before cleaning a USPS PV module surface.

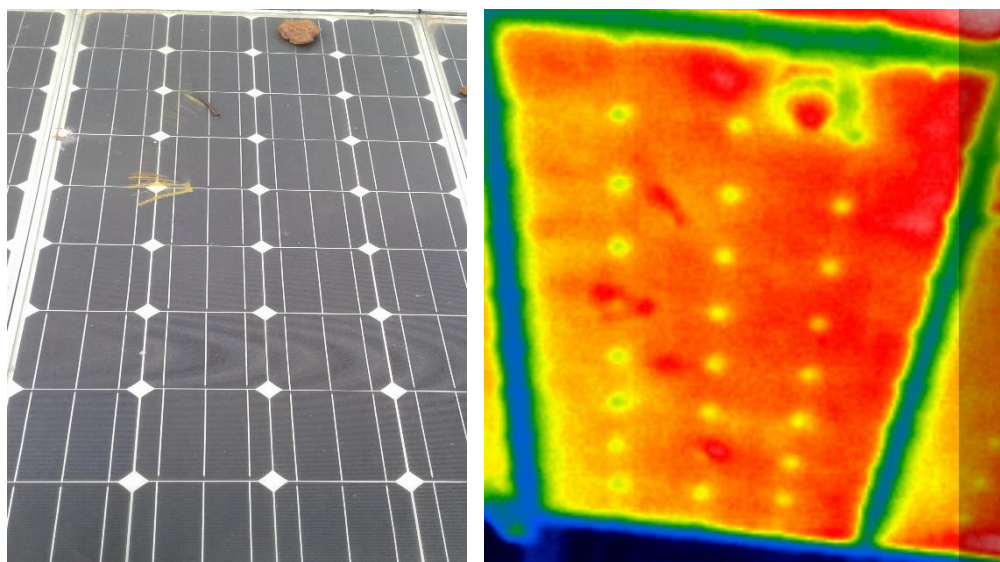
Fig. 4: Normal (left) and IR (right) images obtained before cleaning another USPS PV module surface.

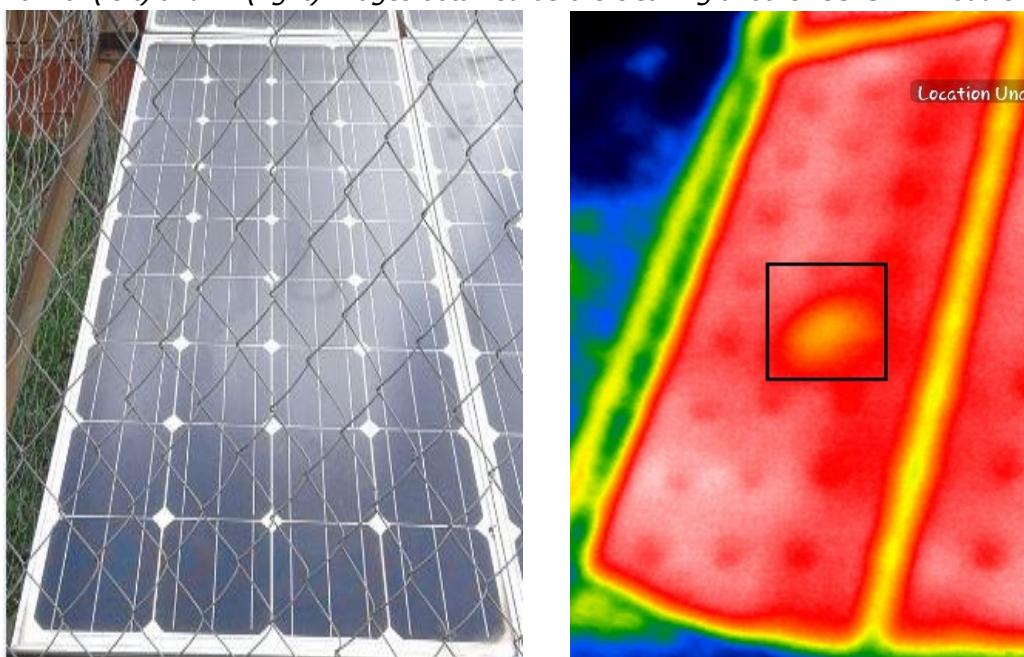
On the left of Fig. 5 is shown the normal image of the module of Fig. 3 after the system had been

cleaned to remove the droppings and dust deposits. Its corresponding IR thermogram is shown on the right of the figure. Inasmuch as the dirt and droppings were well removed, the IR thermogram shows that a permanent defect on the PV module may have resulted from the impact of the stone, which remained even after the cleaning.

Fig. 5: Normal (left) and IR (right) images of PV module surface obtained after the installation at the USPS.

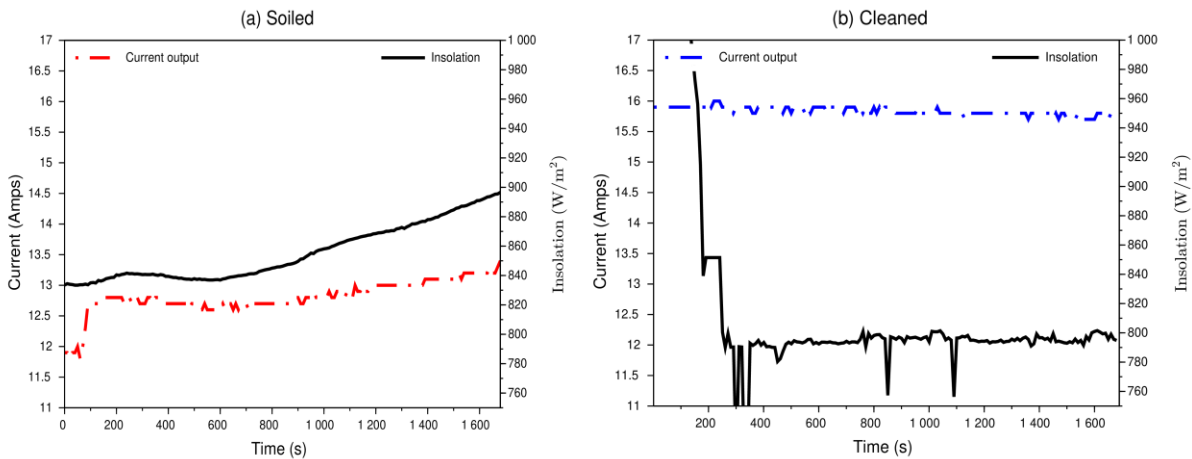
Figure 6(a) and (b) show the responses of the current outputs to changes in the insolation prevailing during the measurements on the soiled and clean modules, respectively. During the test on the soiled array (Fig. 6(a)), a gradual rise in insolation was recorded, and this caused a corresponding increase in the array's current output. The maximum short-circuit current generated by the soiled array within the test interval was 13.4 A when the radiation intensity was 896.6 W/m<sup>2</sup>.

There were major fluctuations in the insolation during the tests on the array after cleaning (Fig. 6(b)), with a maximum insolation of 1,090 W/m<sup>2</sup> recorded close to the start of the test. It steadied however in the course of the test to a value of 800

W/m<sup>2</sup>. The current output from the clean array was also relatively steady at a value close to 16 A. Comparing the outputs before and after cleaning, a remarkable rise in the generated current (~9 %) is observed despite the noticeable drop in insolation (~10 %). The current outputs from the PV array at the USPS are shown in Fig. 7(a) and (b), for array conditions before and after cleaning, respectively. A maximum *ISC* of 6.72 A was generated during the tests. The insolation was steadier during the test on the cleaned system, being mostly with the range of 960 to 1,100 W/m<sup>2</sup>.

Fig. 6: Transient response of the current output of the NCERD solar PV array to changes in solar irradiation when (a) soiled and (b) cleaned

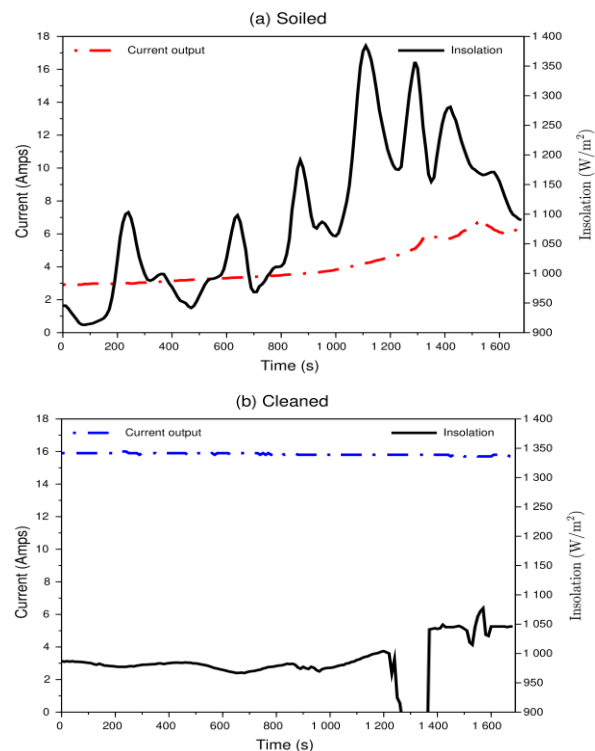
The maximum  $I_{SC}$  measured was 16 A coinciding with a radiation intensity of  $977.3 \text{ W/m}^2$ . Akin to the tests on the NCERD array, the cleaning of the modules resulted in a rise in current output (of  $\sim 300\%$ ).

Fig. 7: Evolution of current output of the USPS solar PV array when (a) soiled and (b) cleaned

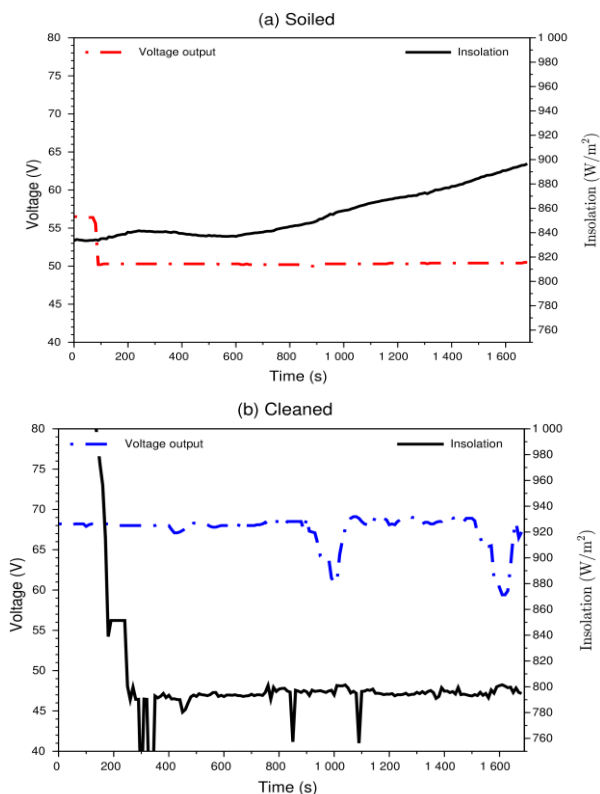
The impacts of soiling on the output voltages developed by the PV arrays were also assessed and found to be as significant as the impacts on the currents generated. For the NCERD PV array, the open circuit voltage ( $V_{OC}$ ) produced by the system when soiled were  $\sim 50 \text{ V}$ , as shown in Fig. 8(a). After the modules were cleaned (Fig. 8(b)), the recorded voltages increased to  $\sim 68 \text{ V}$ , indicating that the soiling had caused decrements in voltage as much as 26% (compared to the  $\sim 9\%$  decrease in the current generated).

Fig. 8: Transient response of voltages developed by the NCERD solar PV array to changes in solar irradiation when (a) soiled and (b) cleaned

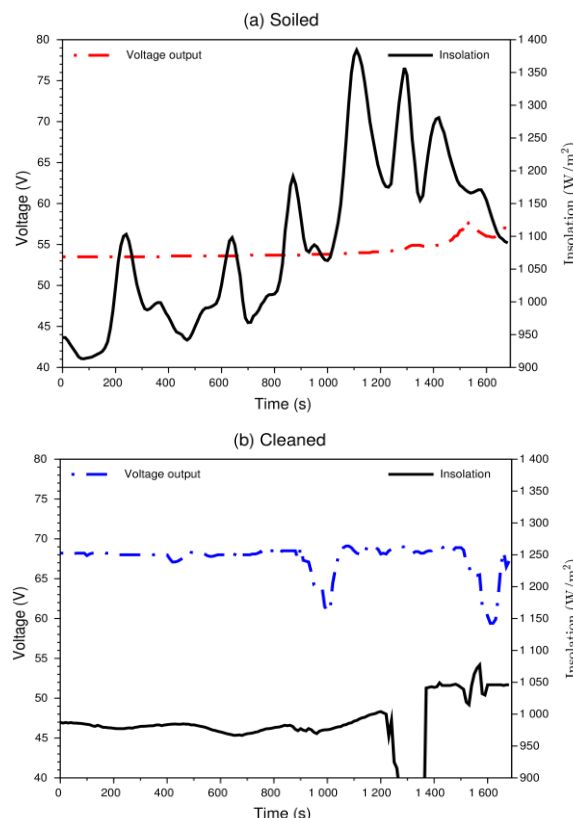
Figure 9(a) and (b) show the voltages produced by the PV array installed at the USPS. The voltages similarly increased from 53–58 V, when the modules were soiled, to  $\sim 68 \text{ V}$ , after they had been cleaned – an increase of  $\sim 24\%$ . These increases in current and voltage outputs recorded by the two PV systems as a result of cleaning corresponded to increases in power output. The soiling of the PV modules evidently caused greater deterioration in the power outputs of the USPS system than for the NCERD system.

Fig. 9: Evolution of voltages developed by the USPS solar PV array when (a) soiled and (b) cleaned

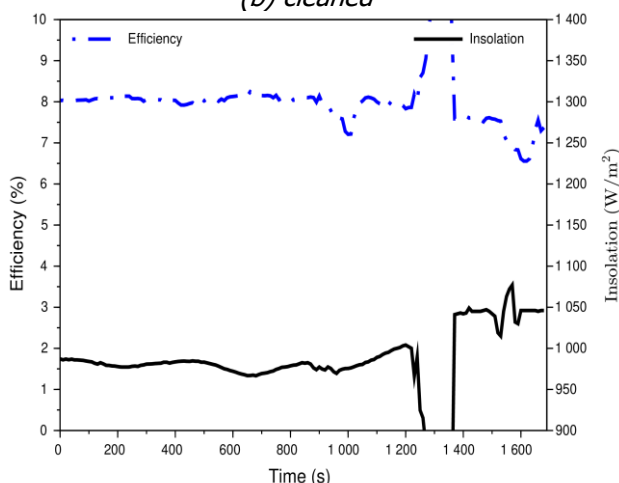
Fig. 11: Output efficiencies of the USPS solar PV array when cleaned
