A CHARACTERIZATION OF WOODPECKER DAMAGE TO HOUSES IN EAST TENNESSEE

Dan Evans, James L. Byford, Department of Forestry, Wildlife and Fisheries, Box 1071, University of Tennessee, Knoxville, TN 37901; and Robert H. Wainberg, Department of Zoology, University of Tennessee, Knoxville, TN 37996

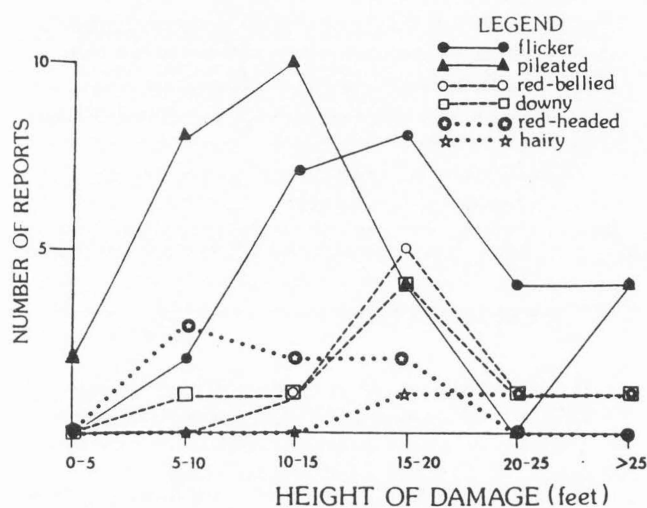
Conner concluded that factors other than sun warmth determined nest orientation. Information from the present study also conflicts with a study done by Turcek (1959) in which he observed that 60% of the holes in power or telephone poles had a southeast to southwest orientation, and there were no holes on the north side of the pole. It should be kept in mind that the present study dealt with all types of woodpecker attacks—not just nest excavations. Although the majority (53%) of reported damage occurred at a height of 10 to 20 feet, height selection varied among the woodpecker species involved (Fig. 1). Turcek

Fig. 1. Height of woodpecker damage (by species) to houses in east Tennessee.

(1959) reported that most of holes he observed in power or telephone poles were located at a height greater than 20 feet. However, Turcek made no attempt to correlate height of damage with the species involved. Also, since houses are not as tall as utility poles, it might be expected that damage would occur proportionally lower.
