BUSHINGS

Retrofitting of a 420 kV draw-lead type bushing with a draw-rod type - Part II

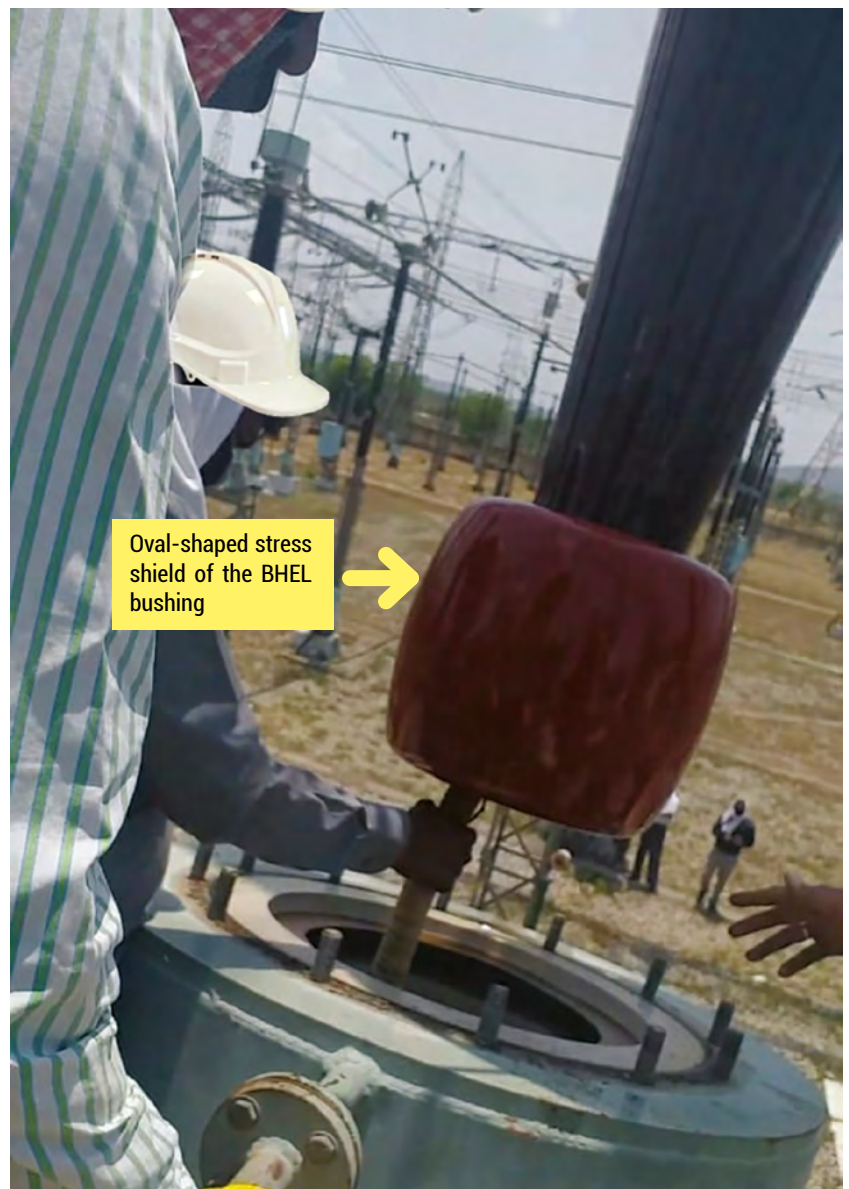
Fig. 1 shows the removal of the 420 kV BHEL bushing with the help of a Hydra crane.

Figure 1. The process of removing the 420 kV BHEL bushing with the Hydra crane.

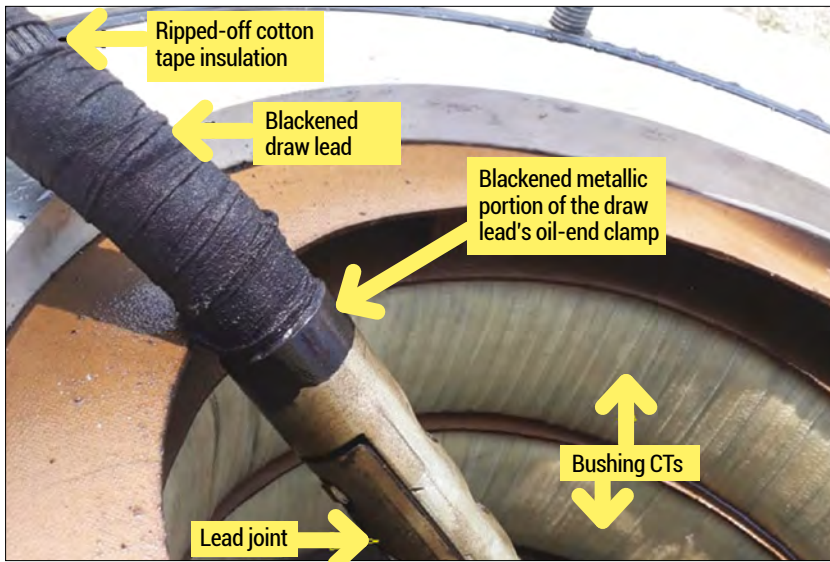
Figure 2. 420 kV BHEL bushing's draw lead after being detached from the OIP bushing's hollow shell is held at the turret edge of 1 V phase of 315 MVA, 400/220 kV/33 kV transformer no. 2.

- a. DGA test reports of the oil samples of the main tank are tabulated in the Table 1 and Table 2, which depicts key gas ratios and existence of CO and CO₂ in ppm. Analyses of these parameters have been used as diagnostic tools.
- b. Looking at the Fig. 2, 3 and 4, the root cause appears to be heating of the bulged peripheral strands due to a skin effect over a certain period. It appears that the bulging of strands must have taken place during erection / installation of the 420 kV OIP bushing of 1 V phase of 315 MVA 400/220/33 kV BHEL transformer No. 1.
- c. Thermal fault of > 700 °C (T3), IEC: 60599 [2], as per DGA analysis by POWERGRID's oil test lab, Itarsi, report dated 11 May 2018 [3] on transformer main tank oil, substantiates the overheating of the draw lead.

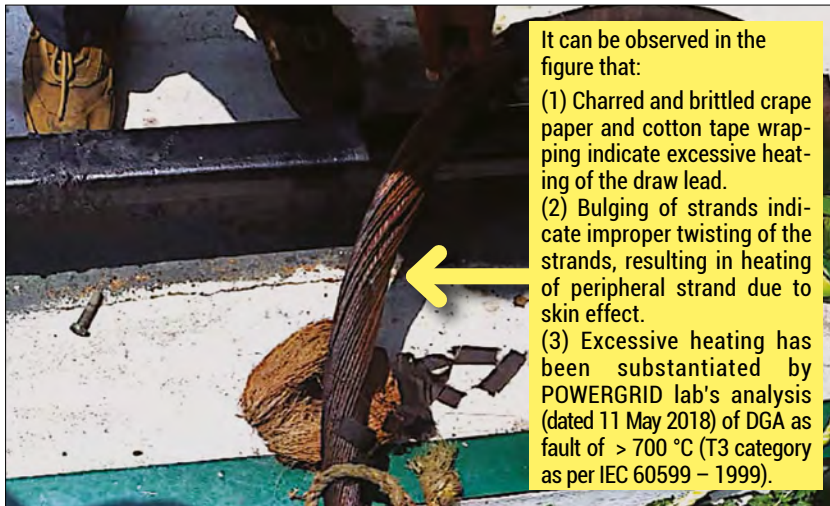
Figure 3. Charred and brittle crepe paper and cotton tape, and bulged strands of draw-lead of 1 V phase of 420 kV OIP BHEL bushing removed from the 1 V phase of BHEL design 315 MVA, 400/220/33 kV transformer No. 2.

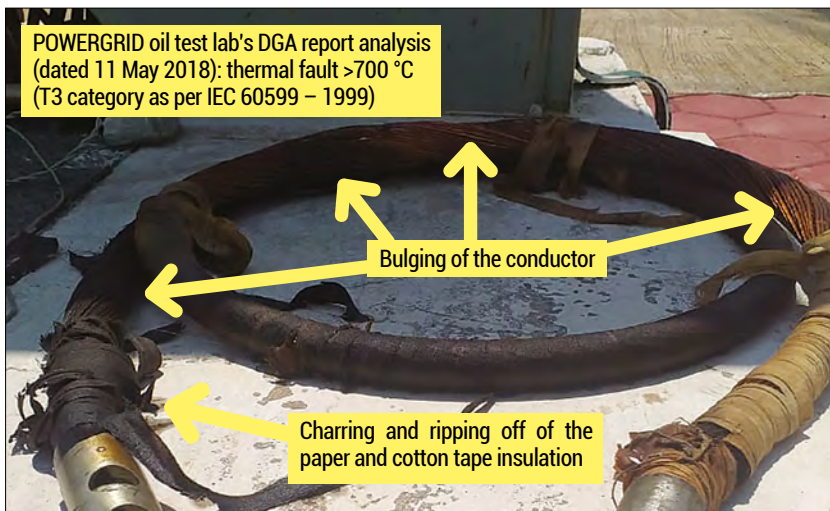
Figure 4. Depicts bulging of the strands, charred and ripped-off condition of cotton tape and the crepe paper strips of the draw-lead of 1V phase 420 kV OIP BHEL bushing of the BHEL 315 MVA, 400/220/33 kV transformer No. 1.

Note: Considering the arguments stated above from (a) to (c), it is firmly inferred that the value of $\tan \delta$ has deteriorated due to the heating of the draw-lead of the 420 kV OIP bushing of 1 V phase of the BHEL transformer no. 1.

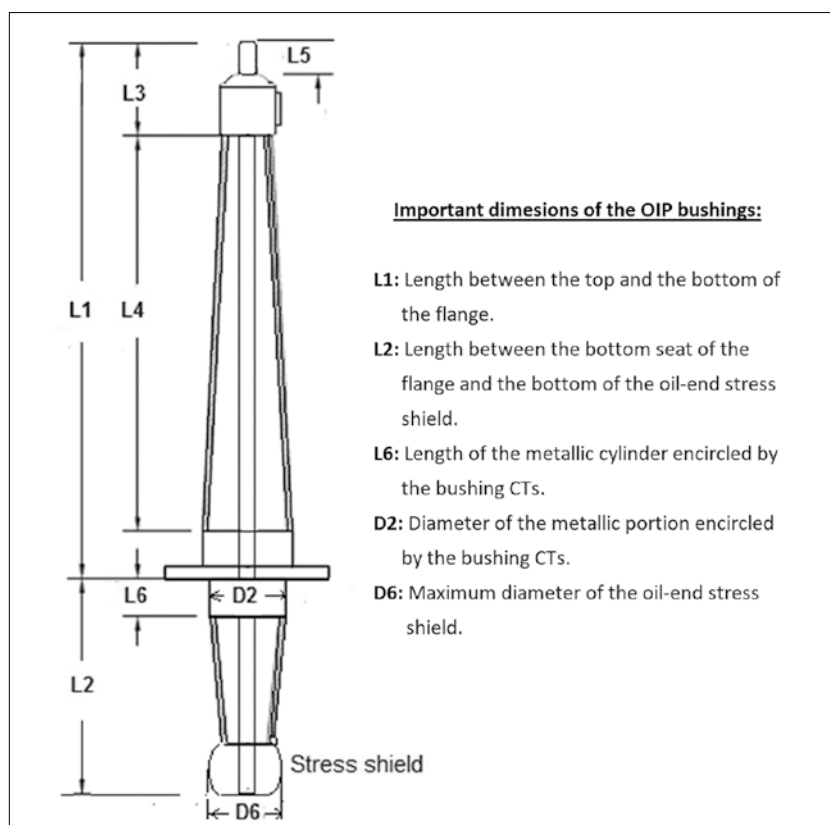
With reference to the Fig. 5, relevant dimensions of TELK's design OIP bushing were compared with the defective 420 kV BHEL OIP bushing.

Figure 5. OIP bushing dimensions (in erect position) as per IS: 12676-1989 [5]

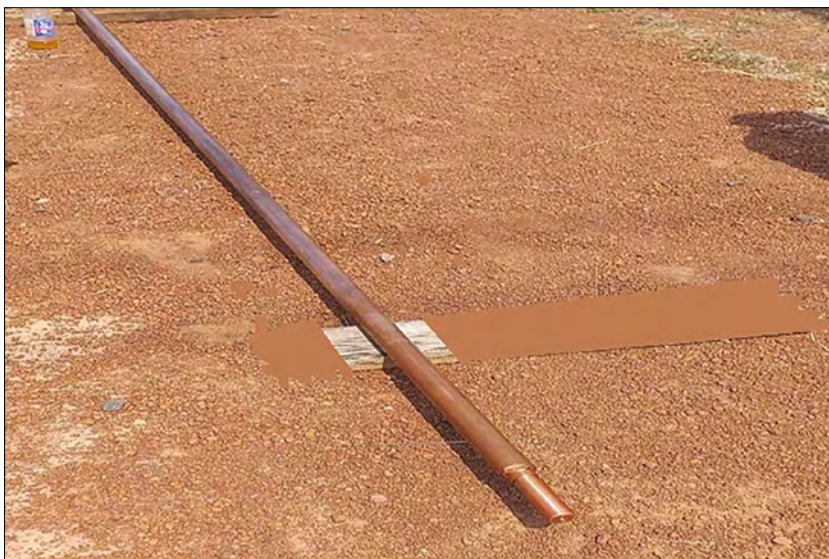
Figure 7. Draw-rod of the 420 kV TELK OIP bushing

- i. The draw-rod was thoroughly cleaned with acetone.
- ii. Thorough cleaning of the existing TELK's design spare bushing was done and was held in vertical position for a period of 24 hours with the support of a locally fabricated structure facilitating the settling down of oil in the bushing. Then the measurements of $\tan \delta$, capacitance and IR values were carried out and found to be in order. The test results were as shown below: At an ambient temp of 37 °C; $\tan \delta = 0.2739 \%$, Cap = 386.11 pF and IR value = 3.197 G Ω

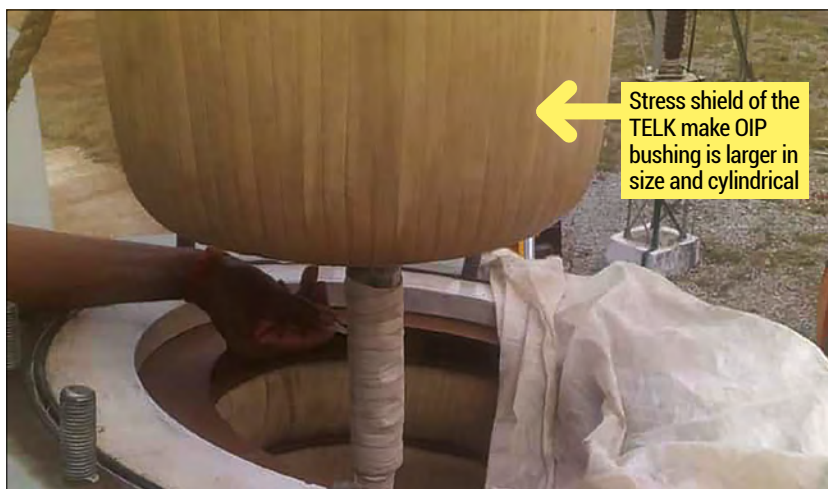
Figure 8. A 420 kV OIP TELK's design bushing being inserted through the turret with a stress shield

ix. Since the 1 V turret is tilted towards the outer side by about 15 degrees, an appropriate angle of the bushing was established with the second Hydra crane such that the TELK bushing (Fig. 10) assumed a tilted position of about 15 degrees to the vertical plane and then it was gradually lowered down through the turret CT (bushing CT), keeping all precautions since that the portion of the bushing CT area diameter of the TELK bushing was 10.0 mm larger than that of the BHEL bushing. There was hardly any play between the inner diameter of the turret CT (installed in the groove of the turret) and the diameter of the metallic portion of the bushing (diameter D2 in Fig. 5), which was encircled by the bushing CTs. The bushing was lowered down through the turret with utmost precision, maintaining an accurate angle with the successfully fitted stress shield, with the help of two Hydra cranes (Fig. 10).

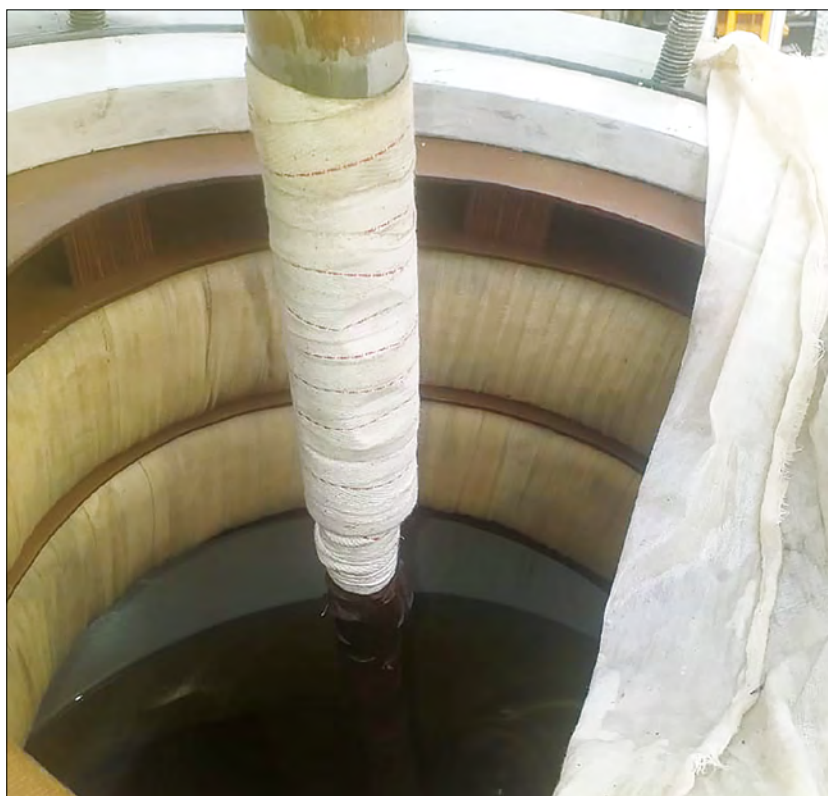
Figure 9. Cotton tape wrapped over the half-lap joints of 1 V phase winding lead and the draw-rod type bushing, tightened

vii. After properly tightening the half-lap joint of the winding lead connector with the half-lap joint of the 420 kV draw-rod end and grinding the larger portion of the draw-rod half-lap connector to size, the whole exposed winding lead and the terminal connector (two halves of half-lap joint connector) were wrapped with a crape tape and then with a cotton tape over that (Fig. 9).
