FSEC Energy Research Center®

12-31-2009

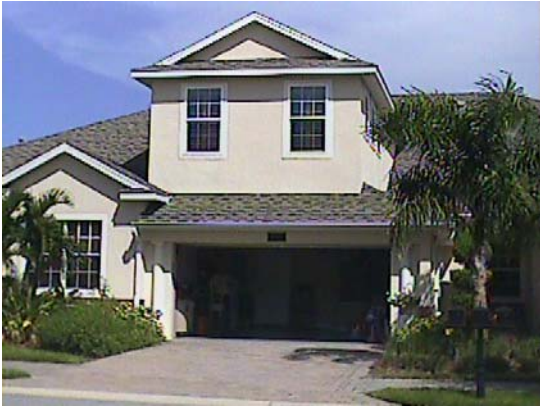
**Figure E-1** Home (H7G) faces west.

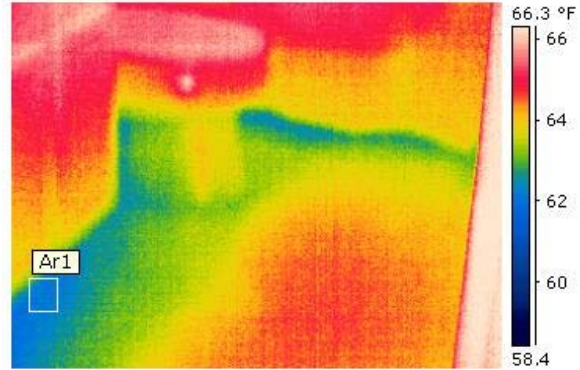
**Figure E-2** Infrared image of 2<sup>nd</sup> story bathroom floor before repair. Area in box (Ar1) is 62.7°F on a cold day.

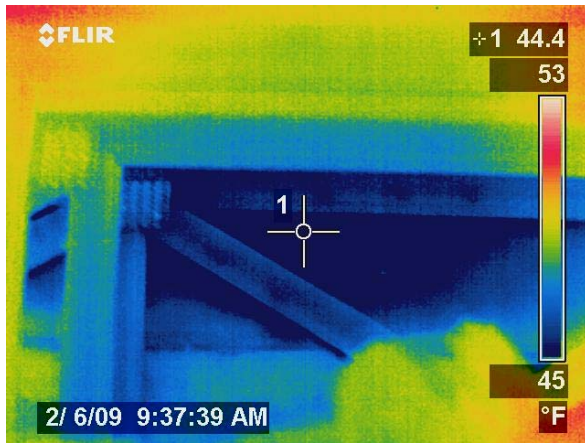
**Figure E-3** IR scan inside (H7G) bonus room floor cavity facing west. Coldest area is plywood.

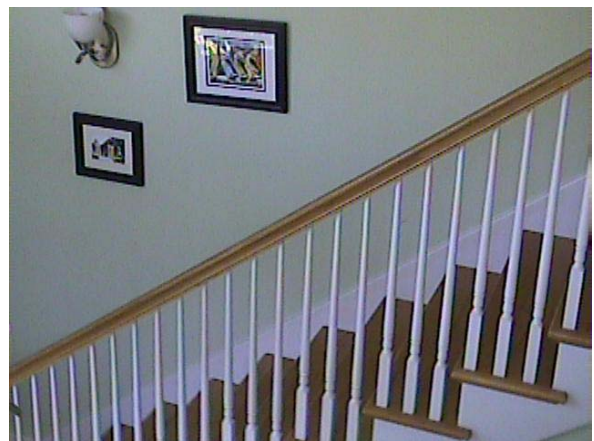
**Figure E-10** There are conditioned rooms on the other side of this wall above and below the floor space that runs along the lower picture hung on wall.

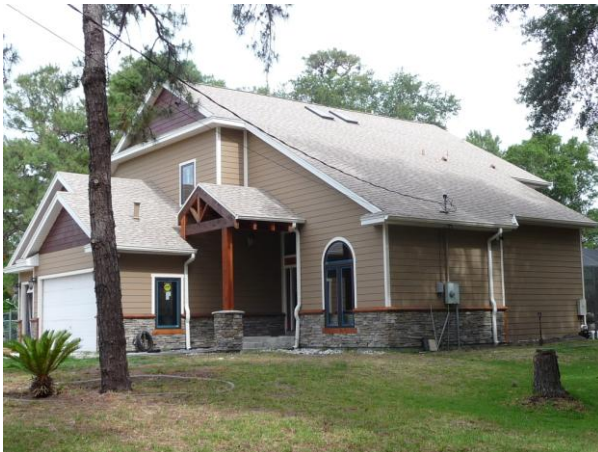
**Figure E-11** Attic over garage faces south in house H16B.

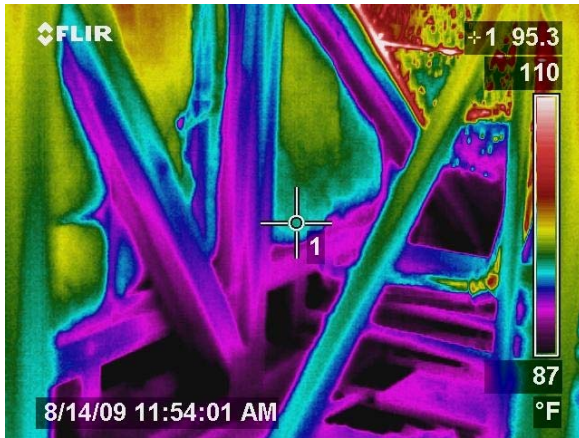
**Figure E-13** IR view inside the hot attic shows cooled surfaces low in attic in H16B before repair.

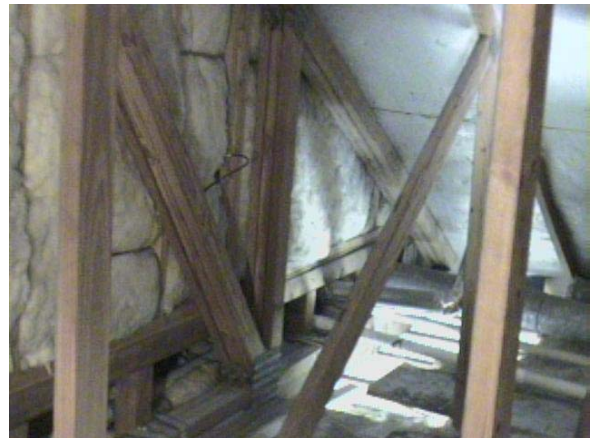
**Figure E-14** Photo of IR image to the left. The floor cavity at the bottom of the wall is open to attic space.

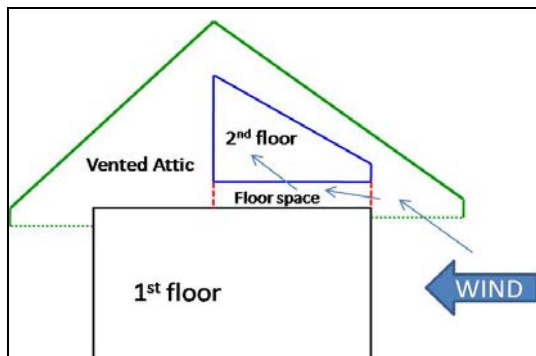
**Figure 1** Wind-driven attic air is pushed into the space between floors.

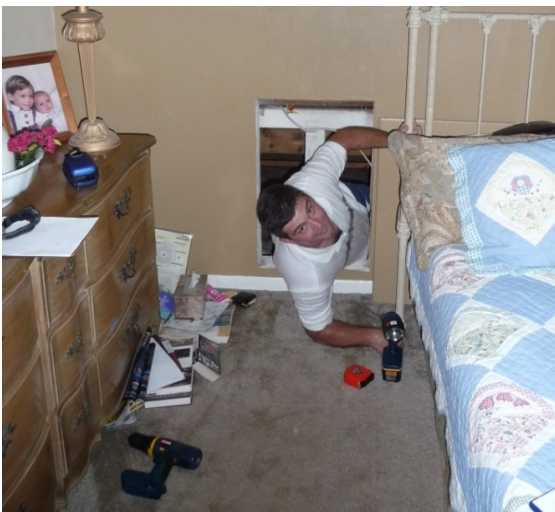
**Figure 3** House H13. Visual inspection in the attic space is necessary to identify the presence and magnitude of wind washing.

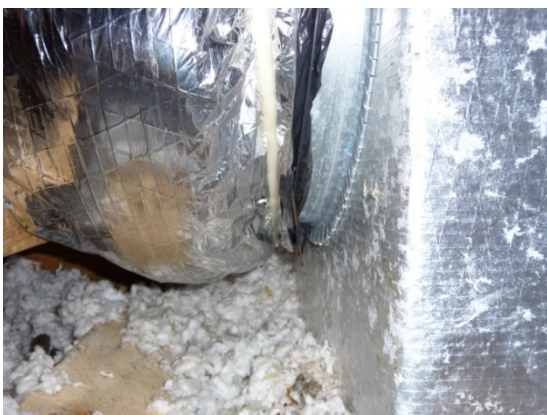
**Figure 5** In House H2, a loose fitting flex duct creates part of a large return leak.

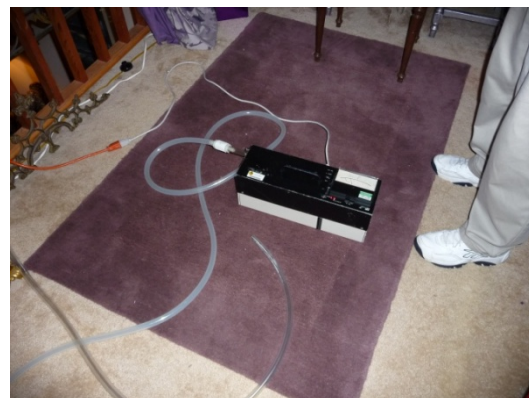
**Figure 6** Specific gas analyzer measures the house air change rate and return leak fraction with the AHUs operating.

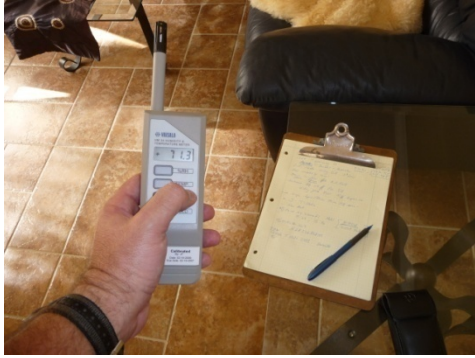
**Figure 7** Air temperature and relative humidity measurements were taken using a Vaisala HM34 probe.

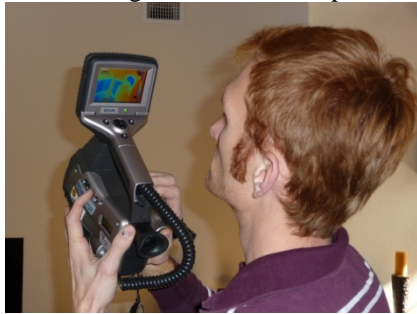
**Figure 8** Infrared images taken using a FLIR Model P40 Thermacam.

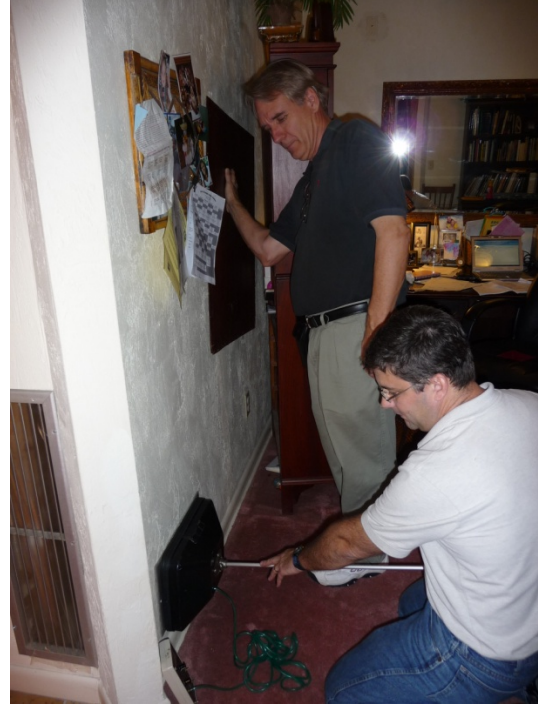
**Figure 9** In House H5, a pressure pan measures return leakage in a wall cavity indicating substantial return leakage.

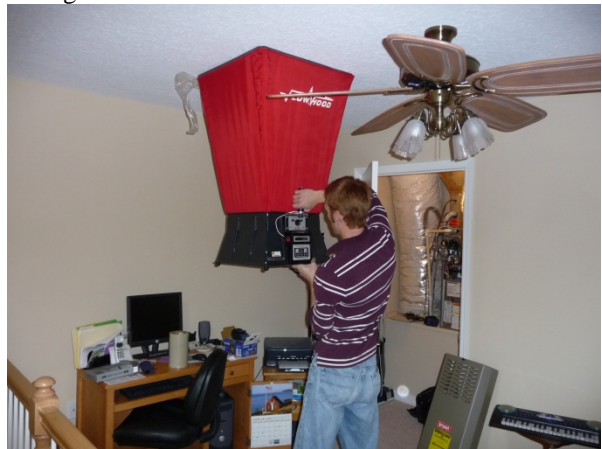
**Figure 11** Airflow measurement at House H7.

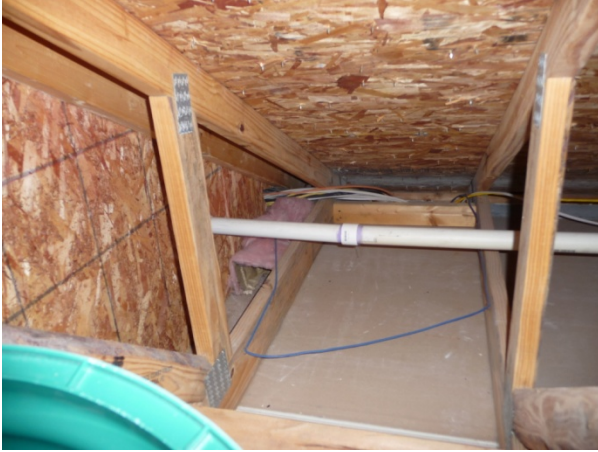
**Figure 12** No wind washing potential was found in House H18 because the kneewall insulation and floor cavity are covered by plywood.

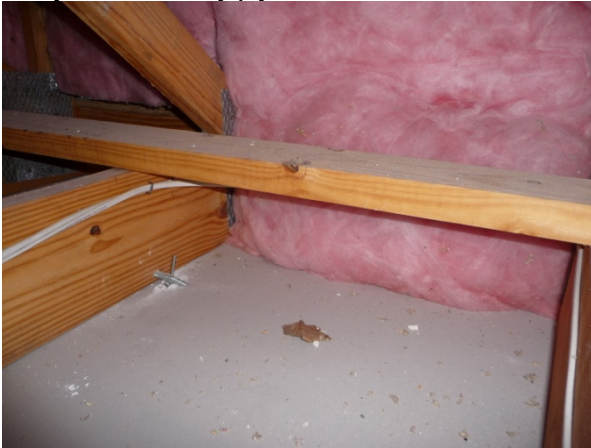
**Figure 13** Good quality insulation batt installation blocks opening to floor cavity in House H22. No insulation on top of ceiling since garage is below.

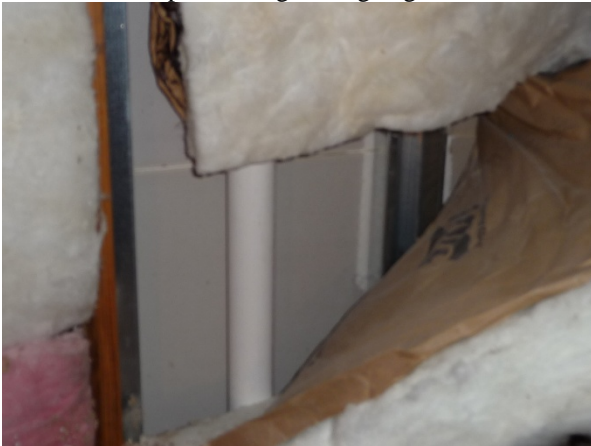
**Figure 15** In House H22, an area of fallen batt on kneewall allows hot attic air to transfer heat through wallboard into conditioned space.

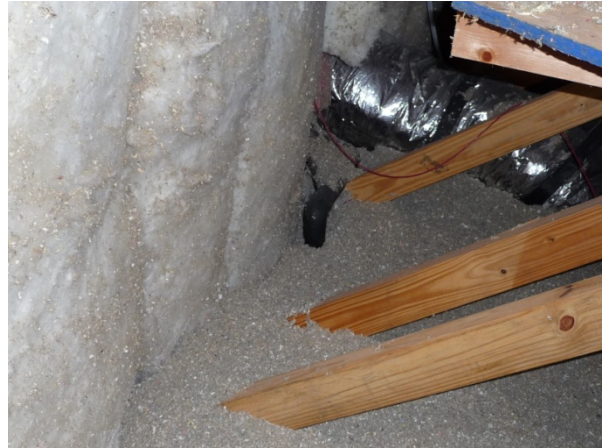
**Figure 14** In House H22, batts and blown insulation cover the opening to floor cavity.

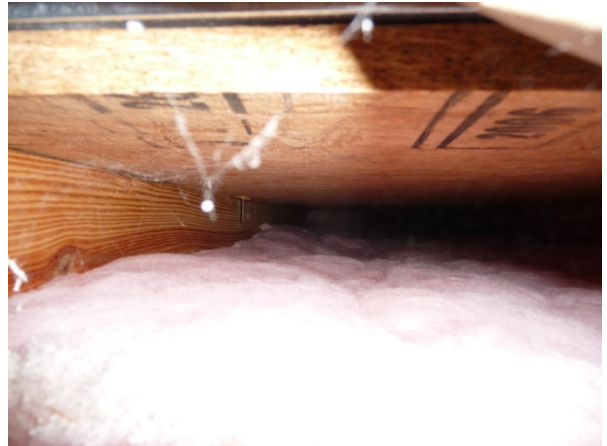
**Figure 16** A view inside the floor cavity of House H22 shows that batt insulation is lying on top of 1<sup>st</sup> floor ceiling, providing a thermal barrier to heat flow through the ceiling, but not through the floor of the 2<sup>nd</sup> story. These batts were used only where garage portions were below 2<sup>nd</sup> story conditioned space.

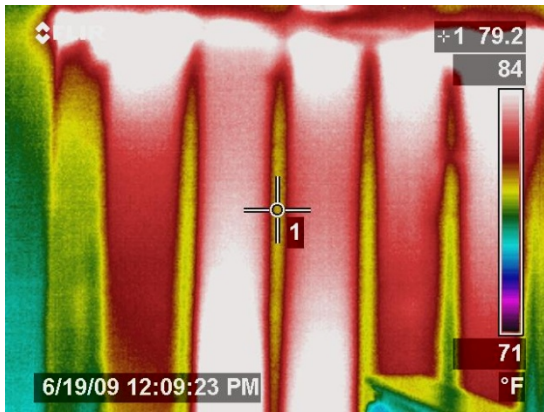
**Figure 17** IR image of Wall adjacent to unconditioned space.

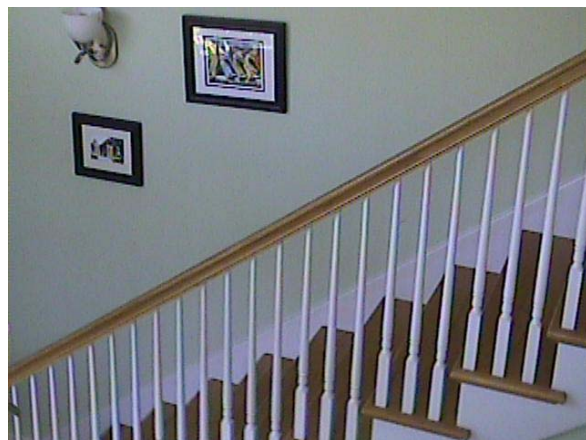
**Figure 20** There are conditioned rooms on the other side of this wall.

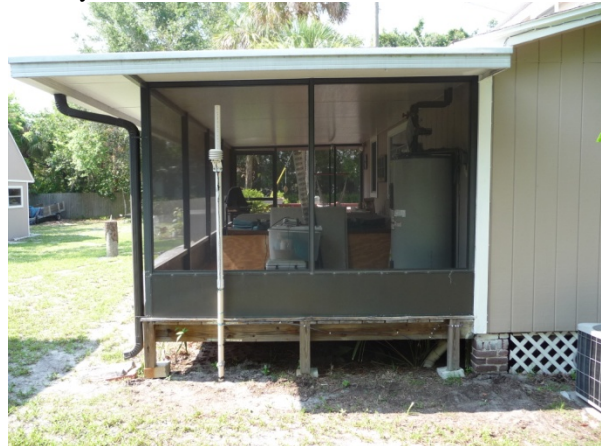
**Figure 24** H10 outdoor temperature and relative humidity measured about 6 feet above ground within gill plate radiation shield.

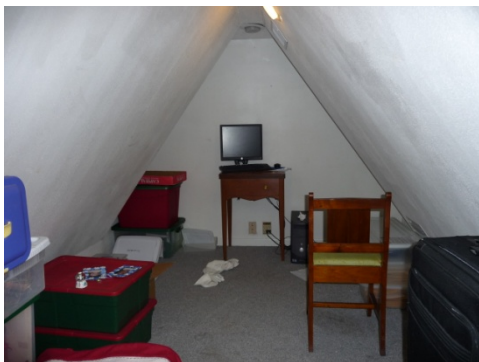
**Figure 25** Bonus room with steep pitched wall/ceiling assembly

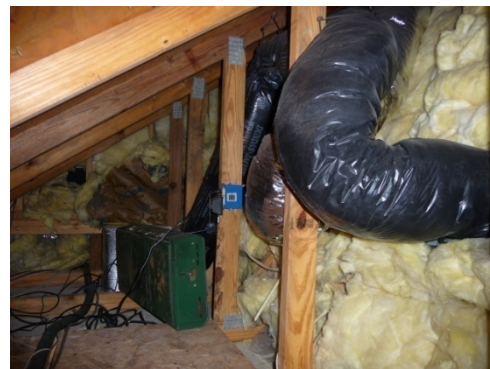
**Figure 26** One side of bonus room wall as seen from attic space.

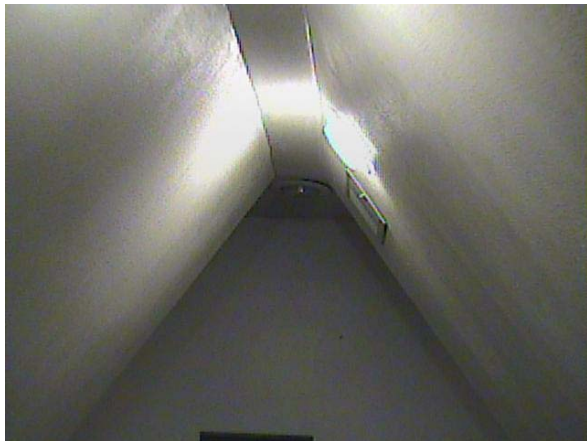
**Figure 33** Ceiling of bonus room with leaky recessed light.

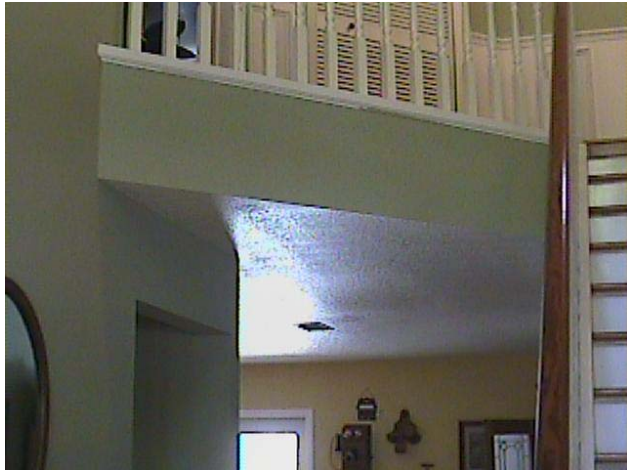
**Figure 35** Second story floor space

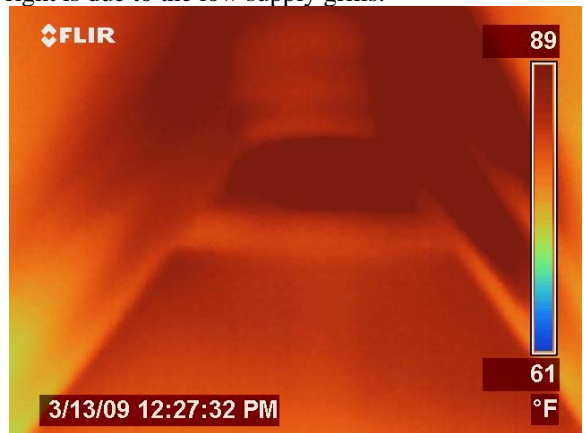
**Figure 34** IR image showing very hot areas of ceiling and air infiltrating from the garage attic.

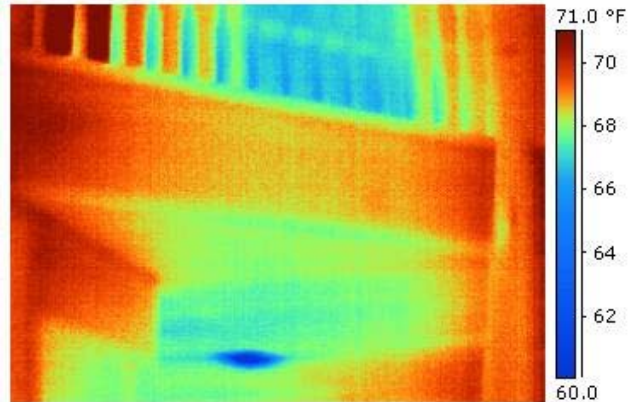
**Figure 36** Infrared image of 2<sup>nd</sup> story floor cavity which is partially open to the attic. Slightly warmer temperatures in proximity to the attic.

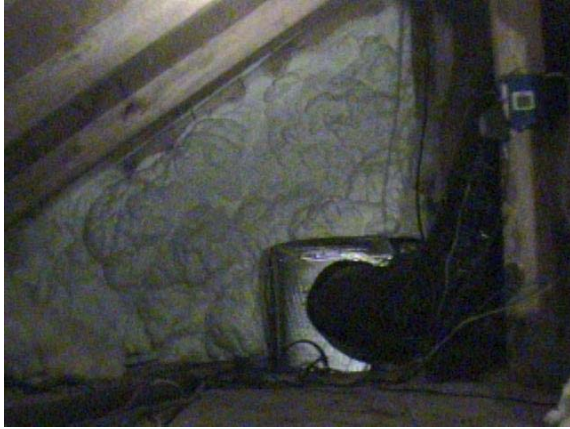
**Figure 37** Kneewall effectively sealed with foam product. Duct penetrations were wrapped with a foil faced insulation product to prevent moisture condensation.

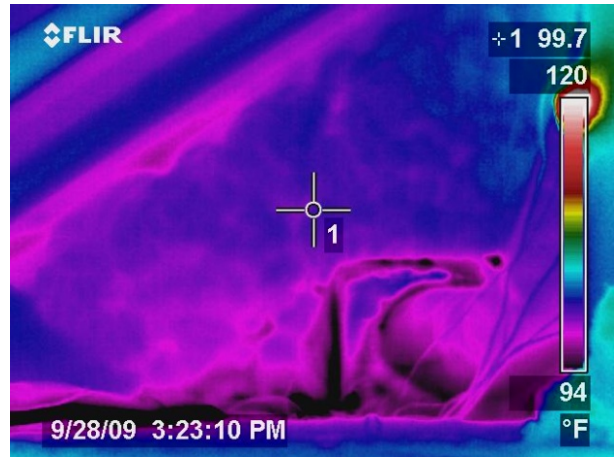
**Figure 38** A continuous shield of foam was applied to the kneewall, sealing off attic air from house interstitial cavities.

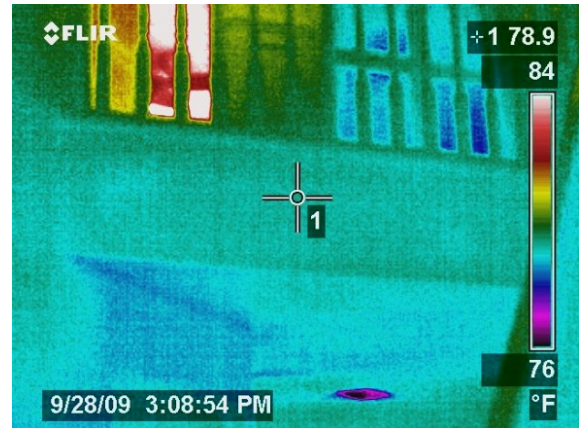
**Figure 44** After repair, evidence of wind washing heat penetration into house interstitial cavities is now gone.

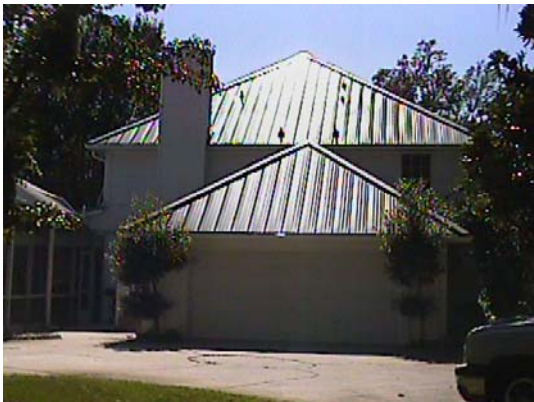
**Figure 45** Garage with standing seam metal roof.

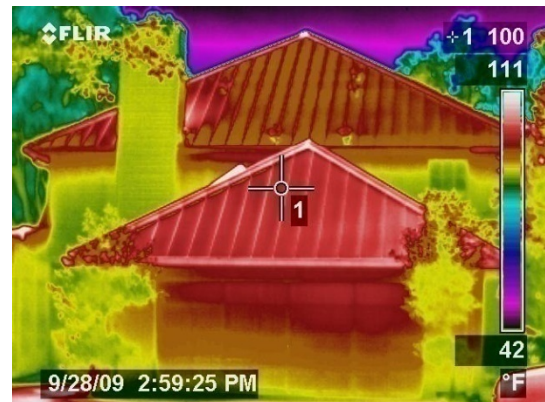
**Figure 46** Roof in excess of 100°F. The bonus room is located in the center of the garage attic space.

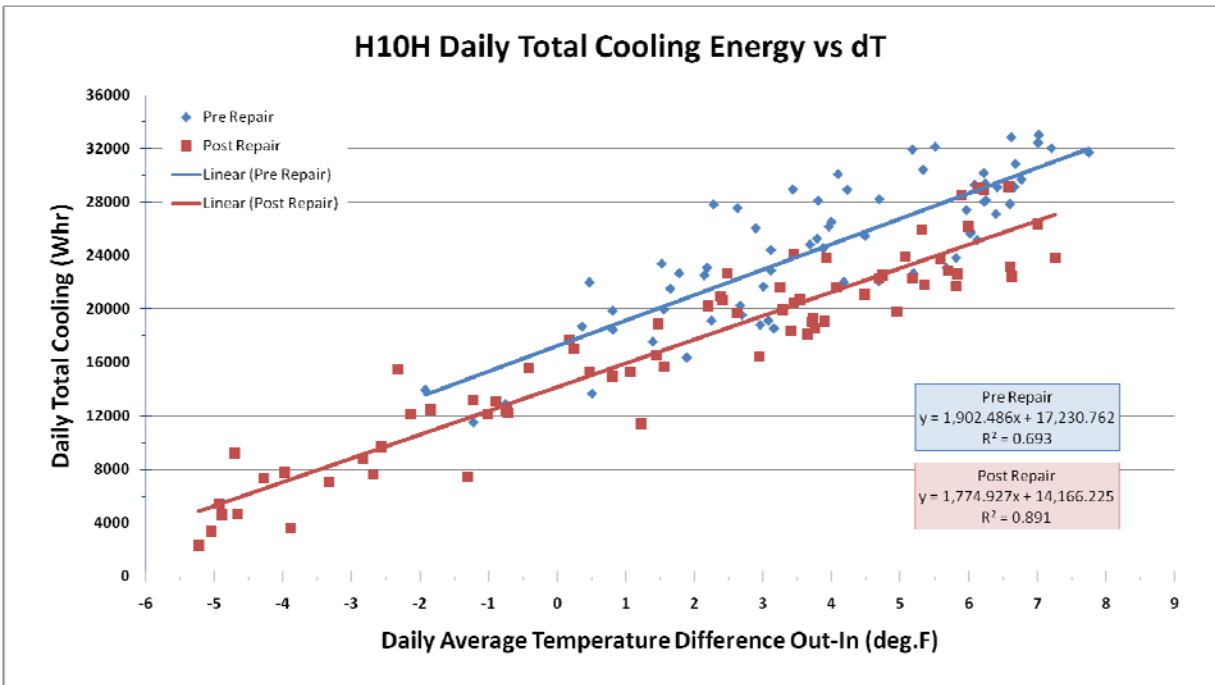
Graph 1 H10 cooling energy versus temperature difference.

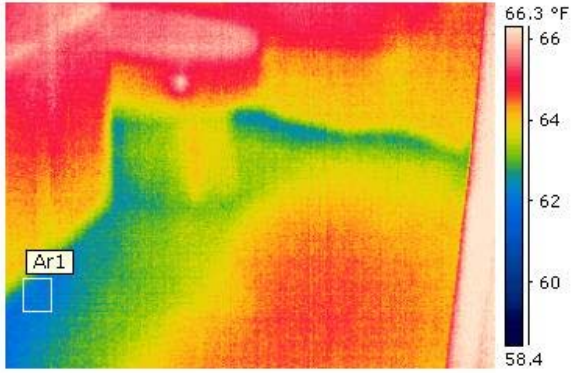
**Figure 47** 2<sup>nd</sup> story bathroom floor before repair. Area in box is 62.7°F on a cold day.

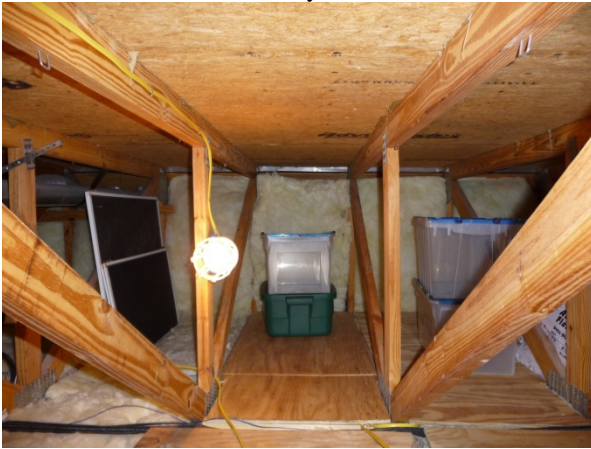
**Figure 48** H7 inside bonus room floor space facing south. Batts separate floor space from a small vented attic area.

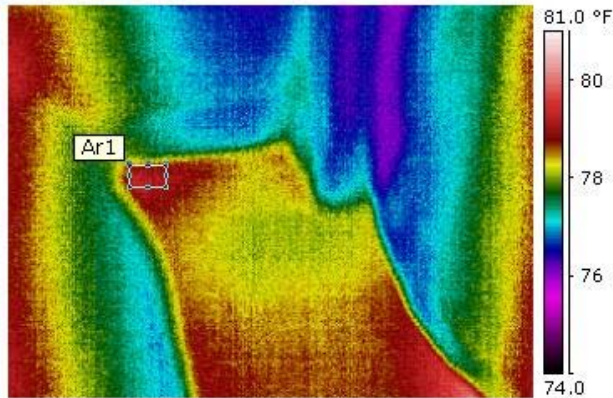
**Figure 58** Tile floor surface temperature before repair in the area box is in a location shielded from the supply vent and is about 79.5F when indoor air temperature is about 77F.

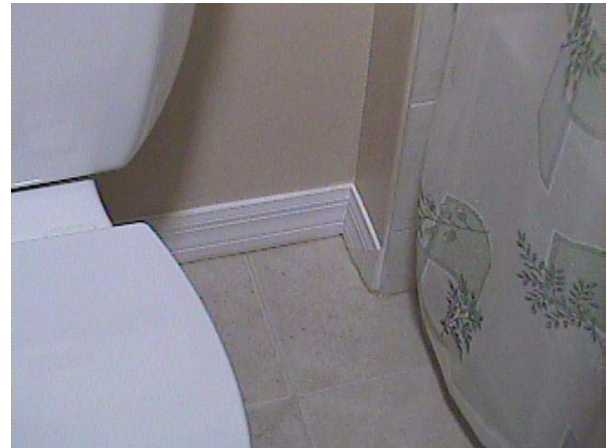
**Figure 59** Photo of IR image at left.

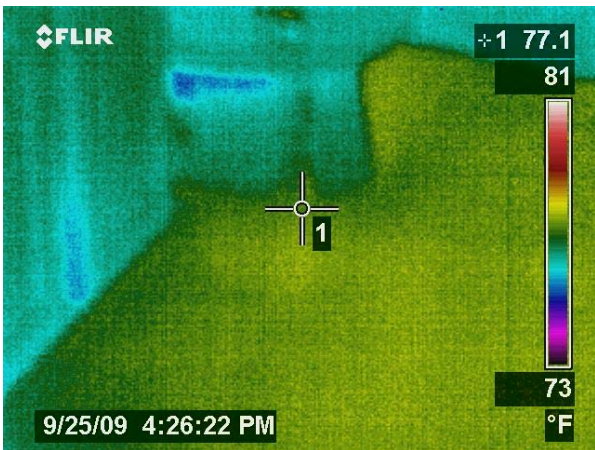
**Figure 62** IR image of 2<sup>nd</sup> story bathroom floor after repair. Floor surface is about 1.2°F cooler than pre-repair.

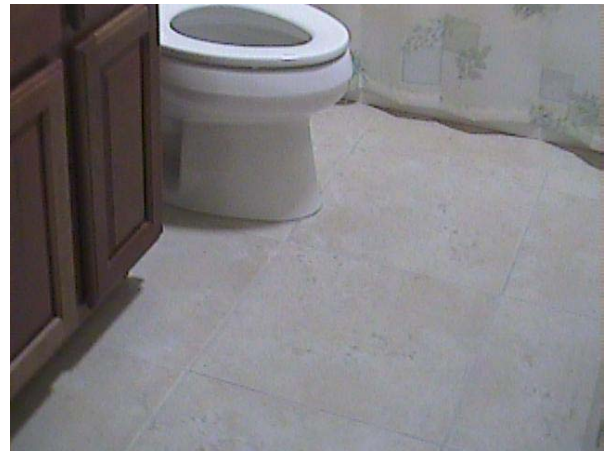
**Figure 63** A relative cool spot is a bathroom exhaust duct that vents to the attic.

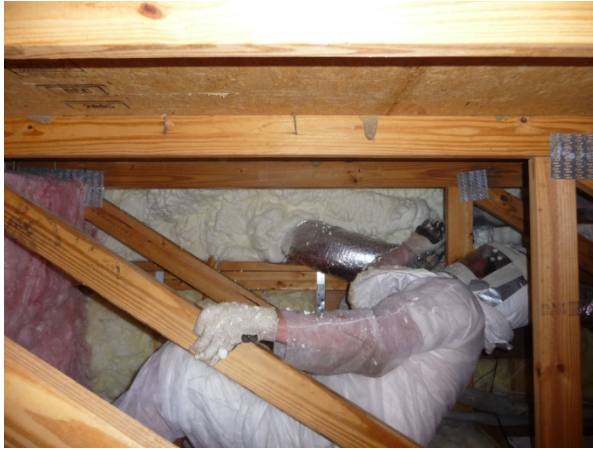
**Figure 64** Technician applying foam to opening between the 2<sup>nd</sup> story floor cavity and the bonus room floor cavity.

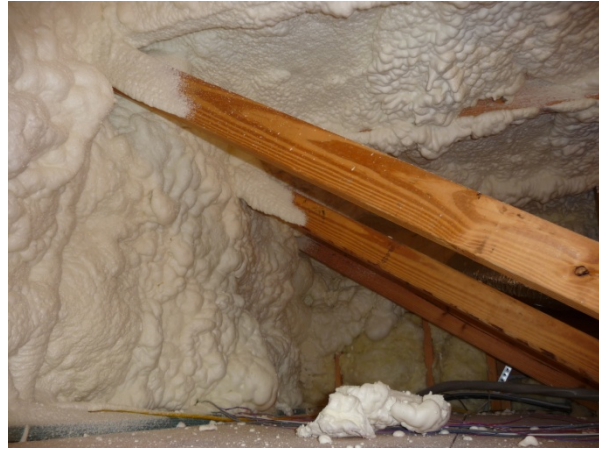
**Figure 65** Foam applied to wall and ceiling of the bonus room (3' high) floor cavity.

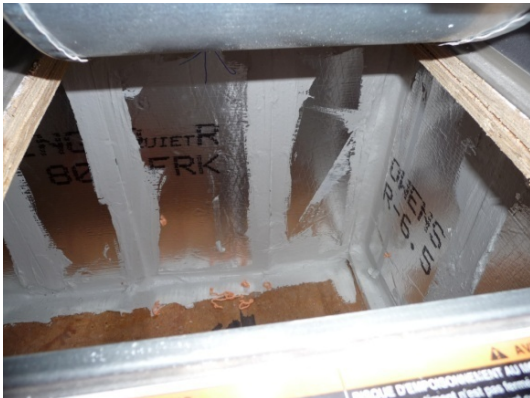
**Figure 66** Inside of return plenum after repair.

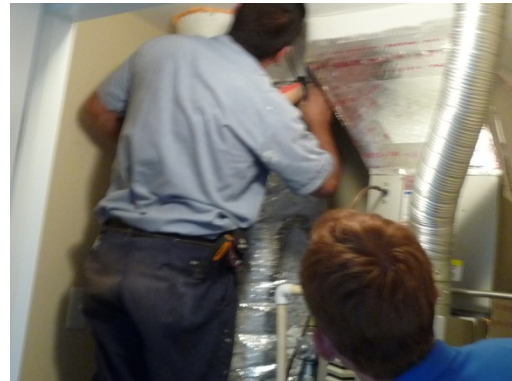
**Figure 67** Technician sealing duct penetration on second floor system.

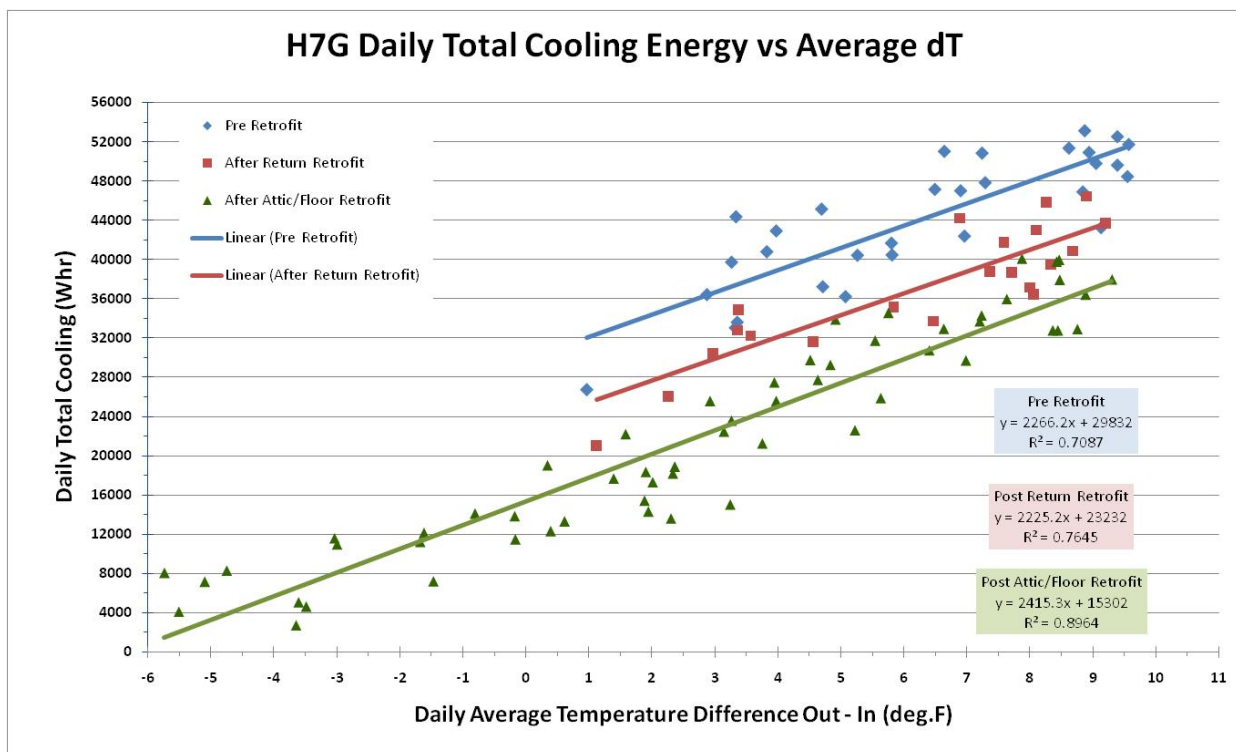
**Graph 2** H7 cooling energy versus temperature difference.

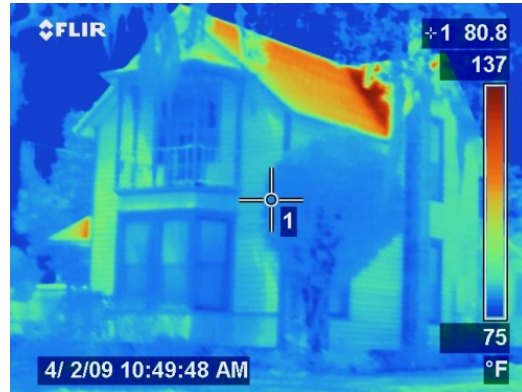
**Figure 68** IR view of well-shaded front of H14Y.

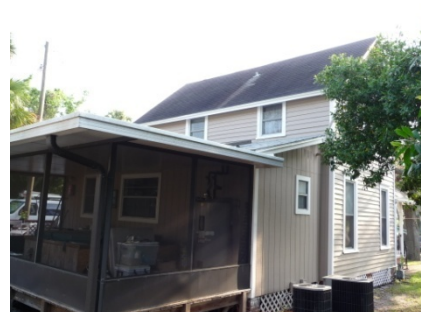
**Figure 70** Back of residence.

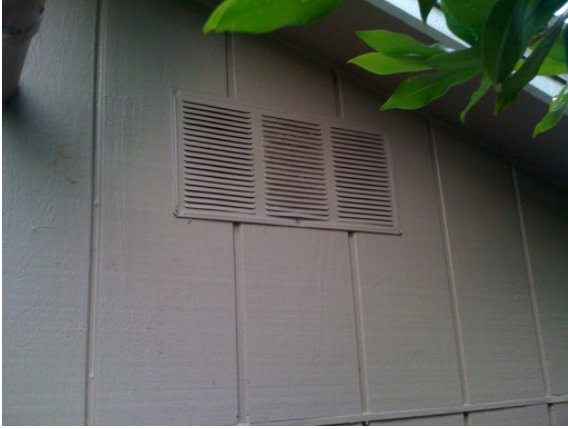
**Figure 71** Gable vent view from outdoors.

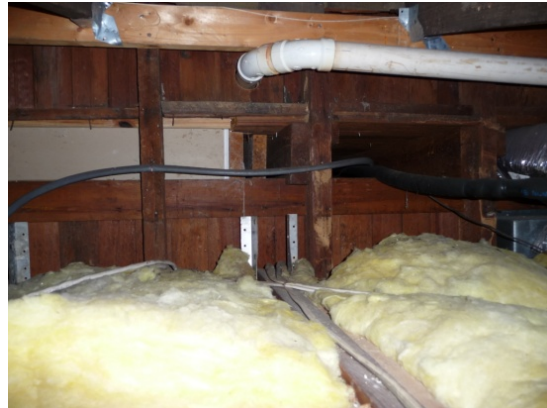
**Figure 74** Floor cavity directly connected to attic area.

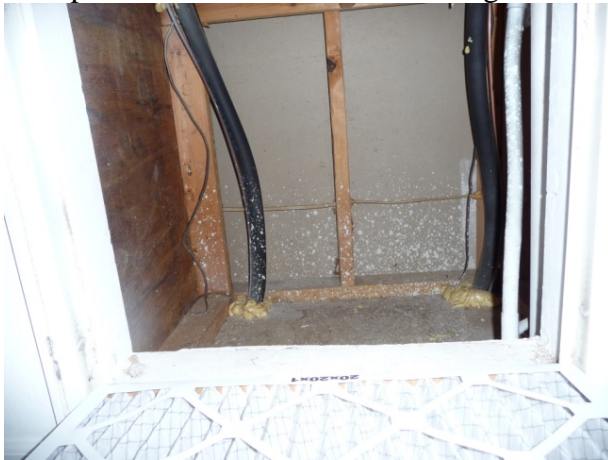
**Figure 75** Leaky return plenum.

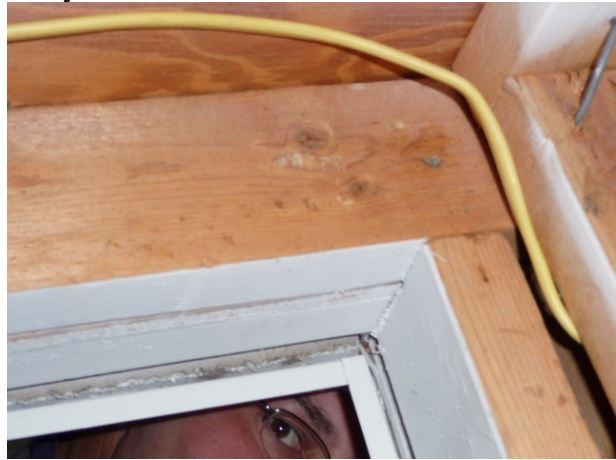
**Figure 76** A view from inside the return plenum shows a lack of sealant or air barrier in return plenum.

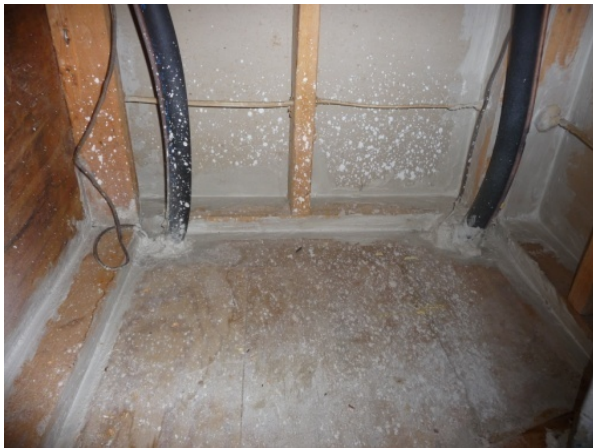
**Figure 77** 1<sup>st</sup> floor system return plenum with effective air barrier at all joints and penetrations.

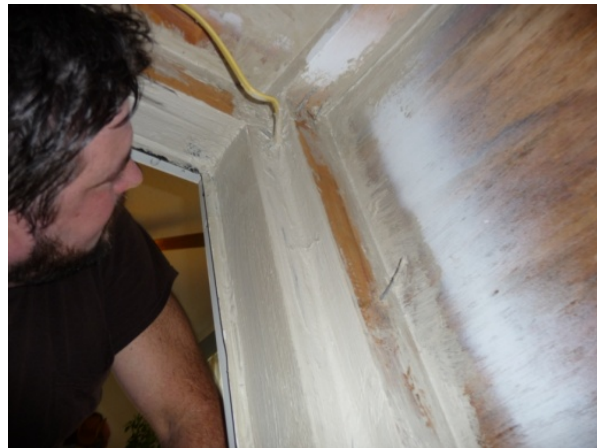
**Figure 78** Mastic properly applied reduced return leaks from unconditioned space.

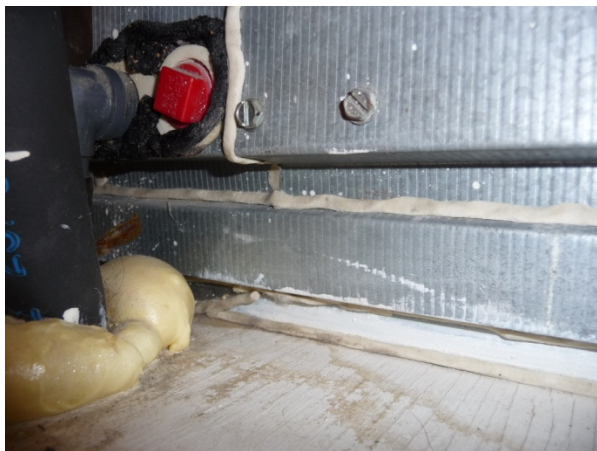
**Figure 79** AHU leaks sealed with expanding foam and caulk on first floor system.

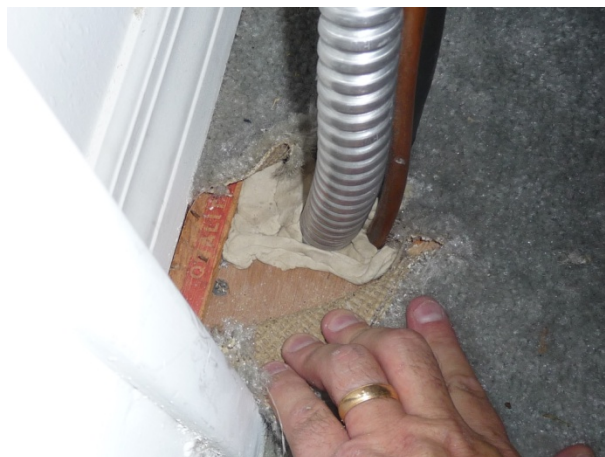
**Figure 80** Conduit and refrigerant line penetrations were sealed on the second floor system.

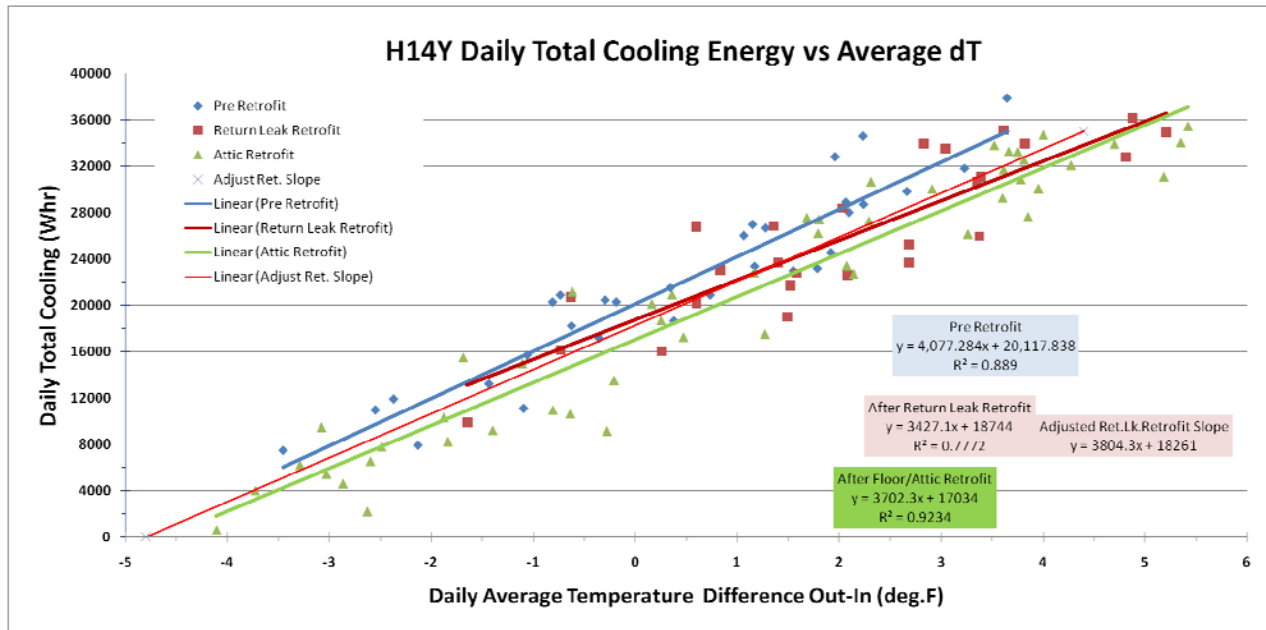
**Graph 3** H14 cooling energy versus temperature difference.

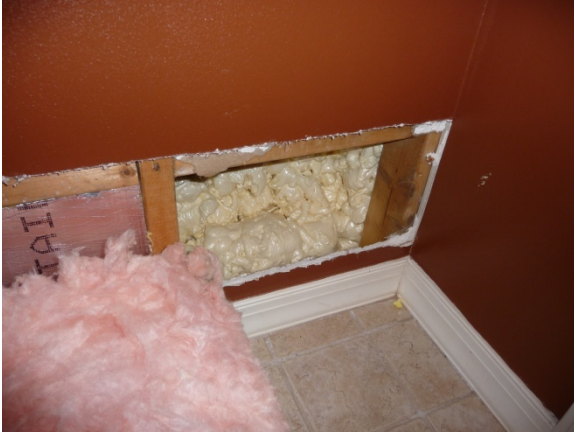
**Figure 83** Attempt by homeowner to seal perceived air pathway in bathroom.

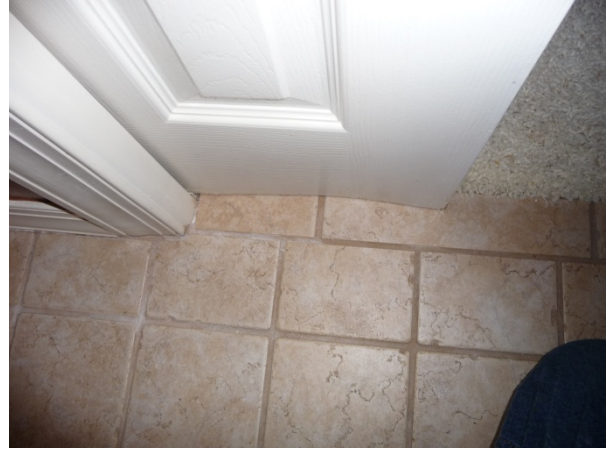
**Figure 84** Warped pocket door from air infiltration from north attic area.

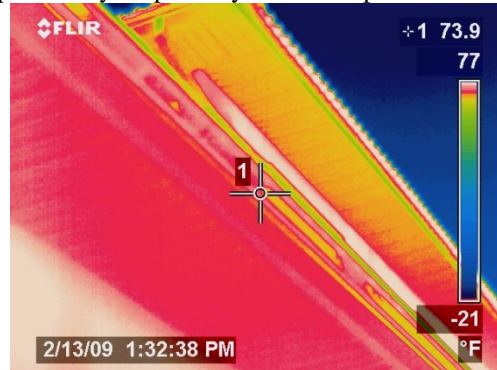
**Figure 90** IR North soffit.

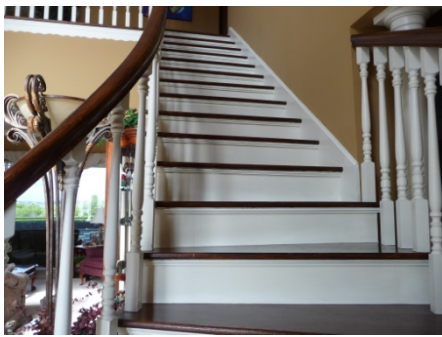
**Figure 91** Right staircase

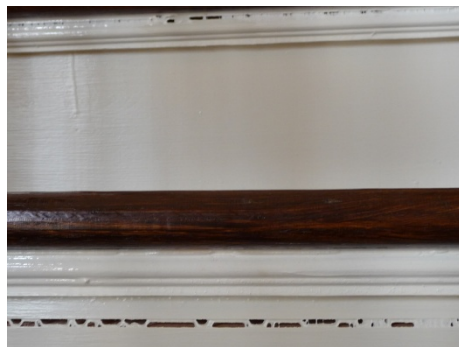
**Figure 92** Riser separation before repair.

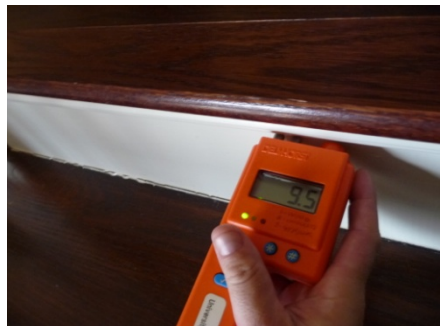
**Figure 93** Moisture content readings were about 13% at top of stairs with trend that fell to about 9.5% at bottom of stairs.

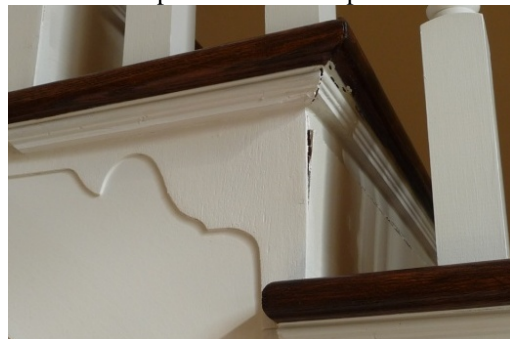
**Figure 94** Cracking and separation before repair.

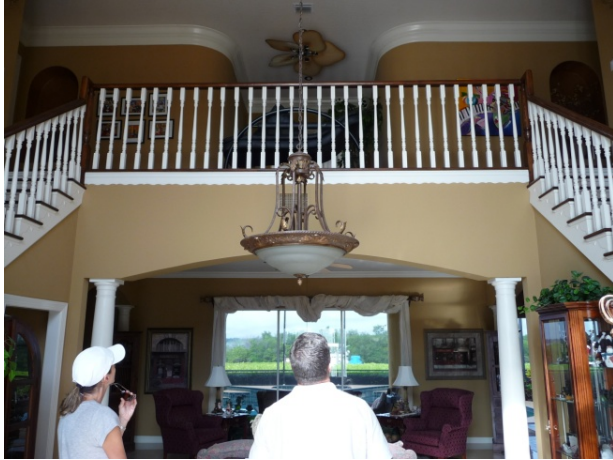
**Figure 95** Foyer grand staircase had more cracking on the right side stairs which is closer to most of wind washing areas.

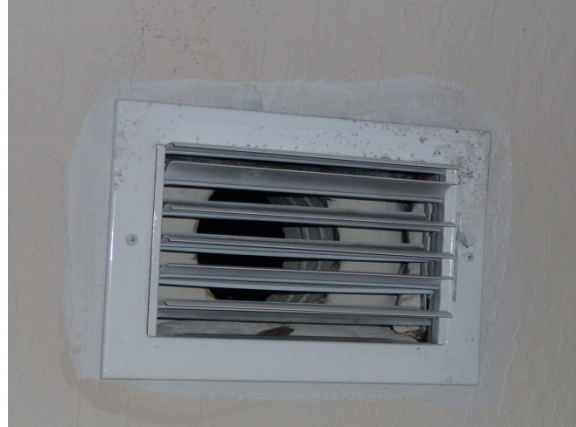
**Figure 96** Evidence of condensation damage, mold and recent repairs by homeowner.

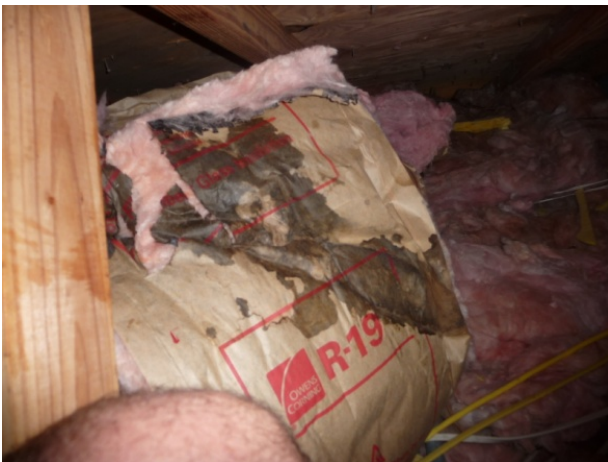
**Figure 97** Moisture damaged batt.

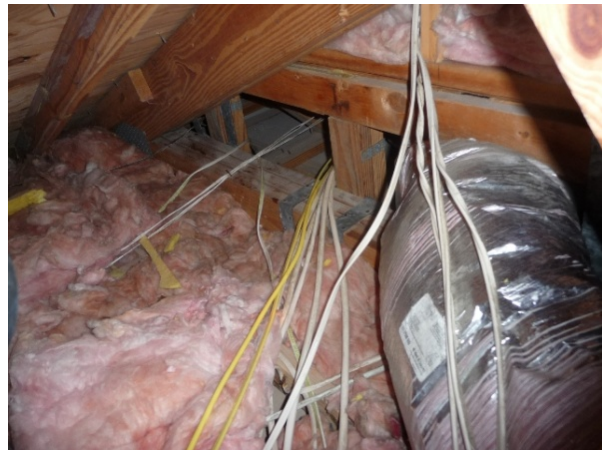
**Figure 98** Supply duct running into an open floor cavity in garage attic kneewall.

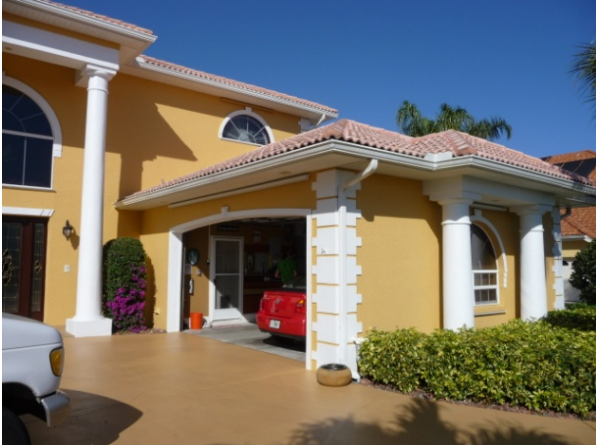
**Figure 99** Garage attic adjacent to floor cavity.

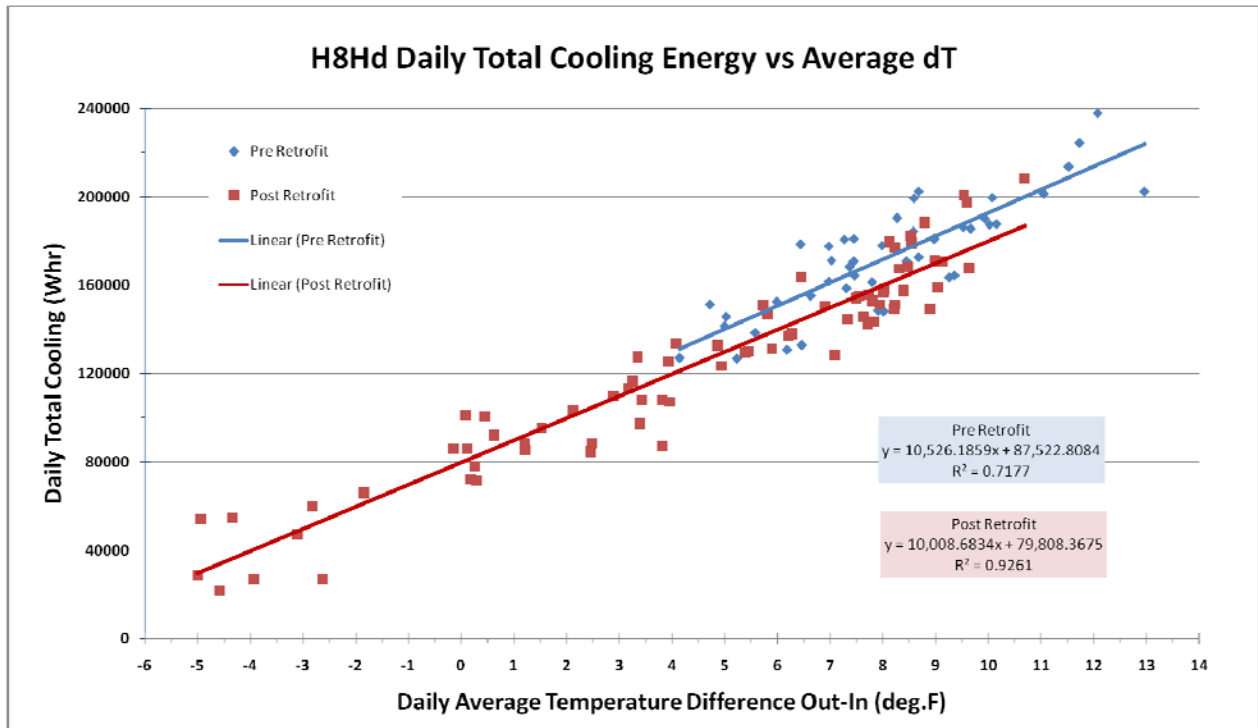
Graph 4 H8 cooling energy versus temperature difference.

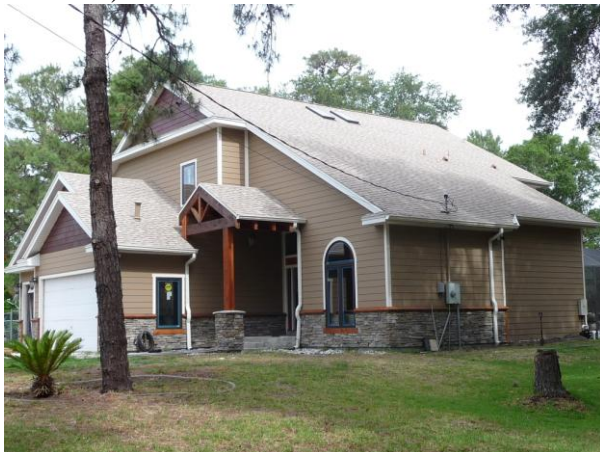
**Figure 104** Attic over garage faces south.

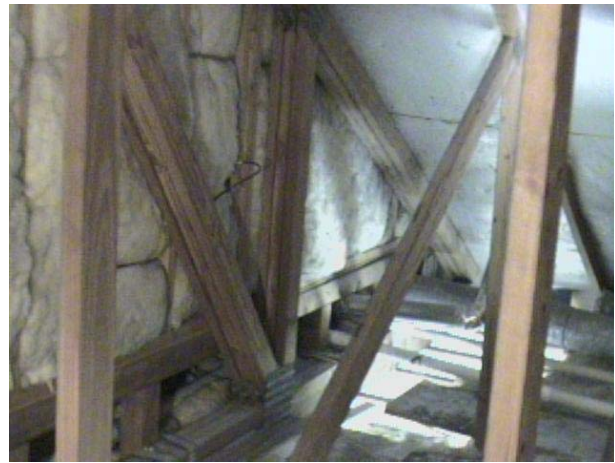
**Figure 107** Photographic view of IR image to the left. The interstitial floor cavity at the bottom of the wall is open to garage attic space.

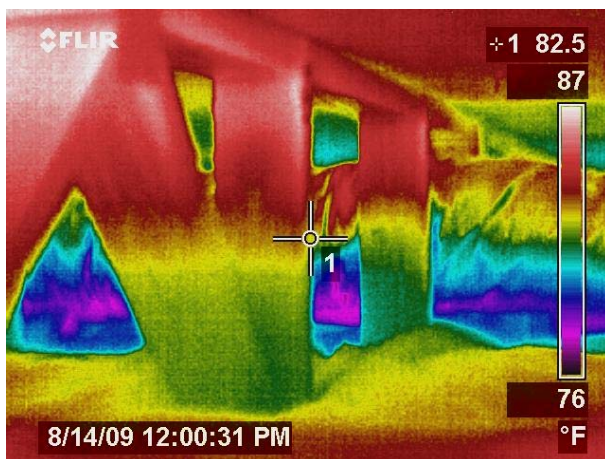
**Figure 108** IR inside floor space shows stratification before foam retrofit.

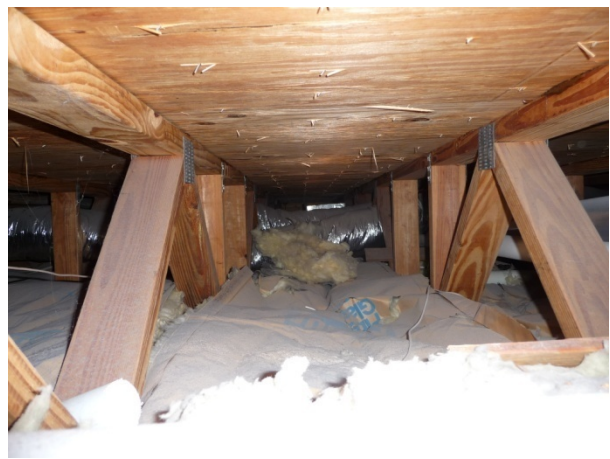
**Figure 109** View inside floor space.

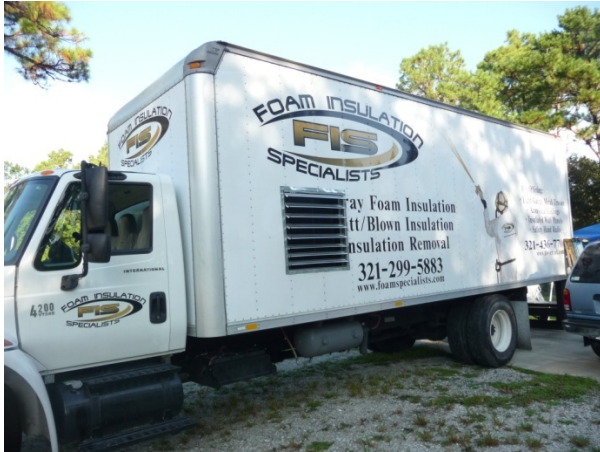
Figure 110 Insulation rig at site.

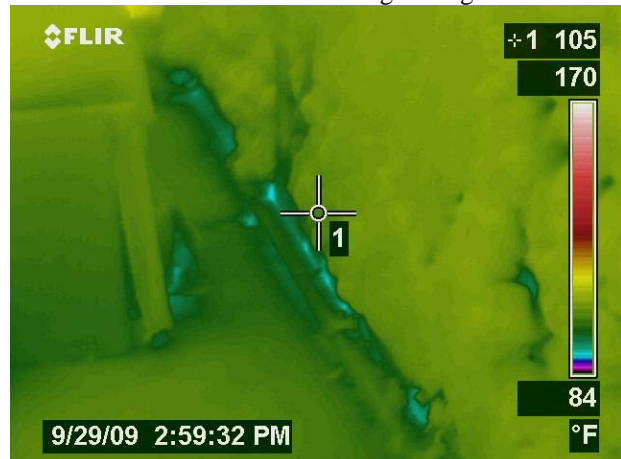
Figure 113 IR image from inside attic after repair.
