FSEC Energy Research Center®

12-31-2009

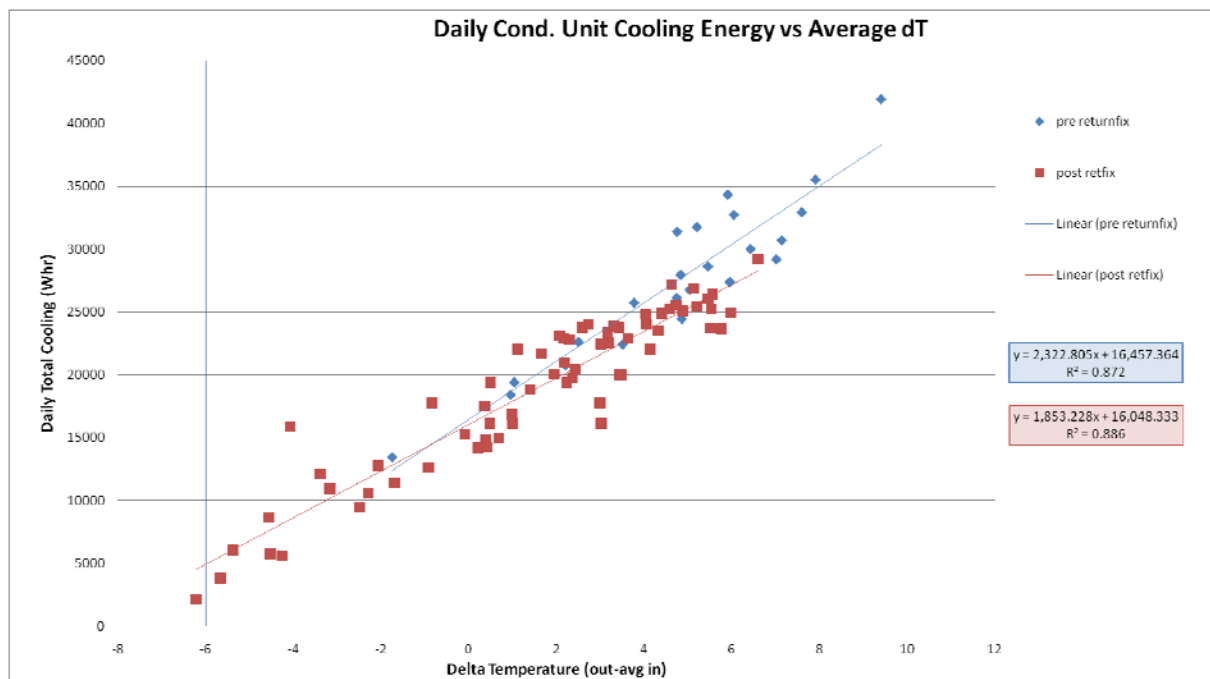
**Graph 5** H16B cooling energy versus temperature difference.

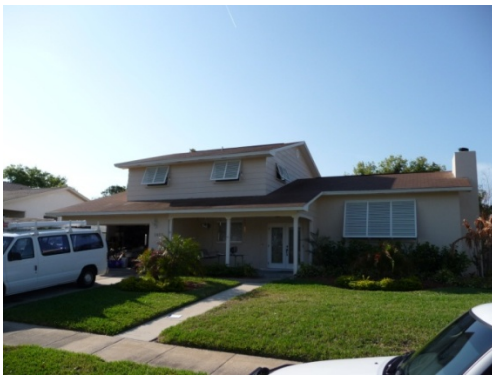
**Figure 114** Front of split level home faces north. There is a small attic space above the front porch and garage which is open to the interstitial floor cavities.

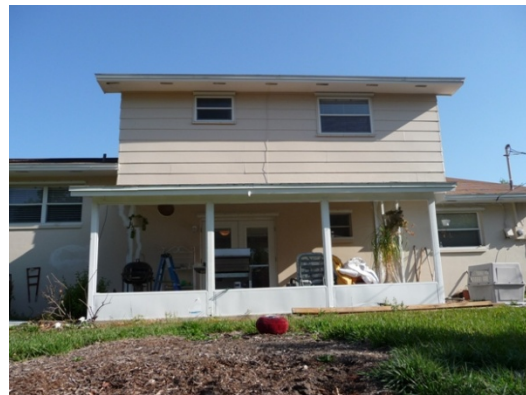
**Figure 115** Back of home (facing south) with top story floor space cantilevered and vented over patio.

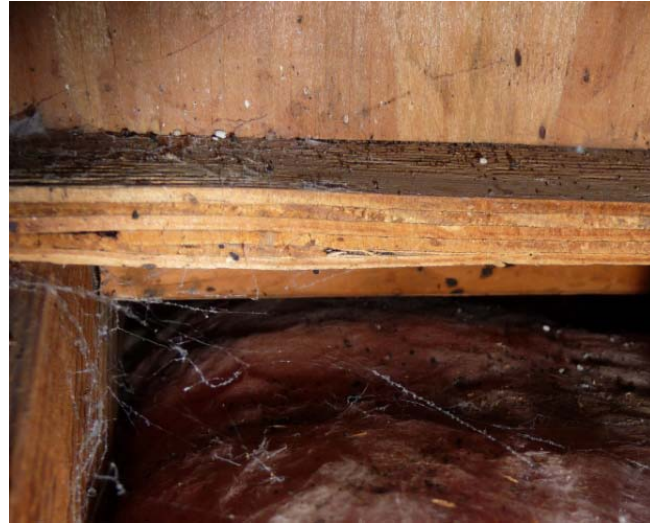
**Figure 120** View of air leakage between batt and floor deck on north side facing South. Air leakage estimated to be about 2"x 22" in each bay.

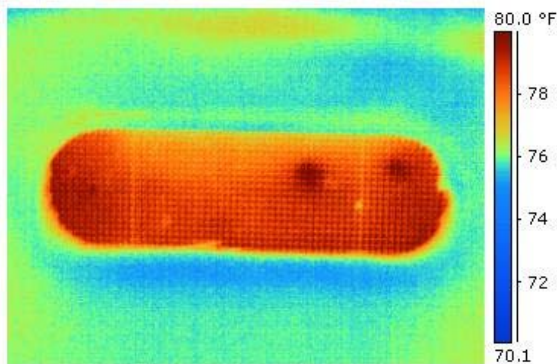
**Figure 121** With 10 mph wind from the north, the north soffit vent shows interior surface temperatures about 78-80 °F. Outside air temperature =80.1 °F and interior air temperature=71.0 °F.

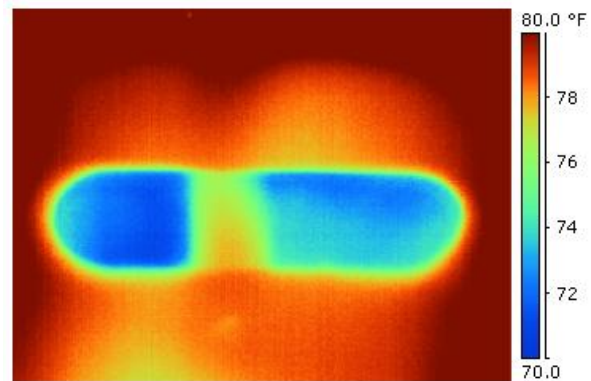
**Figure 122** With 10 mph wind from the north, the south soffit vent shows average of 71.9 °F on interior surfaces in left bay and about 73.2 °F on right bay indicating cool house air being pushed through the house by means of the floor cavity and the force of the wind.

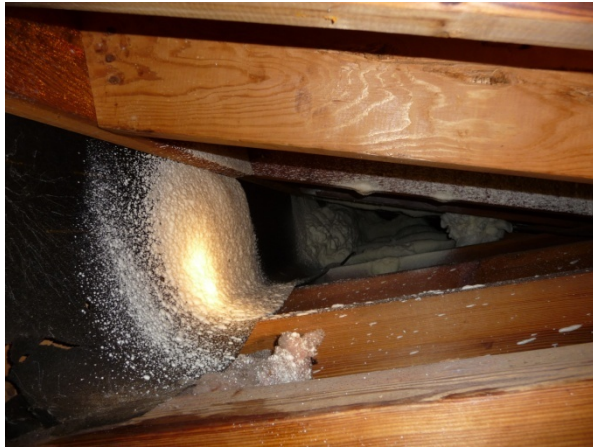
**Figure 123** Beginning of north side sealing.

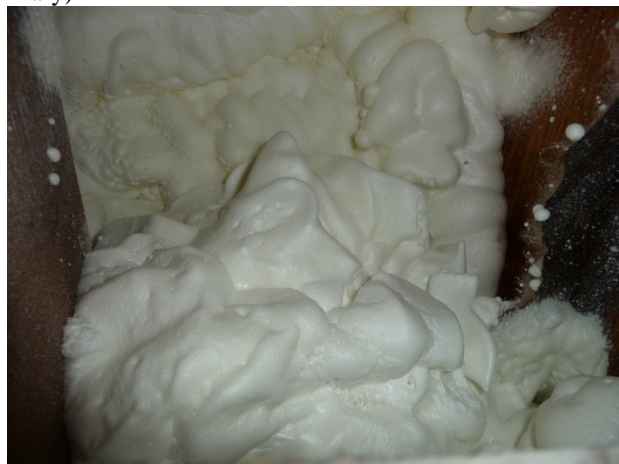
**Figure 126** South side insulation applied over top of floor deck, then floor space vertically sealed off by foam wall from floor deck down to bottom of floor space.

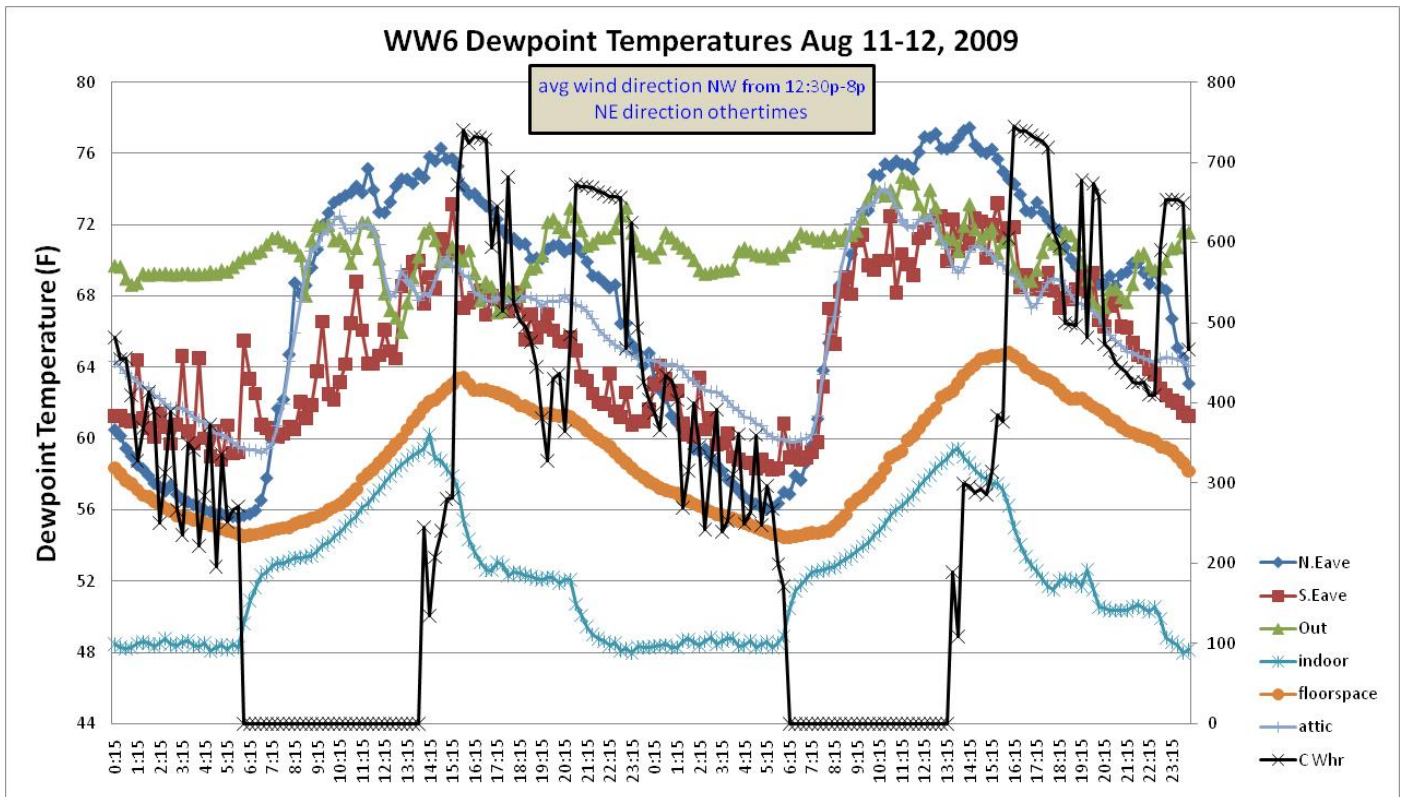
**Graph 6** H111C Dewpoint temperatures indoors, outdoors and in unconditioned spaces during two-day period.

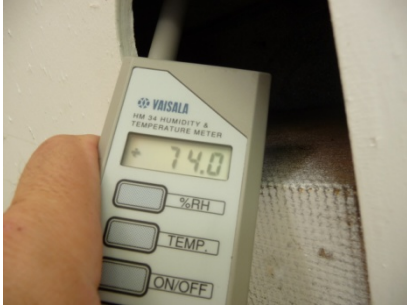
**Figure 127** Evidence of cool, dry air emanating from the vented eaves on the south side of the house. (T)

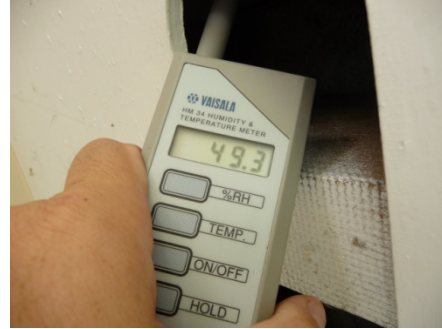
**Figure 128** Measurement of RH (%) showing low humidity air discharging from the soffit vent on the south side of the house.

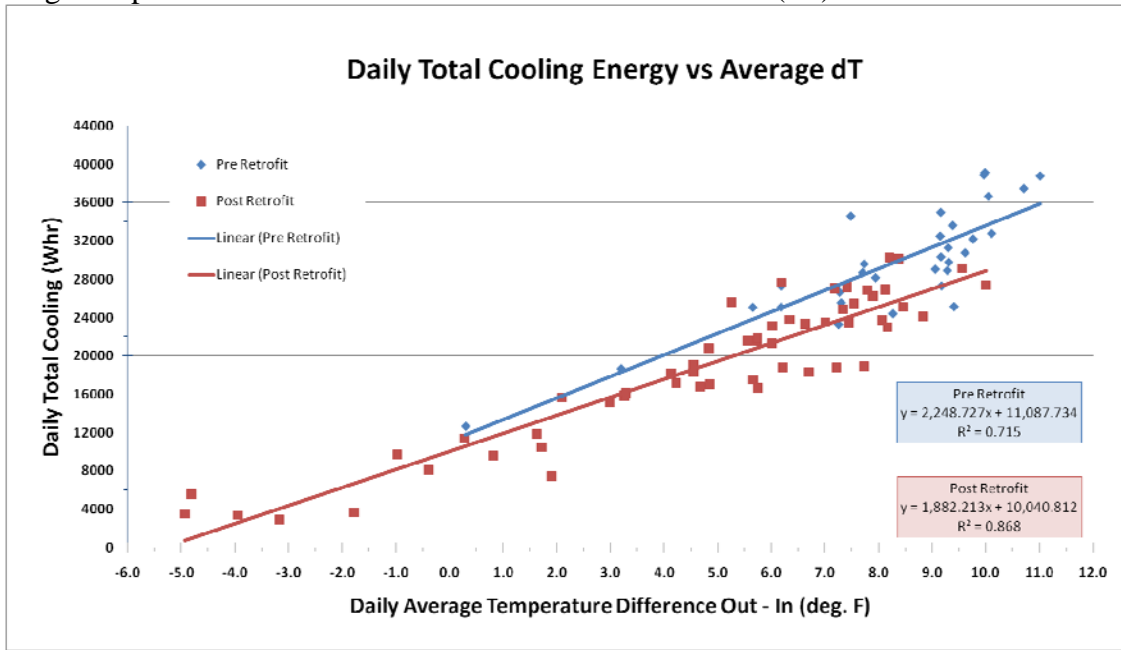
Graph 7 H11C cooling energy versus temperature differential.

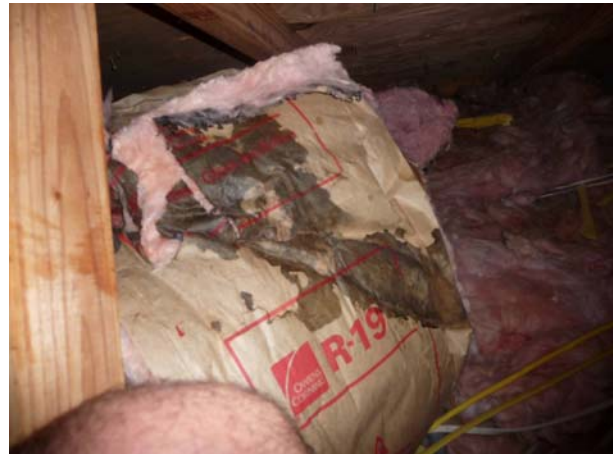
**Figure 130** Batt pulled away from duct shows it is soaked where dark areas are seen on paper facing.

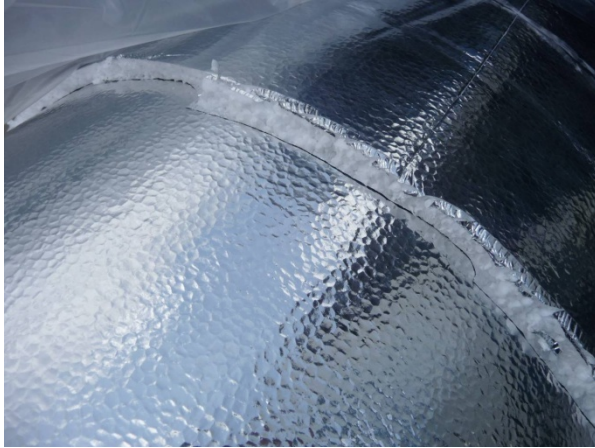
**Figure 131** 3/8 inch beadboard insulation with foil face on one side and plastic film on the other.

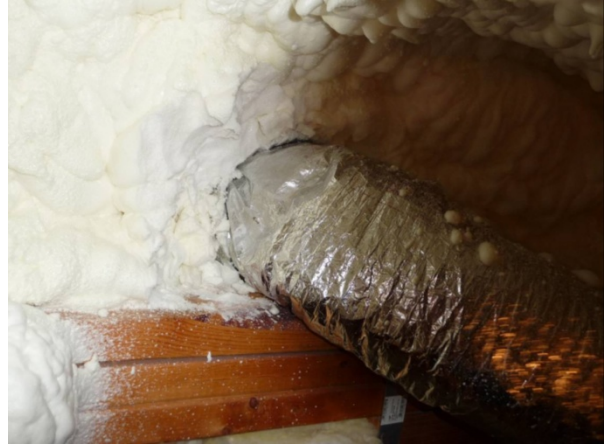
**Figure 132** Supply duct from attic to floor space with insulation wrap around duct after foam applied.

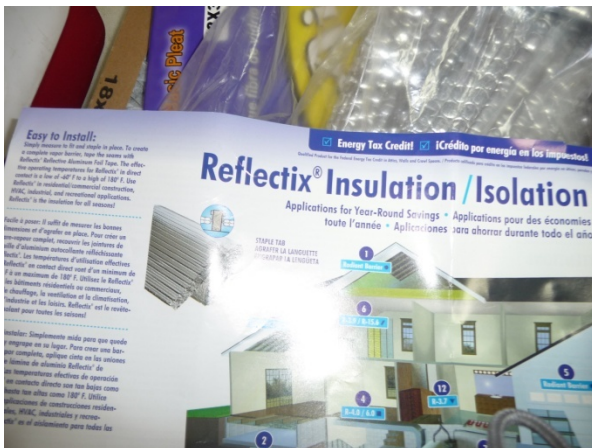
**Figure 133** Second product used to wrap supply ducts has foil facing on both sides of a plastic air bubble pack.

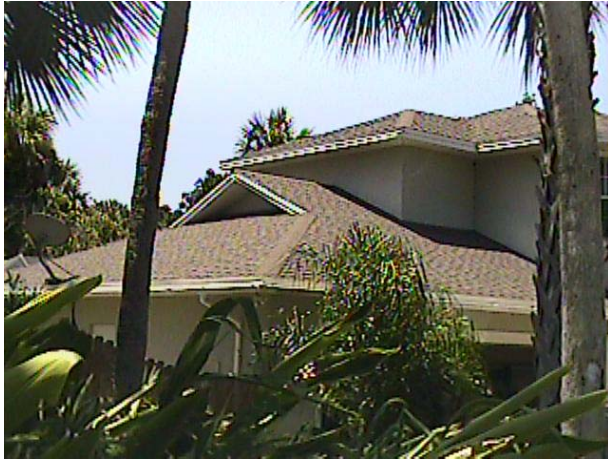
**Figure 134** East and north side of house with attic over garage adjacent to open floor cavities.

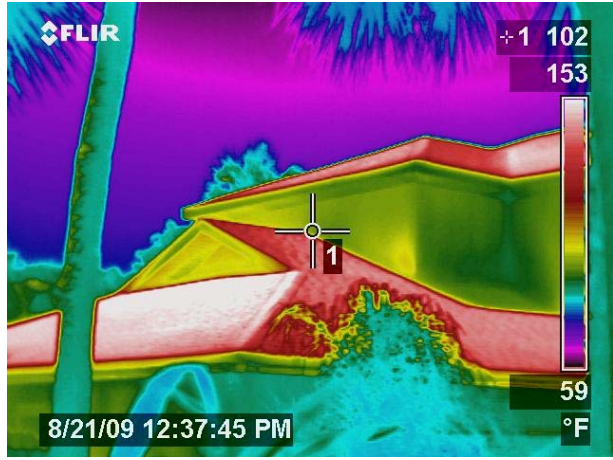
**Figure 135** Infrared image of the house during midday after mostly sunny conditions all morning.

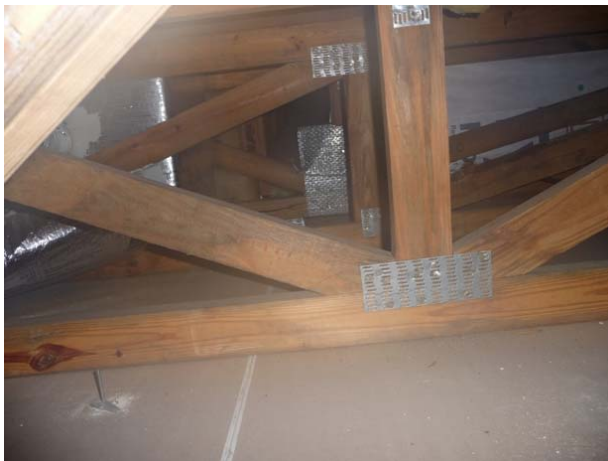
**Figure 136** Open floor cavity area in the east attic. (view looking toward the west into the floor space)

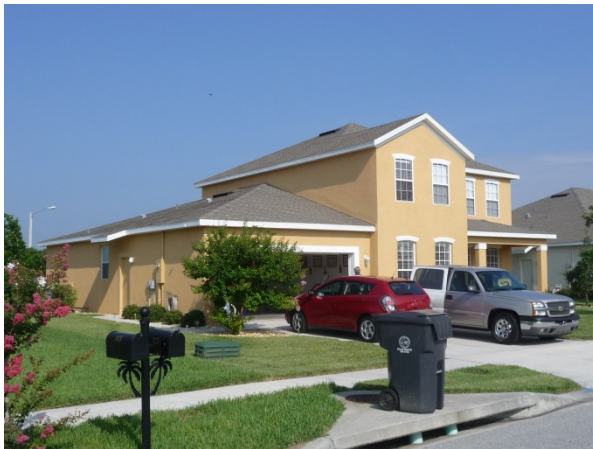
**Figure 157** H19 Exterior view of home.

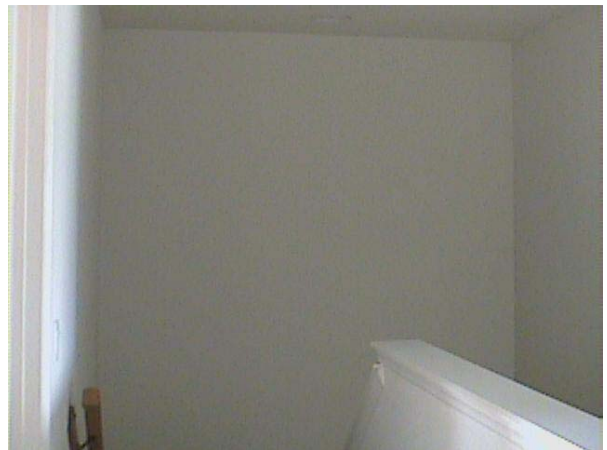
**Figure 162** Photo of IR image to left.

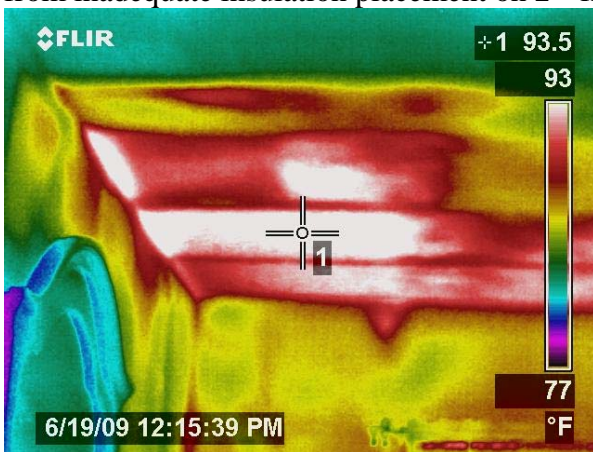
**Figure 163** Area of front left 2<sup>nd</sup> fl. bedroom with very hot ceiling due to inadequate insulation placement.

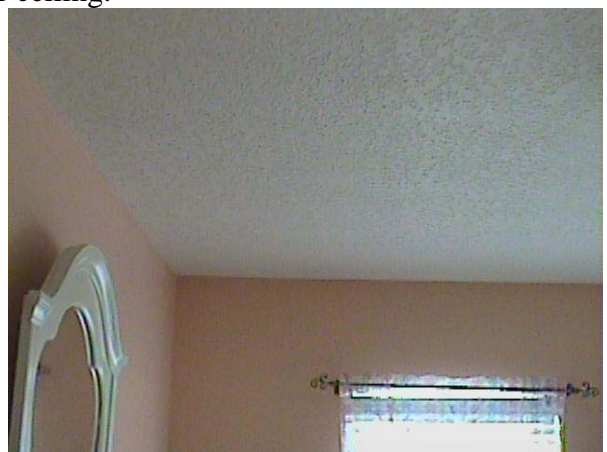
**Figure 164** Photo of IR image to the left.

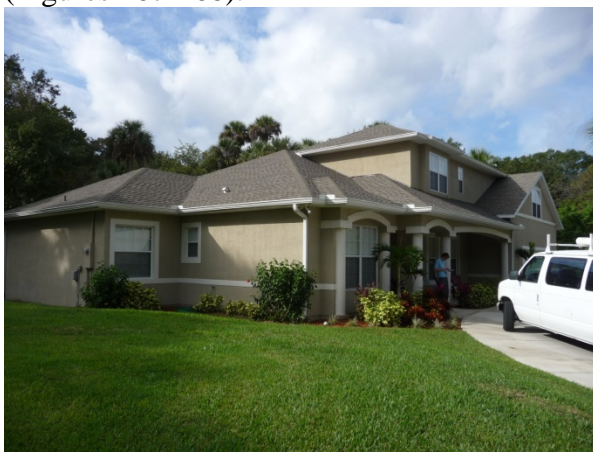
**Figure 167** Front northeast view of home.

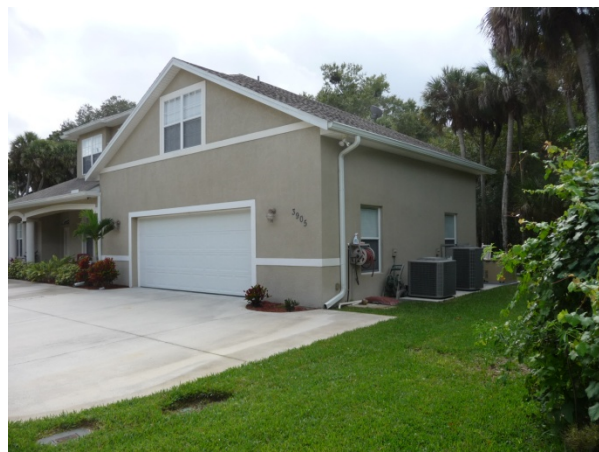
**Figure 168** Northwest corner of home shows bonus room over garage.

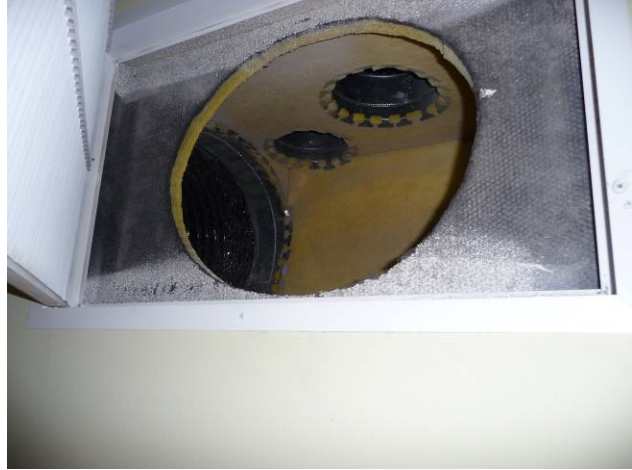
**Figure 173** Main return for first floor with undersized opening into return junction. View inside box shows return ducts (from left to right) 20" diam. flex to main plenum, office, and master bedroom.

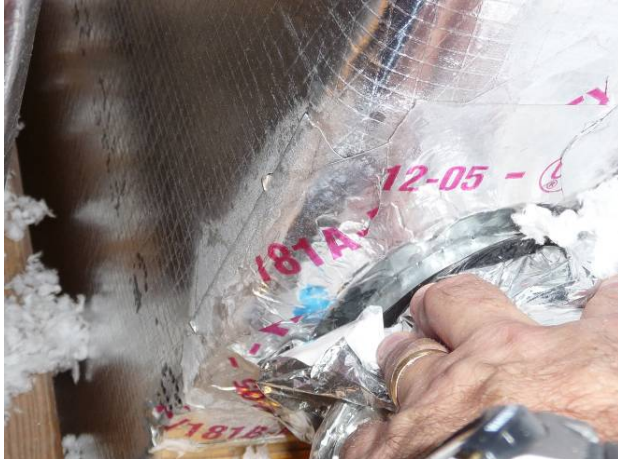
**Figure 174** Flex duct connection with no mastic on first floor return plenum. Flexduct is mechanically fastened, but not airtight.

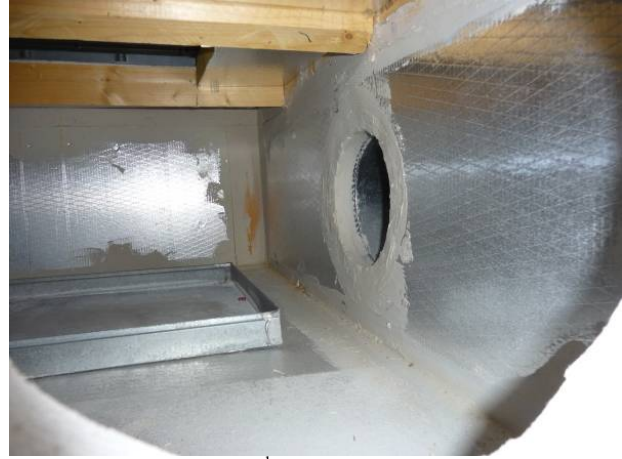
**Figure 175** Inside of 2<sup>nd</sup> story support platform sealed well with mastic on seams and duct connections.

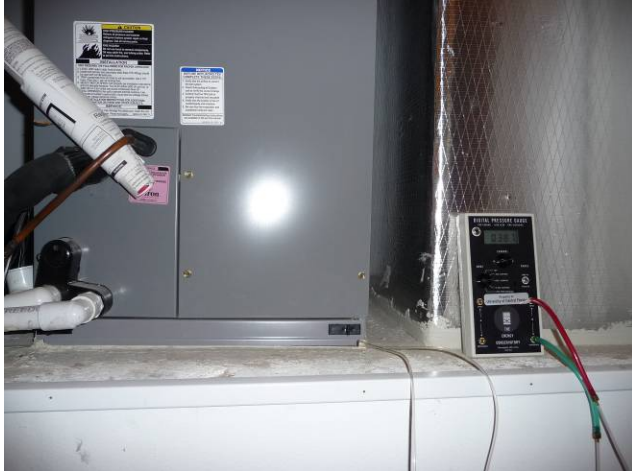
**Figure 176** Air handler in garage has typical panel leakage at seams and penetrations.
