**Comparison of the Modes and Mechanisms of Degradation of  
Experimental c-Si PV Modules with Various Encapsulants**

FSEC-CR-2036-16

**NREL Project, UCF/FSEC Account No. 2012-6117**

**Report: October, 2016**

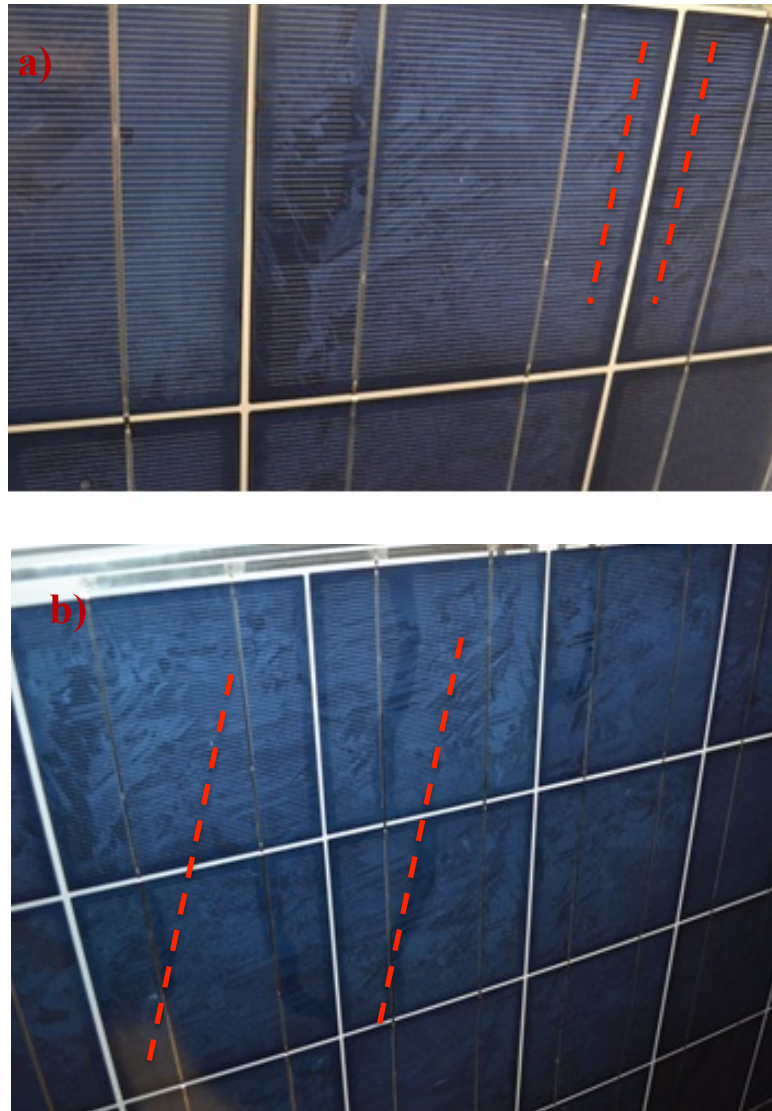
Snail trails have been identified on this module previously, however it seems they are more pronounced as of the most recent visual inspection. Several examples are shown in Figure 1.

**Figure 1:** Visual image of 110413-NRE-TPU showing the formation of snail trails on several cells at bus bar and cell interface (a) and the between solar cell active area (b).

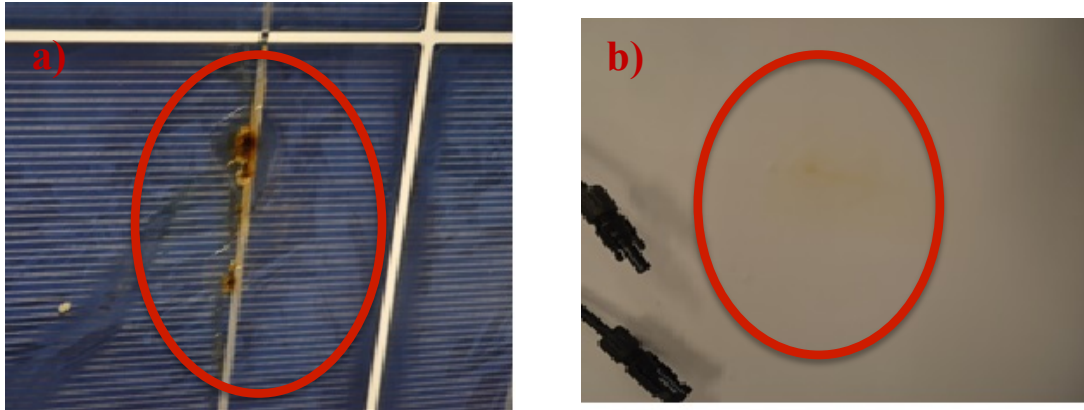
The most notable result in this comparison is that two modules showed significant degradation while the other modules showed little to no problems. For module 110413-NRE-TPU the degradation is largely due to a reduction in fill factor. This is likely series resistance due to the failed interconnect discussed previously. 110628 NRE-ION also shows a reduction in fill factor. The degradation appears to be caused from shunting in one cell that shows up as a hot spot during infrared imaging.

This particular defect was also observed in 2014 and 2015 visual inspection. It has become more severe in 2016 shown in Figure 2. This hot spot also resulted in severe hot spot during previous infrared inspections as shown in Figure 3.

**Figure 2:** Blistering and yellowing was observed (a) and directly behind the blistering (b) of module 110413-NRE-TPU

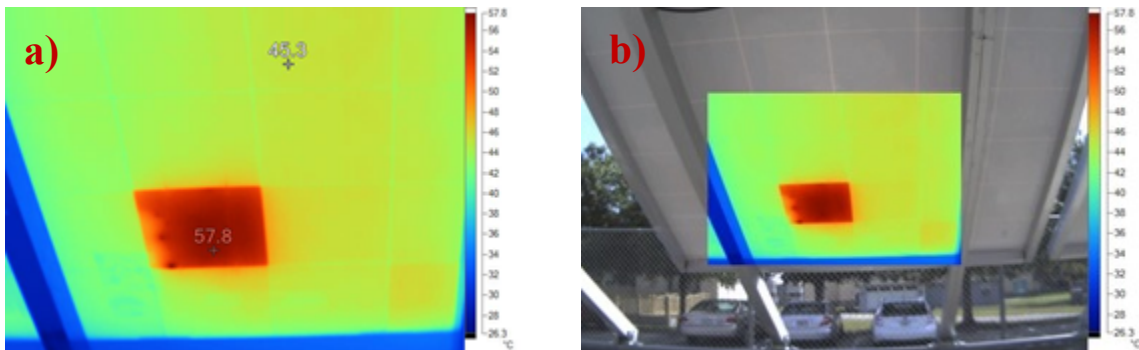
**Figure-3:** Temperature at specific locations, including the hottest spot are highlighted (a). Detail view of the hotspot from the back side (b) of module 110628-NRE-ION.

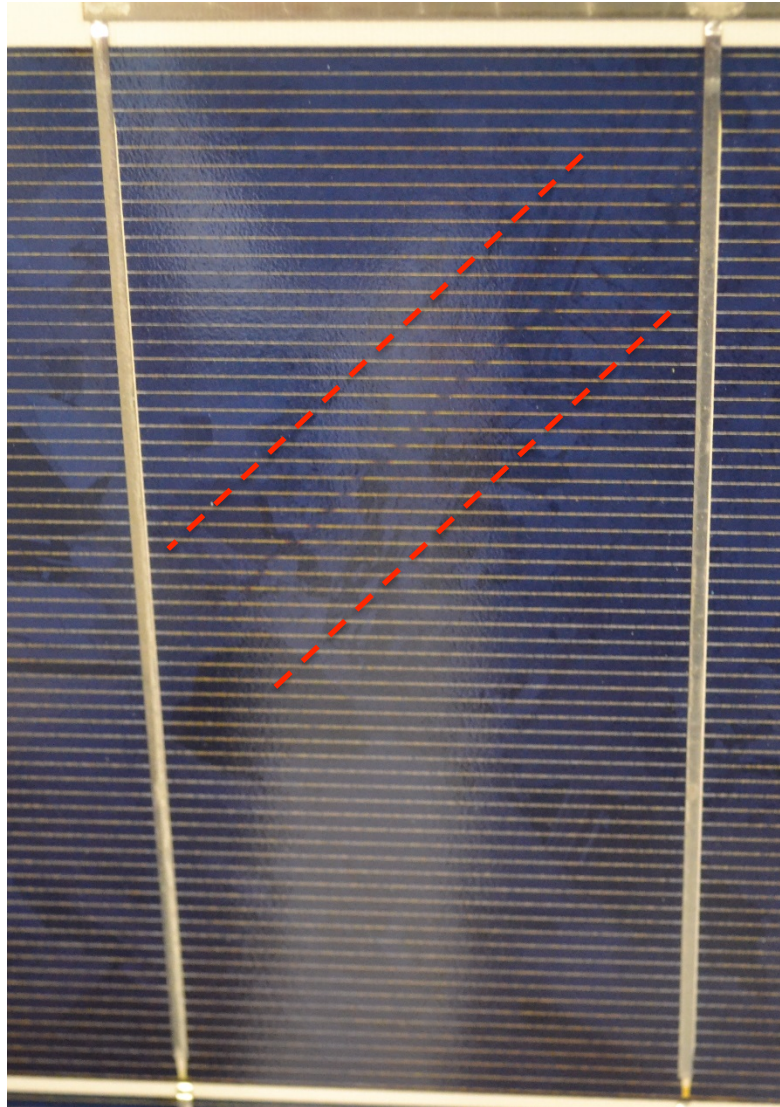
Discoloration was observed for the first time in module 110512-NRE-PVB. It is important to note that only a single defect was observed as is shown in Figure 4.

**Figure-4:** Visual image of the snail trail in module 110512-NRE-PVB

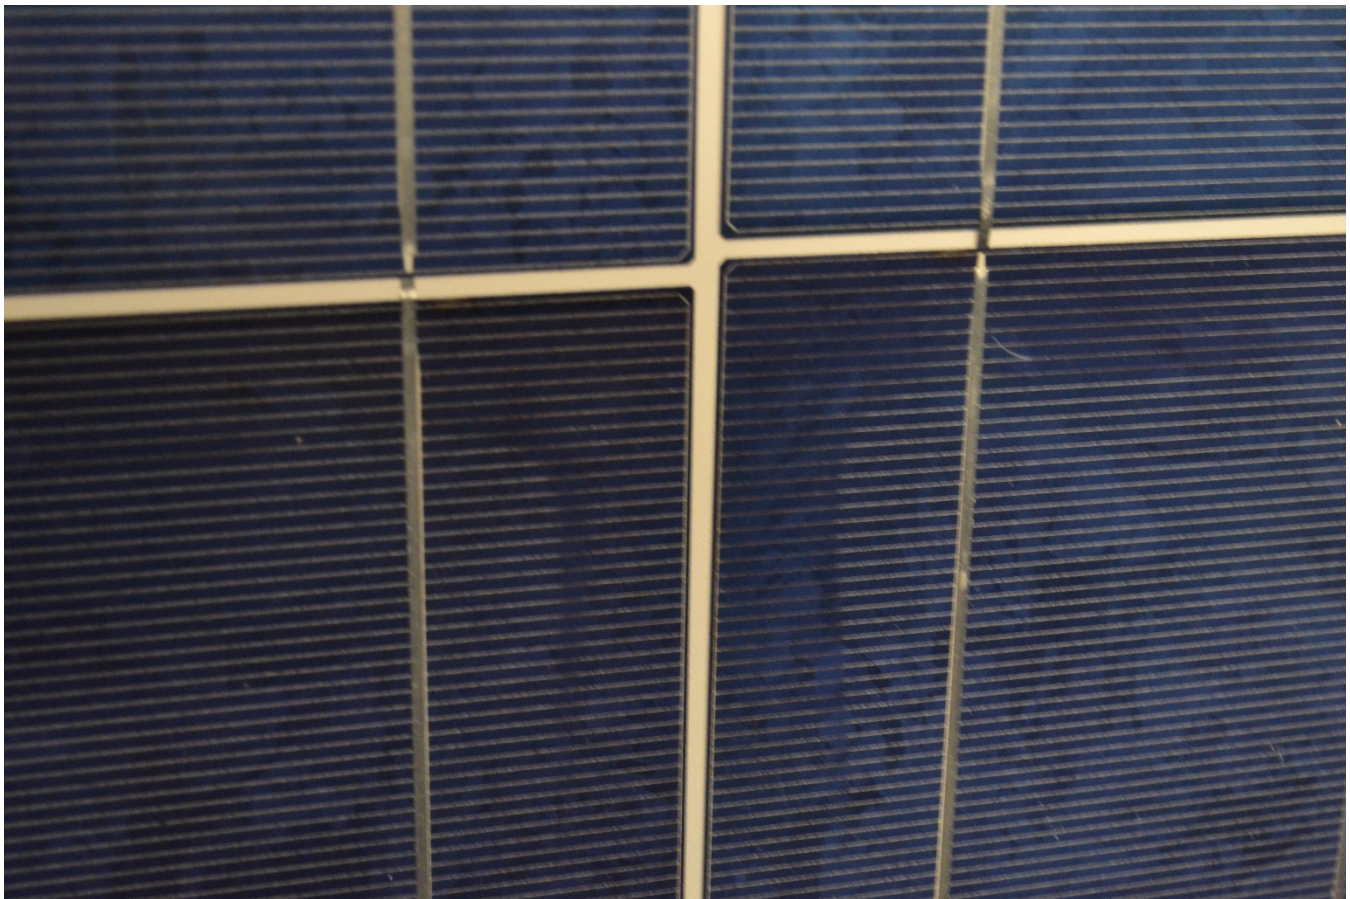
Discoloration was observed for the first time in module 110413-NRE-EVA-NC. The pattern seems to be about 1 inch from the edge of the cell on most cells in the module. The discoloration can be seen in Figure 5.

**Figure-5:** Visual image of the discoloration in module 110413-NRE-EVA-NC
