Wind-induced failures and structural modeling of largevolume buildings impacted by Hurricane Michael (2018)

ABSTRACT: (10 pt)

This paper describes the forensic assessments and observed failure mechanisms to a collection of large-volume, lowrise buildings in Panama City, FL that failed during below-design conditions induced by Hurricane Michael (2018). The buildings represented multiple structural systems, including pre-engineered metal buildings, precast tilt-up concrete systems, and metal rack buildings, and represented a range of years of construction. Three case study buildings are studied in detail, informed by static and dynamic analysis of the structural systems through 3D, linear elastic finite element models developed from structural drawings and extensive reconnaissance data. The analysis demonstrates the critical importance of the longitudinal load path through the end bay of the windward wall in the observed collapse mechanisms.

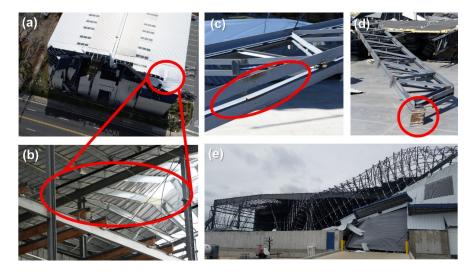
The analysis of these case studies suggests an end bay load path failure mechanism is at fault for many of the premature failures observed, but further exploration is needed. The study identified several possible contributing causes, including internal pressurization, failure of roof decking removing lateral support to framing members, and eccentricities in the lateral load path. The premature failures of these buildings, many of which served as critical facilities, warrants further investigation so that existing vulnerabilities can be identified and prevented in future designs.

Figure 1. Specific failure mechanisms including (a), (b) purlin buckling in the end and interior bays of Watson's Marina, (c), (d) joist girder failures pullout and buckling in the Intermodal Distribution Center, and (e) end bay collapse of the Port of Panama City East Terminal.
