Temporary device malfunction of an MR conditional cardiac resynchronization defibrillator when undergoing MRI without appropriate re-programming: a case report

Barts Heart Centre, West Smithfield, London EC1A 7BE, UK

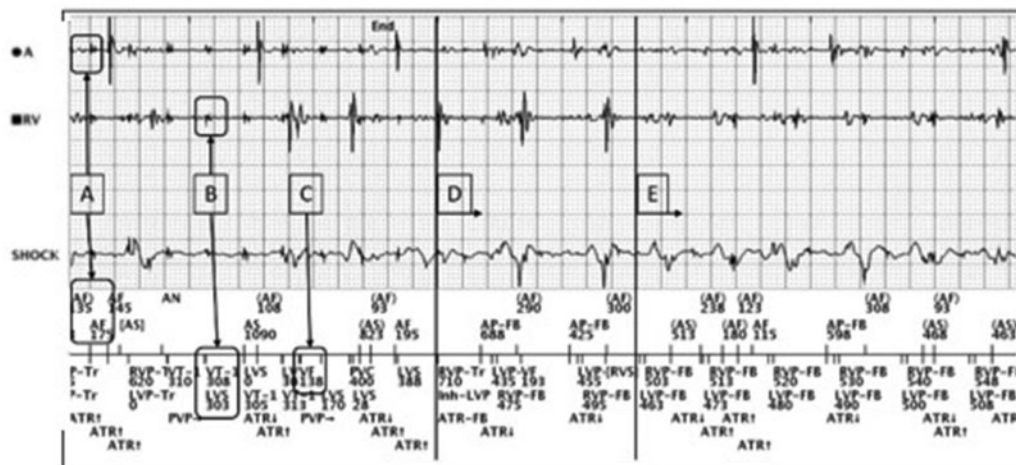
Figure 1 shows intermittent oversensing of EMI on the atrial and RV channels from the RF gradients during the MRI scan. There are periods of inhibited pacing and intervals in the ventricular arrhythmia detection zones. No tachycardia therapy is delivered as there are not enough intervals to meet the detection criteria. The device inappropriately detects an ATR episode, mode switches and stores an EGM of the event. There was no evidence of oversensing at any time point remote from the MRI scan (before or after).

Figure 1 This is a continuation of the stored atrial tachycardia response trace, channels are the same. Intracardiac electrogram showing oversensing interpreted as ventricular fibrillation due to electromechanical interference from magnetic resonance imaging radiofrequency gradients (Figure 1). Point A: inappropriate mode switch due to oversensing of magnetic resonance imaging rotational artefacts on the atrial channel. Point B: right ventricular and left ventricular oversensing of magnetic resonance imaging rotational artefacts. Point C: Interval falling into the ventricular fibrillation tachycardia detection zone, however, not enough to meet tachycardia detection. Point D: trigger pacing from the oversensed artefact. Point E: magnetic resonance imaging artefacts no longer sensed on the right ventricular channel.

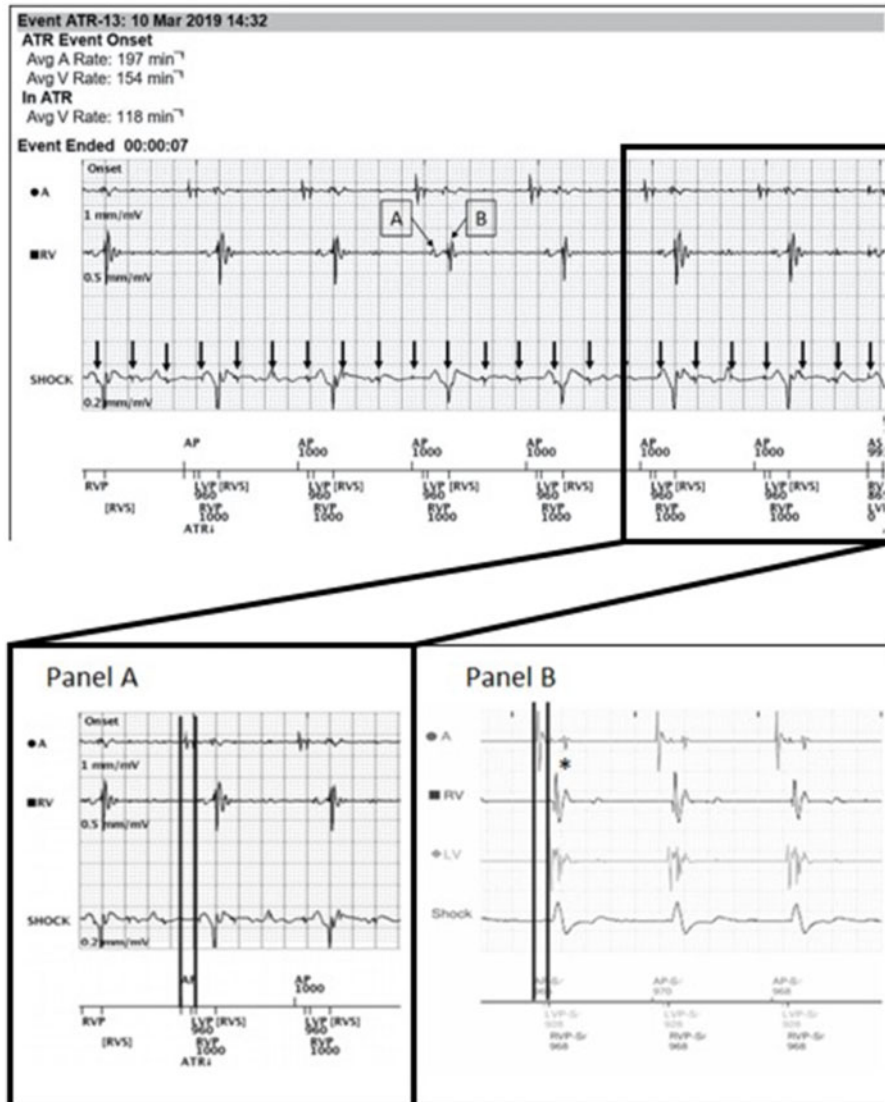
- 3) Loss of RV capture (Figures 2 and 3)
- 4) Figure EGM demonstrates temporary loss of capture on the endocardial RV lead, however, there is capture on the epicardial (coronary sinus LV lead. This is proved in Figure 3, where the loss of evoked response on the RV channel is shown compared to the capture seen in clinic (*). The implications for our patient were minimal due to his continuing pacing from his LV lead and underlying AV conduction.

Figure 2 Stored atrial tachycardia response episode during the magnetic resonance imaging scan. Electrograms: Top—right atrial (A); second—right ventricular; third—shock/farfield; bottom—marker channel. Point A on the trace shows loss of capture on the right ventricular lead. Point B indicating right ventricular activation from left ventricular pacing. The arrows on the shock channel indicate electromagnetic interference artefact (which also correspond visibly on the A and right ventricular channels). The signals are regular, high frequency and low amplitude at the rate of magnetic resonance imaging rotation.

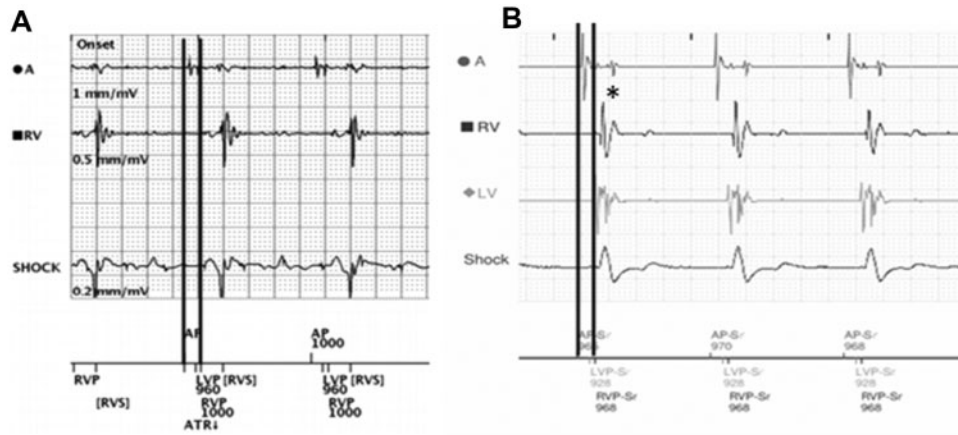
Figure 3 (A) Stored atrial tachycardia response trace. (B) True biventricular pacing with capture. *Evoked response from local right ventricular capture.
