Experimental Evaluation Of A Precast Concrete Beam-To-Column Prototype Design Under A Column Removal Scenario

A Thesis
Submitted to the Faculty of
Mississippi State University
in Partial Fulfillment of the Requirements
for the Degree of Master of Science
in Civil Engineering (Structures)
in the Department of Civil and Environmental Engineering

A full-scale experiment was conducted to investigate the structural performance of a prototype design under a column-removal scenario. The test assembly frame, consisting of three columns and two beams, was subjected to a displacement controlled vertical force acting at the center to characterize the failure modes and collapse mechanisms. Brittle-failures of critical structural elements were observed and significantly impacted the performance.

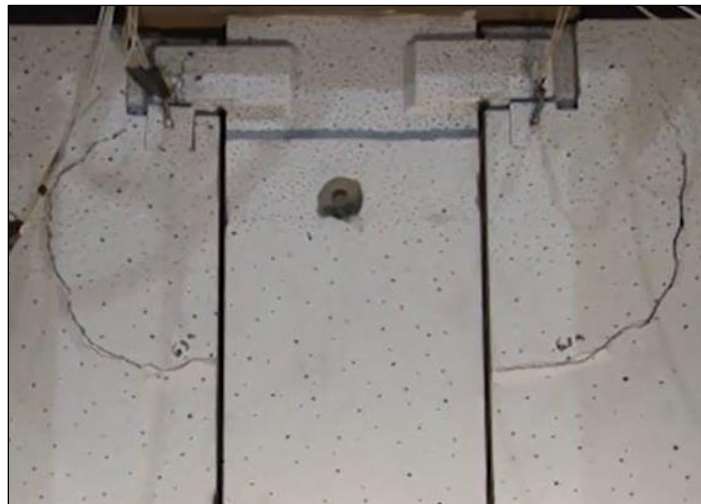
Figure 4.2 Elevation view, development of the first observed cracks in the beams near the top of the center column/stud, at Δ of 0.38 in. (9.6 mm)

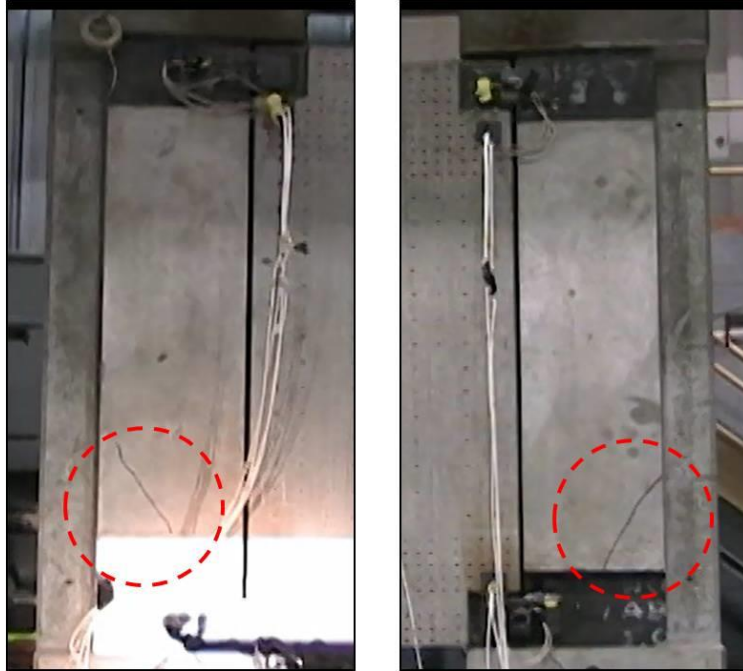
Figure 4.3 Elevation views, development of the first observed cracks in the end-columns at Δ of 1.8 in. (45.7 mm)

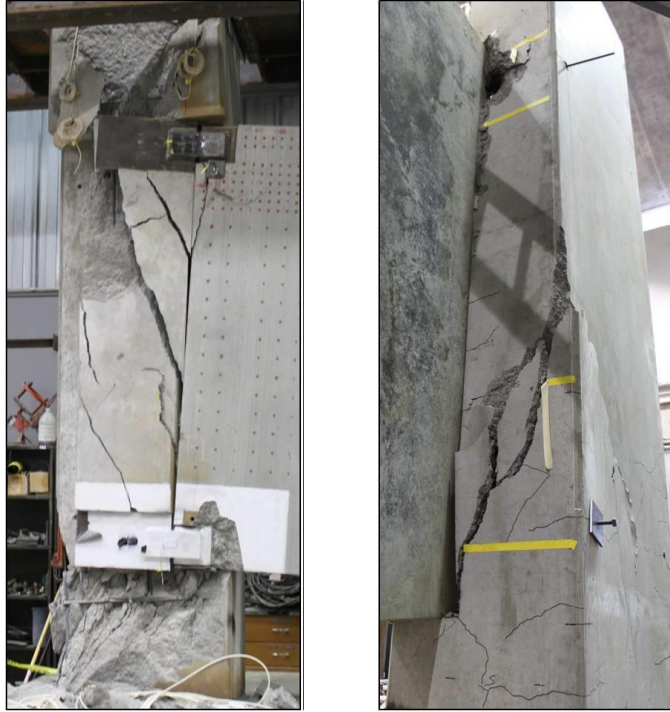
Much distress and scabbing of the concrete at the bottom of the column was observed. A closer view of the bottom area of the column is shown in Figure 4.7. Much of the concrete had completely fallen away, and much reinforcement was exposed. A similar behavior was observed around the top M8 embedded plate (see Figure 4.8). As cracks began to become more defined around the steel plate, concrete began to fall, exposing the reinforcement at the top of the column as well as contributing to the partial detachment of the M8 plate from the column.

Figure 4.6 Elevation views, posttest damage of left (east) end-column

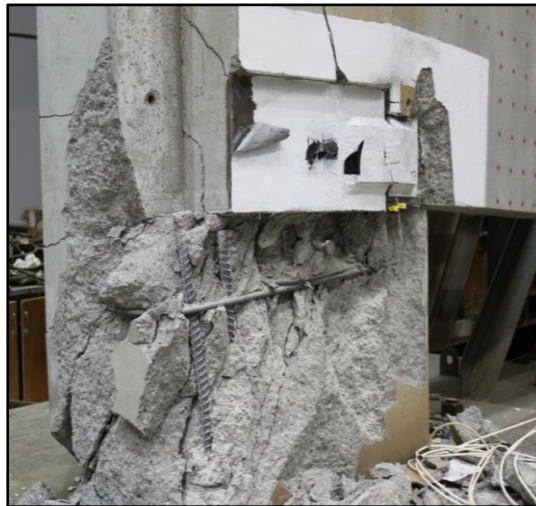
Figure 4.7 Elevation view, posttest damage of bottom of left (east) end-column

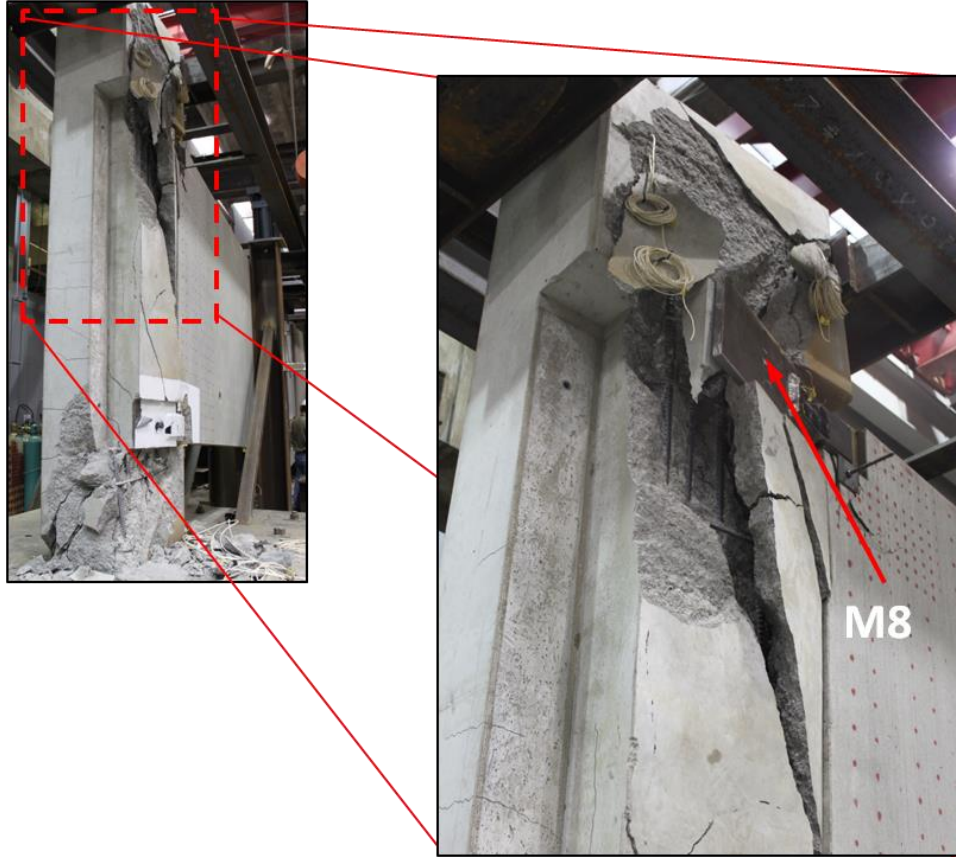
Figure 4.8 Elevation views, detachment of the upper M8 plate in the left (east) end-column

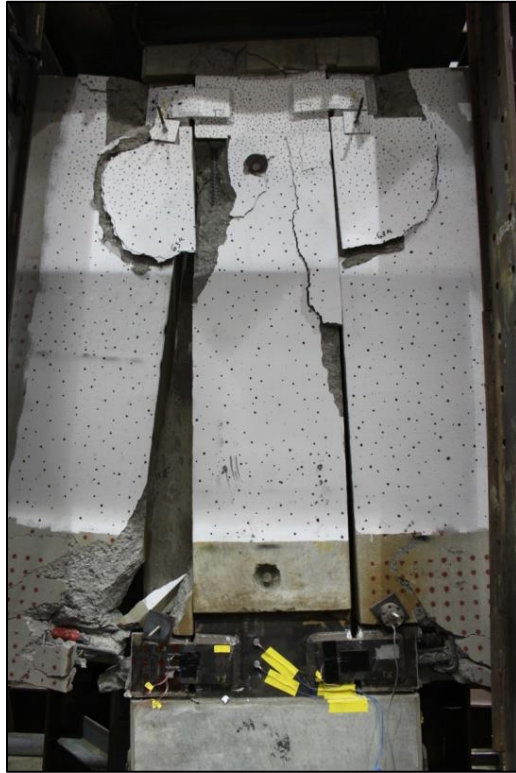
bearing action between Beam-L and the center column. A slight counterclockwise rotation of the center column/stub toward the left (east) end-column occurred.

Figure 4.9 Elevation view, posttest condition of the center column/stud

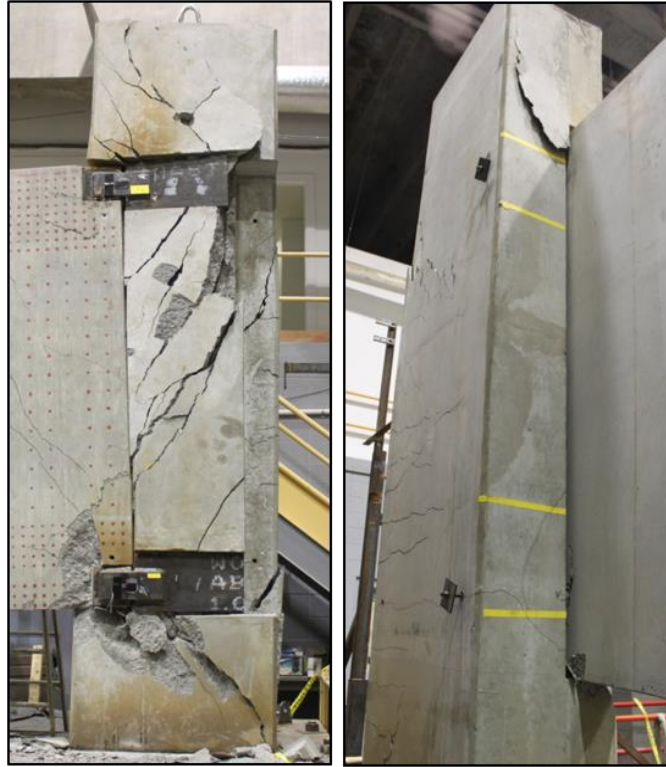
Figure 4.10 Elevation views, posttest damage of right (west) end-column

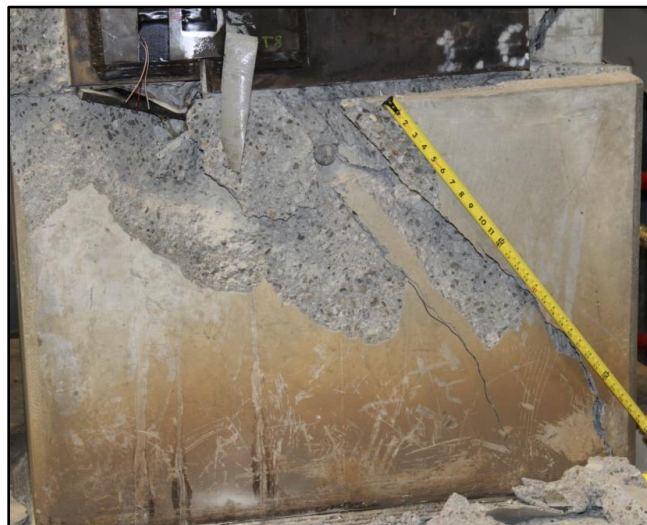
Figure 4.11 Elevation view, posttest damage of bottom of the right (west) end-column

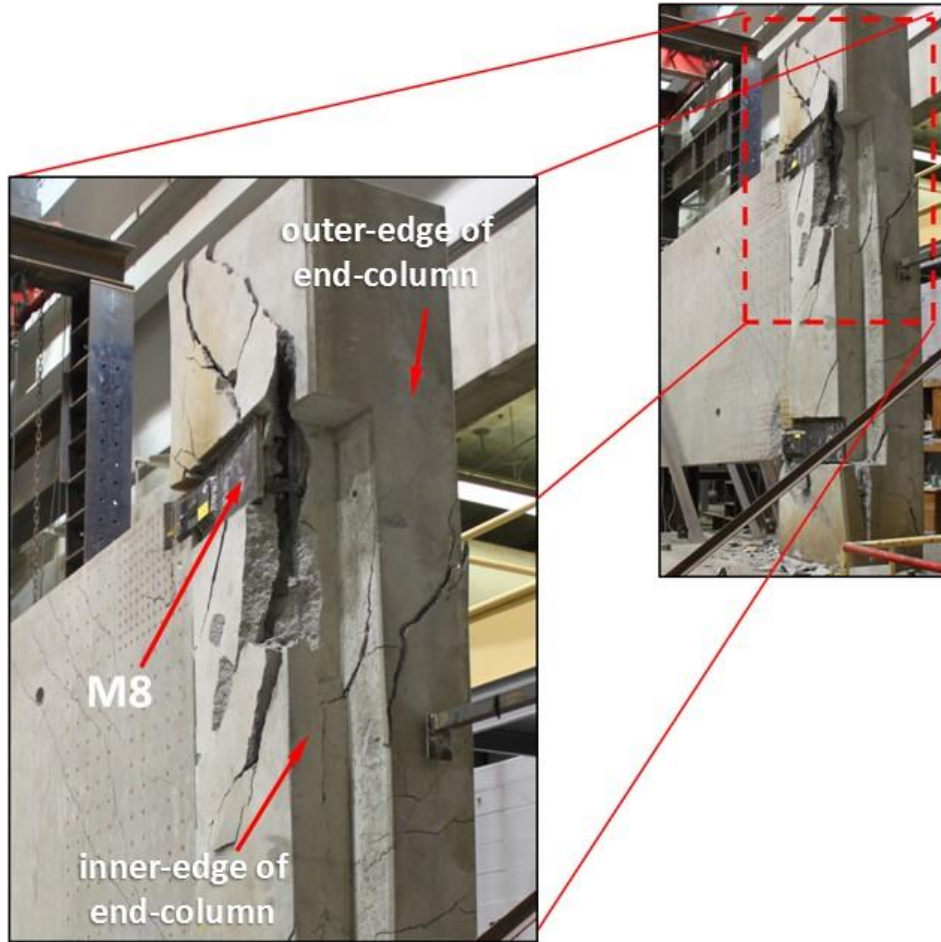
Figure 4.12 Elevation views, detachment of the upper M8 plate in the right (west) end-column

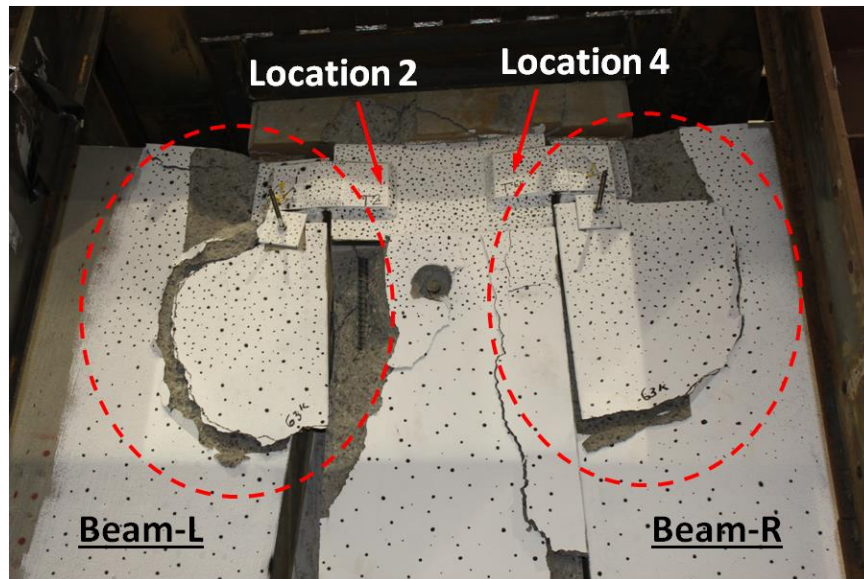
Figure 4.13 Elevation view, posttest damage of the spandrel beams near the top of the center column/stud

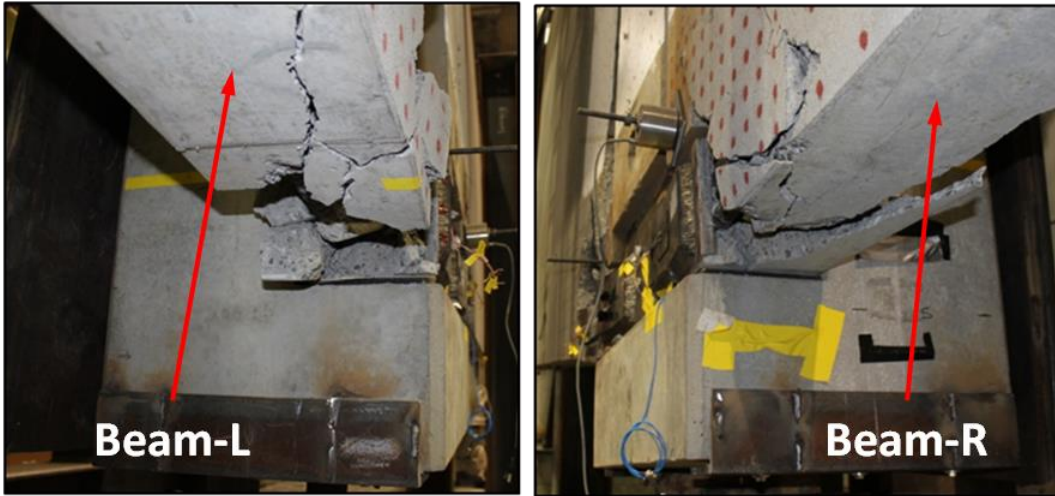
Figure 4.14 Side view, posttest damage of the bottoms of the spandrel beams near the center column/stud

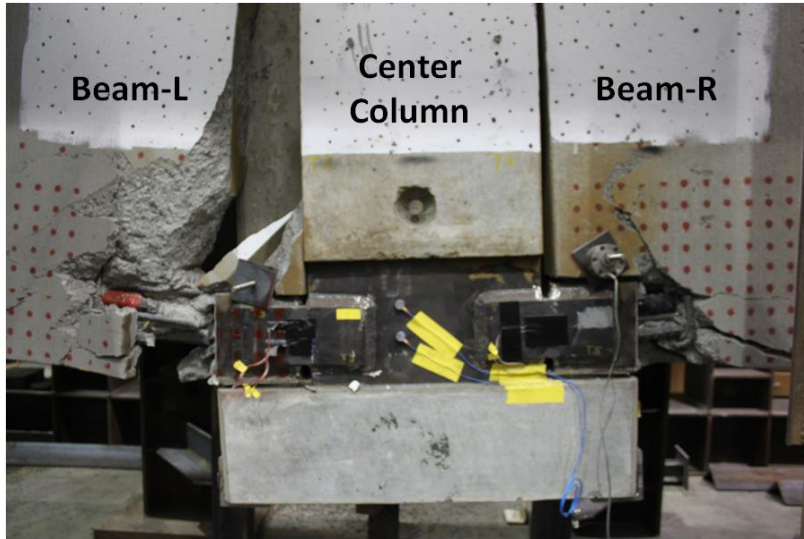
The combination of out-of-plane flexural behavior carried by the assembly evidenced in Figure 4.16 and the extensive crushing of concrete observed at the beam's bottom edges near the center column (Figure 4.14) exposed the reinforcement detail near the steel plate at location #3. This consequently induced the bars to a combination of tension load and bending moment that resulted in the failure of both of the anchor bars welded to the M7 steel angle in Beam-L, as shown in Figure 4.17. The bottom anchor bar fractured at an approximate Δ of 5.69 in. (144.5 mm), which consequently overloaded the upper anchor bar causing it to fail immediately after. Following the failure of the bottom anchor bars, the spandrel beams began to bear against the columns, inducing the beams to compressive forces at opposite directions. The bottom-left corner of Beam-L pushed against the bottom of the left (east) end-column, and the top-right corner pushed against the top of the center column. For Beam-R, the top-left corner pushed against the center column, and the bottom-right corner pushed against the right (west) end-column. This behavior corresponded to the development of additional concrete cracks along the beams. At the time that the second (upper) anchor bar of the M7 angle fractured, the beam was no longer attached to the steel link plate at location #3, contributing to the already out-of-plane behavior and the bearing of the beams against the columns.

Figure 4.16 Elevation view, posttest damage of the spandrel beam at the bottom connections to the center column

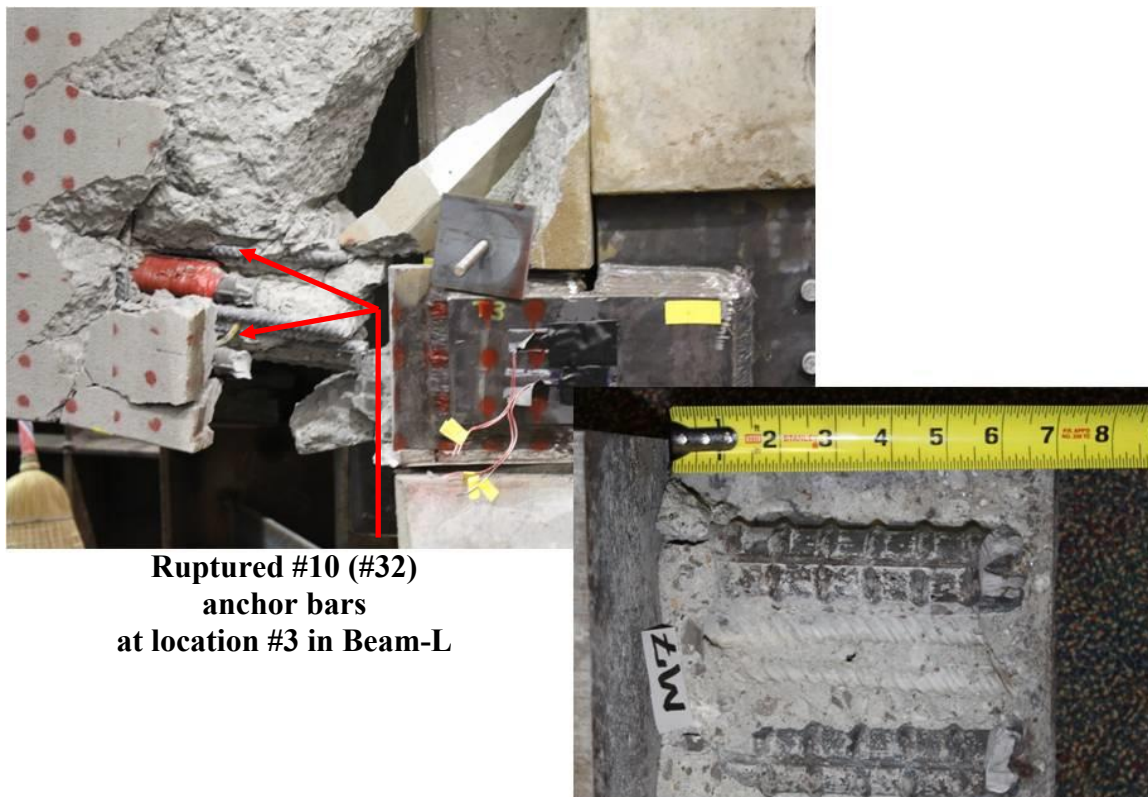
Figure 4.17 Fractured anchor bars of M7 angle plate in Beam-L (elevation view)

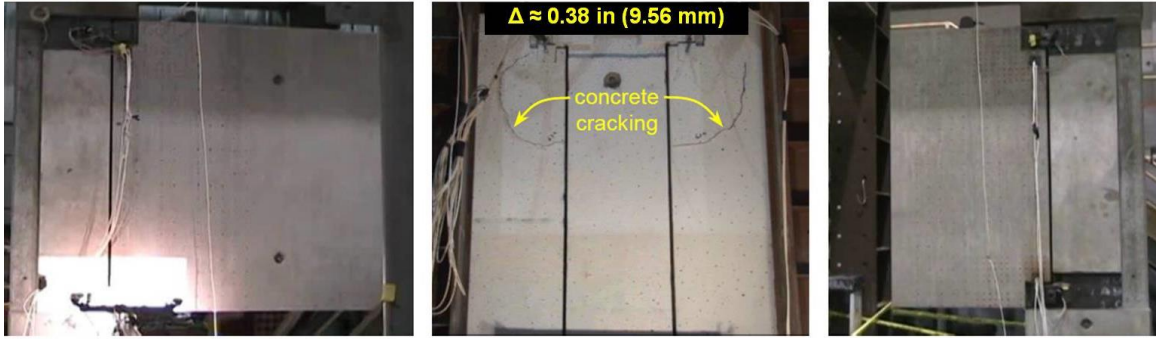
Figure 5.3 Elevation view, response zone I – incident (a): first observed concrete cracks on the test specimen at the center, 63 kips (280 kN)

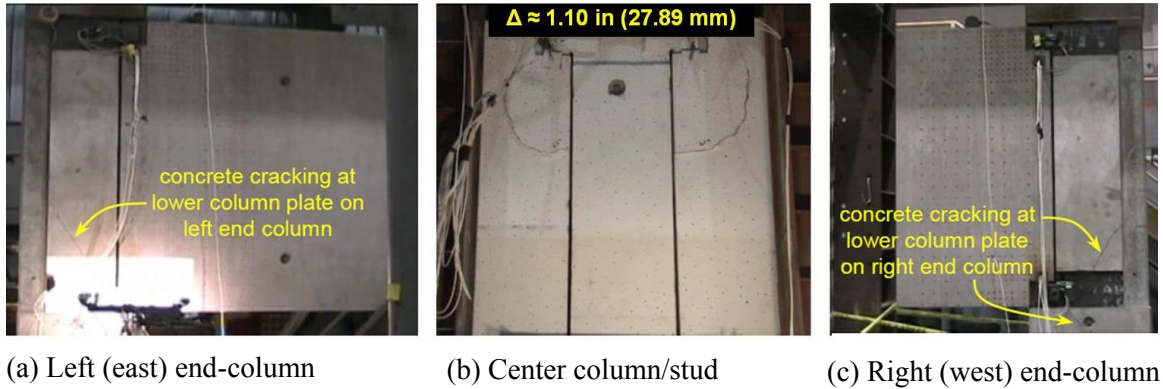
Figure 5.5 Elevation view, response zone II – incident (b): end-columns first concrete cracks at 114 kips (507 kN)

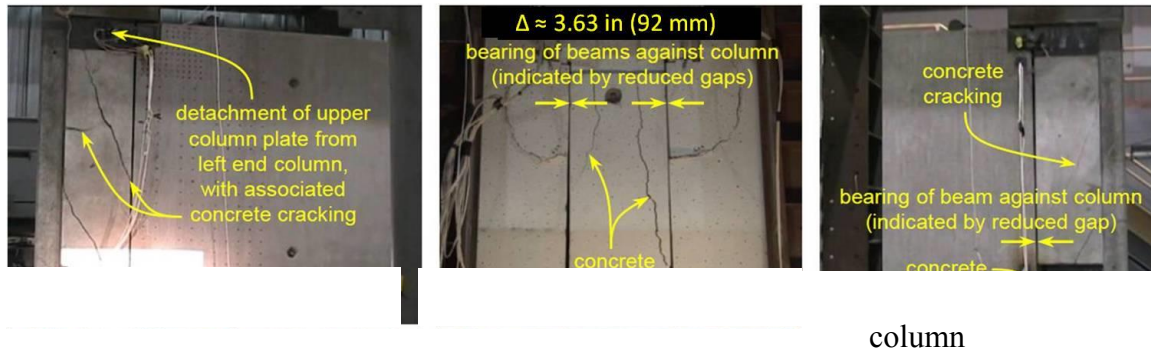
Figure 5.7 Elevation view, response zone III – incident (e): concrete crack growth around top M8 plate at left (east) end-column, initiation of bearing of beams to columns

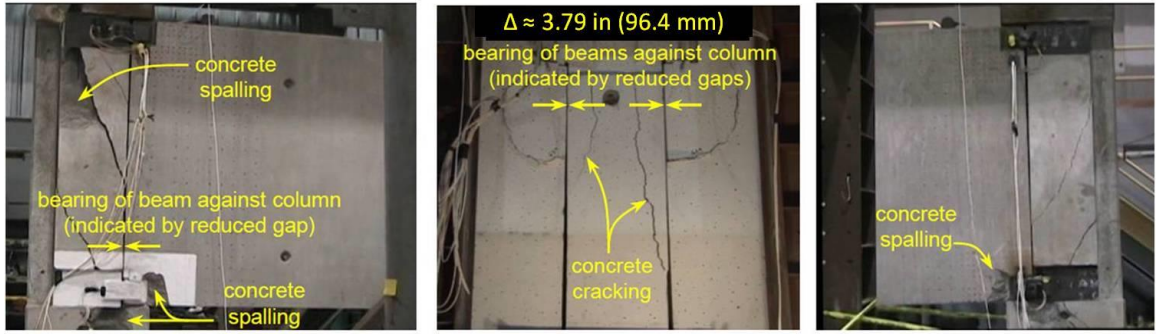
Figure 5.8 Elevation view, response zone III – incident (f): initial bearing of beams against columns.

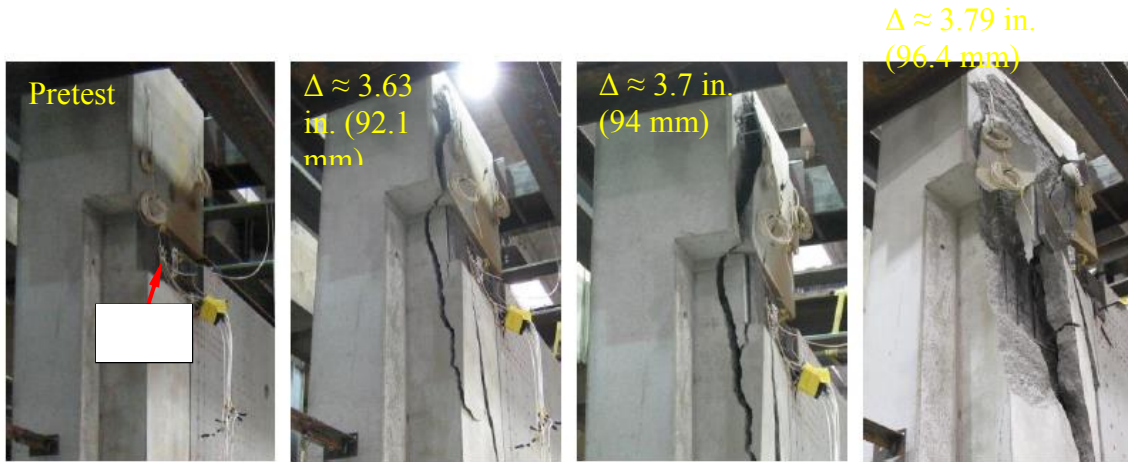
Figure 5.9 Development of concrete cracks around the upper M8 plate in left (east) end-column; detachment of M8

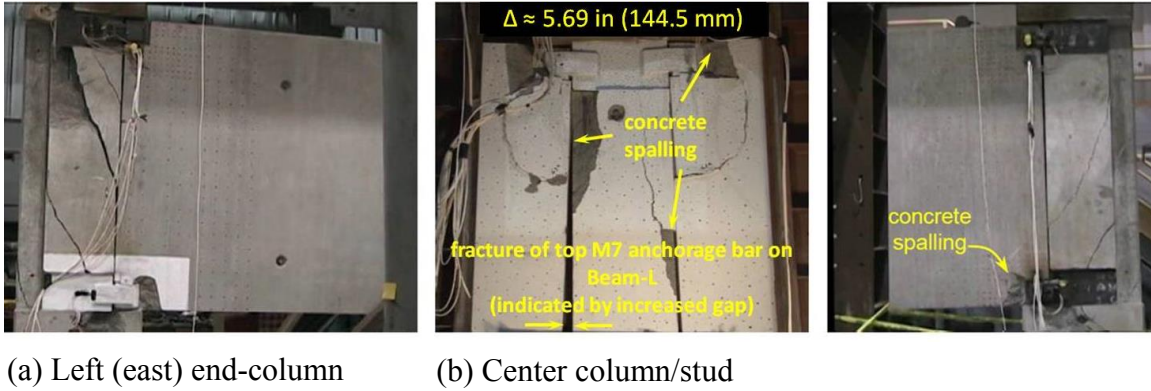
Figure 5.10 Elevation view, response zone IV – incidents (g), (h) and (i): concrete spalling due to arching and rupture of the upper M7 anchorage bar

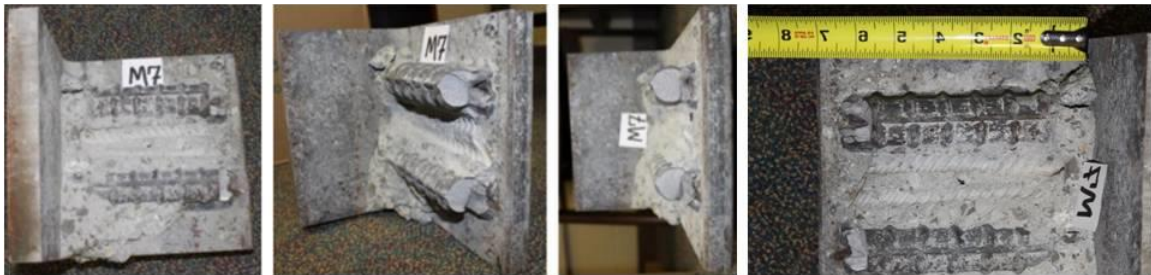
Figure 5.11 Different angles showing the location of fracture of the M7 anchor bars embedded in Beam-L near the center column

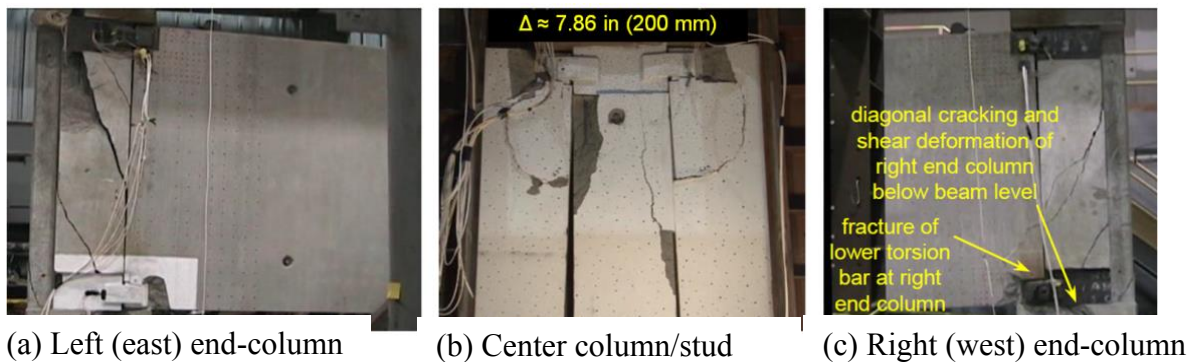
Figure 5.12 Elevation view, response zone V – incident (j): fracture of lower torsion bar in right end-column

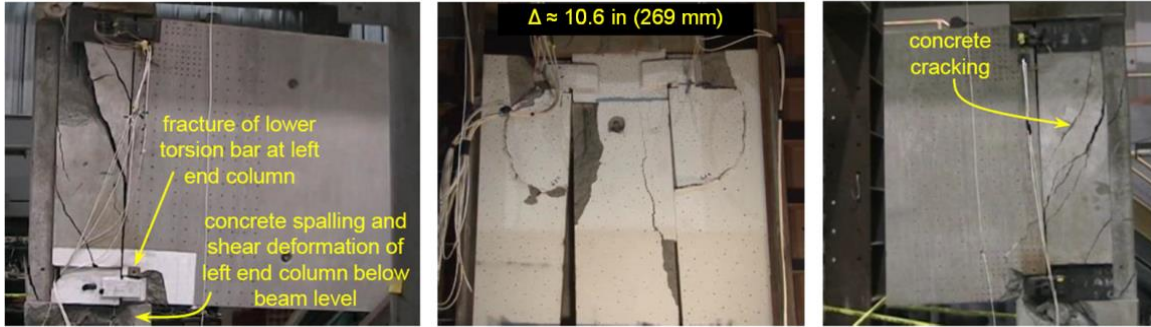
(a) Left (east) end-column, fracture of lower torsion bar at left end column, and concrete spalling and shear deformation of left end column below beam level. (b) Center column/stud, response zone V – incident (k): $\Delta \approx 10.6$ in (269 mm). (c) Right (west) end-column, concrete cracking around top M8 plate in right (west) end-column.

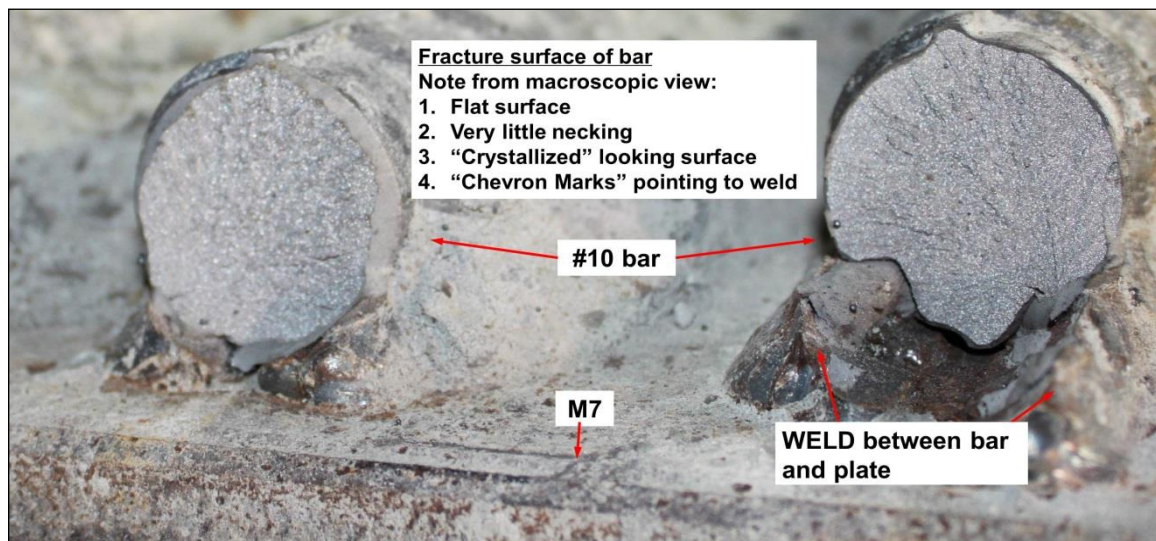
Figure 5.21 Close-up view of the fractured profile of both failed M7 anchor bars

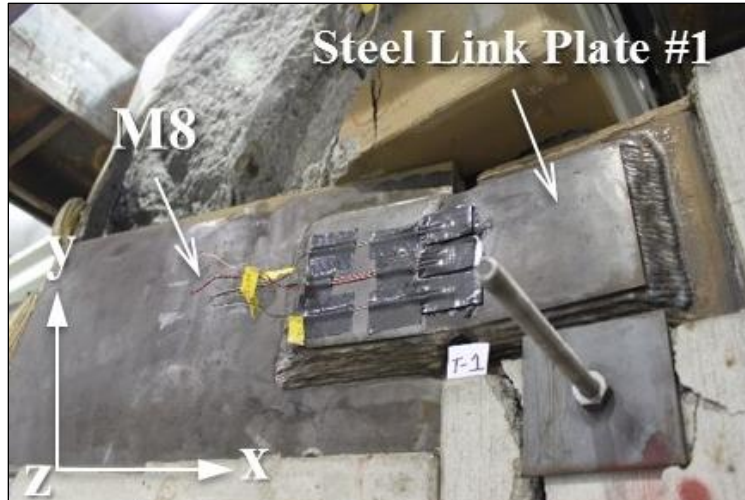
Figure 5.25 Close up view to posttest damage steel link plate #1

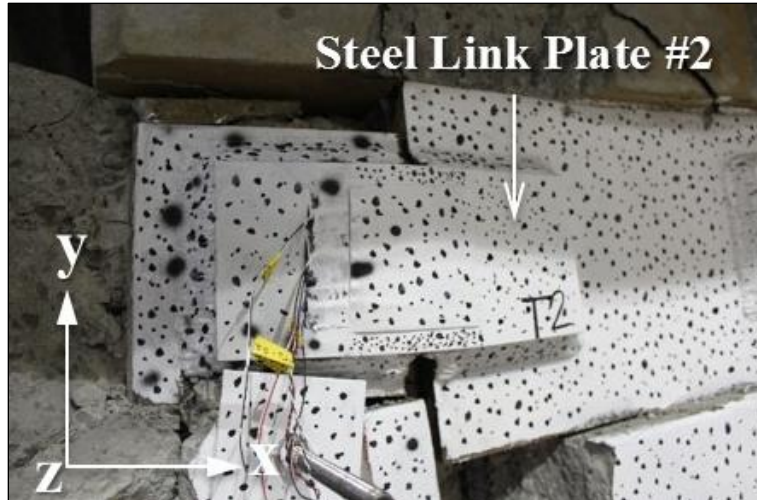
Figure 5.26 Close up view to posttest damage steel link plate #2

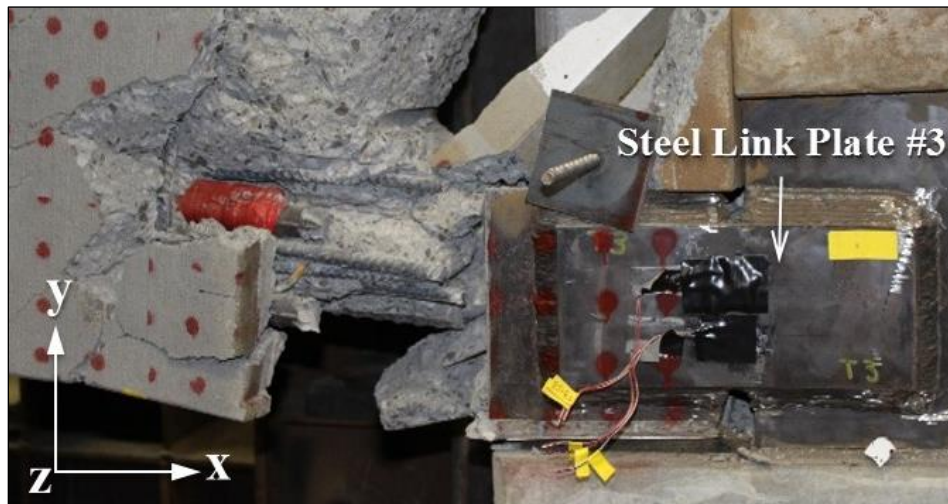
Figure 5.27 Close up view to posttest damage steel link plate #3

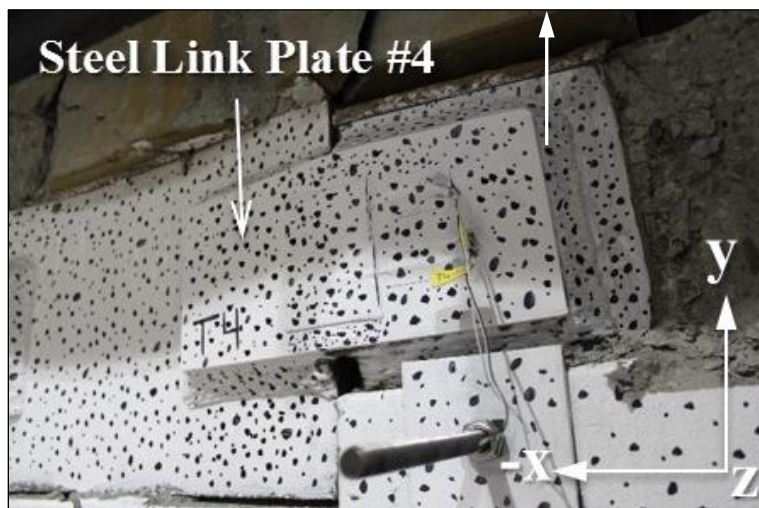
Figure 5.28 Close up view to posttest damage of steel link plate #4

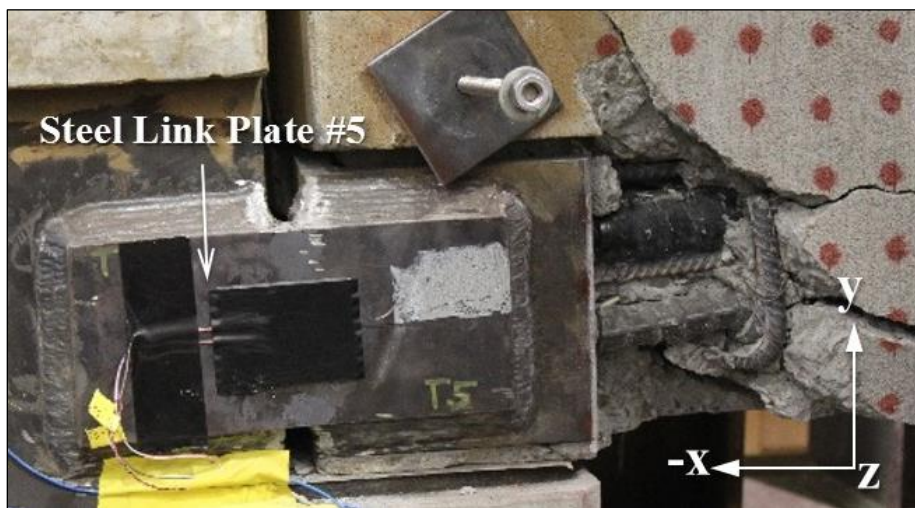
Figure 5.29 Close-up view to posttest damage steel link plate #5

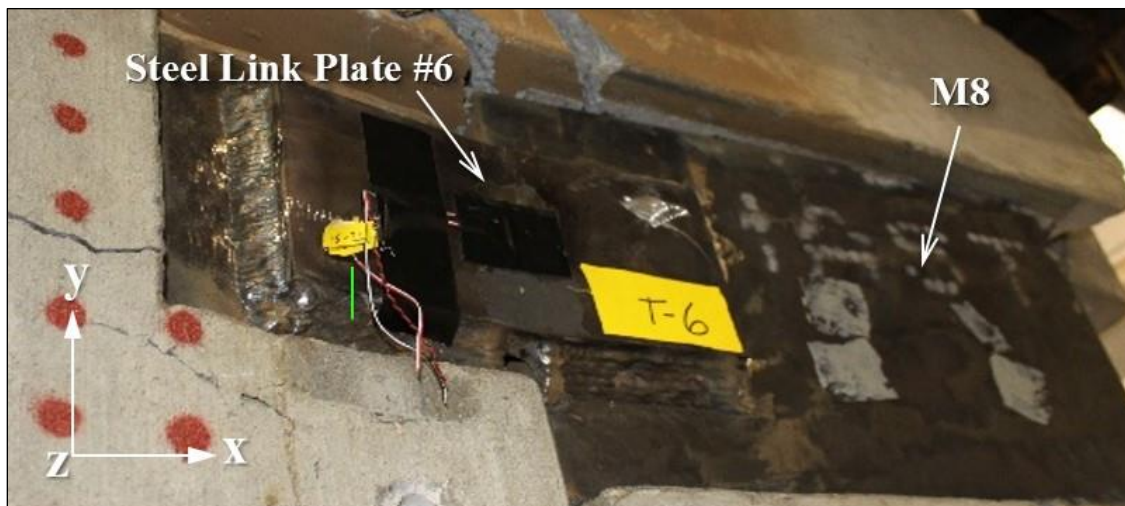
Figure 5.30 Close-up view to posttest damage steel link plate #6.

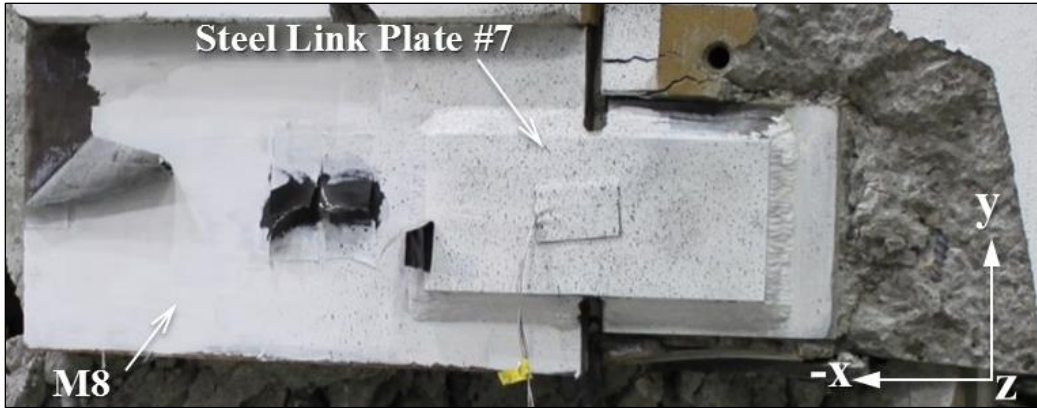
Figure 5.31 Close up view to posttest damage steel link plate #7

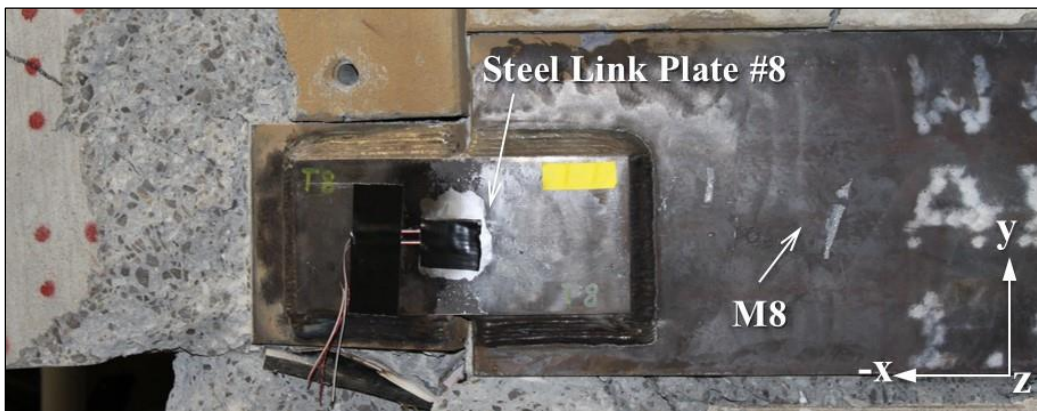
Figure 5.32 Close up view to posttest damage steel link plate #8
