Reconnaissance on Liquefaction-induced Flow Failure Caused by the 2018 Mw 7.5 Sulawesi Earthquake, Palu, Indonesia

Abstract. The M_w 7.5 Sulawesi Earthquake 2018 was a catastrophic disaster that resulted in large numbers of casualties. This study aimed to investigate the damages of liquefaction-induced-flow failure in three areas in Palu city, i.e. Petobo, Balaroa, and Jono Oge. It was found that this flow failure occurred on a large scale at a very gentle ground inclination, ranging from 1 to 3%. In order to gain an understanding of the soil conditions in these specific locations, Portable Dynamic Cone Penetration Tests were conducted in Petobo. The results showed that the soil layers in the affected area were in a loose state compared to the non-affected areas. Furthermore, some spots of freshwater inundation were recognized in Petobo and Balaroa, even two weeks after the disaster. Based on this evidence, a mechanism of liquefaction-induced-flow failure caused by a confined aquifer is proposed.

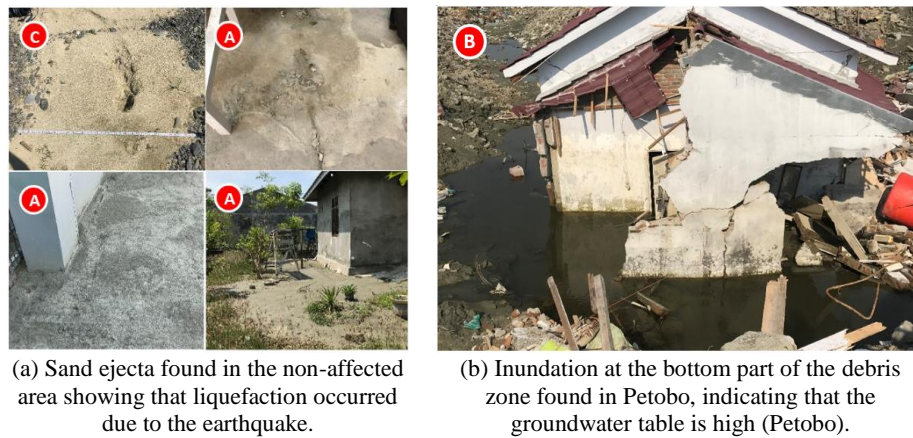
Figure 5 Disaster evidence found at Petobo two weeks after the earthquake.

the main shock, the water flow was reported to have vanished. Figure 5(a), taken at points A and C in Figure 4, displays the evidence of soil liquefaction; sand ejecta was found in several places in non-affected areas.

Even though little rainfall was recorded after the earthquake event, significant water inundation could still be observed in many parts, as shown in Figure 5(b), taken from the B point in Figure 4. In this area, the groundwater level was identified as shallow.

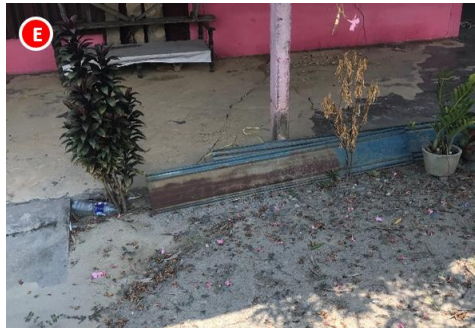
Figure 7(a), taken at point E in Figure 6, shows sand ejecta on a house near the crown zone. Residents who have been living in the surrounding area for decades claimed that Balaroa has a shallow groundwater table. Like the condition at

(a) Sand ejecta found in the upper part, several meters from the crown (Balaroa).

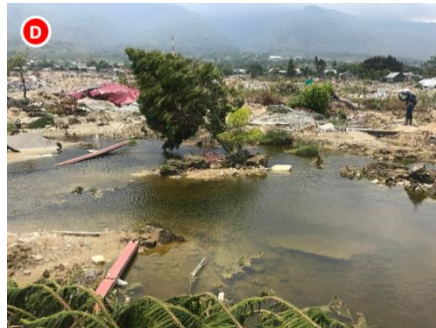
Petobo, after the earthquake, some water inundation spots could also be observed in the middle part, around point D Figure 7(b).

(b) Some water inundation appeared after the event, showing that the groundwater level in this area is high (Balaroa).

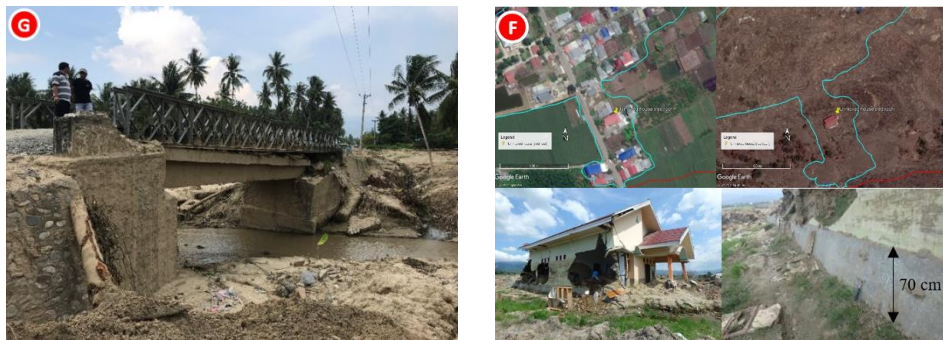
Figure 9 Disaster evidence found at Jono Oge during field reconnaissance.

According to witnesses living in the downstream area, the earthquake triggered a thick mudflow, which flowed for about an hour after the shock, immersing the houses on the leverage of the stream. From Figure 9(a), which was taken at point G in Figure 8, it can be inferred that the mudflow hitting the downstream area reached the structure of the temporary steel bridge. This led to the hypothesis that the thickness of the mudflow in this zone reached 1 to 3 meters.

It was also found that at point F, there was a house that still stood in the same position (Figure 9(b)) after the flow failure occurred, indicating that its foundation could resist the mudflow. Unfortunately, the mat foundation was not fully visible, but the part that was visible from the ground surface was around 70 cm.

(a) Dry mud on the bridge confirms that the thick mudflow passed by the bridge, immersing the houses in the downstream area (Jono Oge).

(b) Evidence of unmoved house to estimate the depth of the mudflow. Clay and silty deposits were found around this house. (Picture taken by T. Kiyota)

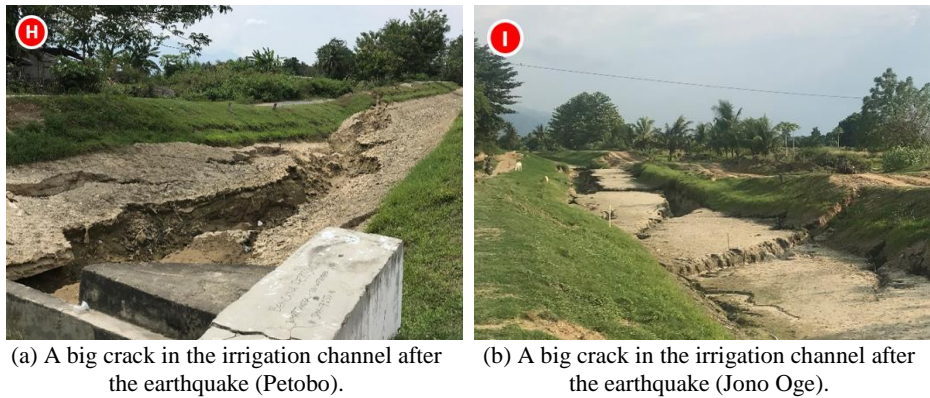
Figure 11 Cracks were found along the irrigation channel. The water was dispersed after the earthquake event.

During the earthquake, the channel was operated with a certain level of water, which had disappeared after the earthquake through large cracks in the channel body. A witness living close to the crown area in Jogo One stated that the irrigation channel was constructed in the 1980s to supply water to paddy and crop fields in the surrounding area. Before its construction, it was hard for people living in the downstream area to find groundwater, but one to two years after the construction people could quickly collect groundwater. It can be inferred that the presence of this channel affected the groundwater profile in the surrounding area.

(a) A big crack in the irrigation channel after the earthquake (Petobo).

(b) A big crack in the irrigation channel after the earthquake (Jono Oge).

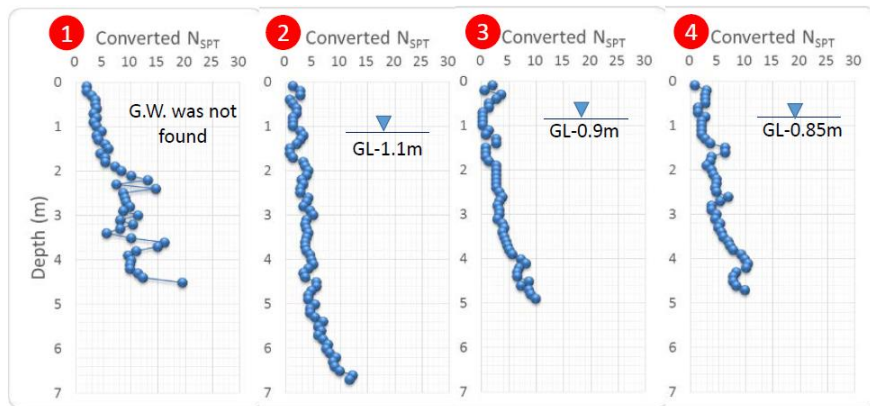
Figure 13 Converted N-SPT values from the DCPT tests. The groundwater level (GL) at points 2, 3, and 4 was low.

The DCPT conversion results are presented in Figure 3. From the test, the N-SPT value at point 1, which was several meters outside of the crown area, was relatively more dense than in the other spots. No evidence of liquefaction was observed around the spots. The groundwater level was identified at a shallow depth.

The soil condition in the crown area are represented by DCPT 2 and DCPT 3. In this location, up to a depth of 5-6 m, the N-SPT value was below 5, indicating that the soil was in a loose state. According to the Unified Soil Classification System, the sand ejecta samples taken at these points were classified as silt with low plasticity (ML), because the amount of fine content was more than 50% (Figure 14); the liquid limit (LL) was 28; and PI was 0 or non-plastic. The groundwater was found at a shallow depth. The combination of loose soil and shallow groundwater level possibly led to liquefaction due to earthquake shaking. DCPT 4 represents the soil condition at the bottom area. As this location is outside of the affected area, the N-SPT value was slightly higher than that of the affected locations. The groundwater level was identified at a shallow depth.

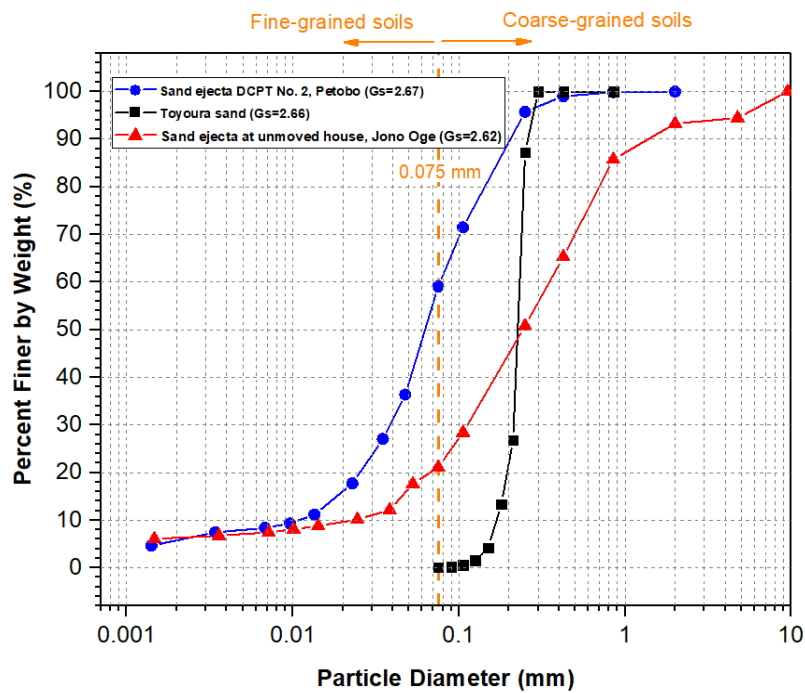
Figure 14 The grain size distribution of sand ejecta collected from Petobo and Jono Oge compared to Toyoura Sand. Both samples contained fine fractions.

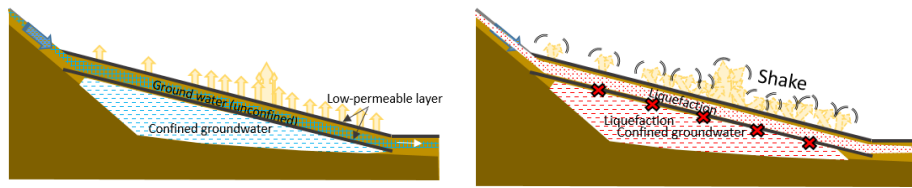
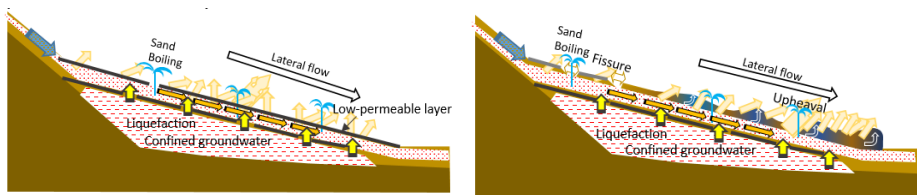
Figure 15 Proposed mechanism of the liquefaction-induced flow failure due to the earthquake.

This condition is illustrated in Figure 15(a). When the earthquake occurred, the sandy soil layer was liquefied. This interpretation is in line with the results of the portable DCPT, which identified the loose sandy soil layer in this area. Simultaneously, the earthquake motion also disturbed the low-permeable-layer in the shallow layer (Figure 15(b)).

As a result, lateral flow and sand boiling occurred. After the earthquake shaking, the excess pore water pressure is usually dissipated and the soil layer becomes stiff again. However, in this condition the dissipation of excess pore water pressure may be restricted by the presence of a low-permeable surface layer (Figure 15(c)).

This restriction made the liquefaction state continue and the flow continued due to the upward osmotic pressure from the liquefied confined aquifer. This flow pushed the houses and all the infrastructure to a lower elevation and deposited them at the bottom of the slope. In the upper part, tensile cracks started to develop (Figure 15(d)). After reaching a large deformation, the liquefaction stopped and the induced-flow became stable. At some points, the seepage of groundwater from the confined aquifer can still be observed (Figure 15(e)).

(a) Illustration of the initial conditions in the affected areas.

(b) The earthquake motion induced liquefaction in the sandy layer and disturbed the low permeable layer.

(c) Excess pore water pressure was unable to dissipate, so flow deformation continued to occur.

(d) The osmotic pressure from the confined aquifer made the flow continue and push all the buildings.

(e) The flow stopped and all the debris was deposited at the bottom part.
