Deterioration of the “Quinta Nova Torres Vedras” wall tile panel – an analytical approach

by Ricardo Triães + Luís Santos + João Coroado
+ Fernando Rocha

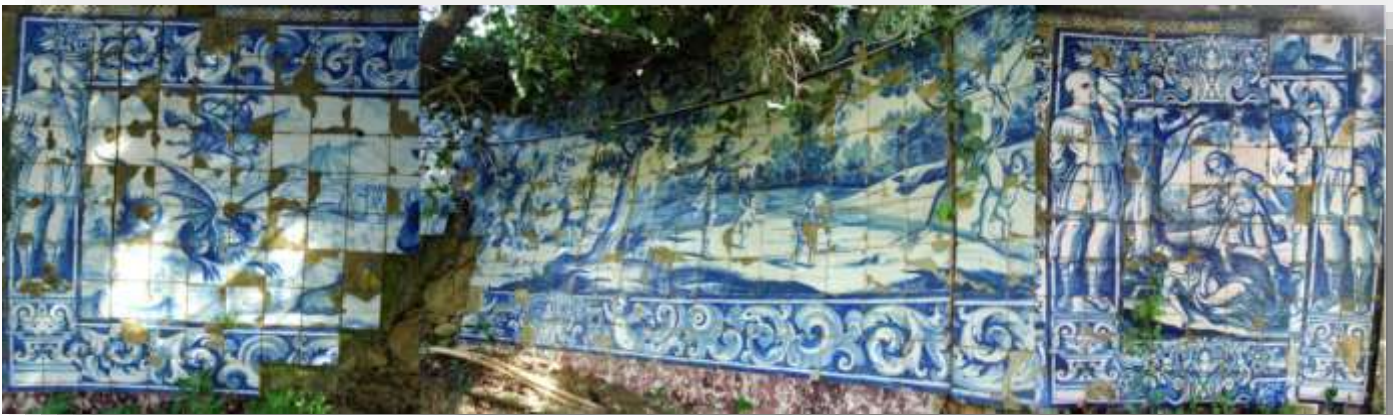
Tile panel before the intervention

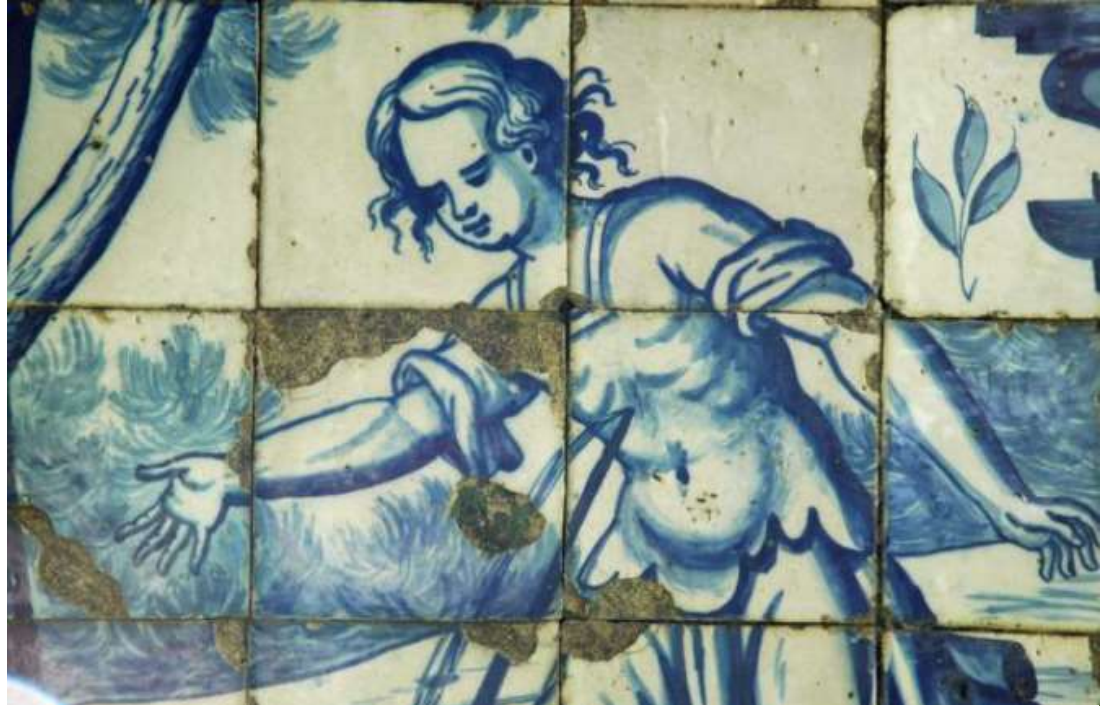
Loss of glaze and evidence of biological colonisation

The latter was extensive and occurred where the glazing was absent, which contributed significantly to the spread of the problem.

Glaze spalling is present at the edges of the tiles exhibiting partial glaze loss. The development of micro-organisms is also associated with pores and loss of glaze.

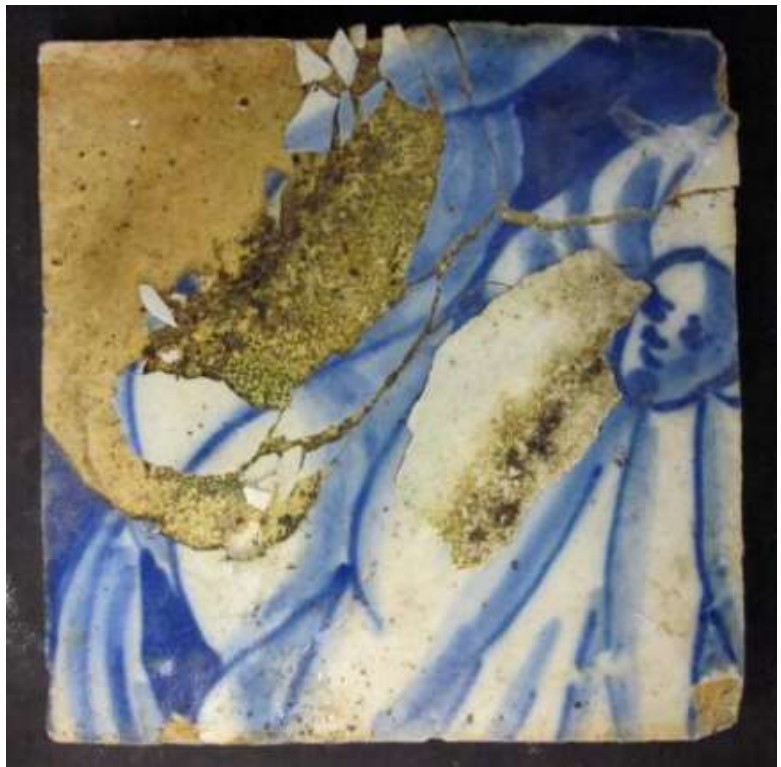
In both forms of degradation the glaze is not lost, just detached from the ceramic body.

Biological colonisation under the glaze

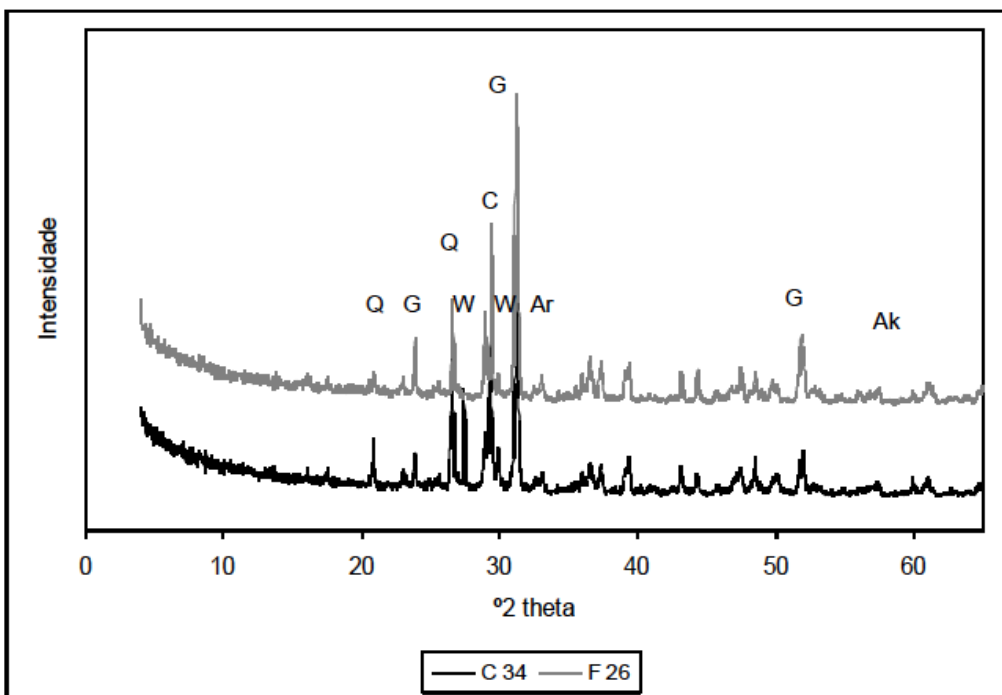
Results obtained by DRX and FRX point to a faience of calcite composition, though the presence of high levels of Mg, corresponding to the crystalline phase akermanite in sample F26 when compared with sample C34 may indicate distinct productions. The presence of crystalline phases resulting from the firing process, gehlenite, wollastonite and akermanite, which are observed in both samples, indicates firing temperature of around 1000°C. Crystalline phases result from high temperature transformations, essentially controlled by the elevated content of Silicon, Aluminium, Calcium and Magnesium (Si, Al, Ca, Mg).

X-Ray Diffraction of the samples C34 and F26, from the bar and panel respectively. Q – Quartz; G – gehlenite; W – wollastonite; Ar – aragonite; Ak - akermanite

The presence of aragonite and calcite, corroborates the thesis of free Calcium Oxide (CaO) deriving from the firing process or from lime mortar composition which in both cases suffers posterior re-crystallisation. Aragonite is a metastable crystalline phase, as a result of situations associated with deterioration of these materials.

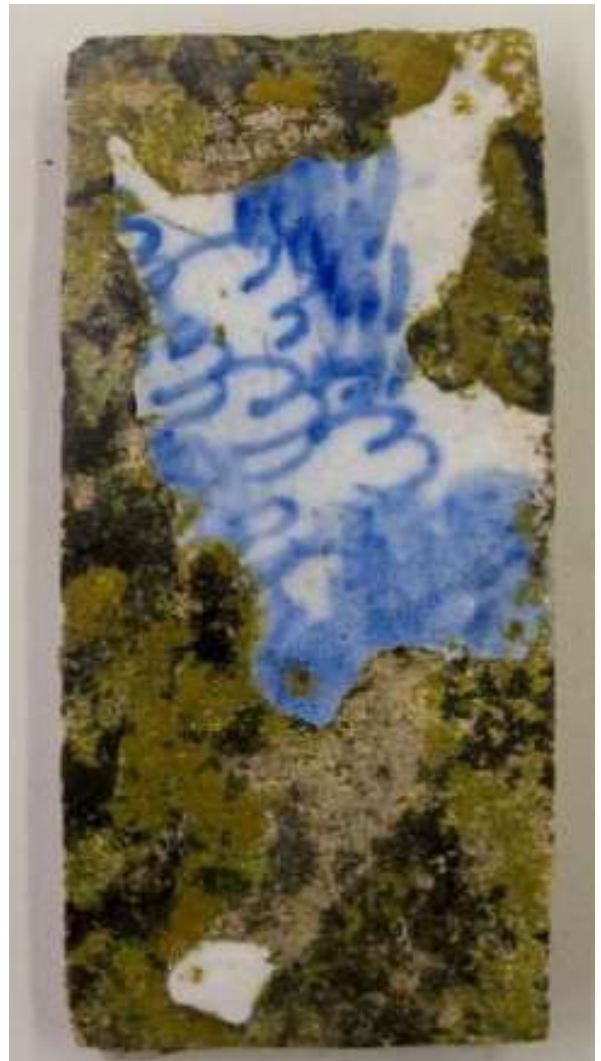
However, for the purpose of this study lichens were the main focus of the investigation. Following a preliminary observation of the whole panel it was decided to choose two tiles that were fully representative of the species abundance and diversity, labelled F1 and H3. The F1 tile exhibited near total loss of glaze, while tile H3 exhibited partial loss of glaze.

Biological degradation on tile H3
