SPECIAL ISSUE - RESEARCH ARTICLE

Discovering the colours of industrial heritage characterisation of paint coatings from the powerplant at the Levada de Tomar

J Raman Spectrosc. 2021;52:208-216.

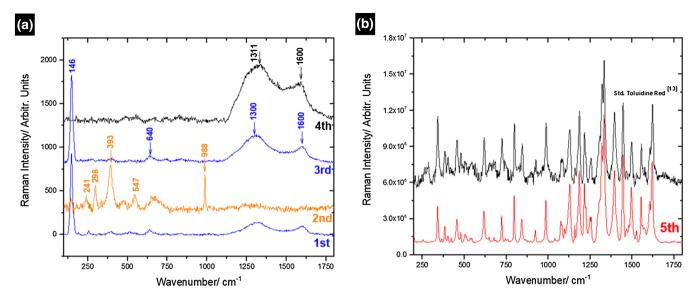
The identification of the compounds of each layer was carried out by µRaman. Figure 3A shows the Raman spectra obtained for each layer. The first and third layers show a very strong band at approximately 146 and a medium band at approximately 640 cm⁻¹ distinctive of titanium dioxide (TiO₂),^[28] and the carbon black characteristic broad bands at approximately 1,300 and 1,600 cm⁻¹. Data suggest that these layers are composed of a mixture of TiO2 and carbon black, which is in accordance with their grey colour and the EDS results. The vellow colour of the second layer is obtained by mixing artificial yellow ochre (Fe(OH)3), identified by the 241, 298, 393, and 547 cm⁻¹ bands, [20] with barite (BaSO₄), with a main band at approximately 988 cm⁻¹. [20] The black colour layer is composed of carbon black identified by the 1,311 and 1,600 cm⁻¹ broad bands. The colouring agent of the outer layer is toluidine red identified by comparison with a standard reference spectrum (Figure 3B).[21]

FIGURE 3 Raman spectra obtained for the first four layers that compose the ASEA alternator paint system (a) and for the fifth layer to which was added the standard reference of the toluidine red $(b)^{[21]}$

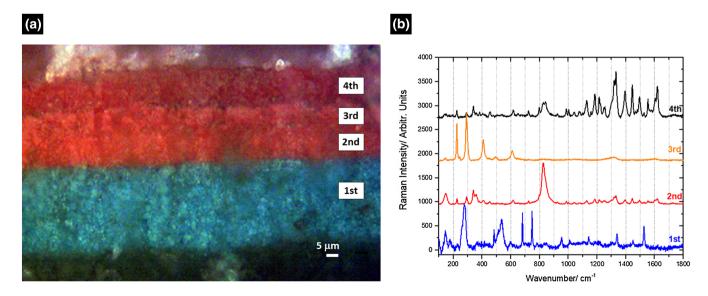
An additional paint system was observed for the G3 alternator (Figure S1B). Figure 4 shows the cross section and Raman spectra of the red lubrication lid revealing a paint system comprising four layers. The first, with 30 μ m, is composed of Cu phthalocyanine blue, followed by a 10 μ m molybdate red (PbCrO₄.PbSO₄. PbMO₄) and by a 10 μ m toluidine red layer. Between the two red layers exists a 10 μ m haematite layer. It should be emphasised the identification of molybdate red, ascribed by the presence of Mo, Cr, and Pb at the μ XRF

FIGURE 4 (a) Micrography of a coating cross section from the ASEA alternator (G3) revealing the existence of four layers, the first in blue and the others in red, and (b) Raman spectra obtained for each layer allowing the compounds identification as phthalocyanine blue (first), molybdate red (second), haematite (third), and toluidine red (fourth)

spectrum (Figure S3) and by the very strong band at approximately 830 cm⁻¹ and by the 340 and 360 cm⁻¹ bands at the Raman spectrum. [22] This inorganic pigment has a good tinting strength and good hiding power. Although being lightfast, a gradual colour loss can occur due to bleaching by sulphur dioxide due to extended exposure to industrial atmospheres. [26] Since its introduction in 1936, its application was reported in the production of paints, coatings, and plastics^[27] and in 20thcentury concrete on woodblock prints. [22] As the alternator cover is blue and only the lubrication lid is in red, we can suggest that first was applied a blue paint over all the surface and then a molybdate red layer was applied over the lid, becoming easier to paint. The toluidine red and the haematite layers can be a result of maintenance actions aiming the lid recoating.

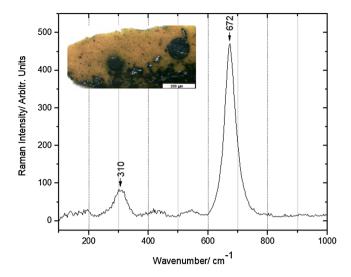
It was also observed at some cross-section samples the existence of an interface layer between the iron substrate and paint coating composed of a mixture of corrosion products and paint coating from the yellow paint of the alternator' base of the 1924 generator group (Figure 5).

FIGURE 5 Raman spectrum of magnetite, displaying the characteristic bands at 310 and 672 cm⁻¹. Inset: Micrography of the coating cross section of the ASEA alternator base showing the chrome yellow (PbCrO₄) paint layer and the iron corrosion product (magnetite) in the middle of the coating

The key corrosion product identified by Raman is magnetite (Fe₃O₄) characterised by the spectrum band^[33] at 672 cm⁻¹ (Figure 5). Iron corrosion products resulting from atmospheric corrosion are mainly composed by a mixture of oxides and hydroxides. These compounds can be converted, by heating or electrochemical reactions, from one phase to another being sometimes difficult to distinguish between them.^[33] For example, maghemite $(y-Fe_2O_3)$ can be formed by heating magnetite at 60° C. Maghemite shows Raman spectra bands at 385, 505, 670, 710, and 1,360 cm⁻¹ whereas magnetite has only one main band at 670 cm⁻¹. [34] That means if a Raman spectrum shows more bands than the 670 cm⁻¹ one, the corrosion is composed by maghemite or by a mixture of maghemite and magnetite. Considering that only magnetite has been identified as corrosion product, we may suggest that corrosion developed after the engine shutdown and not while the engine was in operation, when the surface could reach temperatures above 60°C.
