INVESTIGATION OF CAUSES OF SCRAP OCCURRENCE IN THREAD CUTTING ON STEEL SLEEVES FOR MOTORCAR INDUSTRY

V. Marušić, I. Budić, T. Šarić, Faculty of Mechanical Engineering University of Osijek, Slavonski Brod, Croatia

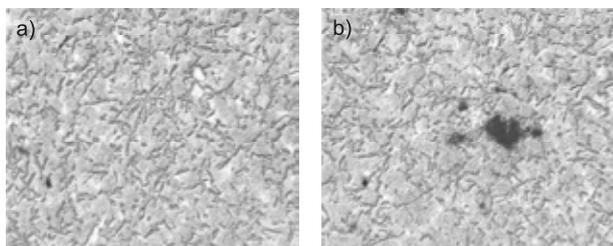
Figure 2. shows the characteristic cross section microstructure of Al casting. It should be noticed that the microstructure corresponds to the customer contract provisions, whereby smaller irregularities in the form of internal gas holes and small inclusions of impurities [4] can also be observed.

Figure 2. Typical cross section microstructure of Al carriers; Magnification 220x, Etching: Nital + hydrogen fluor acid (HF)
Slika 2. Karakteristična struktura poprečnog presjeka Al nosača. Povećanje 220 puta. Nagrizanje: nital + fluorovodonična kiselina (HF)

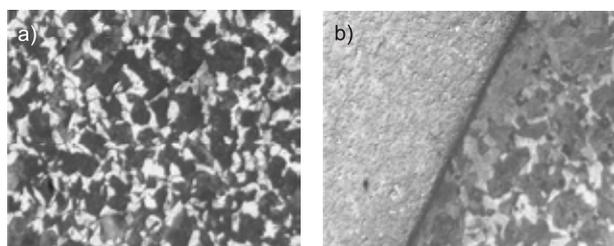
Figure 3. Characteristic microstructure of cross section of steel sleeves; Magnification 220x, Nital etching: a) sleeve center; b) sleeve margin (up to Al.)

The measured hardness values range from 250 to 270 HB. It was not observed that point of measurement affected the measured values.

Metallographic examination on the cross section of steel sleeves (Figure 3.a) was carried out. The microstructure is rather homogenous ferrite - pearlite structure, typical for a normalized steel and no significant differences between the central and marginally located areas of Al (Figure 3.b) could be observed.

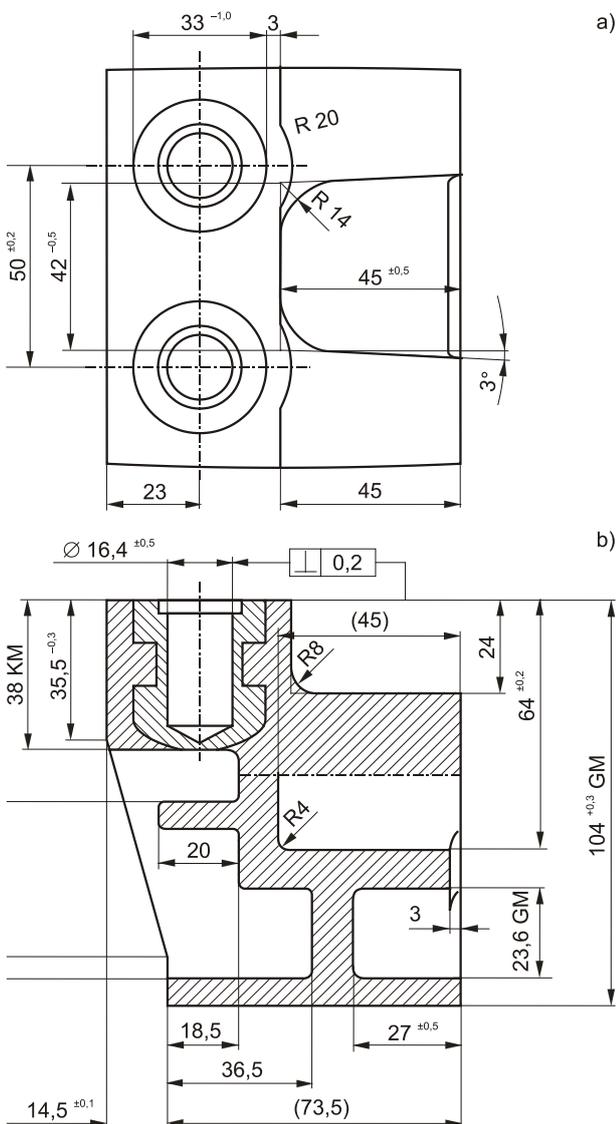
Figure 4. Typical dimensions of Al casting: a) span of symmetry lines of sleeve bores; b) diameter, depth and perpendicularity to sleeve symmetry lines

Much more important is to notice that three sleeves out of tested five carriers (i.e. ten sleeves) showed lesser diameter than the minimally allowed of 16, 35 mm.

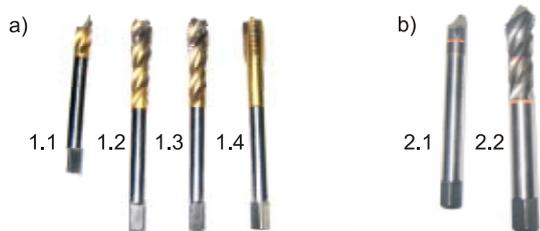
Several different cutters were examined for the purpose of control of the present damages. Besides their geometry, the cutters differ also by composition of their surface protective coating on base material (HSS steel). This protective coating is with some cutters titan nitride (TiN) and with other titan carbide (TiC). The appearance of damaged cutters is shown on photo in Figure 5.

Figure 5. The appearance of damaged cutters prior to thread cutting in the sleeve: a) thread cutters with protective coating TiN; b) thread cutters with TiC protective coating

Based upon the inspection of delivered cutters (Figure 3.a and 3.b) it can be seen they broke (cutters 1.1; 2.1; 2.2), while the others displayed only signs of "wear" (cutters 1.2; 1.3; 1.4). Discoloration of some of the cutters caused ("turned blue"), by the overheating during thread cutting. The following can be concluded:

- because 3D control established satisfactory perpendicularity of symmetry lines of the sleeve, it is not to be expected that damaging of cutters came as result of deviation of coaxial hole;
- due to fact that cutters with surface coating TiN and TiC on HSS steel display breakage and material wear, coating itself does not affect essentially to cutter breakage.

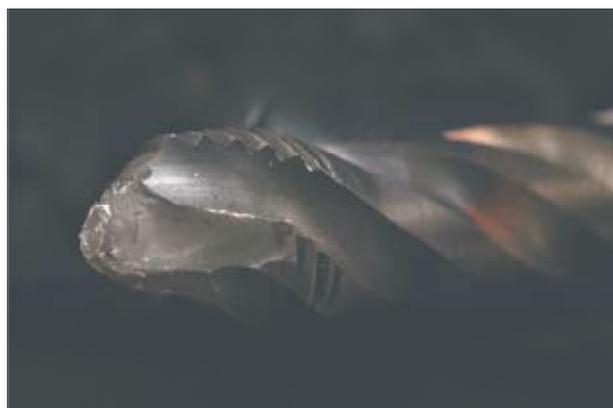
- the cutters broke under an angle of 45°,
- local wrinkling of base material due to stresses over boundary of base metal tensile strength occurred,
- some cutters changed color (“turned blue”) due to overheating prior to breakage.

Figure 6. Appearance of the cracked surfaces of the thread cutter (macro record)

Cutter wear is in partly consequence of grind "drainage", but real cause of breakage with those sleeves which had smaller internal diameter than minimally allowed lies prevalently in overstress (stress above tensile strength of material), because the cutter not only enters the sleeve by cutting, it also shapes it by process of "rolling".

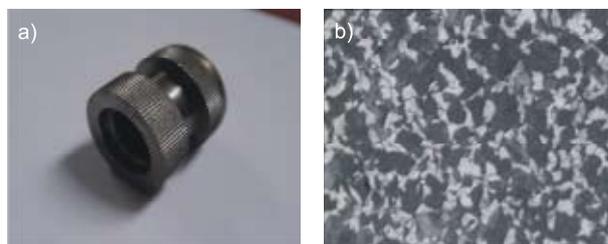
The analysis of microstructure of cross section of *as delivered* sleeves was performed, after the simulated annealing treatment. In both cases characteristic for the ferrite - pearlite microstructure could be observed the relatively small grain size and a significant difference between marginal areas and the central cross section area could not be noticed. The microstructure of these sleeves is shown in Figure 7.b.

Figure 7. Clamp sleeve: a) appearance in *as delivered* condition; b) characteristic microstructure of the cross section. Magnification 220 \times , Nital etching
