BULLETIN 676

10-YEAR PAINT TESTS ON WEATHERED GALVANIZED ROOFING

By A. J. Muehling and J. O. Curtis

UNIVERSITY OF ILLINOIS
AGRICULTURAL EXPERIMENT STATION

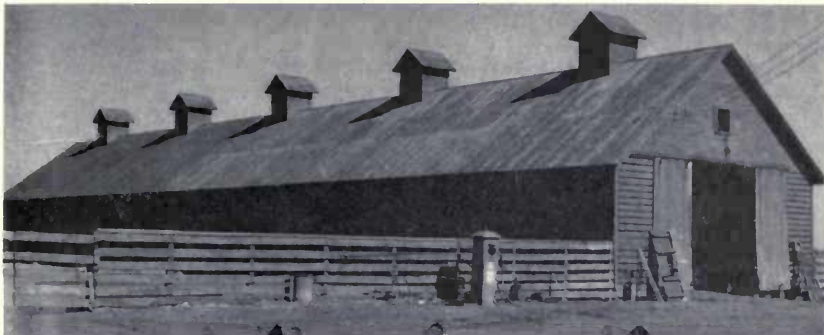
North side of crib before painting. The one-third of the roof at the left (Panels 46 through 81) was 100 percent rusty. (Fig. 2)

The panels on the northern exposure for the second replication were 100 percent rusty when they were painted, and the average film failure at the end of 10 years was 28.4 percent. The panels for the first replication on the northern exposure varied from 50 to 90 percent rusty, with an average of 65 percent rusty, and the average film failure

at the end of 10 years was only 7.8 percent. The difference between these two averages indicates that the original condition of the panels had a definite effect on the performance of the paint systems.

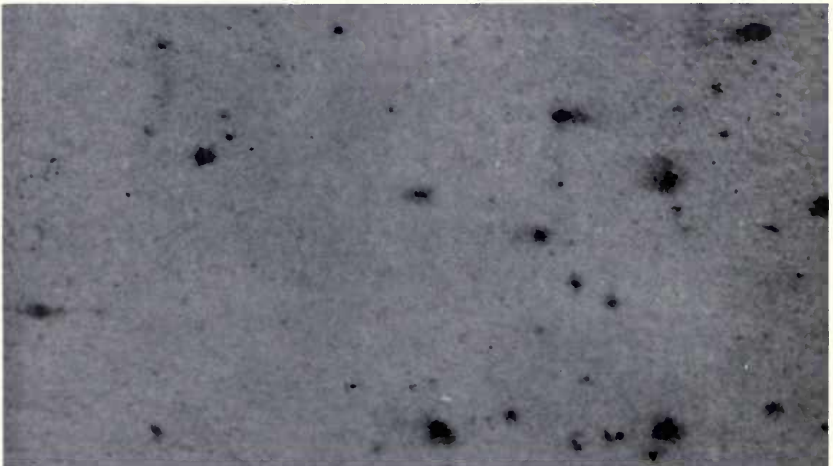
One way to define repaint stage is to compare the condition of a panel with the ASTM photographic standards (12) as adopted in 1943 and reapproved without change in 1958. Numerous authorities (Singleton, Walton, Burgener) have recommended ASTM No. 8 as the stage in the photographic standards when repainting is necessary (Fig. 4). This standard corresponds to a film failure of about 5 percent (4). For comparison of paint performance in this test, 5-percent film failure was used as the repaint stage. All panels did not reach 5-percent film failure or repaint stage during the 10-year test period.

Photographic reference standard Number 8 — type 1, rusting not accompanied by blistering. This standard has often been recommended as the "repaint stage." Photo courtesy American Society for Testing Materials. (See literature citation 12.) (Fig. 4)

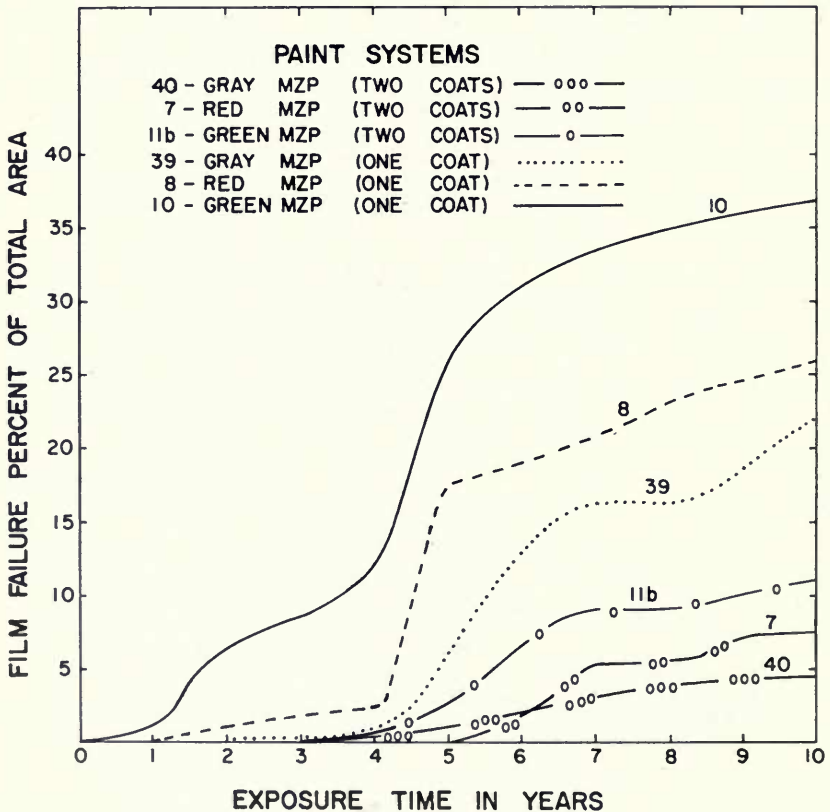
(Fig. 5)

Performance of metallic zinc paints.

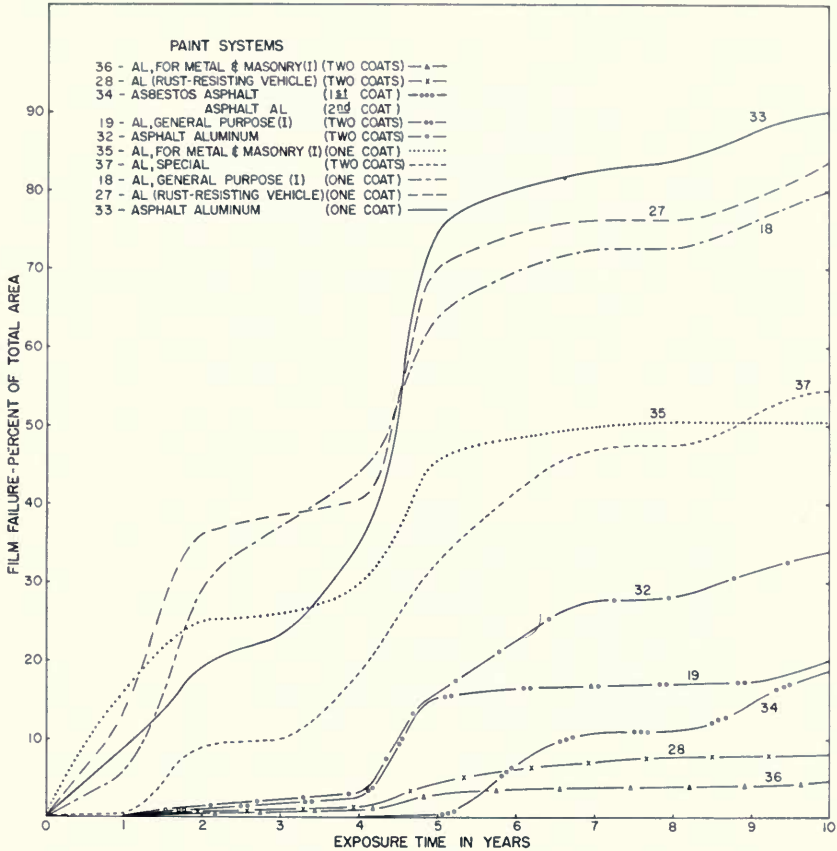
(Fig. 6)

Performance of aluminum paints.

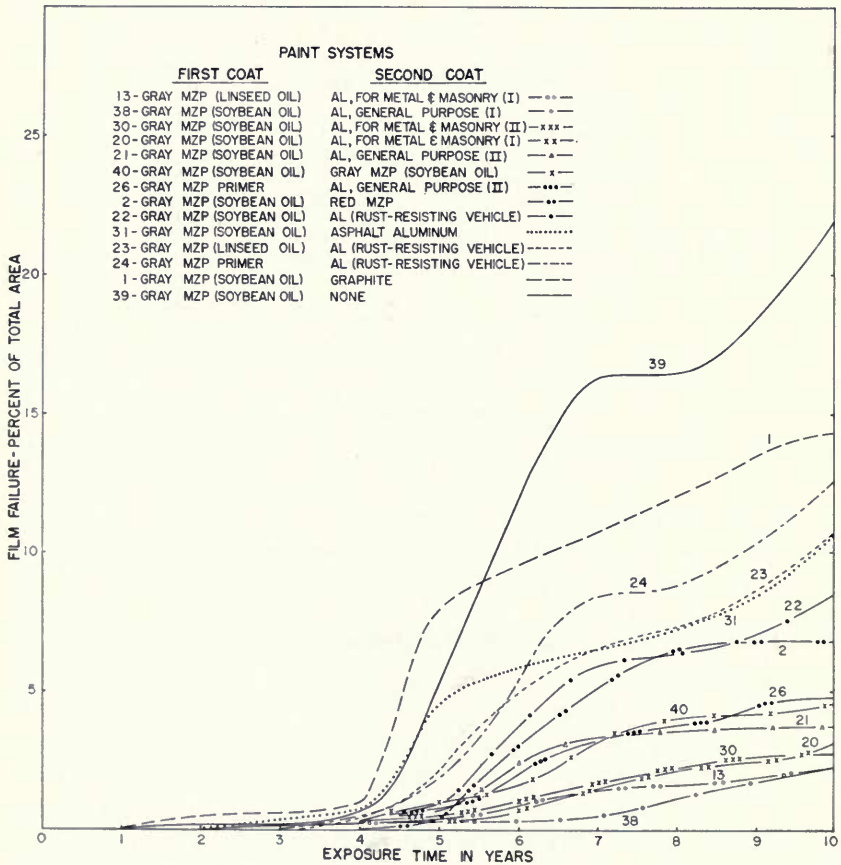
(Fig. 7)

Performance of paint systems with gray MZP for a first coat.

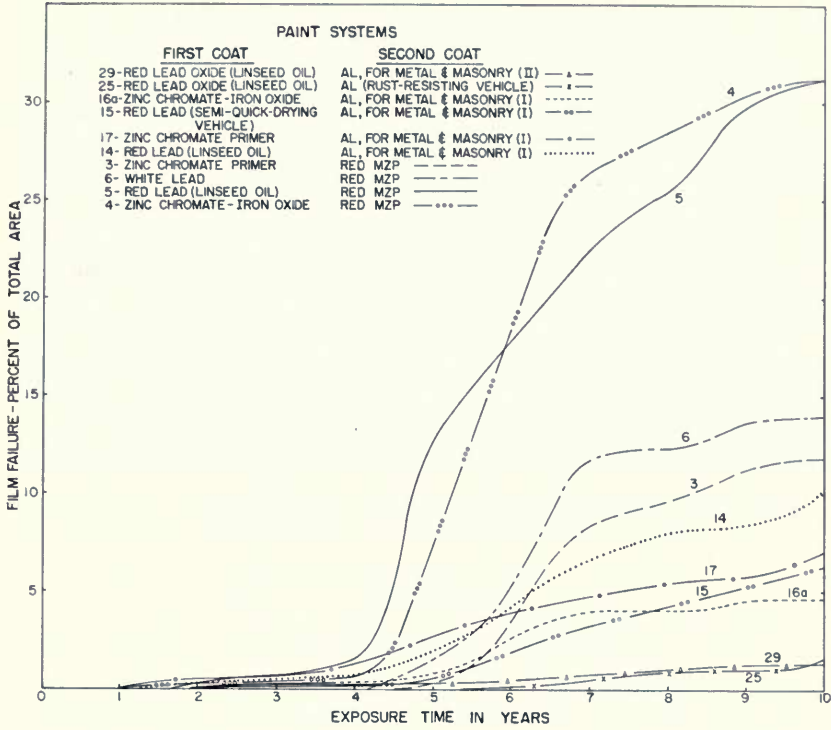
Performance of paint systems with red lead, white lead, or zinc chromate for a first coat. (Fig. 8)

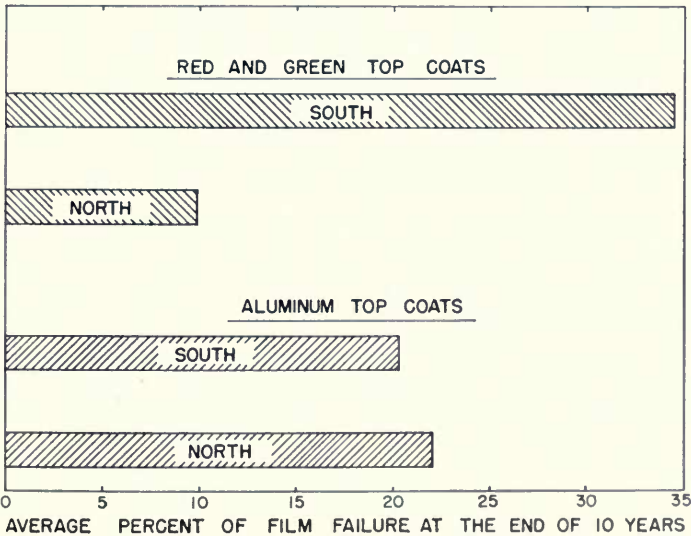
In every case, the film failures from the paint systems with a red or green top coat were larger for the southern exposure than for the northern exposure. The exposure did not seem to affect the performance of the paint systems that had a second coat of one of the aluminum paints. Fig. 9 shows the contrast between the two groups of paints. The average film failures at 10 years were almost equal (20.3 compared with 22.0) for the northern and southern exposures of the paint systems

Effect of exposure on red and green top coats and aluminum top coats (Fig. 9)

1. Exposure had a definite effect on the paint systems with a red or green top coat, but no apparent effect on the paint systems with an aluminum top coat. All panels with a paint system composed of a red or green top coat had an appreciably larger film failure on the southern exposure than on the northern exposure. There was no significant difference between film failures on the northern and southern exposures for the aluminum top coats, or for the gray MZP top coat.

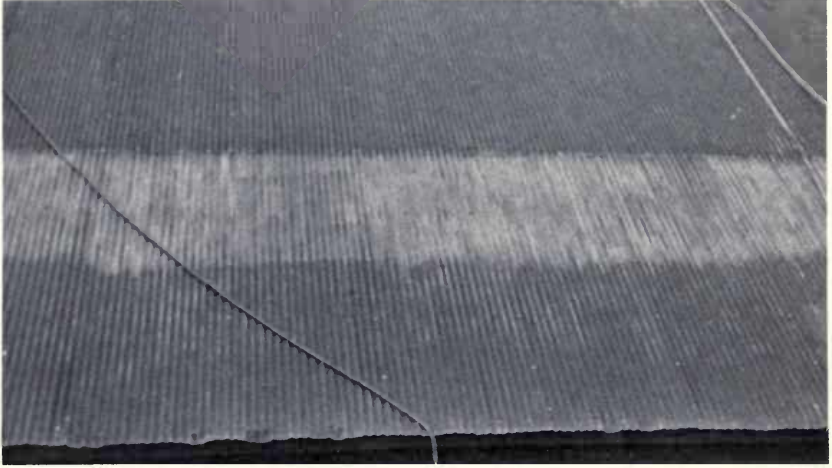
spection, panels 46 through 81 were studied with special care to see if any difference existed between the paint performance of the sections that had been wire brushed and the remaining portions of the panels. As far as could be determined, the wire brushing had no effect on the ability of the paint to withstand weathering.

The top portions of the bottom sheets of Panels 46 through 81 on the north side were wire brushed before painting. These panels were 100 percent rusty (see Fig. 2). (Fig. 10)
