This article focuses on an original case history of replacement of a leaky 245 kV OIP bushing of a 220/132/33 kV, 160 MVA, transformer on site at the 220 kV Jabalpur substation, in Madhya Pradesh state in India with an available 245 kV OIP bushing having longer L-2.

Retrofitting of 245 kV OIP bushing with longer oil-end

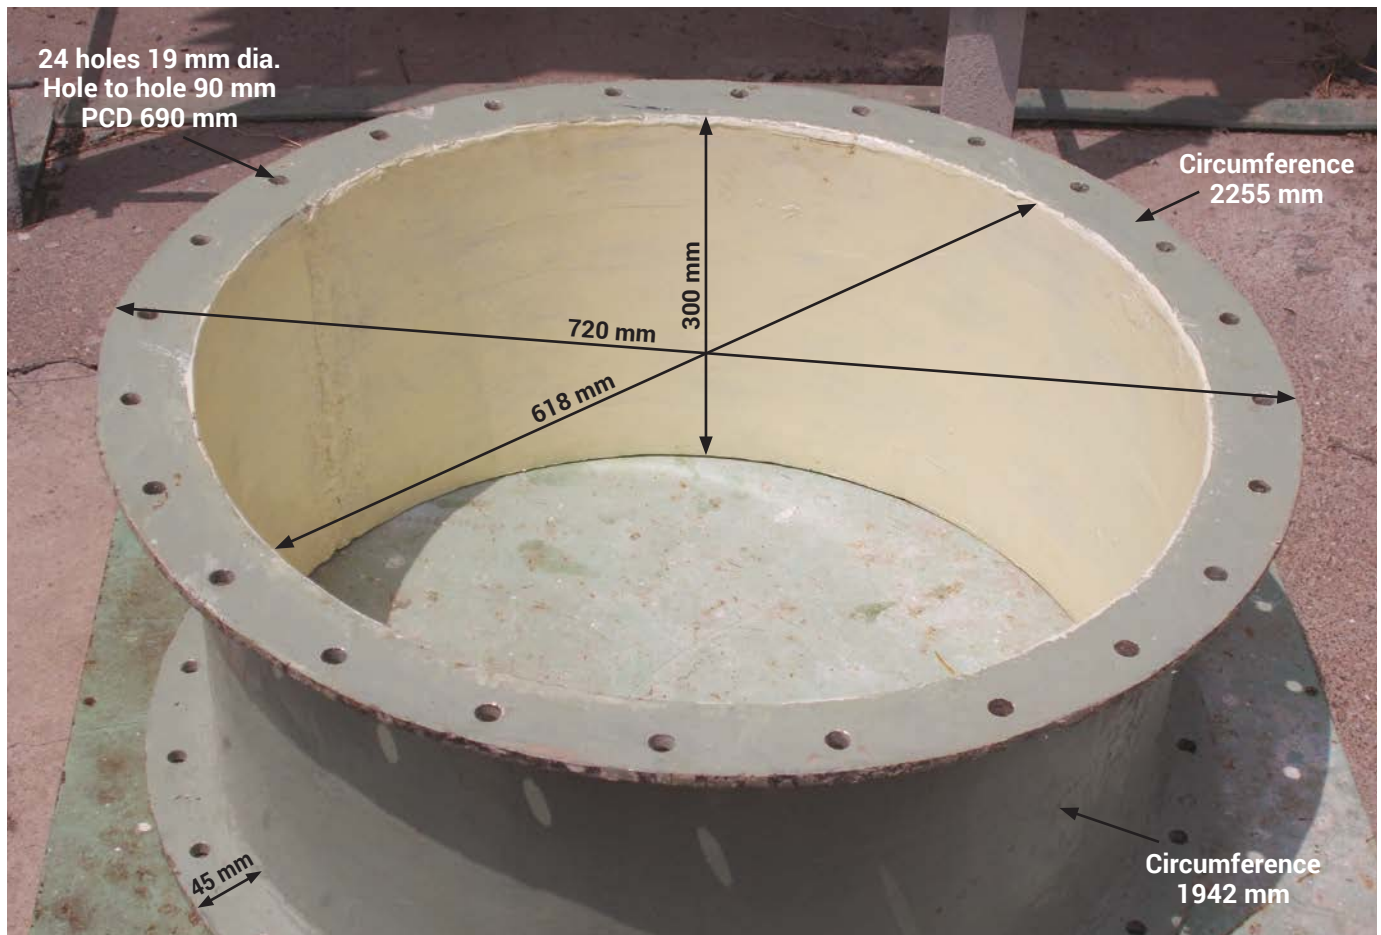
Figure 5. In-house fabricated turret adopter.

A cylindrical extension piece was locally fabricated with a 8 mm thick wrought iron plate with dimensions: 618 mm diameter, 300 mm length and 8 mm thickness with flange on both ends fabricated with 8 mm thick wrought iron plate with internal diameter of 618 mm and external diameter of 720 mm; they have 24 bolting holes of 19 mm diameter at diameter of 690 mm (PCD) and hole to hole distance of 90 mm. The turret adopter fabricated is shown in Fig. 5.

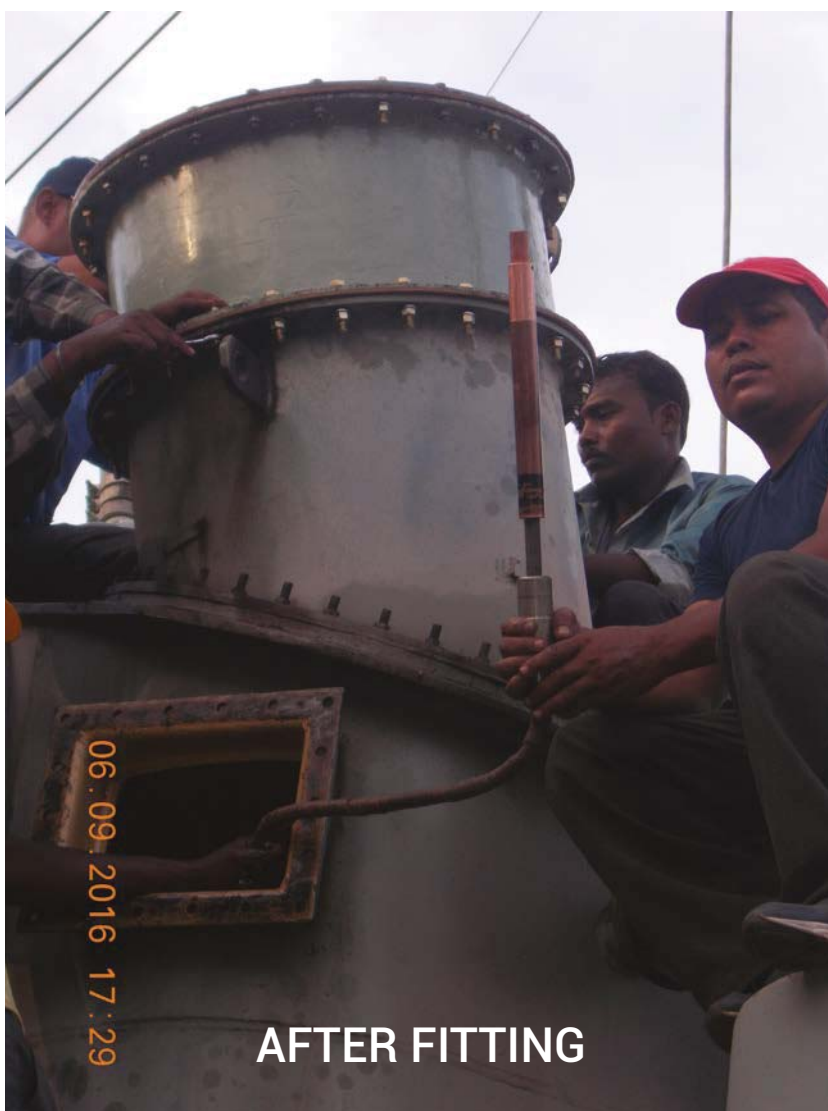
Figure 7. Fitting of extended turret adopter and extension of draw lead.

The length of the draw lead was extended by 300 mm using a 360 mm copper rod available in the substation of a draw rod type bushing by suitably turning the threads on either ends for fixing the lead-end and the terminal-end thimble, Fig. 6. The fabricated copper rod extension piece for elongation of the connecting draw lead was screwed to the original draw lead stud of the bushing and on the other end to the terminal to the thimble. The extended turret adopter is depicted in Fig. 7.
