Oil Tanker Simplified Fatigue Assessment with Inspection and Repair Approach and Parameters

Ozgur Ozguc

doi: 10.7225/toms.v10.n01.003

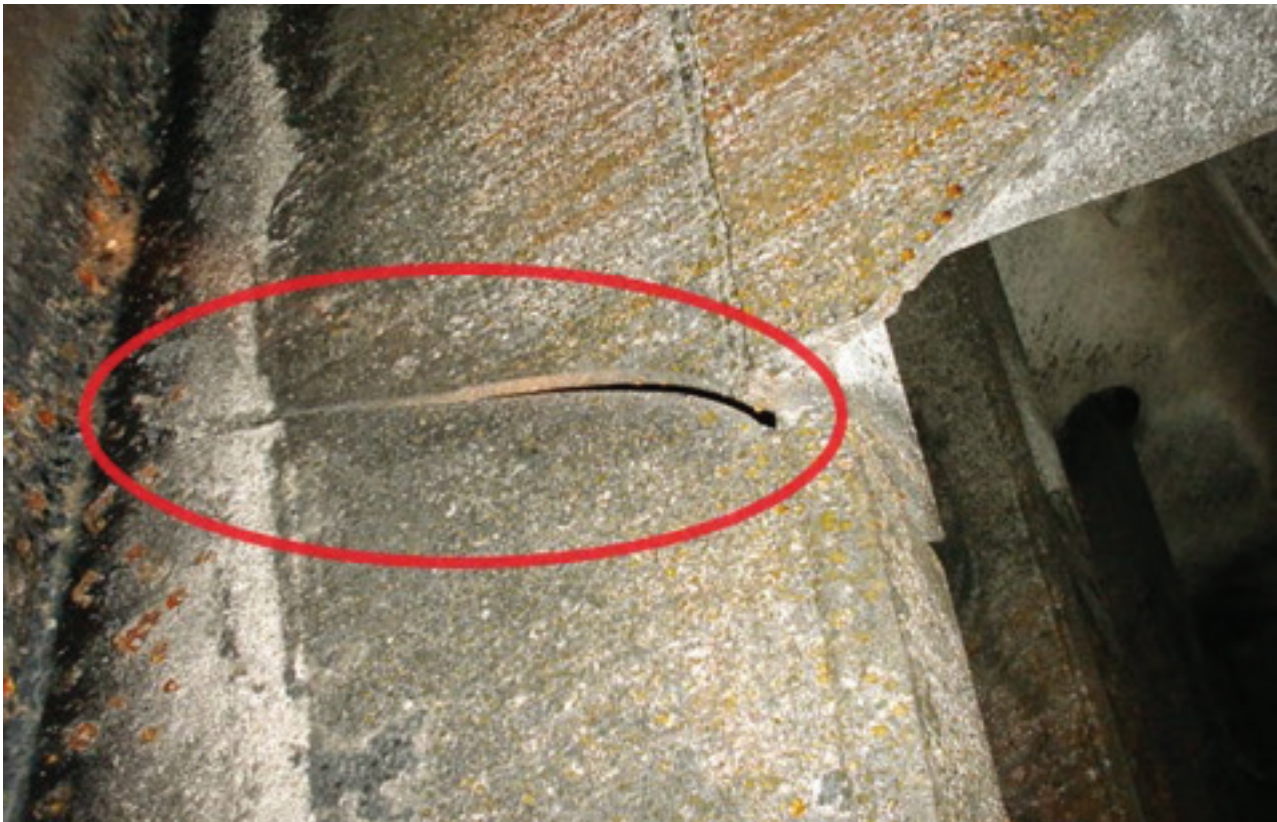
Figure 1.

Many cracks in the side shell were detected at the tripping brackets in both the cargo and ballast tanks. Figure 1 shows that the crack was initiated in the weld between the bracket toe and the stiffener flange. According to the operational information, most cracks were found in the side shell both in ballast and cargo wing tanks, and a few cracks were found in the longitudinal bulkhead at center cargo tank. The cracks in the side shell stiffeners propagated through the stiffener web and into the side shell plating. Further, the design shows that all tripping brackets in the side shell were welded with overlap to the side longitudinals. This increases stress concentration and reduces fatigue life significantly (up to 40 %).

Based on previous experience with large tripping brackets, large brackets represent large local stiffness. Relatively high stress concentration factors were found in the bracket toe and heel. Normally, the heel of brackets is the worst hot spot of one-side bracket details, but no cracks were discovered in the heel for the tripping brackets on this ship. Experience with tripping brackets on other vessels indicates that these details may crack in the toe as well as in the heel (Tanker Structure Co-operative Forum, 2011).

A typical crack at the toe of the tripping bracket (Tanker Structure Co-operative Forum, 2011).

A few tripping brackets in the side shell were repaired over the last two years. The longitudinal stiffeners were partly cropped out and renewed. New triangular brackets (350 x 350 mm) were inserted at the bracket toes. The details that cracked are close to the neutral axis, and both vertical and horizontal bending moments will give small contributions. The lateral dynamic pressure is small as long as both the center cargo tank 7 and wing cargo tank 5 are either full or empty.

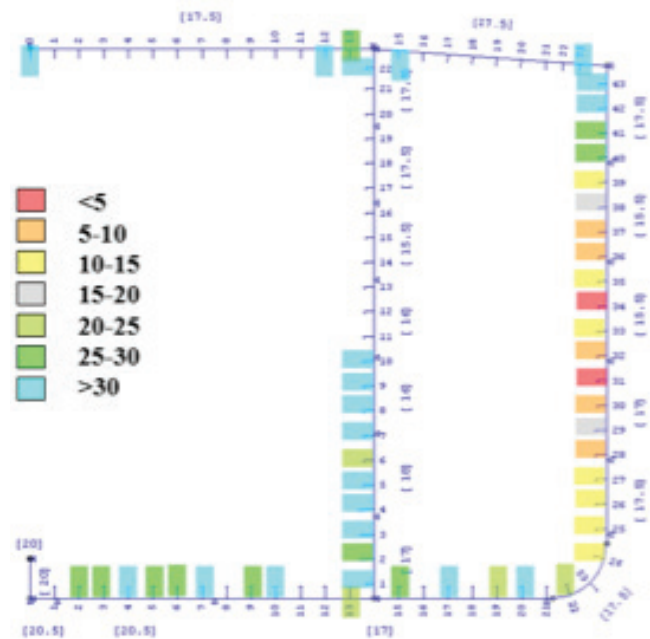
Figure 8.
Representative fatigue lives for frame 240, representing a typical frame in the ballast wing tank amidships.

The fatigue lives in the side shell longitudinals are below 20 years. 20 years are normally regarded as a fatigue target life for new designs. Longitudinal L31 and L34 have fatigue lives below 5 years. These tripping brackets have already cracked at some locations. In addition, longitudinal L28, L30, L32, L36 and L37 have fatigue lives well below 20 years.

The external dynamic sea pressure is the dominant part in the fatigue life calculations of the side shell stiffeners. Other effects such as internal pressure and horizontal bending moment contribute to fatigue, but the main cause is the external pressure. The external pressure taking the dynamics in the splash zone (partly dry, partly wet area with the passing waves) into account gives the largest fatigue loads just below the still water line. In addition, the external pressure at the fully loaded condition contributes slightly more than the ballast condition to the fatigue lives in the side shell. The still water line for fully loaded condition is located approximately at L37. The fatigue life pattern shows a typical behavior when the external pressure dominates the fatigue damage.

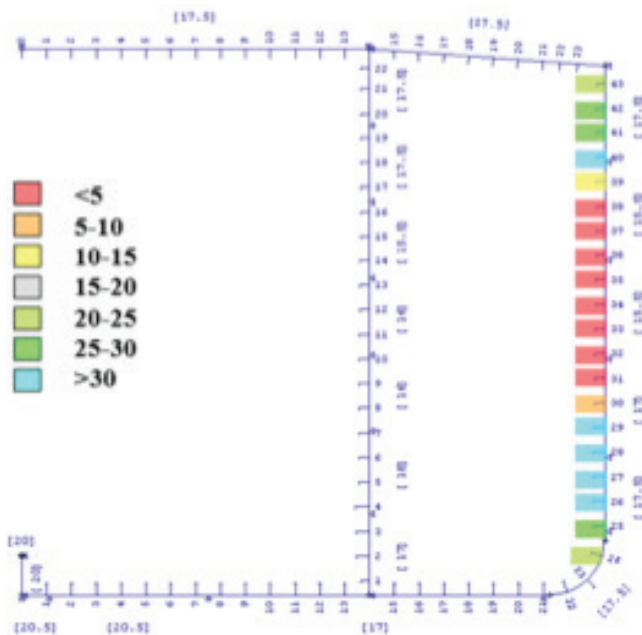
bottom girders. The relative deflection of side-shell longitudinals was then neglected for L29 and below, and L40 and above. In addition, relative deflection can be neglected due to a lack of lateral pressure in the deck and large transverse web frames in the bottom. The results presented in Figure 9 show that the relative deflection largely contributes to the fatigue damage in the side shell stiffeners. Both the external and internal pressure loads contribute to the accumulated fatigue damage. The fully loaded condition is much worse than the ballast condition in this case, and the fully loaded condition itself is sufficient to cause cracks at the transverse bulkhead even if the local design of the bracket details at the transverse bulkhead is better than at the web frames.

The bending effect of the transverse bulkhead due to an empty tank on one side and a full tank on the other side (or unsymmetrical details) makes the fatigue calculations more complex, and a finite element model is necessary to calculate this accurately. However, the fatigue lives found indicate that even if this is roughly assessed herein, the relative deflection effect is considerable at the transverse bulkheads. Cracks have already been repaired at these locations by fitting additional triangular brackets (350 x 350 mm).

Figure 9. Representative fatigue lives of stiffeners at the transverse bulkhead, frame 260. Approximately the same fatigue lives are expected at the other transverse bulkheads.

The previous repairs at the transverse bulkhead, frame 260 consist of fitting small 350 x 350 mm brackets at the bracket toe. Fatigue life for these details may not be sufficient for the next 5 years. If cracks at the transverse bulkhead are a severe problem based on the inspection, an improved design of the brackets is proposed. The old brackets may be removed and new ones fitted. The improvement consists of a smooth bracket toe termination on both sides, as shown in Figure 22. It is preferred that also the backing bracket (on the other side of the bulkhead) is welded on top of the flange to avoid eccentricities. To ease fabrication, only two types of brackets may be used amidships even if the transverse horizontal bulkhead stiffeners are of different sizes (Tanker Structure Co-operative Forum, 2011).

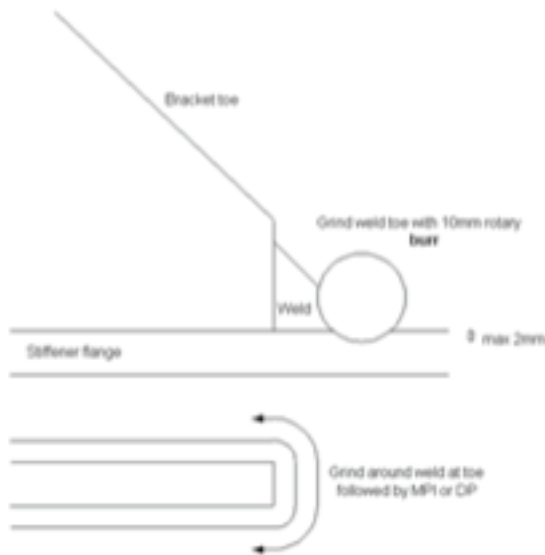
Figure 10.
Principle of bracket toe grinding followed by DP or MPI (IACS, 2017).

For the bracket toes, the inspection proposed is shown schematically in Figure 10. In principle, this will be the same for the brackets with overlap, as shown in Figure 11.

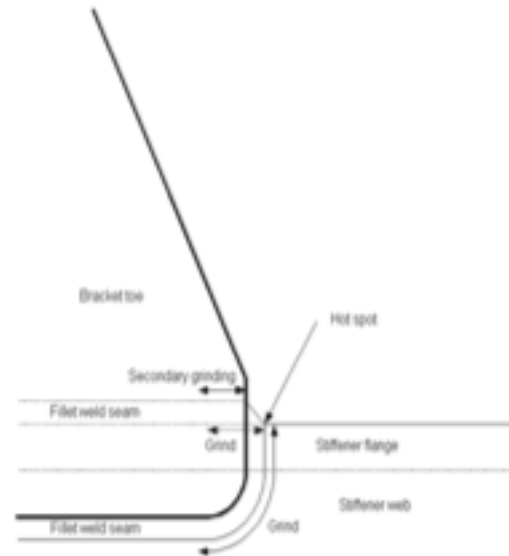
Figure 11.
Proposed grinding for bracket toes with overlap (IACS, 2017).

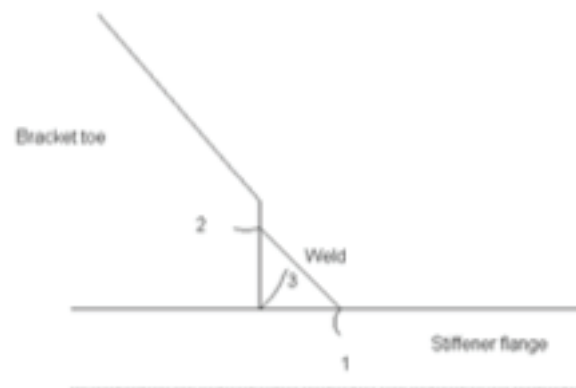
The crack may initiate in principle at three different locations as seen from Figure 12. It should be noted that the intention of the grinding above is to improve the fatigue life of the detail by removing the crack at location 1. The grinding procedure may reduce the fatigue life at location 3, while the fatigue life of location 2 will be unchanged. For the scallops the grinding is proposed as shown in Figure 13. Grinding of the scallops for brackets with overlap is similar as shown in Figure 14.

Figure 12.
Crack location of welds.

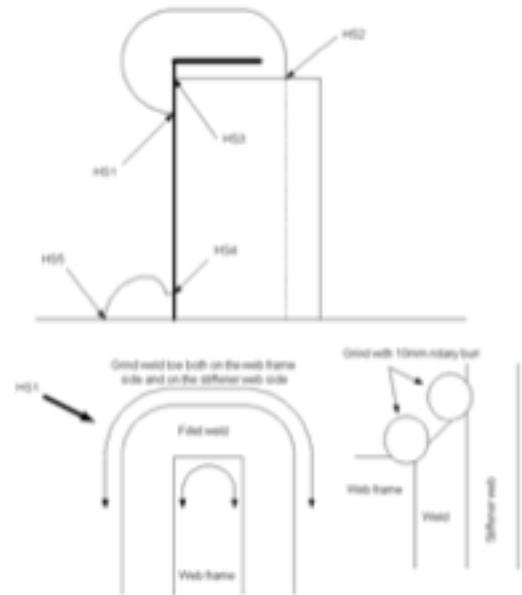
Based on the above, the slots should be checked for the details shown with grey, yellow, orange and red boxes, with special emphasis on the slots at the lower part of the web frame. For midship frames, special emphasis should be given to longitudinal L30 to L34 in the side shell. Typical hot spots to be checked are presented in Figure 15. This slot represents type "J" on the midship drawing, which seems to be a quite good detail except for hot spot 1 (denoted HS1) and hot spot 2. Hot spot 4 is of the recommended design used in order to move the stress flow away from the toe.

Figure 15.
Typical critical hot spots for slot of the "J" type.

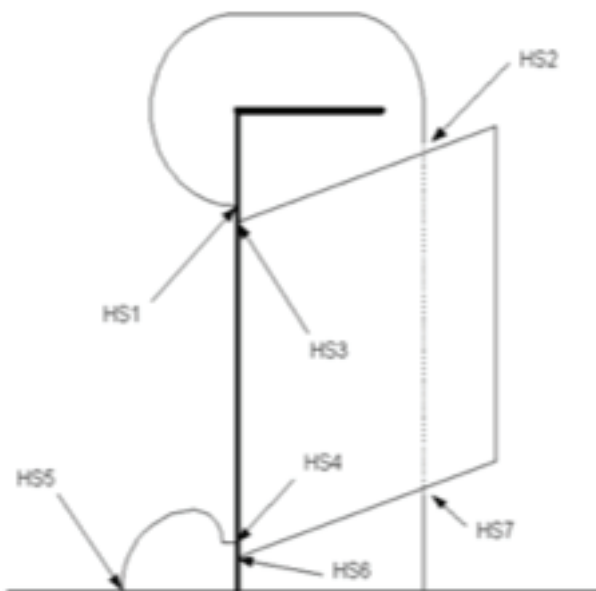
Similarly, the slot of type "H" is also used in the critical areas. This is presented in Figure 16. Typically, HS1, HS2 and HS3 will be the worst. There are also a few other details of concern that were not investigated in the present fatigue analysis, but which may crack according to experience with similar vessels. The first detail is the bracket toe of the large brackets on the web frame, schematically shown in Figure 17. Hot spot HS2 will normally be the worst since it is exposed to the largest external pressure, but also the other three might be critical. The rest of the bracket toes in the frame are less critical.

Figure 16.
Typical critical hot spots for the slot of "H" type.

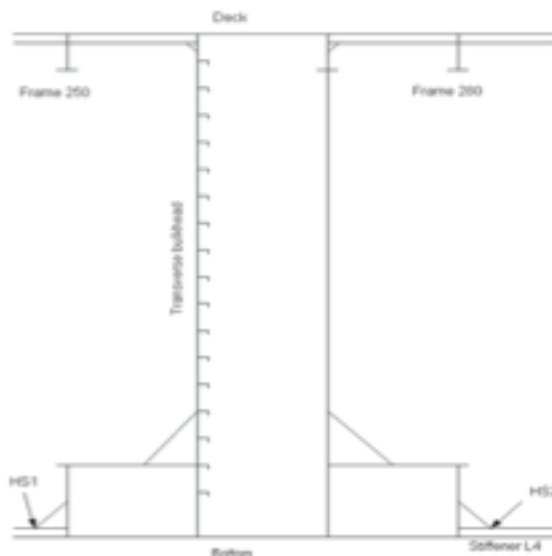
Figure 18.
Vertical girder at the transverse bulkhead and two critical details.

toe detail exposed to relative deflection, as shown in Figure 18.. The relative deflection effect is small for the bottom stiffeners; however, it is connected to a detail with significant longitudinal stiffness, hence these two effects make this detail probably the worst detail in the bottom. It is proposed to check the bracket toes at HS1 and HS2 at the transverse bulkhead, Frame 260.
