CIVIL ENGINEERING STUDIES
STRUCTURAL RESEARCH SERIES NO. 342

LOW CYCLE FATIGUE OF HY-130(T) BUTT WELDS

A REPORT OF AN INVESTIGATION CONDUCTED
by
THE CIVIL ENGINEERING DEPARTMENT
UNIVERSITY OF ILLINOIS, URBANA
in cooperation with
The Naval Ship Systems Command, U.S. Navy
Contract N00024-68-C-5125
Project Serial No. SF020-01-01, Task 729

DECEMBER, 1968

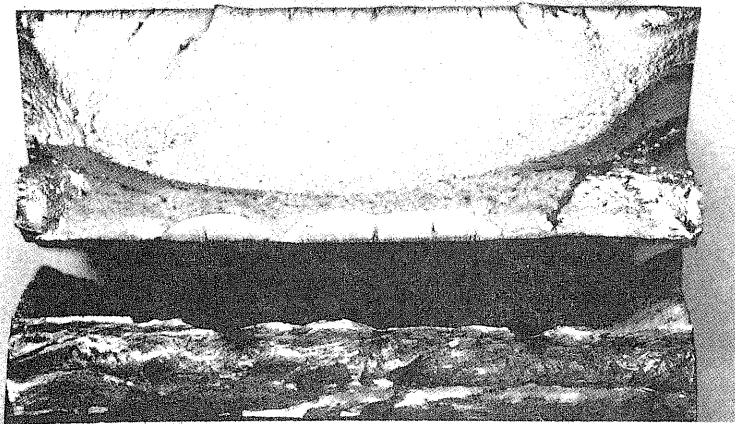
NC-41 FRACTURE
Stress 0 to +80.0 ksi
Life 68,200

(a) Failure Initiated at Toe of Weld

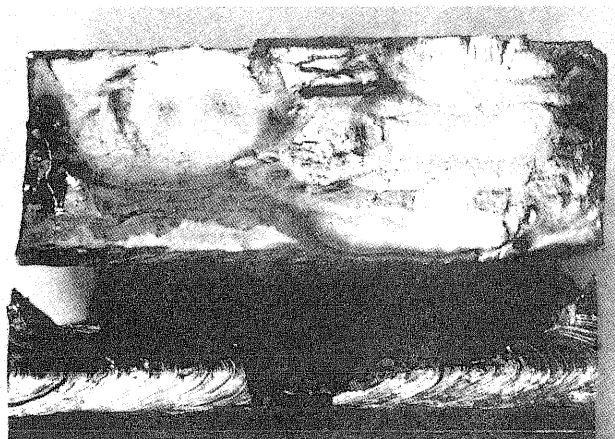
From examination of Table 3.3, it is evident that those specimens which initiated failure at internal defects exhibited shorter fatigue lives (and greater scatter in lives) than those in which failure initiated at the toe of the weld. Within the range of flaws included in this study, it was difficult to obtain a correlation between the size and type of defect identified by radiographic examination and the location of crack initiation. Indeed, eight of the thirteen specimens failing at internal defects were identified as "sound" weldments by radiography, whereas only three of the weldments in which internal flaws were detected actually initiated internal cracking. It is also noteworthy that, for the specimens tested at 0 to +50 ksi and 0 to +60 ksi, the longest fatigue lives were attained by those specimens that had failed the weld inspection requirements,^(8,9) but had, nonetheless, fatigue cracks that initiated at the toe of the weld.

ND-4 FRACTURE
Stress 0 to +80.0 ksi
Life 57,500

(b) Failure Initiated at Internal Defect

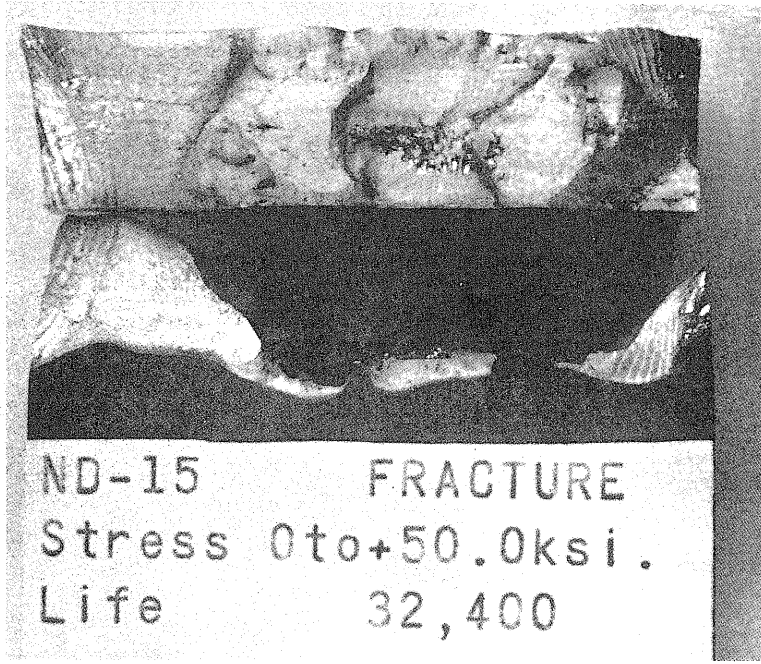
(a) Failure Initiated at Porosity

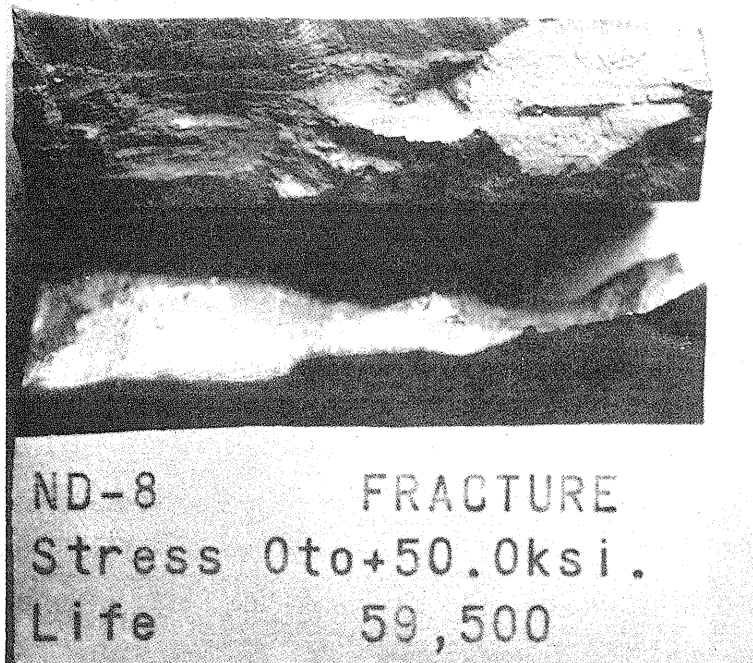
(b) Failure Initiated at Lack of Fusion

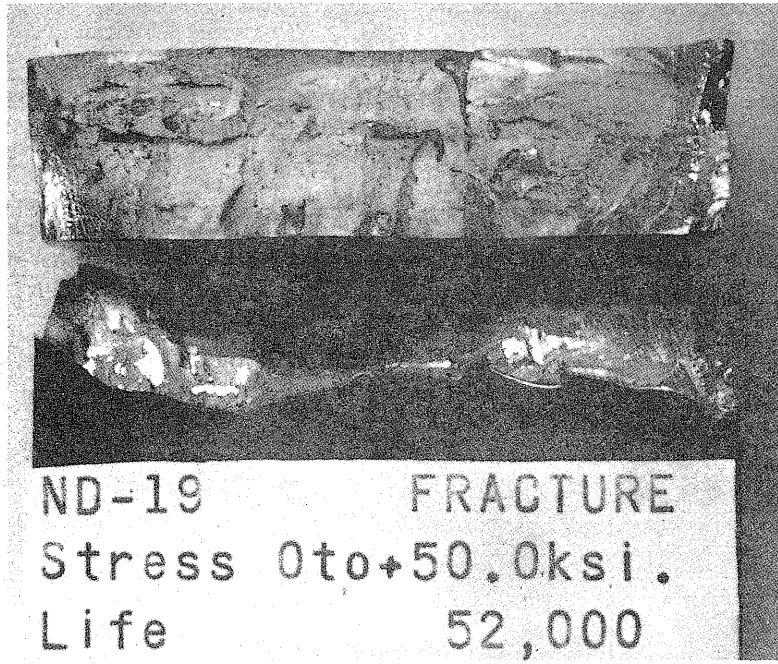
(c) Failure Initiated at Slag

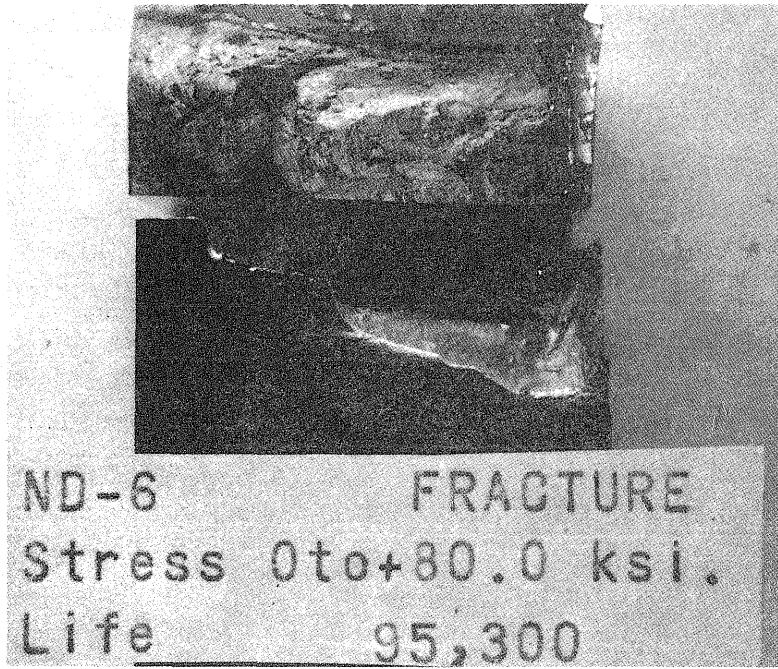
(d) Failure Initiated "In Weld Metal"

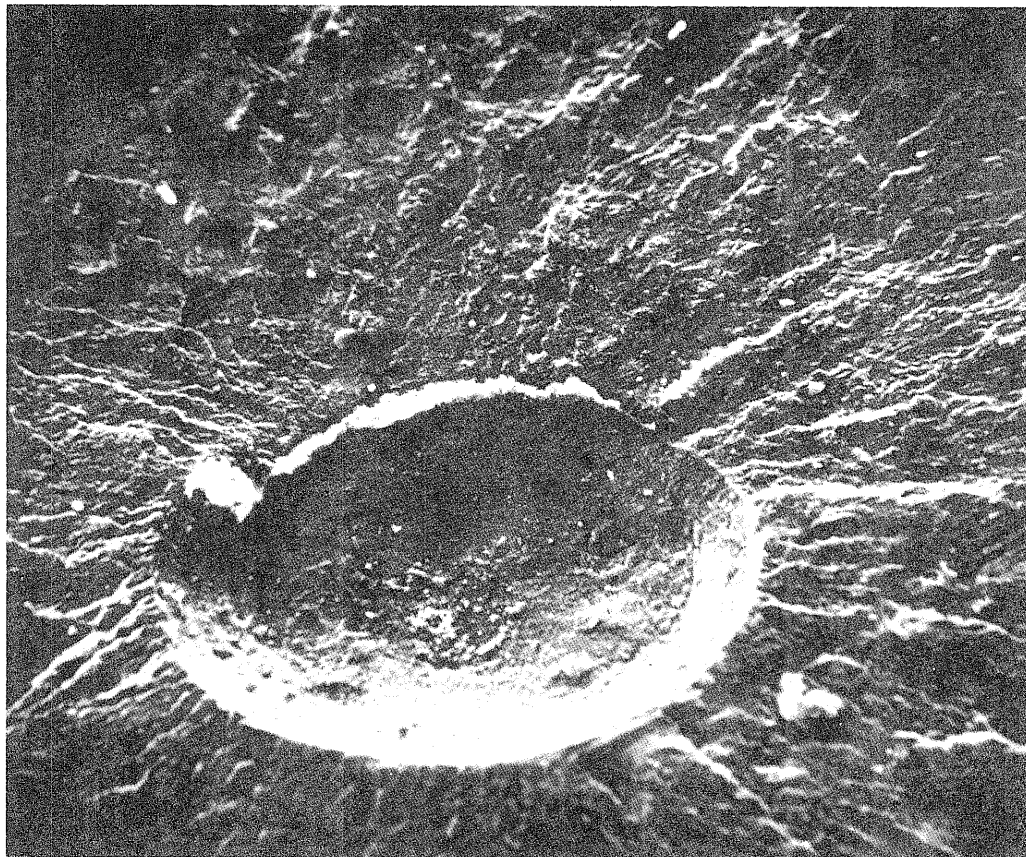
FIG. 3.15 SCANNING ELECTRON MICROSCOPE IMAGE OF PORE INITIATING FATIGUE CRACK IN SPECIMEN ND-30

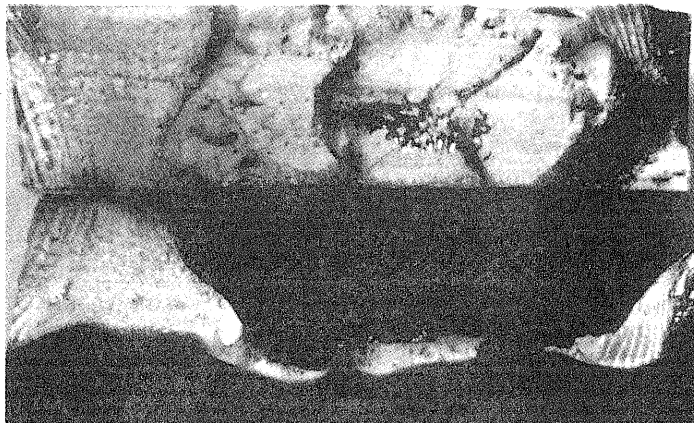
ND-15	FRACTURE
Stress 0 to +50.0ksi.	
Life	32,400

(e) Fracture Surface After Test
