Tailplane or main wing stall? LOC-I event due to suspected icing

Kåre Halvorsen, NSIA, Norway

Michael Bromfield, University of Birmingham, UK

Nadjim Horri, Coventry University, UK

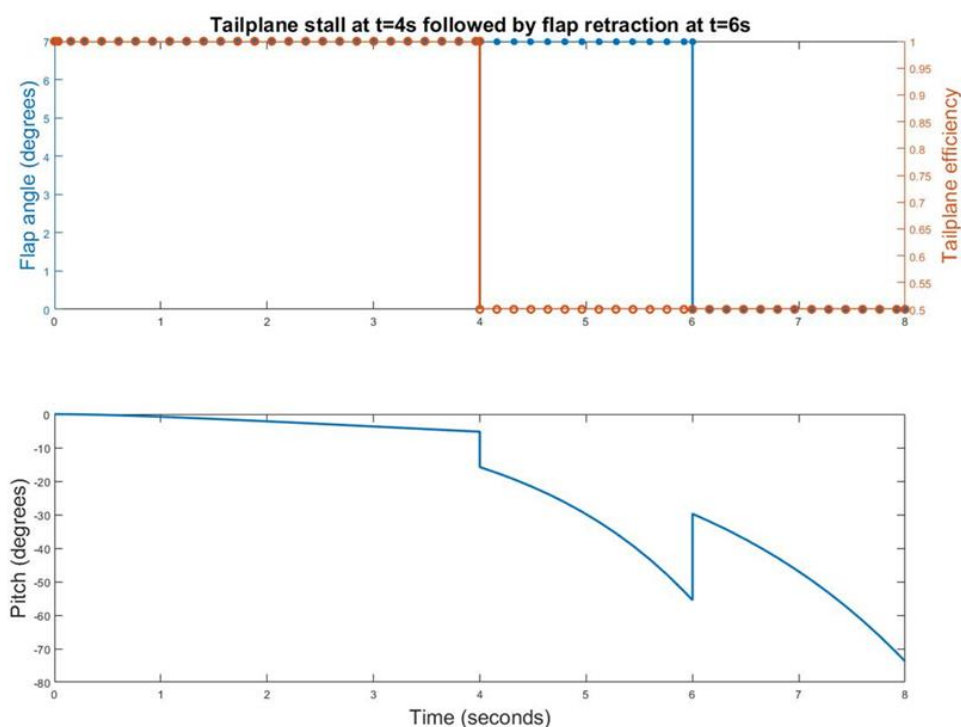
Figure 11, Tailplane Stall Followed by Flap Retraction

The results of a flap retraction following a simulated tailplane stall (Figure 11) were analysed with the tailplane efficiency of 100% and the flap deflection of 7 degrees. At $t=4$ seconds, a tailplane stall was modelled by a step reduction of 50% to horizontal tailplane efficiency, which destabilises the system response. The aircraft pitches down (-30 degrees) within 2 seconds. At $t=6$ seconds, the retraction of flaps from 7 degrees to 0 degrees initially helps, but not sufficiently to stabilise the response with 50% tailplane efficiency. The effect of tailplane efficiency on the initial response to a 1 second elevator impulse (Figure 13) shows that at 100% horizontal tailplane efficiency, a large 20deg elevator down during 1 second is needed to initiate a large magnitude but stable phugoid response, which is shown during the first 20 seconds for comparison purposes. At 50% efficiency, a 1 second 2-degree elevator down input destabilises the system with oscillations and at 20% efficiency, 1-degree elevator down is sufficient to produce very fast divergence without oscillations. Load factor changes with 1 second elevator down commands for varying horizontal tailplane efficiencies were also presented (Figure 11). With 100% efficiency, load factor remains very close to 1 with a small elevator command, as expected. With 50% tailplane efficiency, load factor is reduced but changes are small. Major changes to load factor are however obtained with 20% tailplane efficiency and negative G is quickly reached in this case. This is believed to be closer to the conditions experienced during the incident (1).
