The Maule (Chile) Earthquake of February 27, 2010

Consequence Assessment and Case Studies

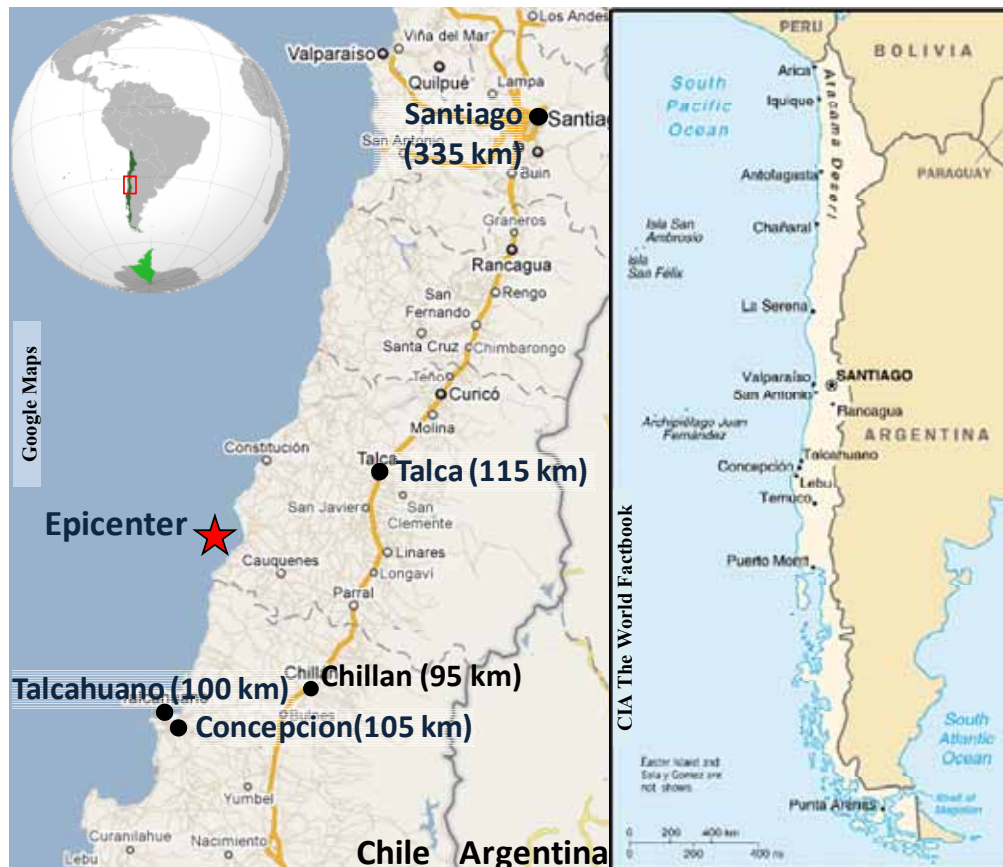
Figure 1.1 Left: epicenter of the February 27, 2010 Maule, Chile earthquake and closest major cities; Right: geographical location and bordering countries of Chile (note: epicentral distances mean very little in the case of great earthquakes of fault rupture regions of thousands of square kilometers)

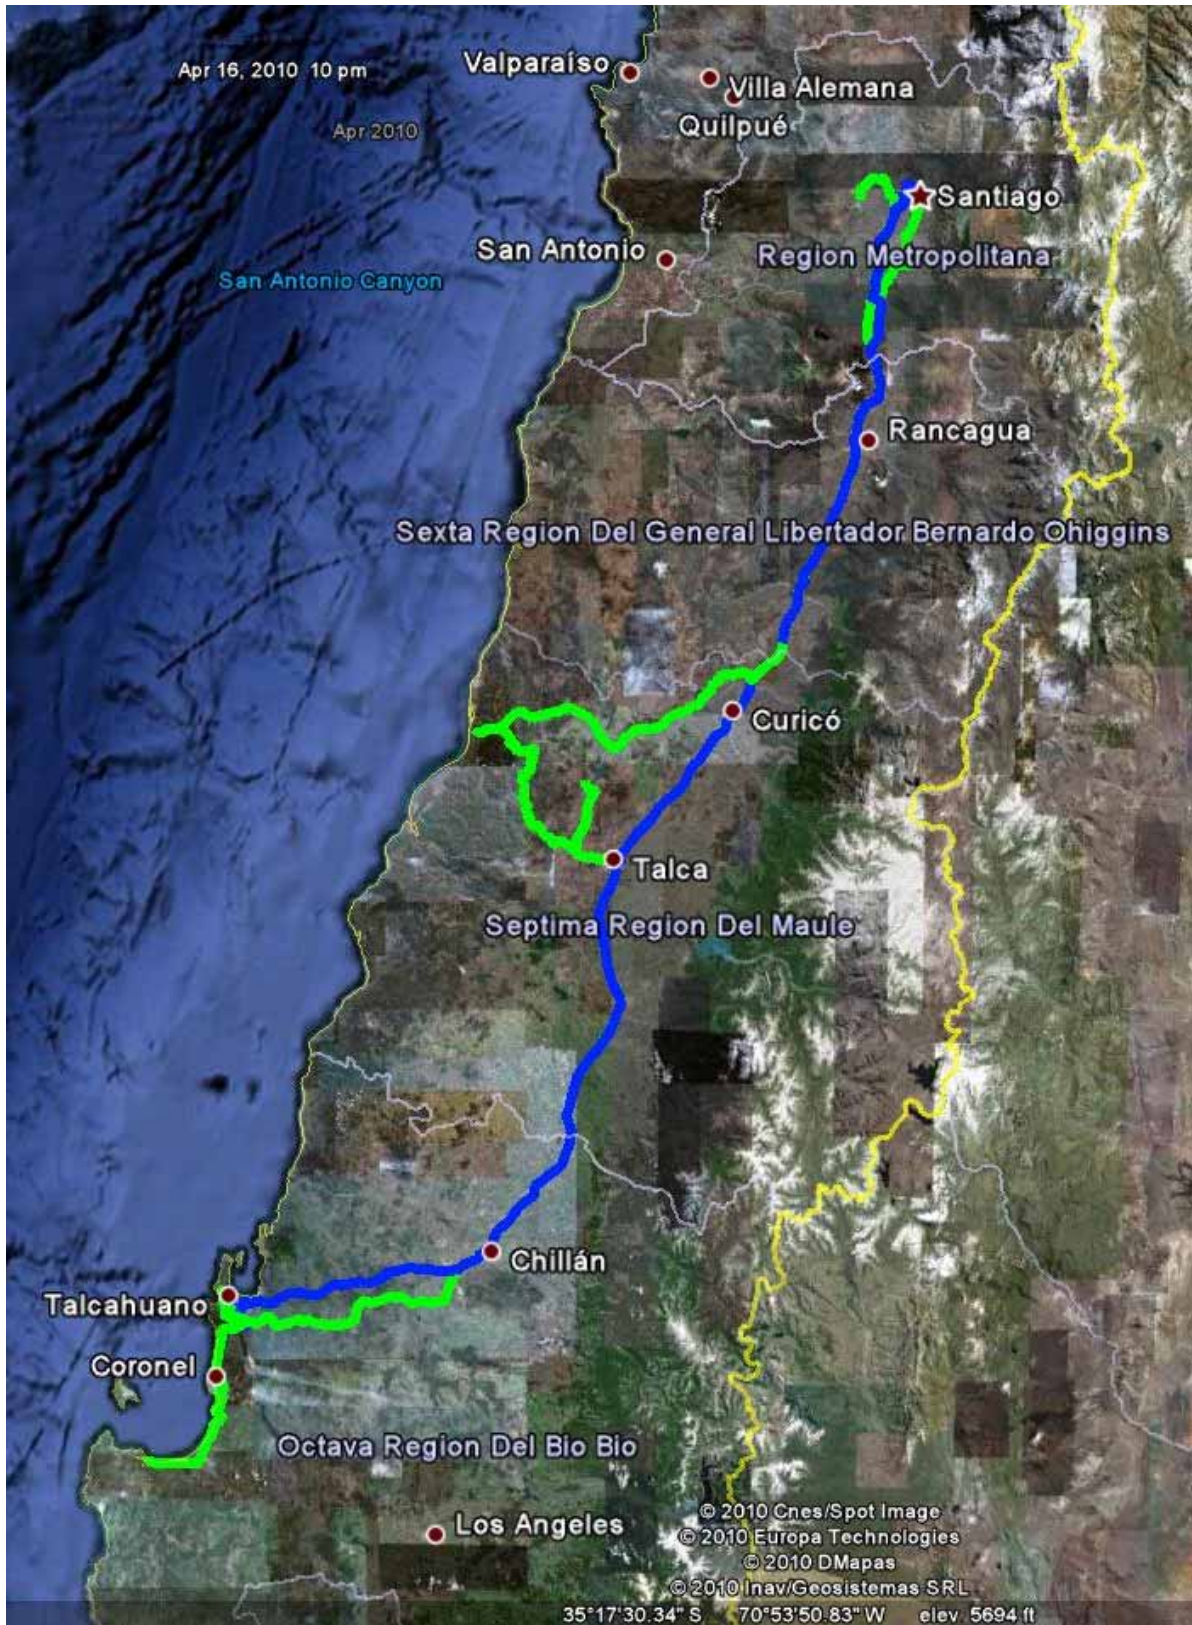
Figure 1.2 GPS travel log for the entire field mission (blue line: structures group, green line: geotechnical group)

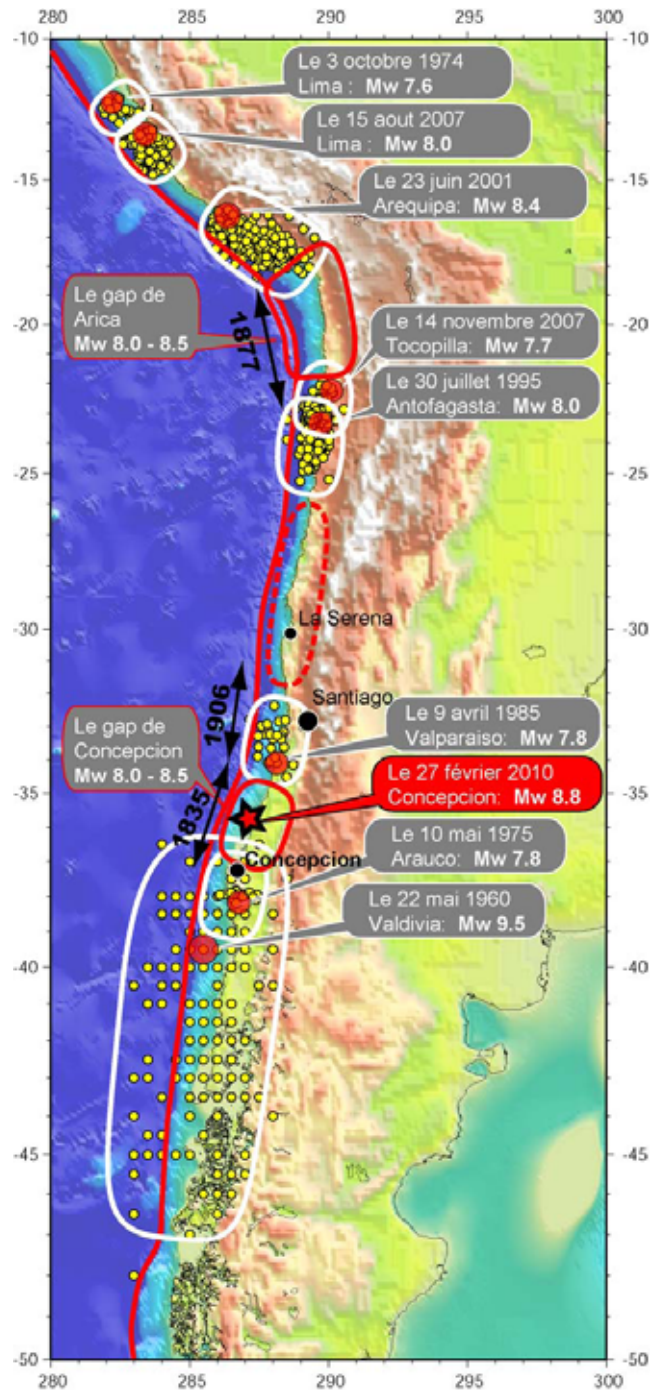
Figure 2.3 Recent major earthquakes in Chile and seismic gaps (Laboratoire de Géologie, Ecole Normale Supérieure (ENS), CNRS, Paris, France, <http://www.geologie.ens.fr/~vigny/chili-f.html>)

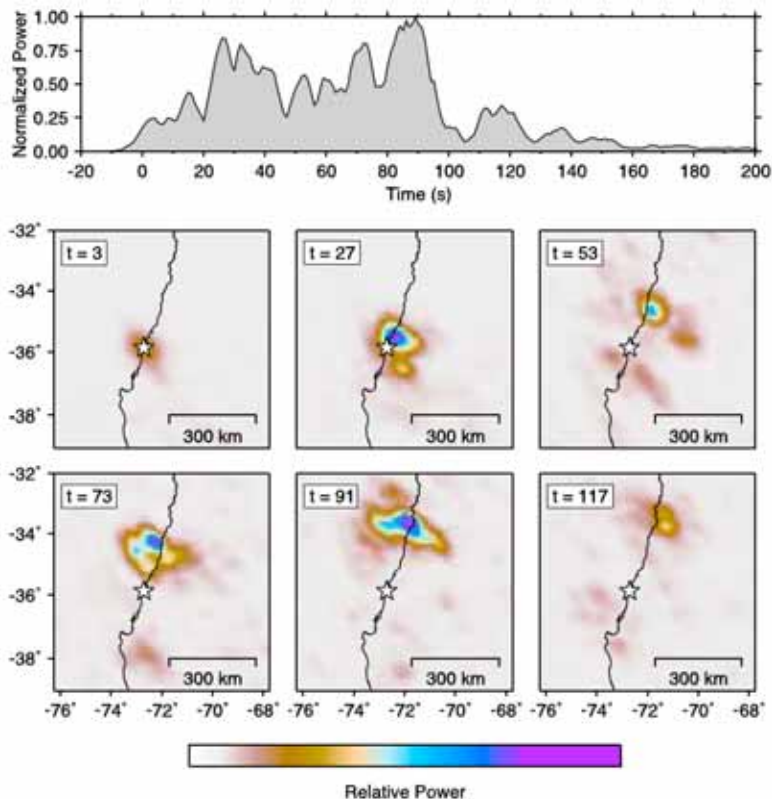
Figure 2.4 Frames from the simulation of the fault rupture (Lay et al., 2010)

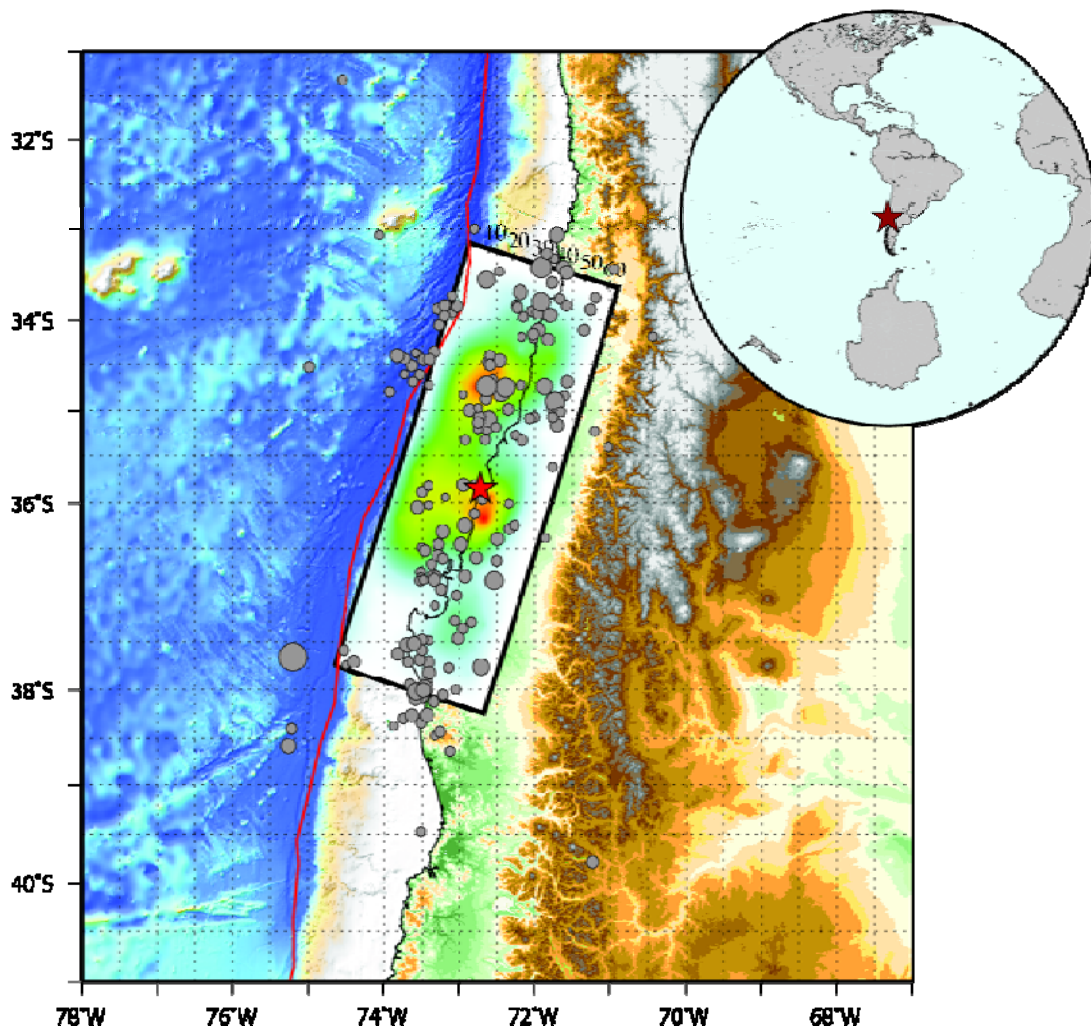
Figure 2.5 Fault zone and surface prediction of the slip distribution, NEIC, USGS (http://earthquake.usgs.gov/earthquakes/eqinthenews/2010/us2010tfan/finite_fault.php)

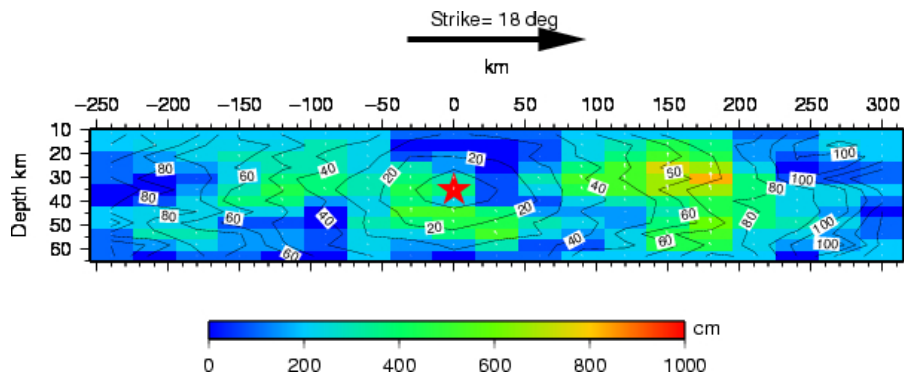
Figure 2.7 Slip distribution on fault cross-section according, California Institute of Technology (http://www.tectonics.caltech.edu/slip_history/2010_chile/)

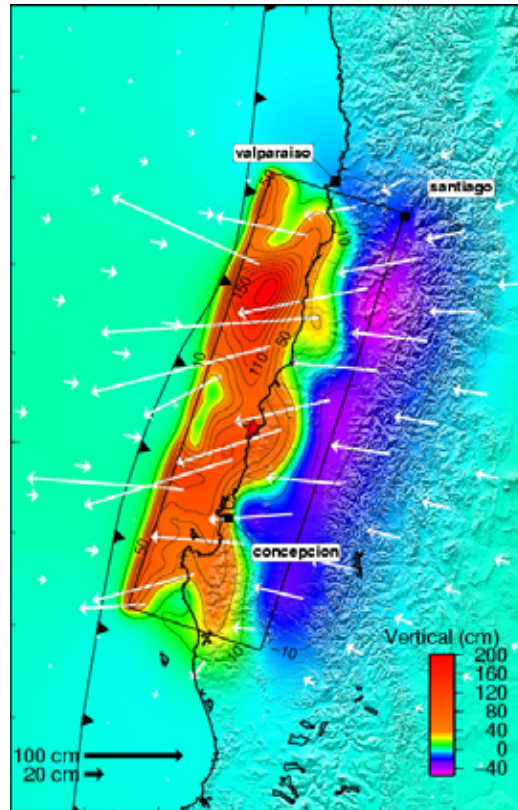
Figure 2.8 Predicted surface deformation. The vertical component is shown with color scale and the horizontal component is indicated with arrows (http://www.tectonics.caltech.edu/slip_history/2010_chile/)

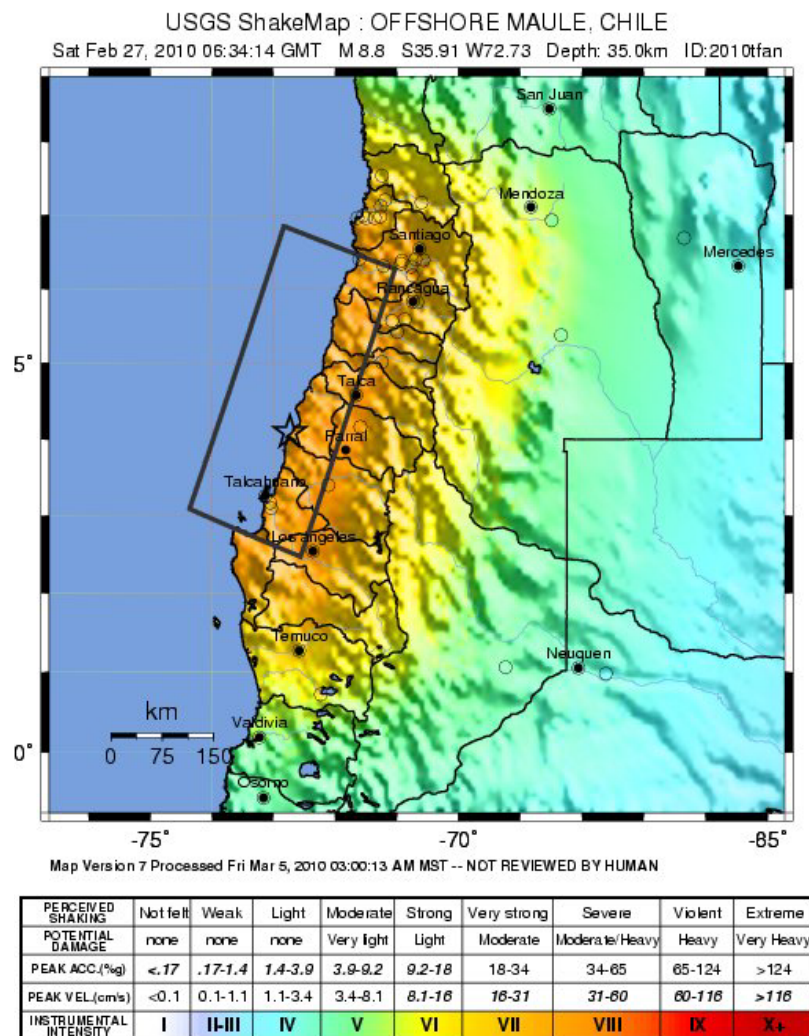
Figure 2.9 Instrumental intensity map for the main shock (<http://earthquake.usgs.gov/earthquakes/shakemap/global/shake/2010tfan/>)

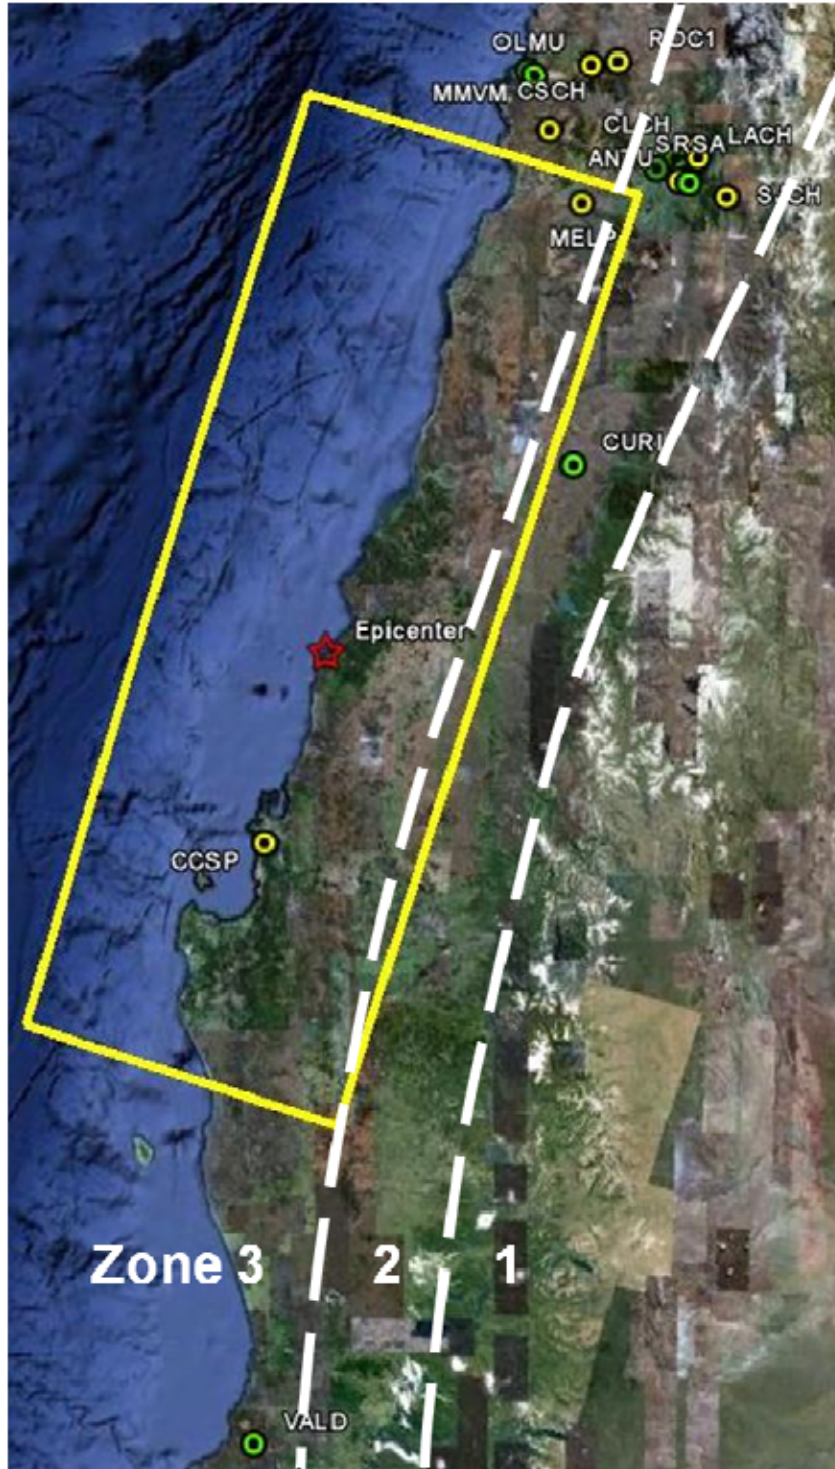
Figure 2.13 Rupture zone, seismic zone from the Chilean seismic code and locations of stations; green circle – RENADIC, yellow circle – Seismological Service

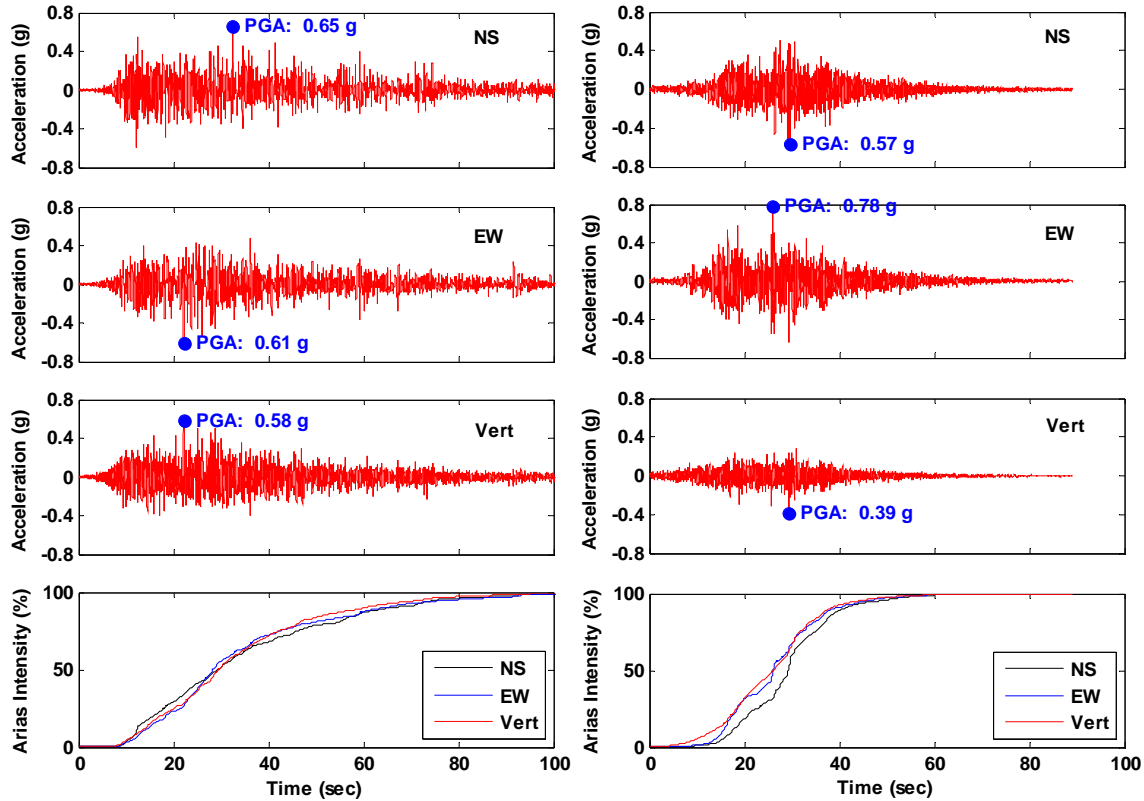
Figure 2.14 Accelerations and Arias Intensity, *Left*: station CCSP; *Right*: station MELP

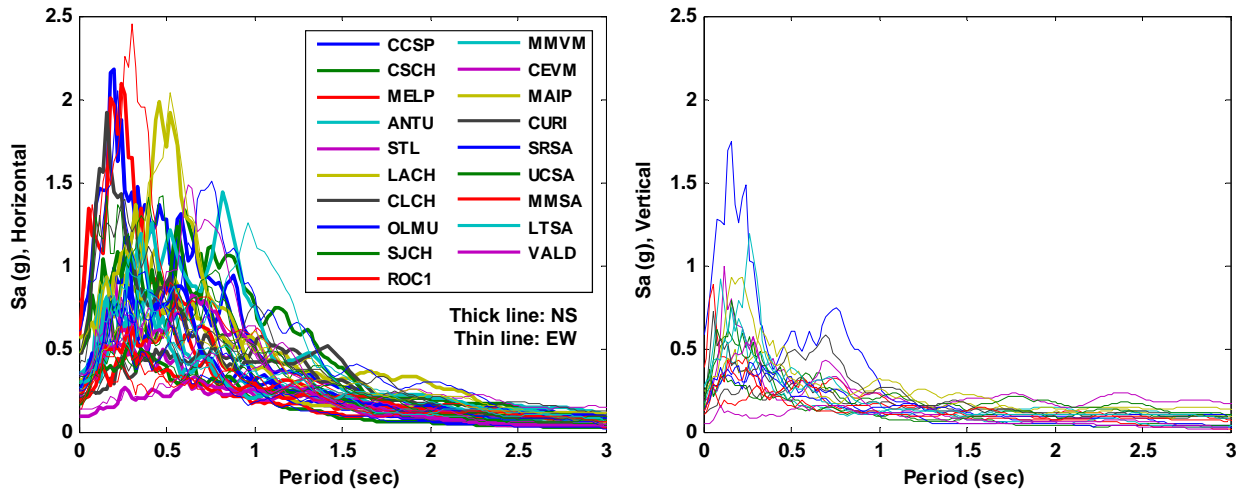
Figure 2.15 *Left: horizontal spectra; Right: vertical spectra*

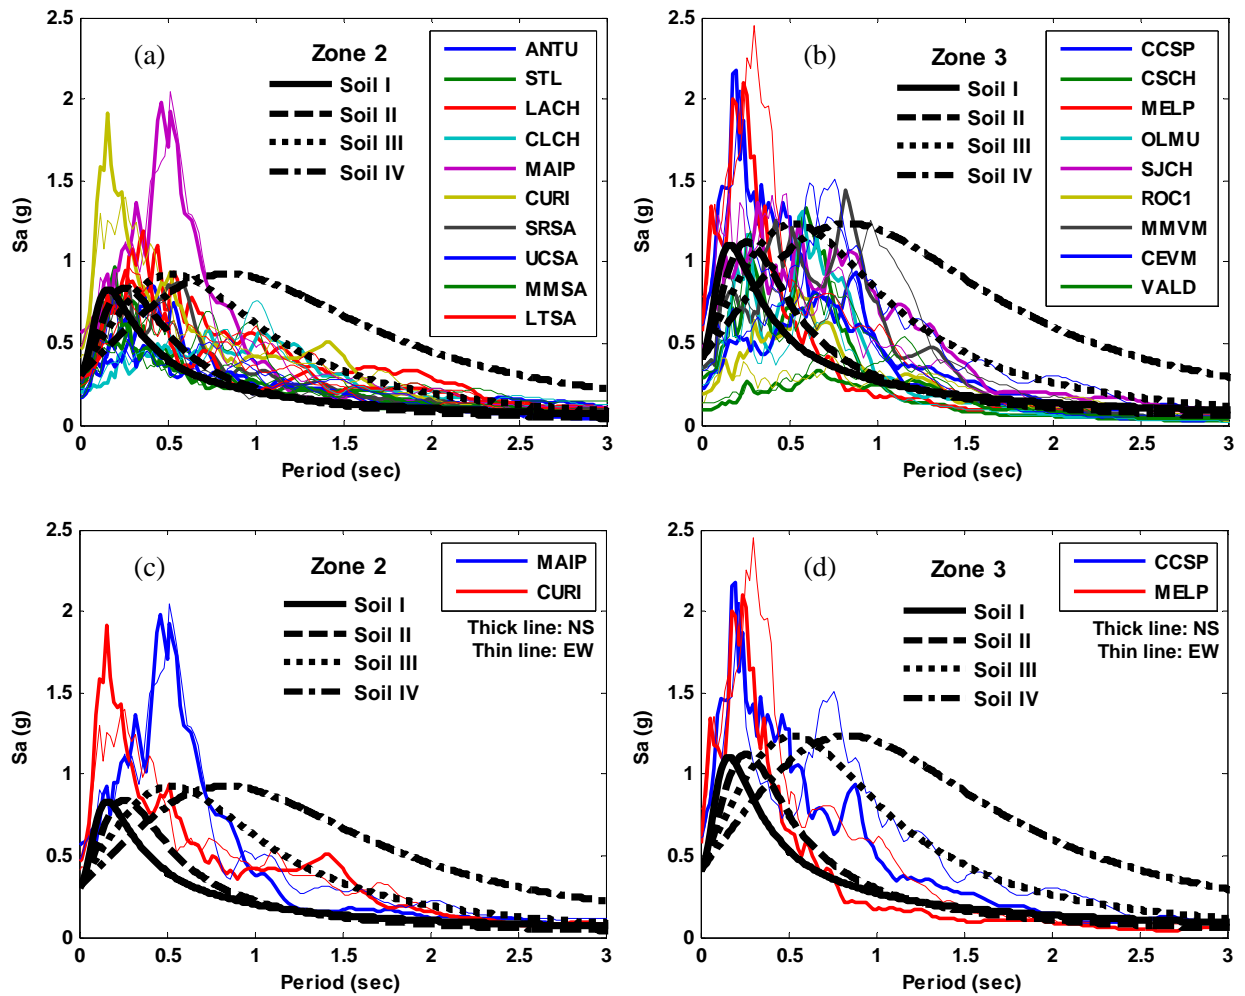
Figure 2.16 Comparison of measured spectra (5 percent damping) with design spectra from the Chilean seismic code

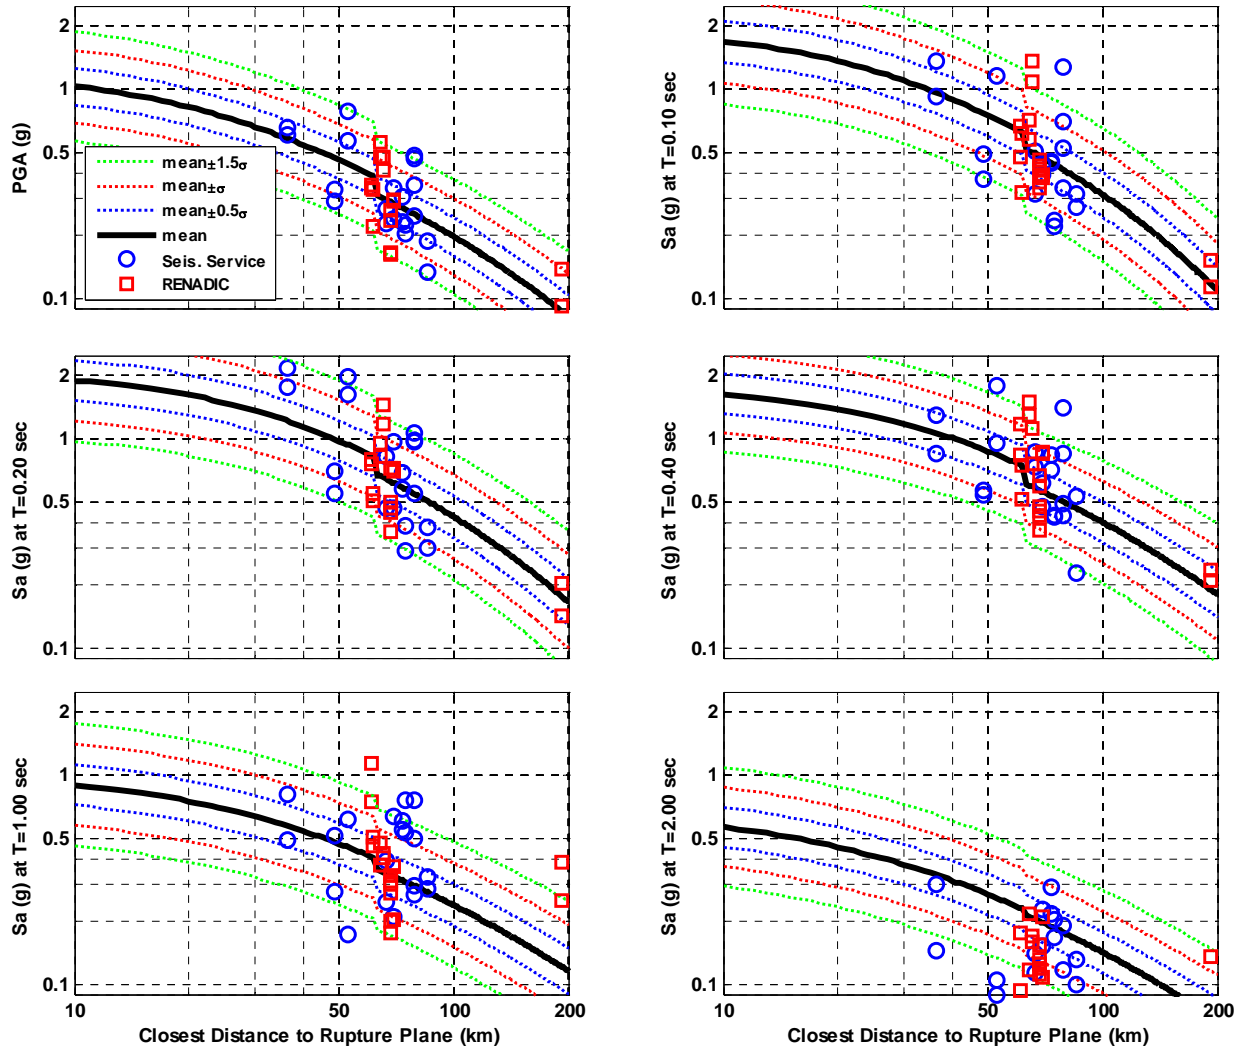
Figure 2.20 Combined attenuation relationship for rock site for PGA and spectral acceleration at different periods

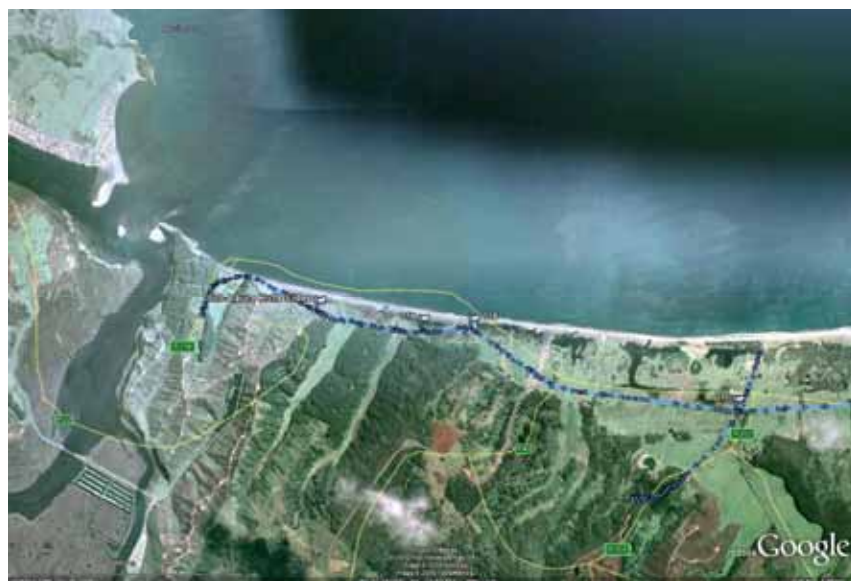
Figure 3.1 Arauco landslides/coastal bluff features view 1, (-37.246292°,-73.324251°) to (-37.242213°,-73.421207°)

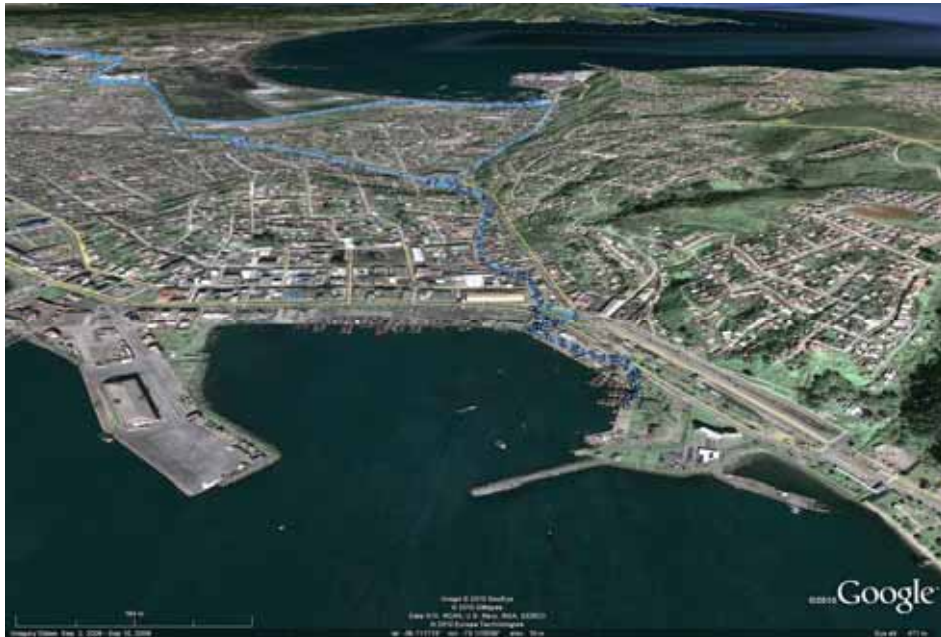
Figure 3.5 Port of Talcahuano, aerial view (-36.71109°, -73.113898°)

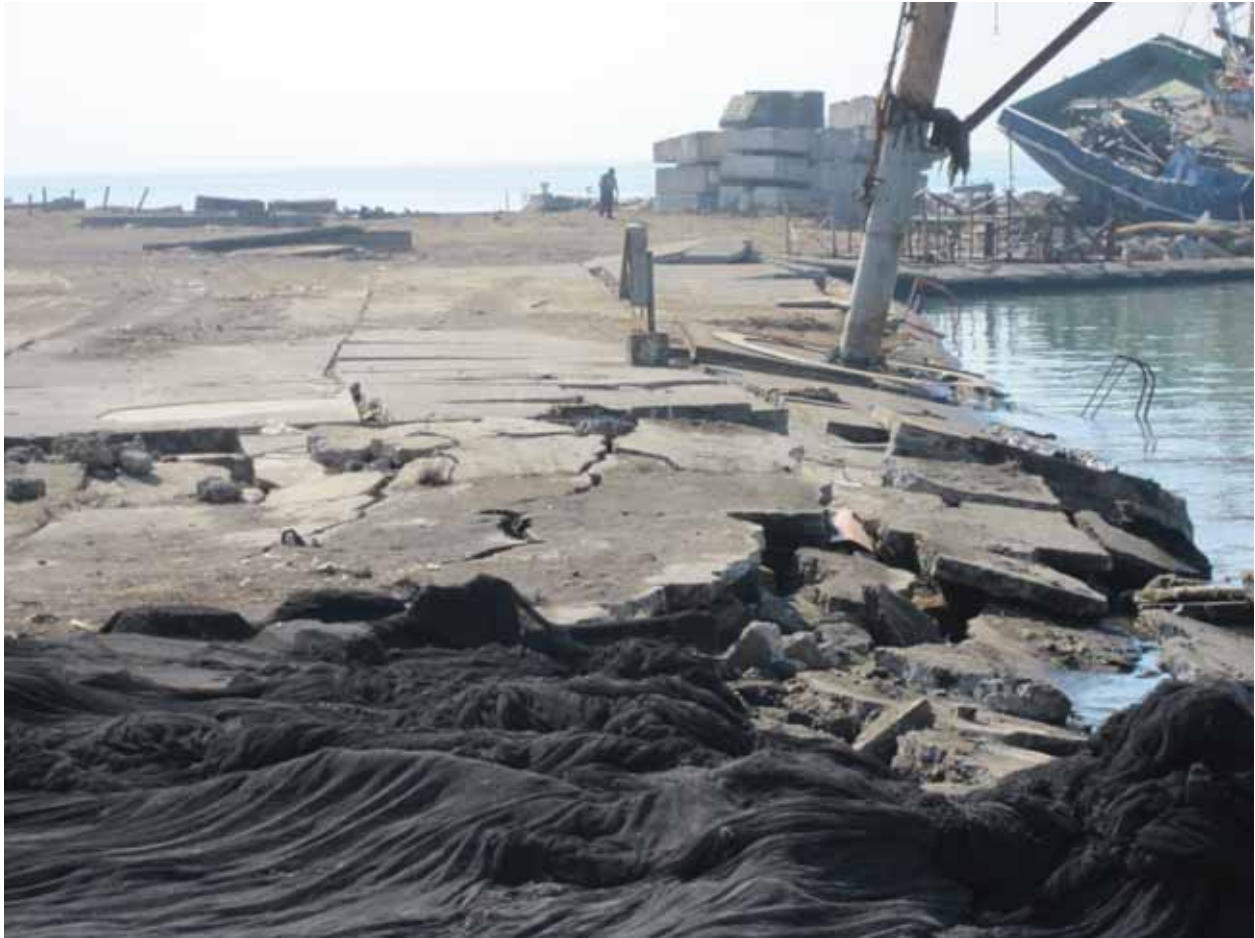
Figure 3.7 Damaged sea wall and dock, Port of Talcahuano, April 15, 2010
(-36.71109°, -73.113898°)

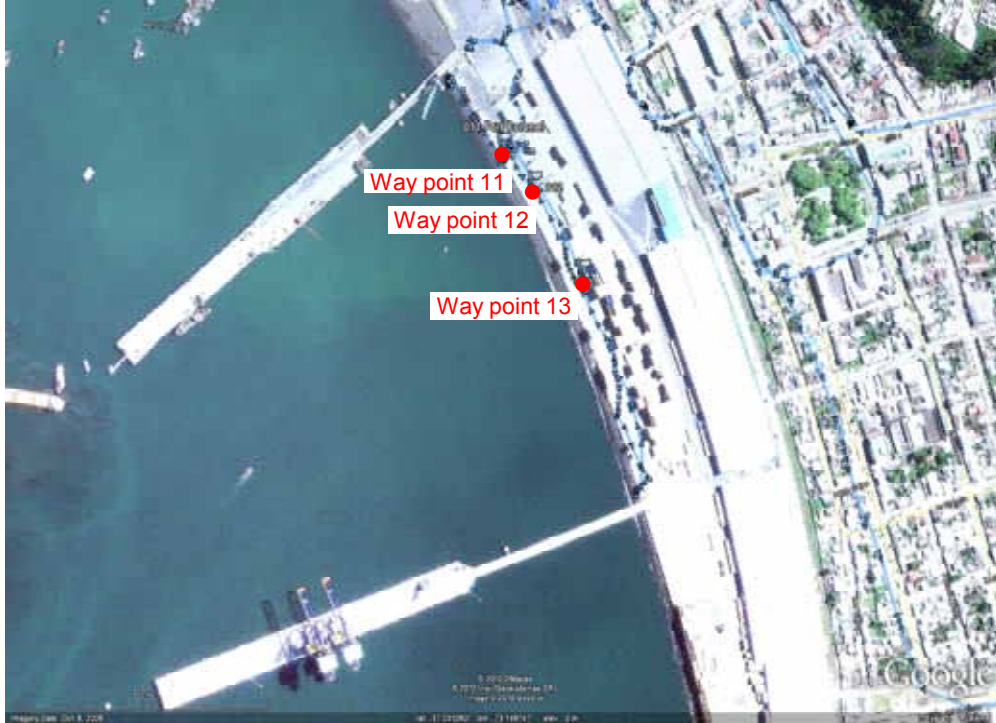
Figure 3.8 Port of Coronel, area marked by GPS tracks along the coast experienced lateral spreading (-37.028874° , -73.149768°)

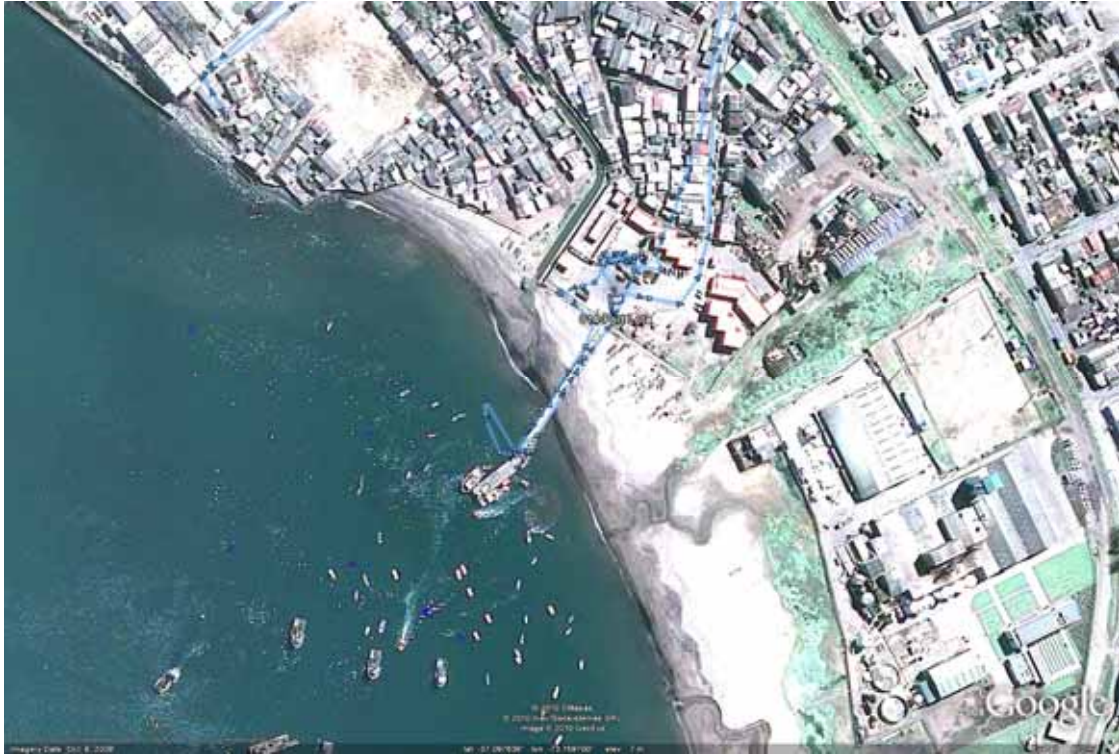
Figure 3.14 Port Lota (-37.097295°,-73.159331°)

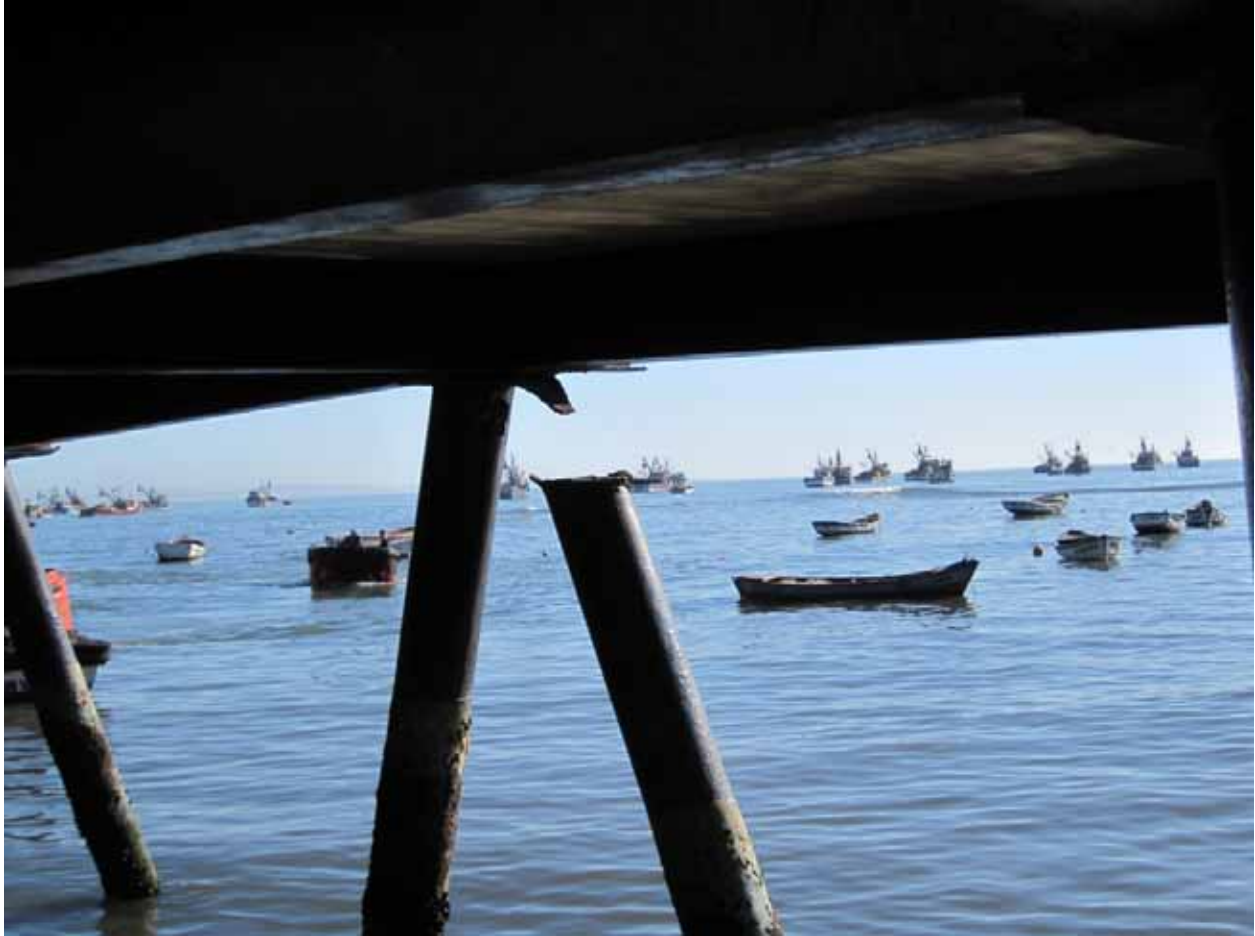
Figure 3.16 Typical broken pile connections, Port Lota, April 14, 2010
(-37.097295°,-73.159331°)

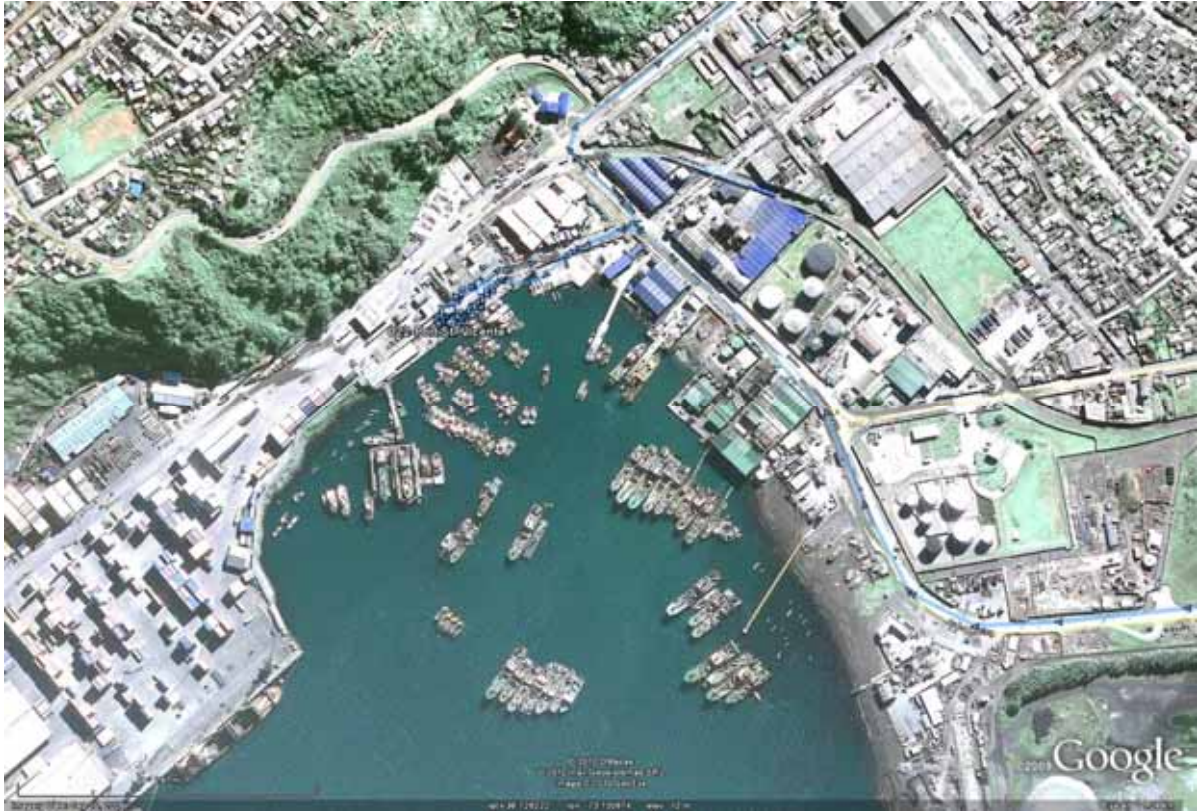
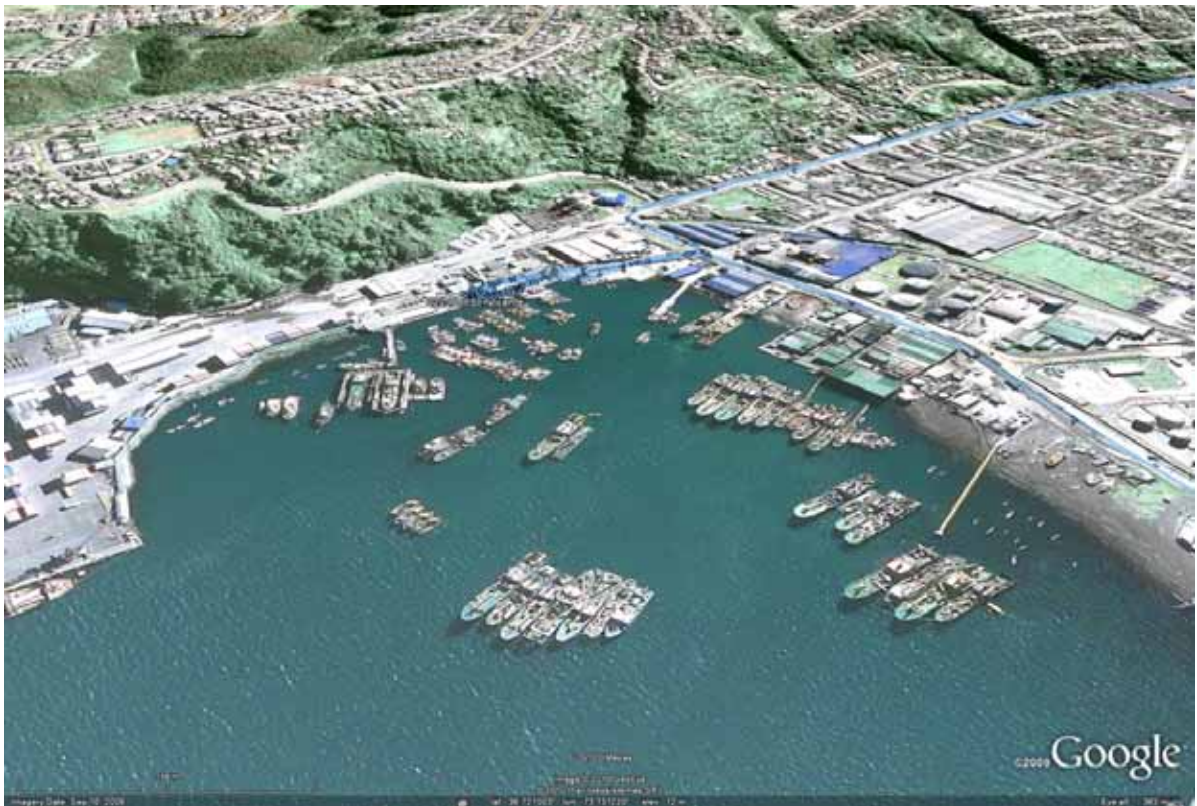
Figure 3.17 Port St. Vicente, observation along fishing wharf

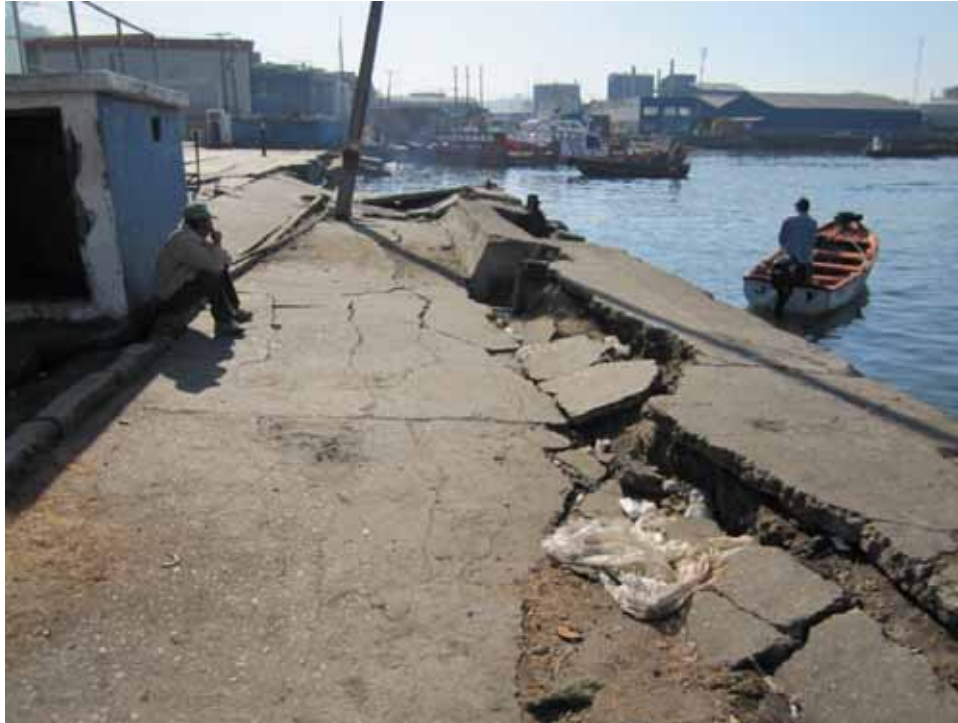
Figure 3.18 Lateral spreading and damage to quay wall, blue fish processing plants in the background damaged by lateral spreading, Port St. Vicente, April 15, 2010 (-36.725517°, -73.132390°)

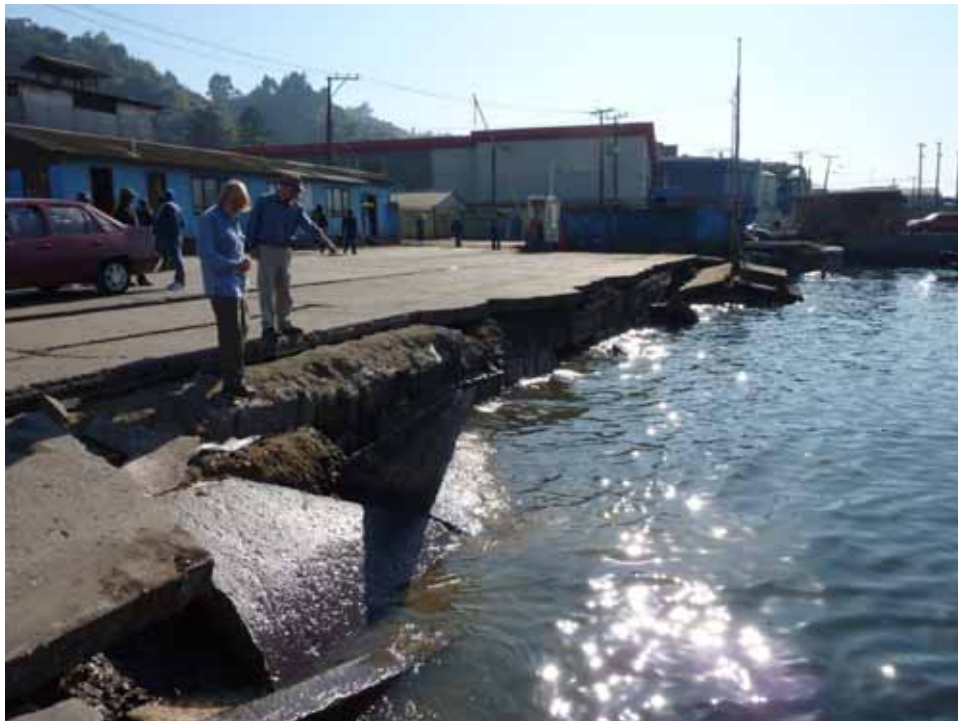
Figure 3.19 Failed section of the quay wall, Port St. Vicente, April 15, 2010 (-36.725517°, -73.132390°)

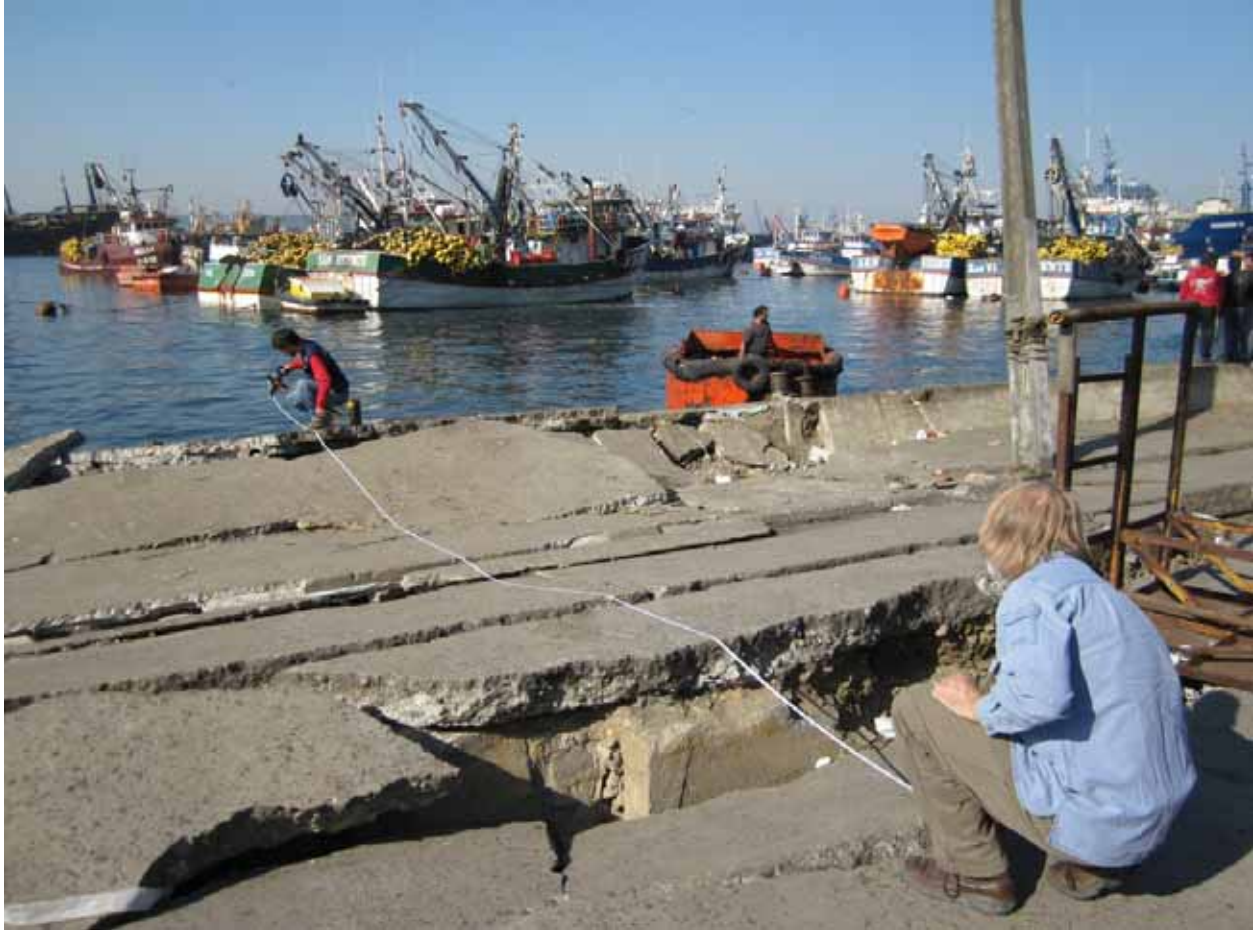
Figure 3.20 Measurement of displacement of the wall due to lateral spreading, Port St. Vicente, April 15, 2010 (-36.725517°, -73.132390°)

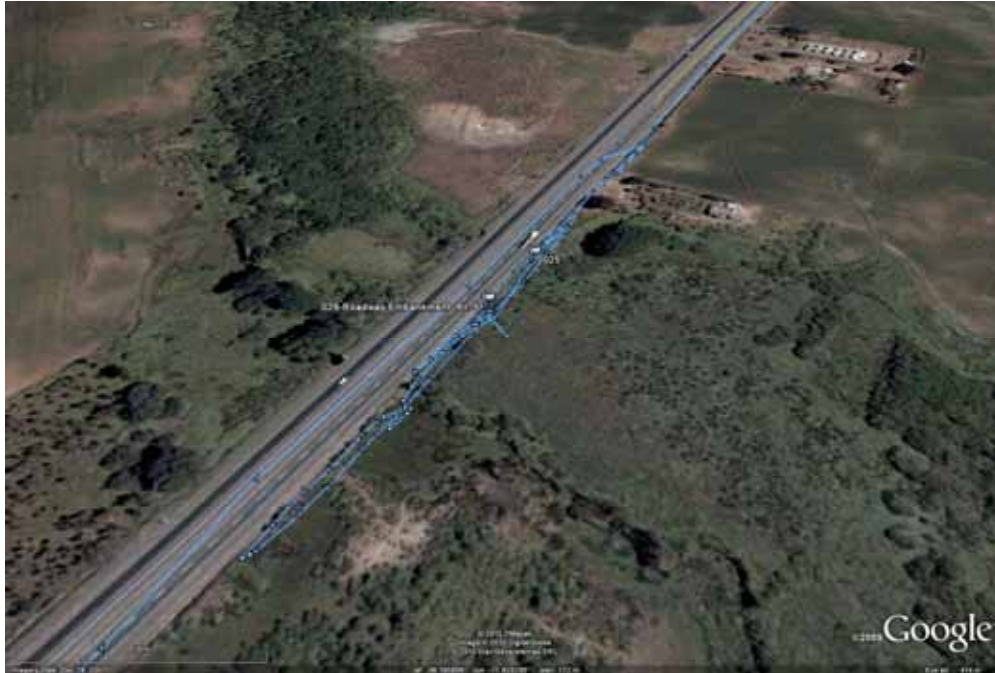
Figure 3.21 Roadway embankment ~5km south of Parral, north is up, Route 5 South (-36.185671°,-71.825415°)
