The Maule (Chile) Earthquake of February 27, 2010

Consequence Assessment and Case Studies

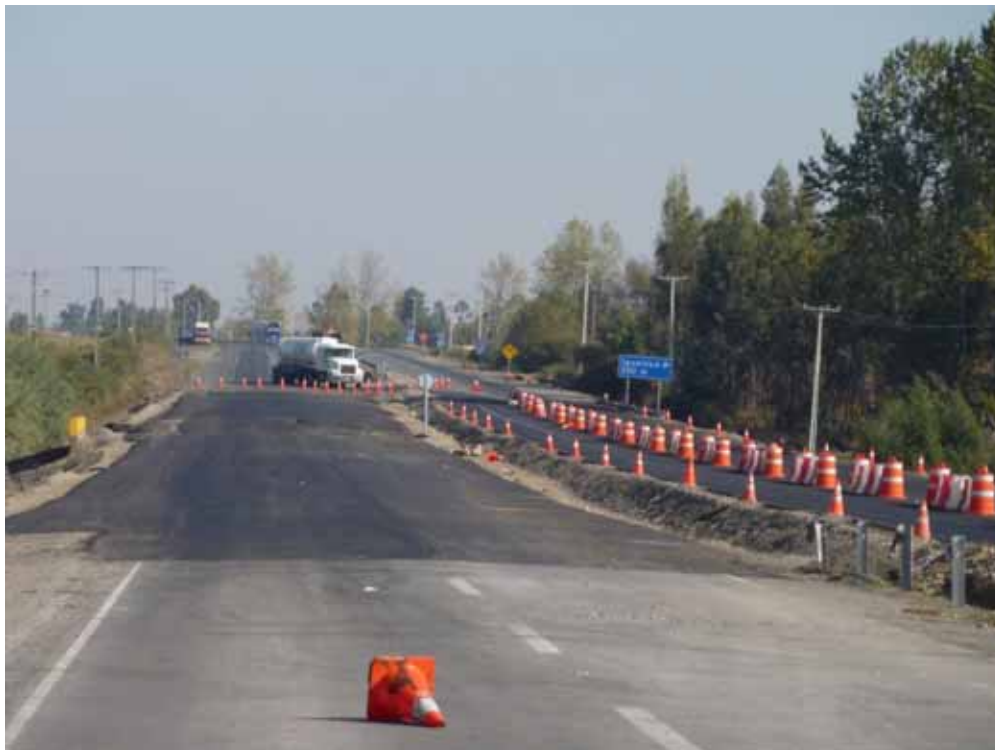
Figure 3.22 Northbound lane looking south, Repaired Roadway Embankment ~5km south of Parral, Route 5 South, April 15, 2010 (-36.185671°, -71.825415°)

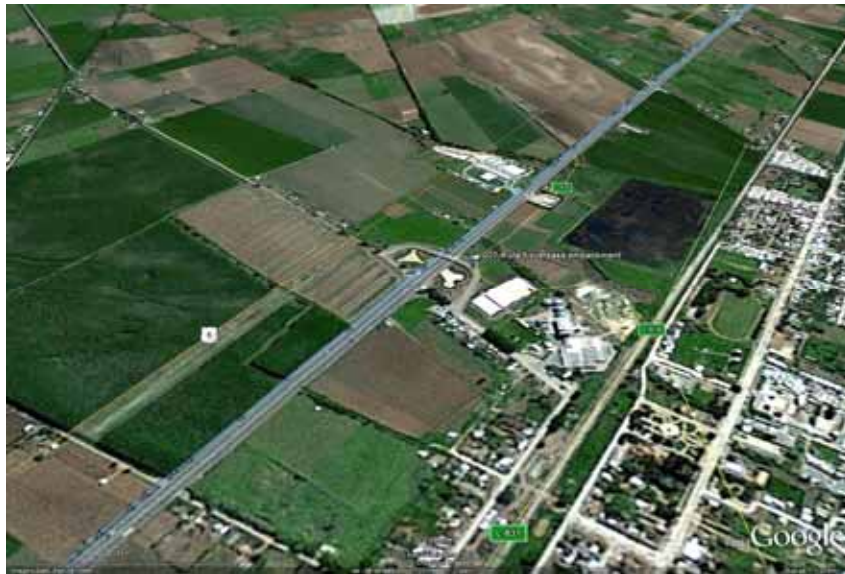
Figure 3.23 Route 5 South overpass embankment, looking north, to Retiro at Tucapel Mill (-36.051209°,-71.768005°)

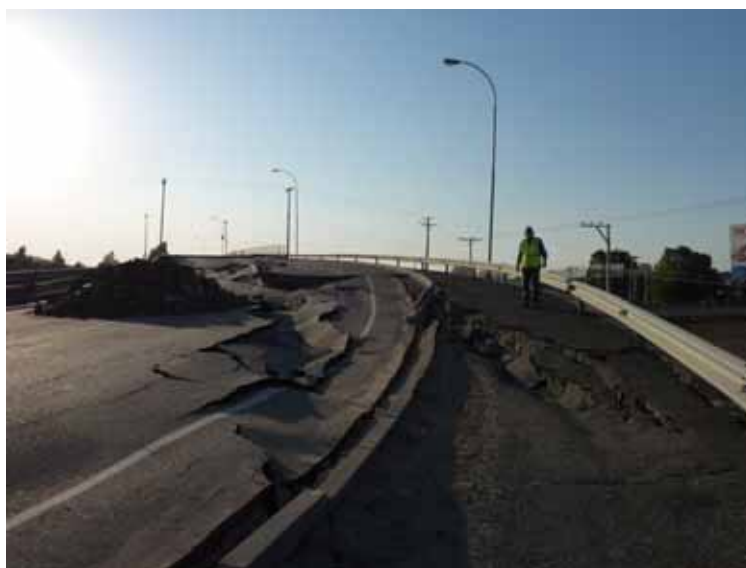
Figure 3.24 Damage to overpass embankment, Route 5 South overpass embankment, to Retiro at Tucapel Mill, April 15, 2010 (-36.051209°,-71.768005°)

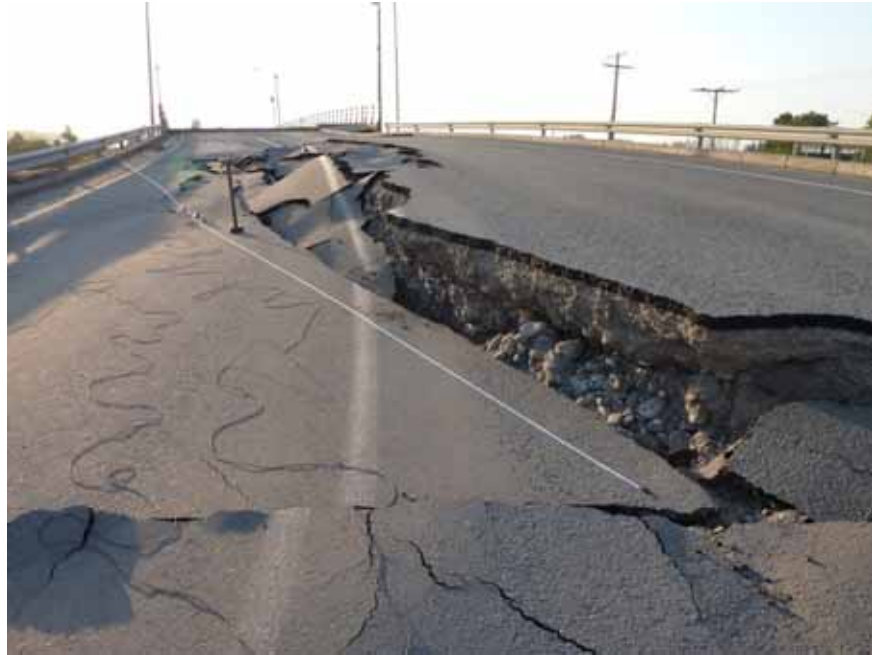
Figure 3.25 Route 5 South overpass embankment, to Retiro at Tucapel Mill, April 15, 2010 (-36.051209°,-71.768005°)

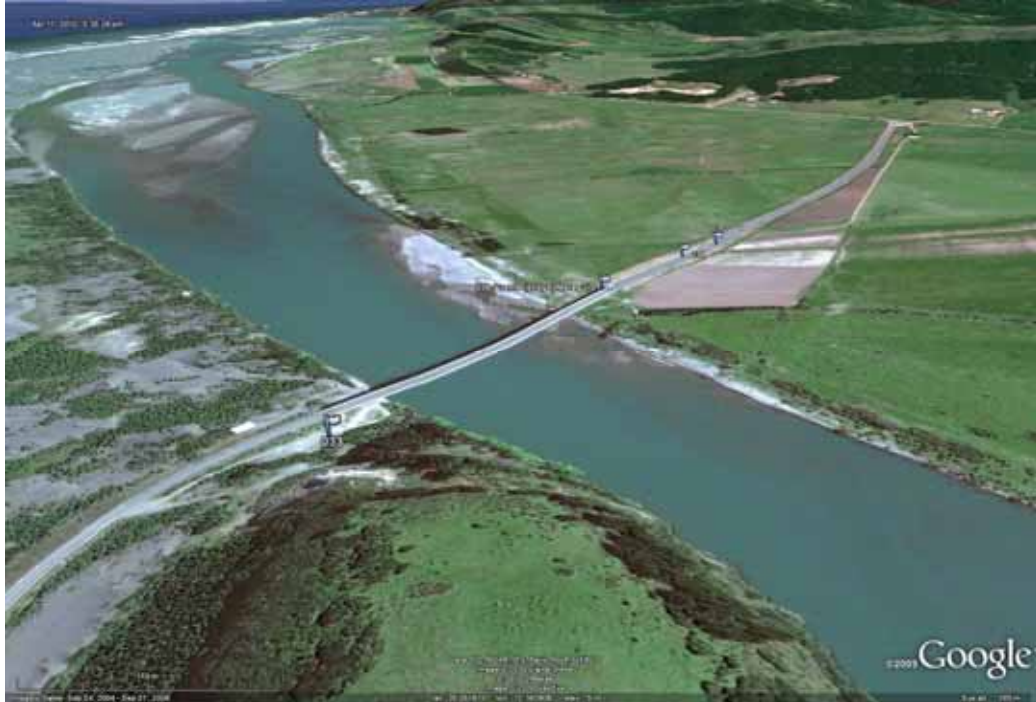
Figure 3.26 Puente Mataquito, looking north, April 16, 2010
(-35.050712°,-72.162258°)

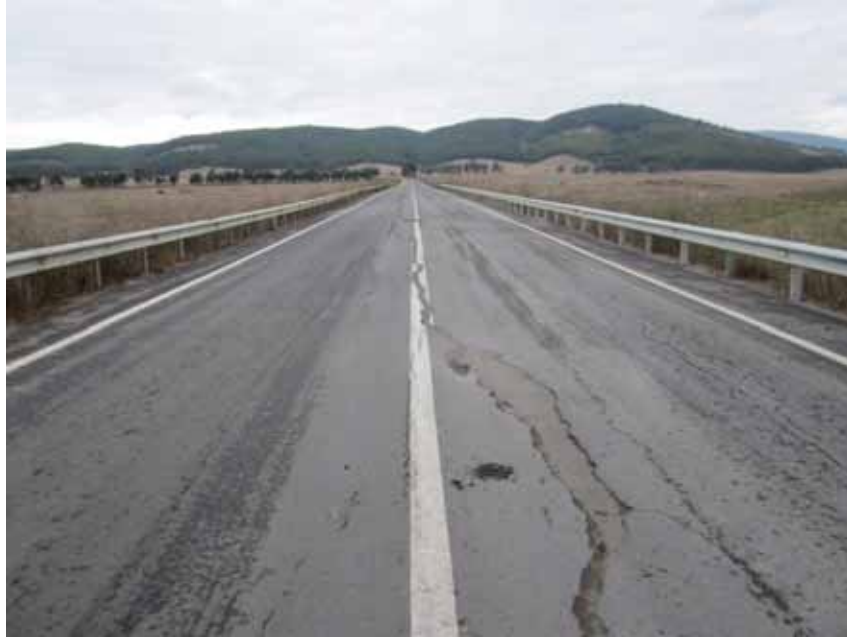
Figure 3.30 Cracking and transverse movement (60 cm on each side) of embankment due to liquefaction of underlying soil, north abutment of the bridge, Puente Mataquito, April 16, 2010 (-35.050712°,-72.162258°)

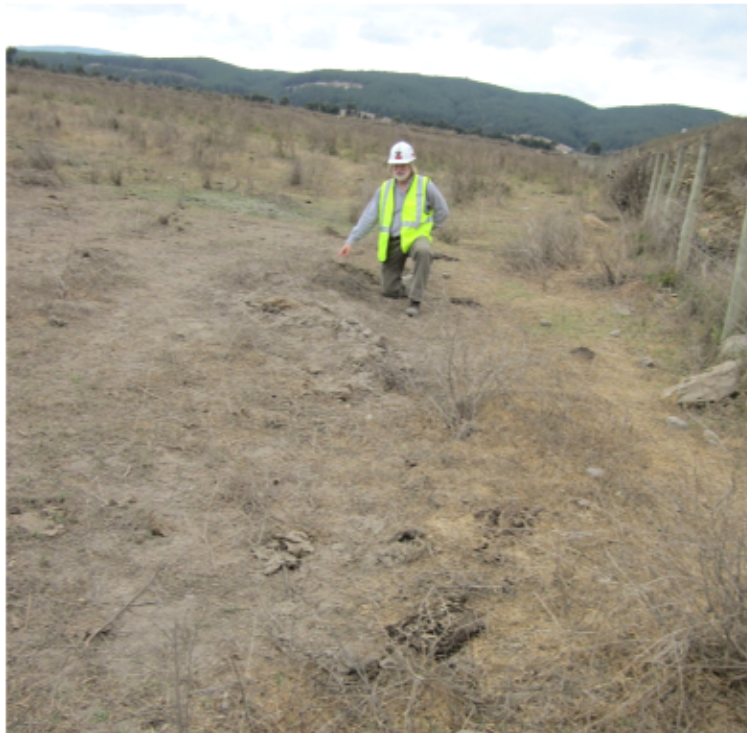
Figure 3.31 Compression ridges at toe of embankment, due to liquefaction of underlying soil and settlement of embankment, north abutment of the bridge, Puente Mataquito, April 16, 2010 (-35.050712°,-72.162258°)

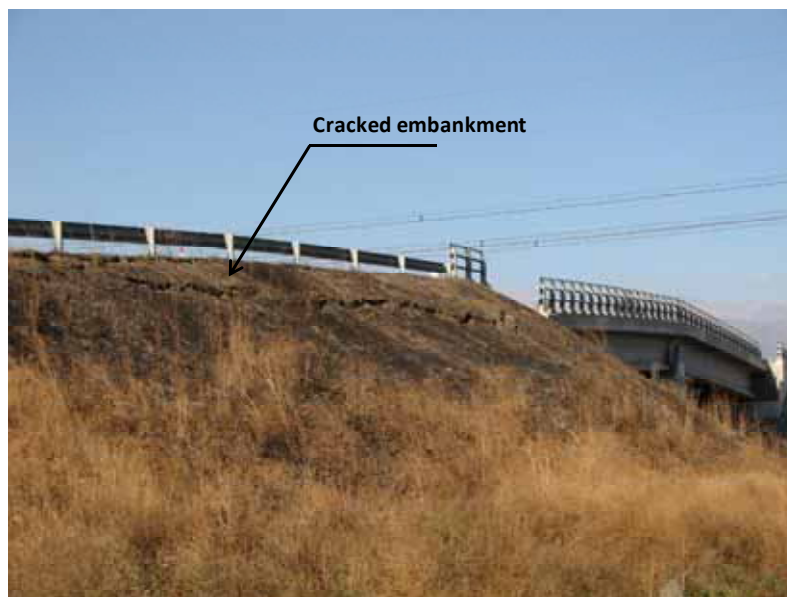
Figure 3.35 Surface cracks at the embankment of Las Mercedes Bridge

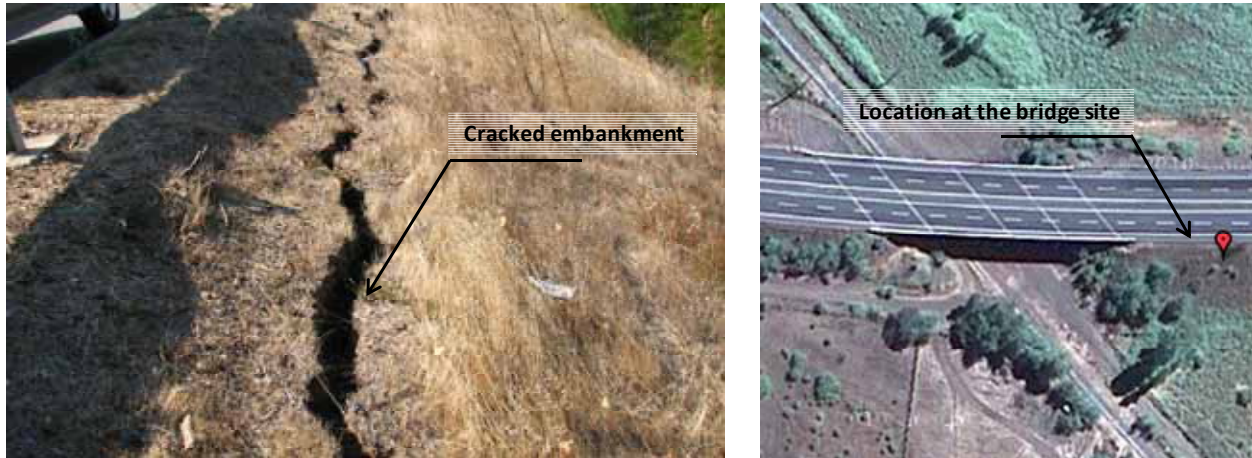
Figure 3.36 Cracks at the embankment of Perquilauquén Bridge

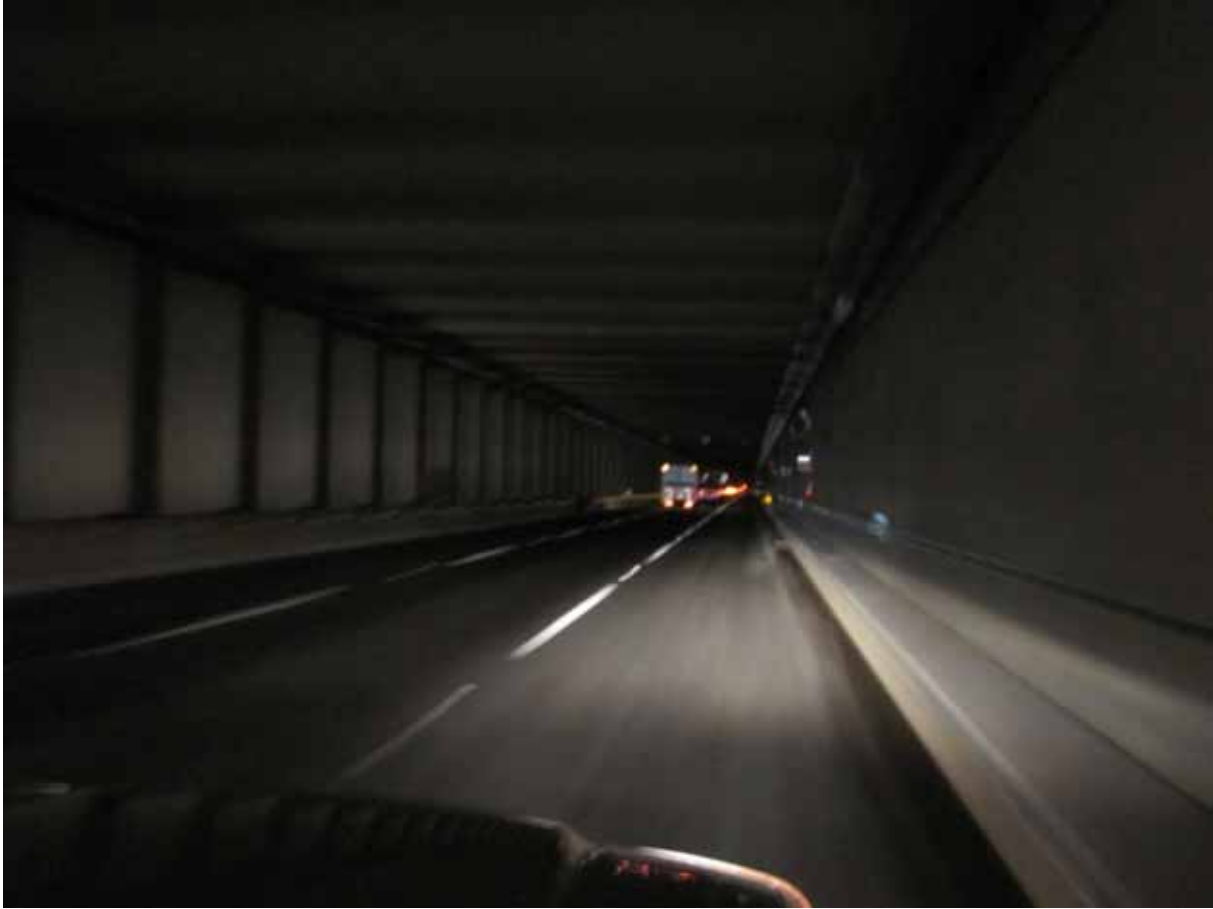
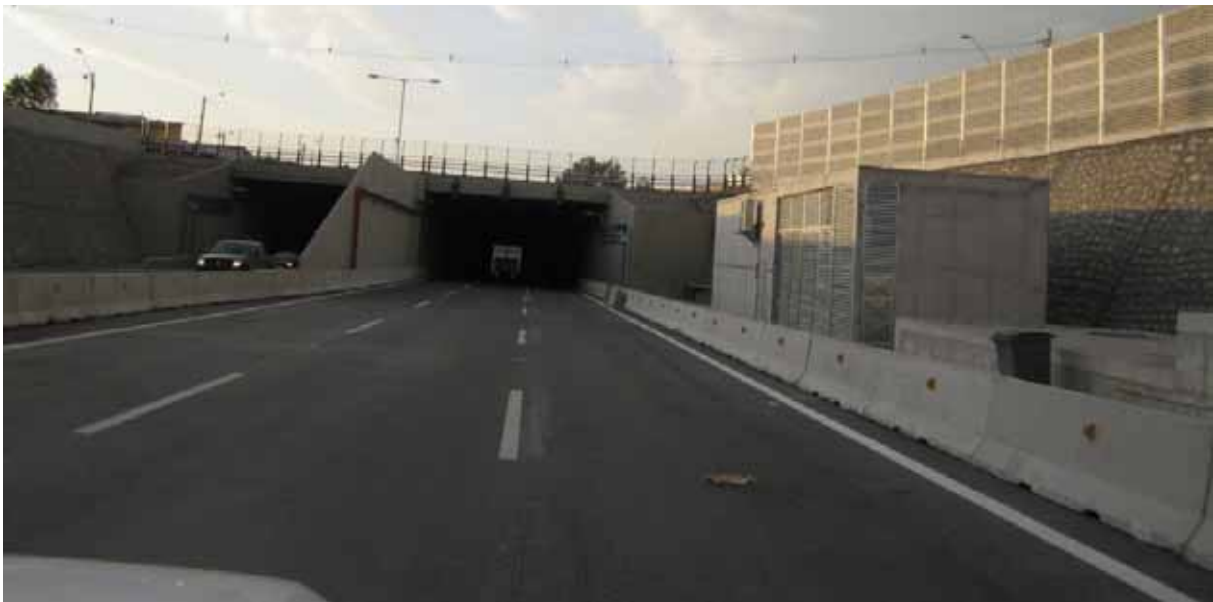
Figure 3.37 Highway box structures in Santiago, *Top*: inside highway box structures, April 12, 2010 (-33.424750°,-70.622422°); *Bottom*: approach to box tunnels, April 16, 2010 (-33.541472°,-33.541472°)

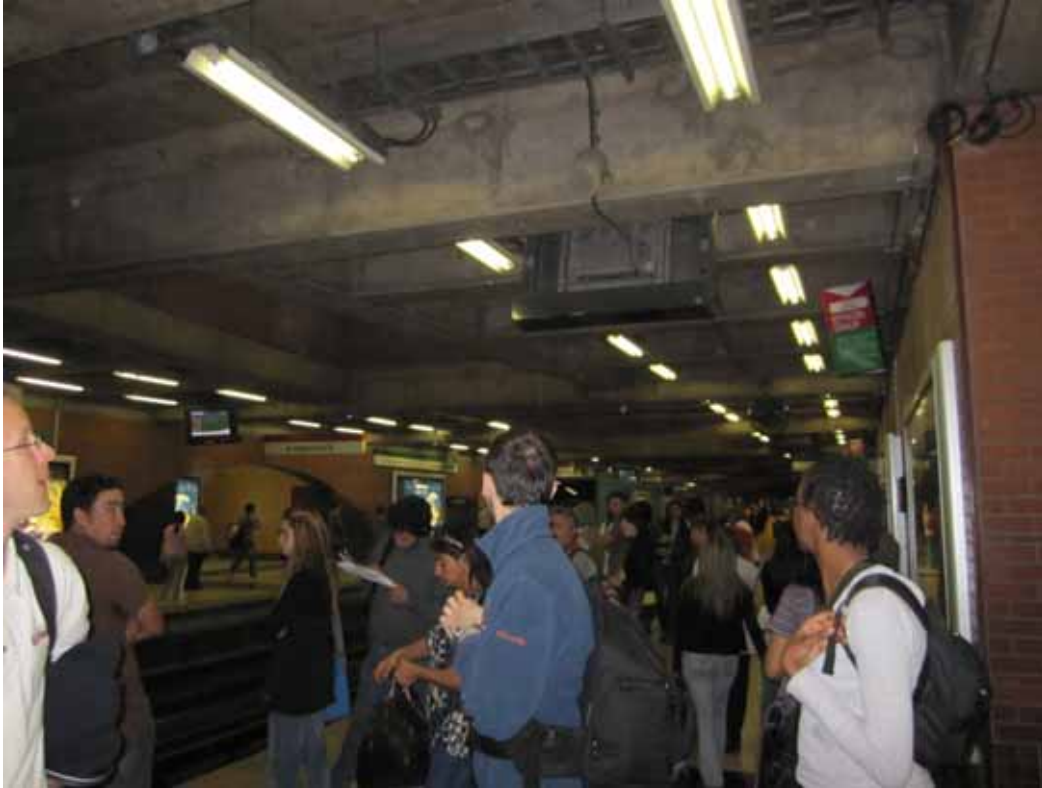
Figure 3.38 Santiago Metro, Baquedano Station, April 12, 2010

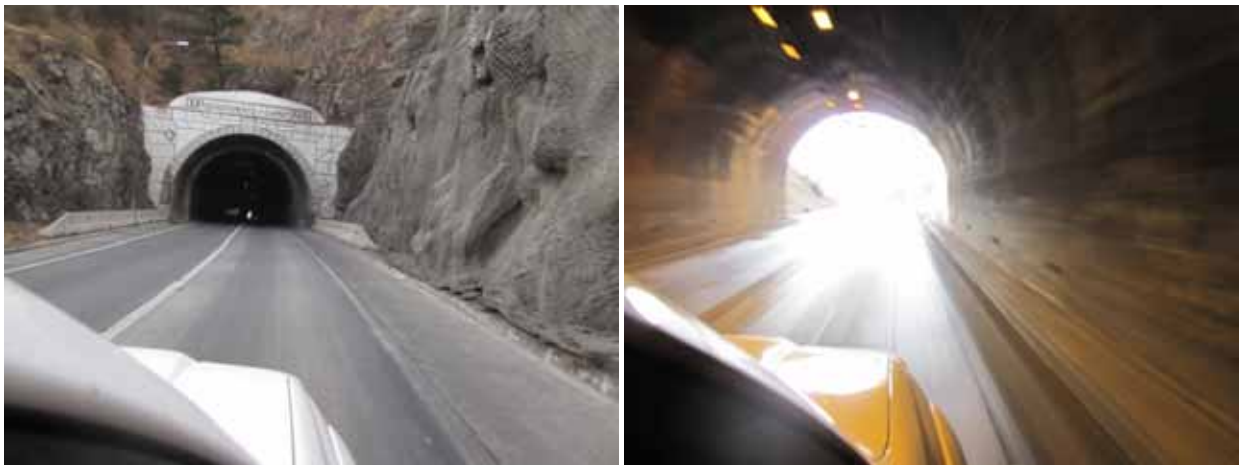
Figure 3.39 Highway tunnel, Route 5 South, April 12, 2010
(-33.912867°,-70.725533°)

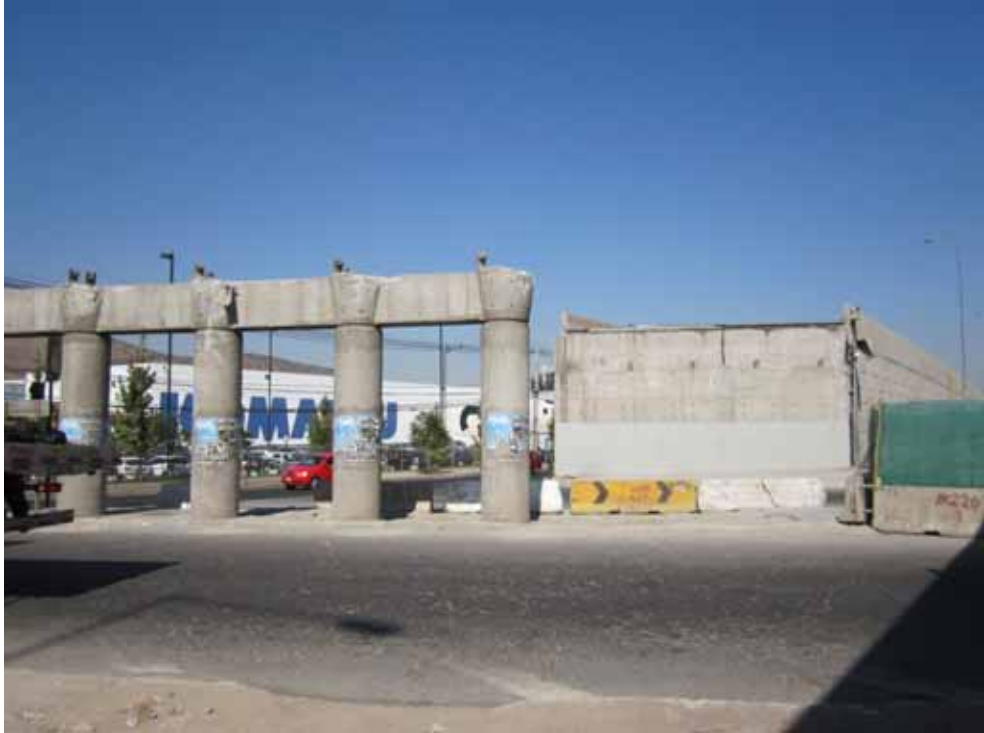
Figure 3.40 Mechanically stabilized earth wall, bridge ring 3, Lo Echevers Bridge, Santiago, April 13, 2010 (-33.376159°,-70.747742°)

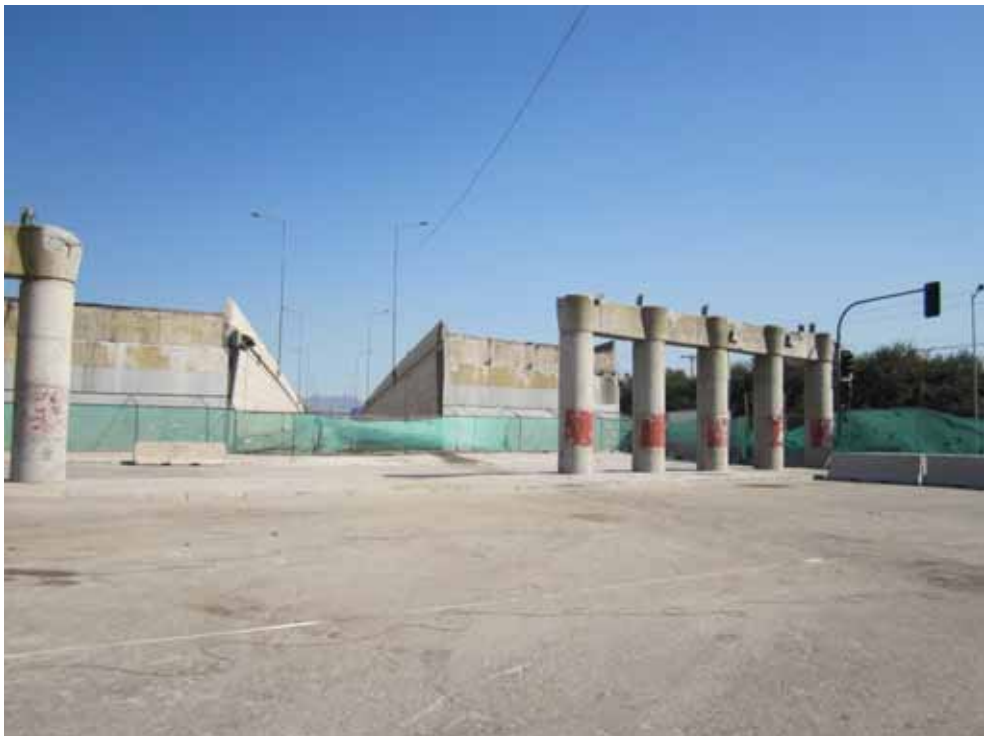
Figure 3.41 Mechanically stabilized earth, bridge ring 2, Miraflores Bridge, Santiago, April 13, 2010 (-33.394269°,-70.769402°)

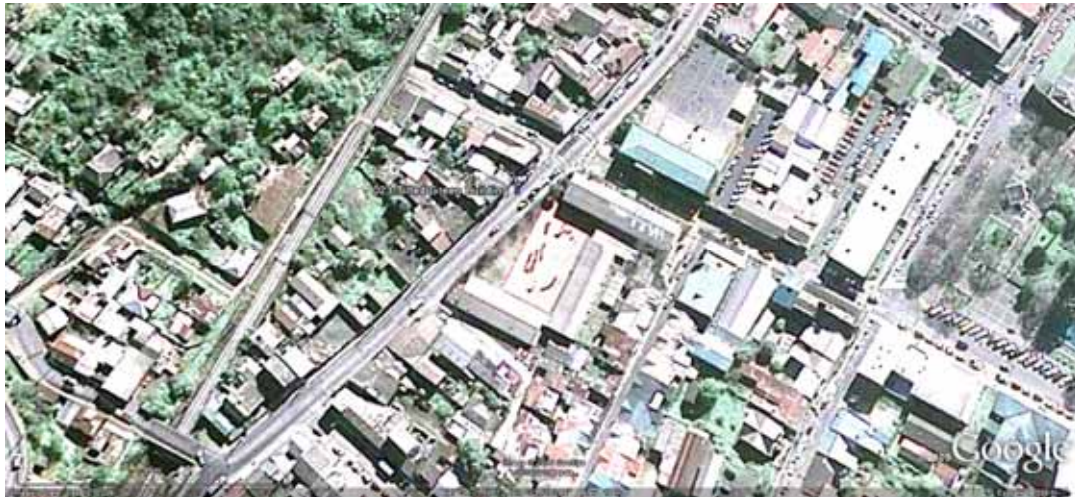
Figure 3.42 Green Building, Talcahuano (-36.714268°,-73.116368°)

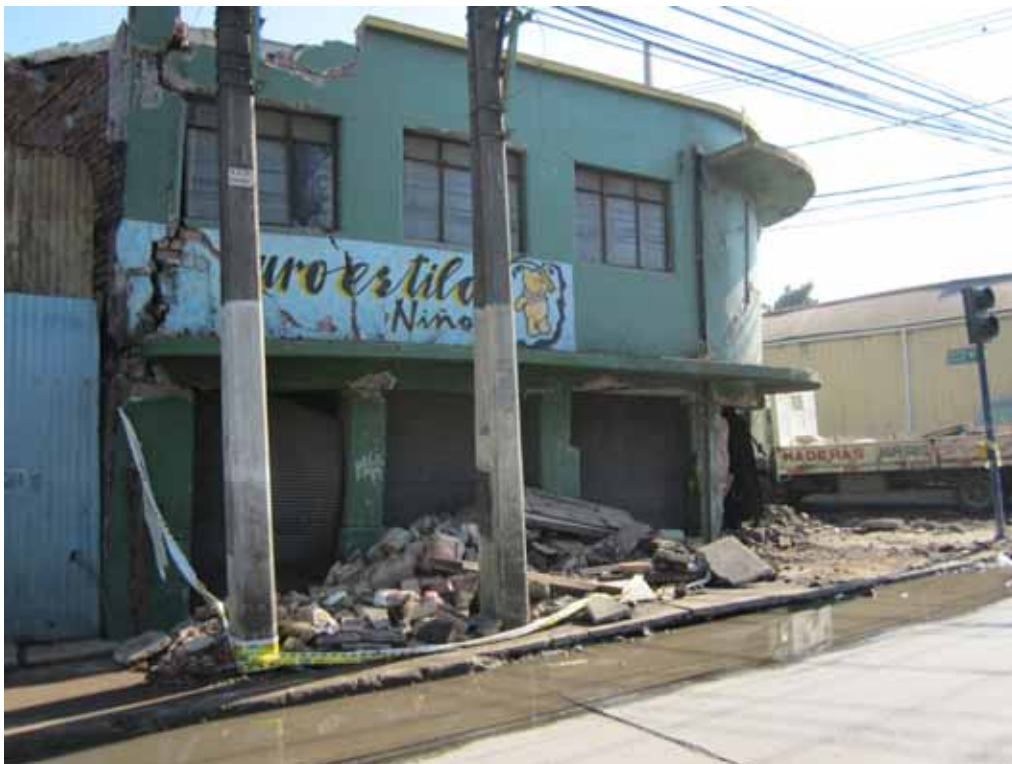
Figure 3.43 Tilting of the Green Building due to bearing soil failure, Talcahuano, April 15, 2010 (-36.714268°,-73.116368°)

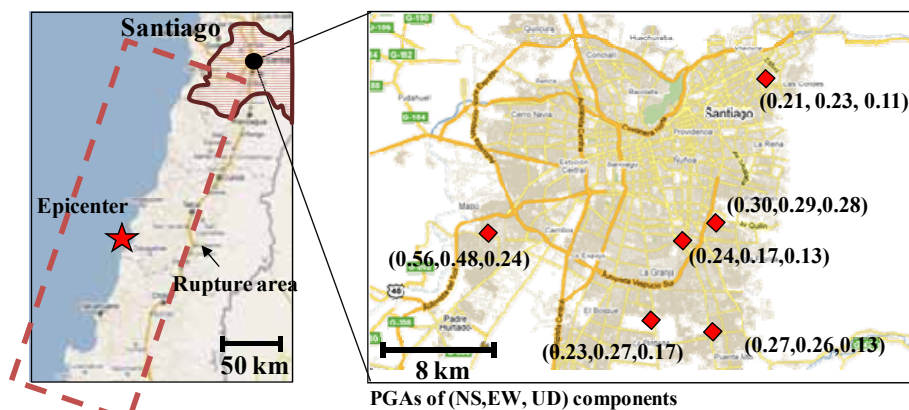
Figure 4.1 Location of Santiago Region and recorded PGAs in Santiago

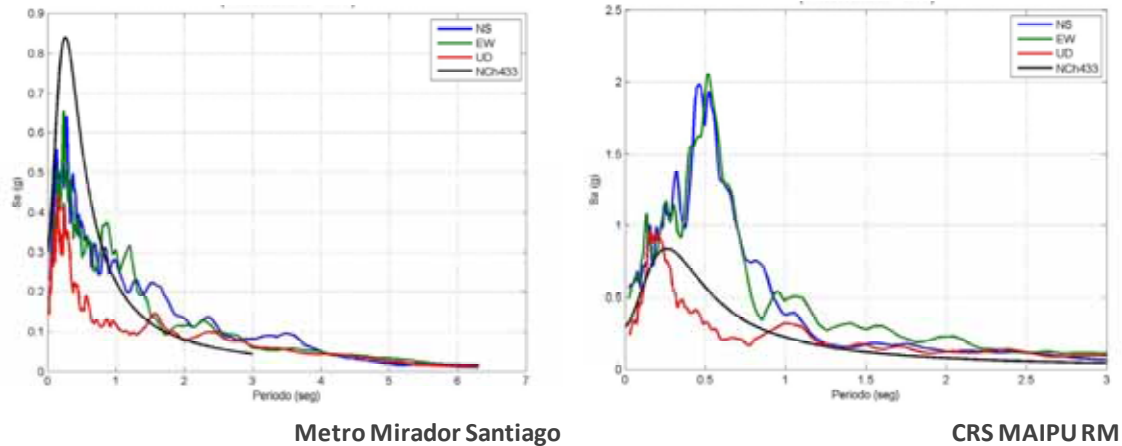
Figure 4.2 Location of Santiago Region and recorded PGAs in Santiago, compared to the code design spectrum (black line)

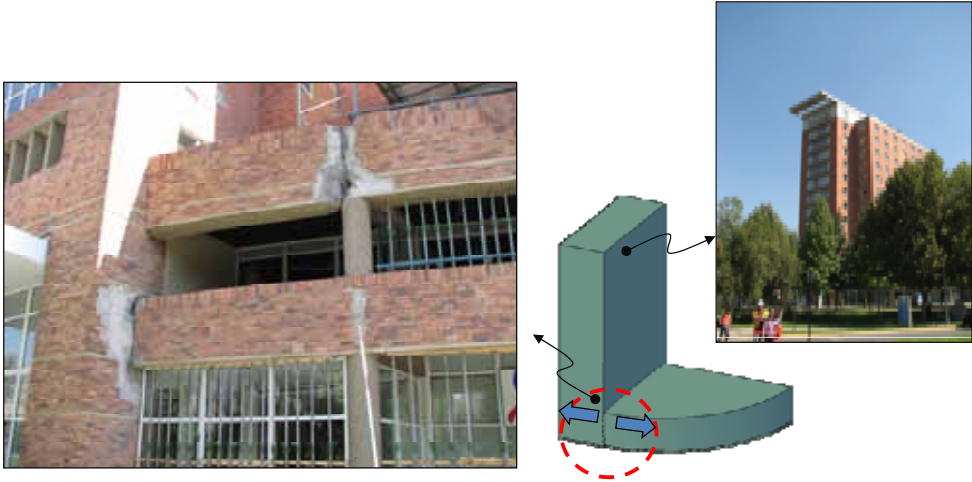
Figure 4.3 Failure due to vertical irregularity

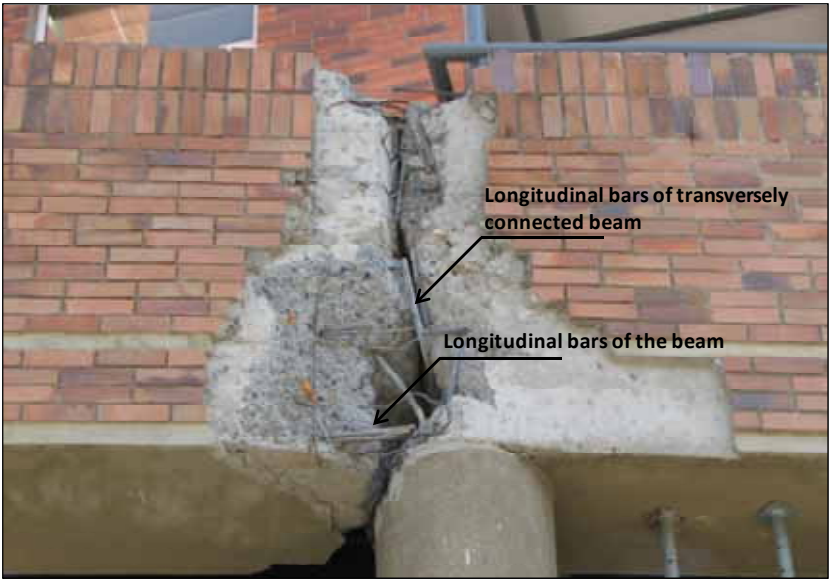
Figure 4.4 Close-up view of the damaged structure

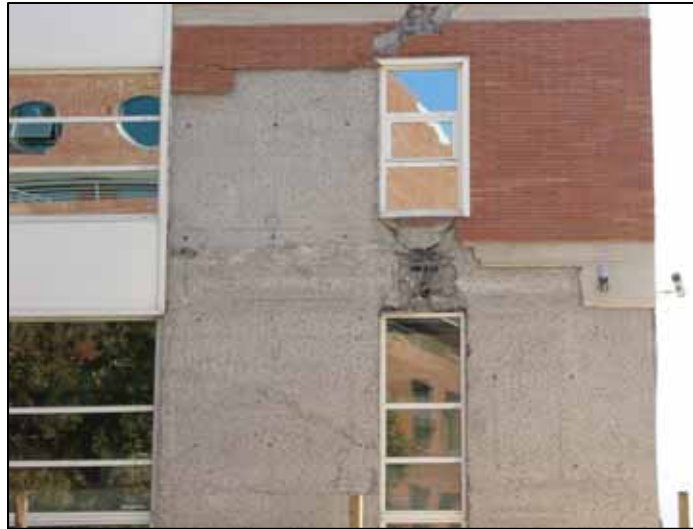
Figure 4.5 Collapsed masonry cladding wall and a damaged beam

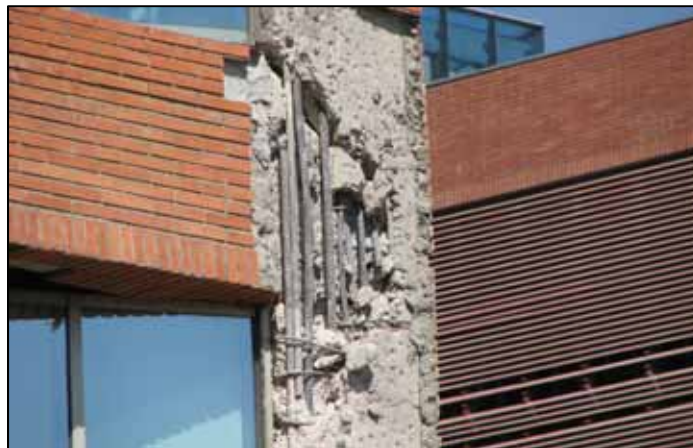
Figure 4.6 Failure of beam-column connection

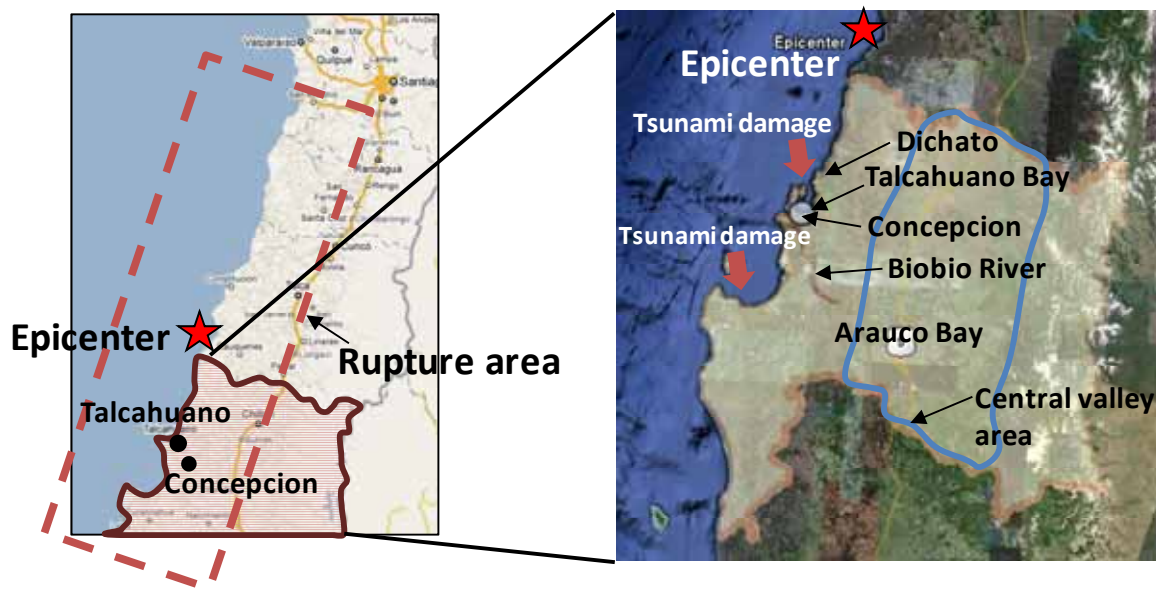
Figure 4.7 Damage to Bío Bío Region

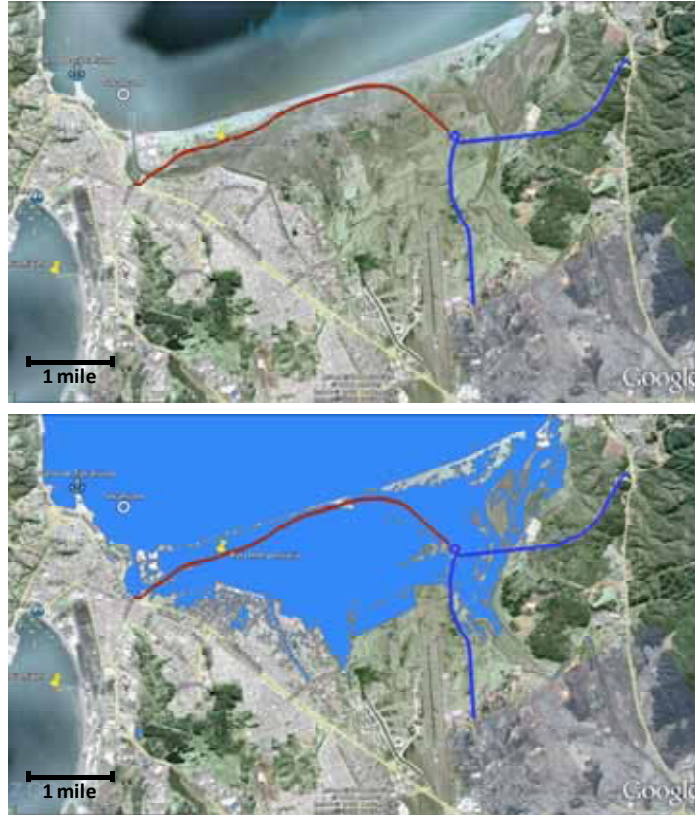
Figure 4.8 Talcahuano Bay area affected by tsunami

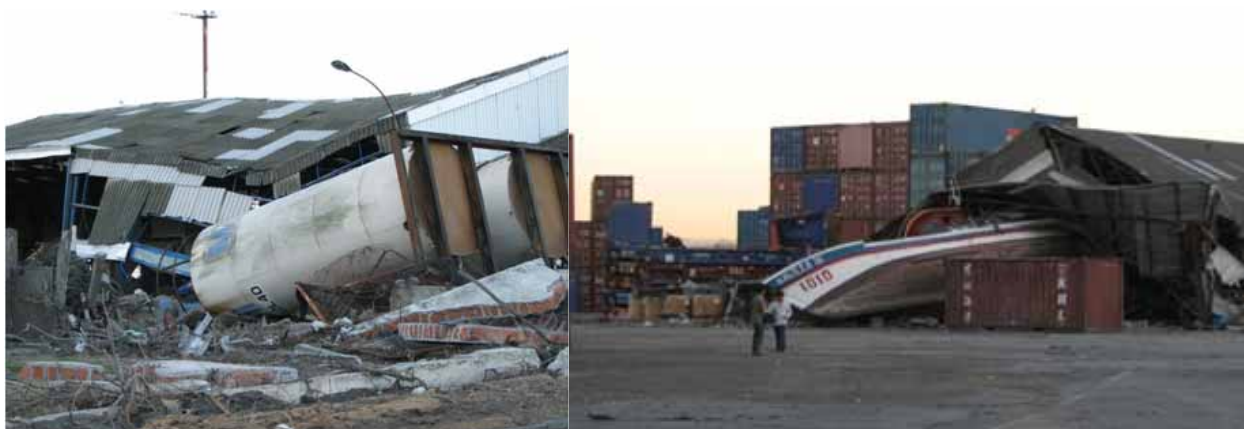
Figure 4.9 Effects of the tsunami on Talcahuano Bay. Top: toppled tank and collapsed building due to tsunami; Bottom: a dislocated ship, which damaged a storage building

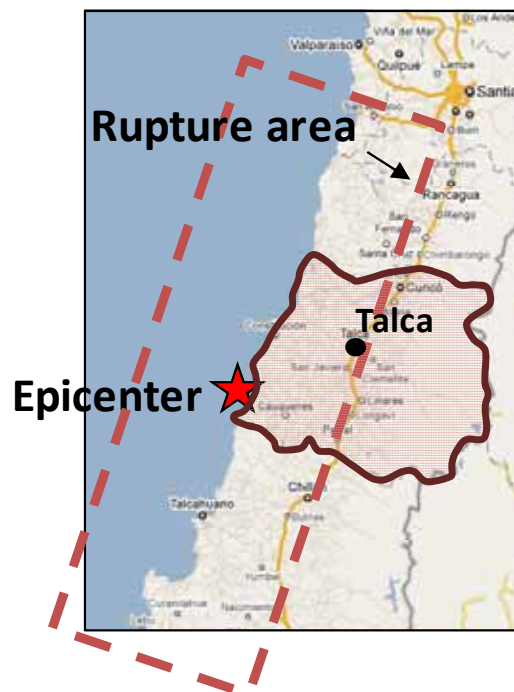
Figure 4.10 Location of the Maule Region and the rupture plane

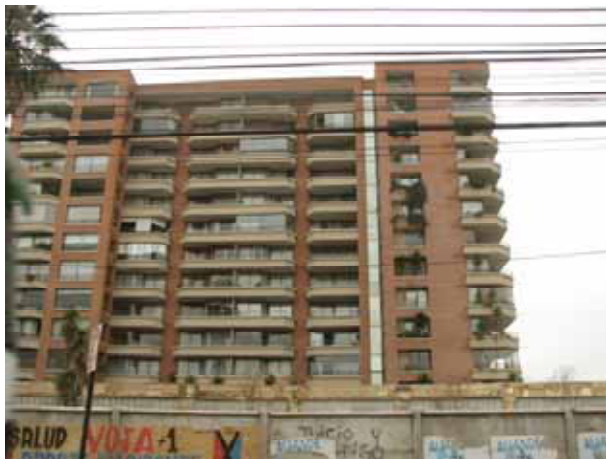
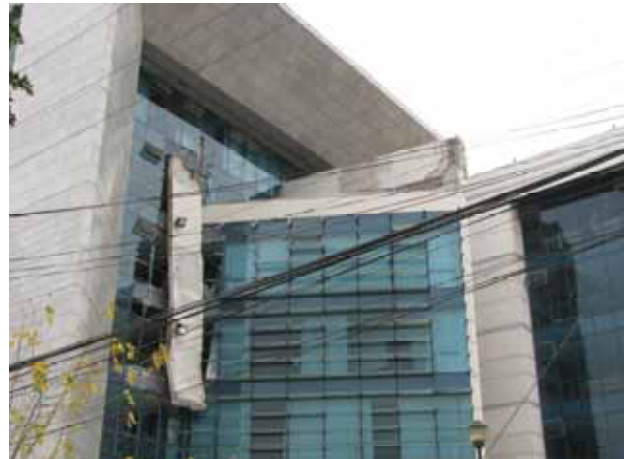
Figure 4.11 Modern RC buildings in Talca

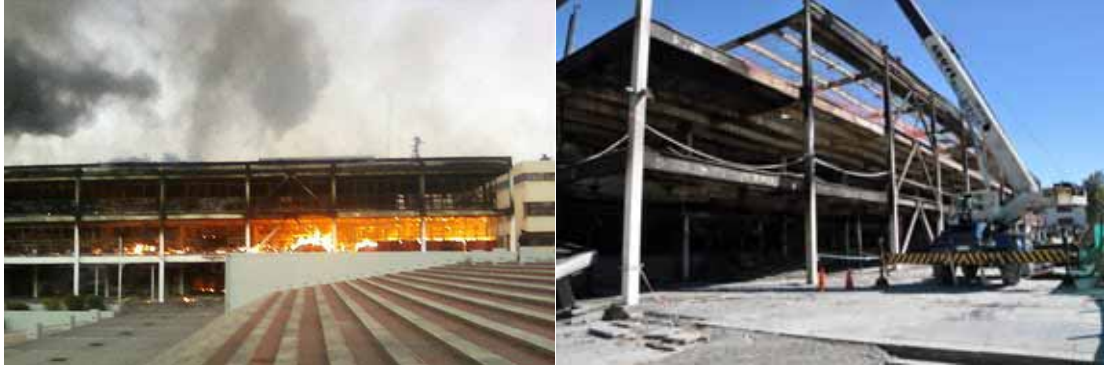
Figure 4.13 Fire in the Chemistry Building after the earthquake and the demolishing process

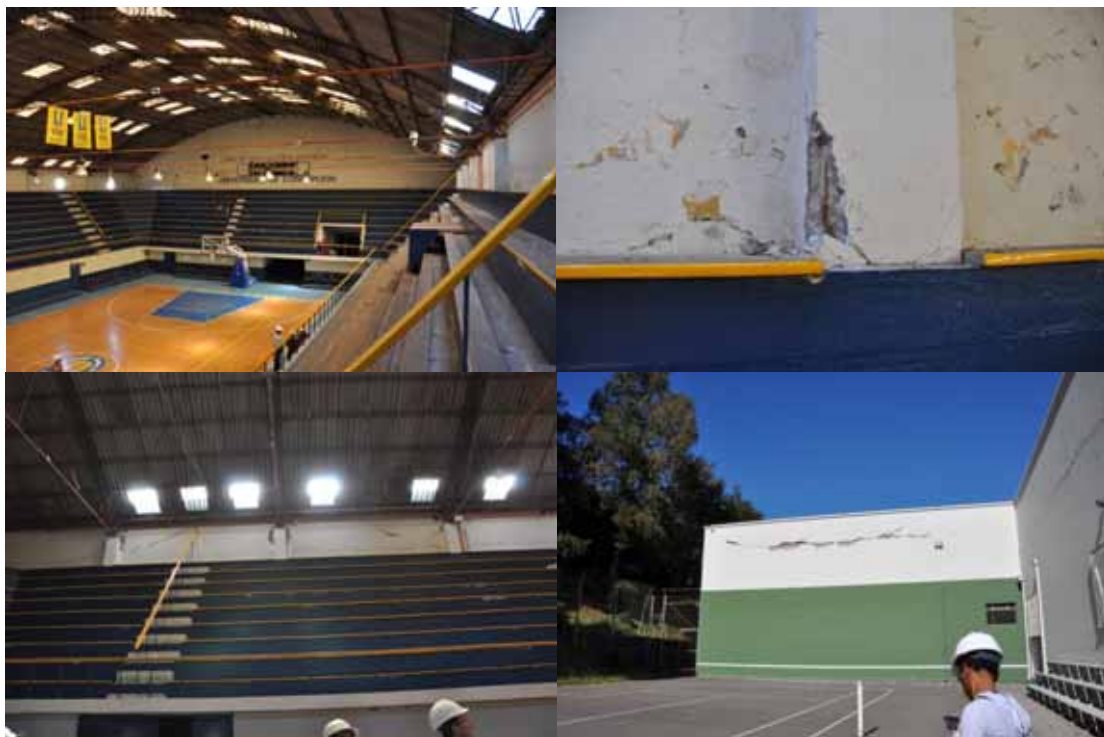
Figure 4.14 Gymnasium, University of Concepción, buckling of longitudinal reinforcement and cover spalling, out-of-plane failure of sidewalls at the wall discontinuity

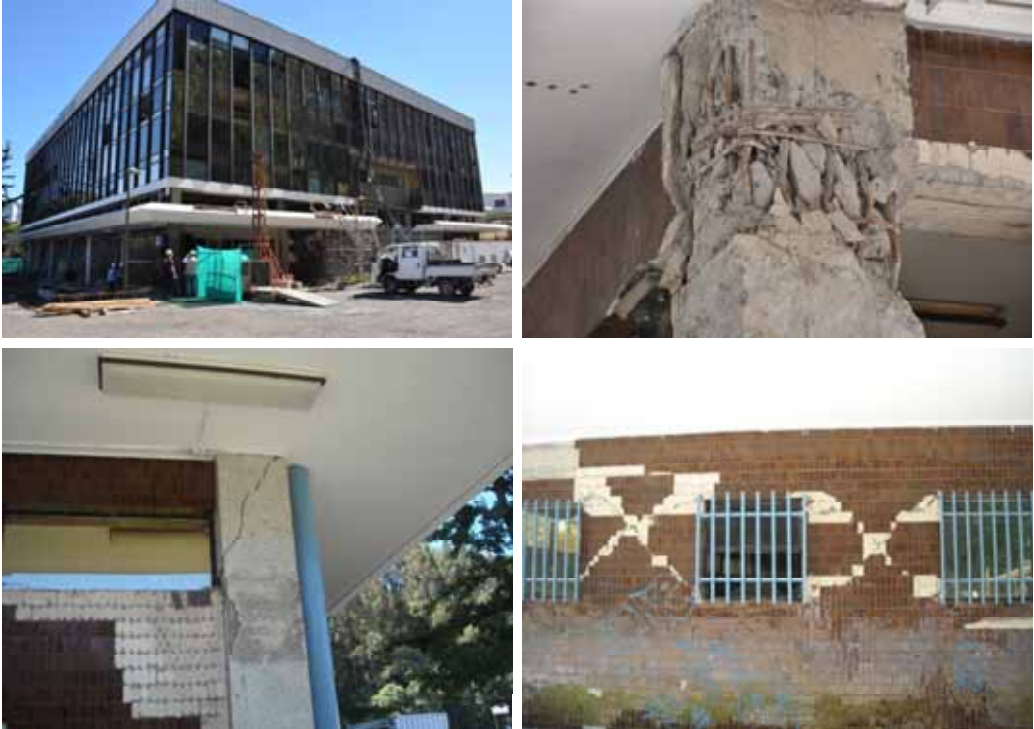
Figure 4.15 Odontology Building, University of Concepción, combined shear-compression failure at the top of first story columns, short column effect, and diagonal cracks in masonry infill walls around openings

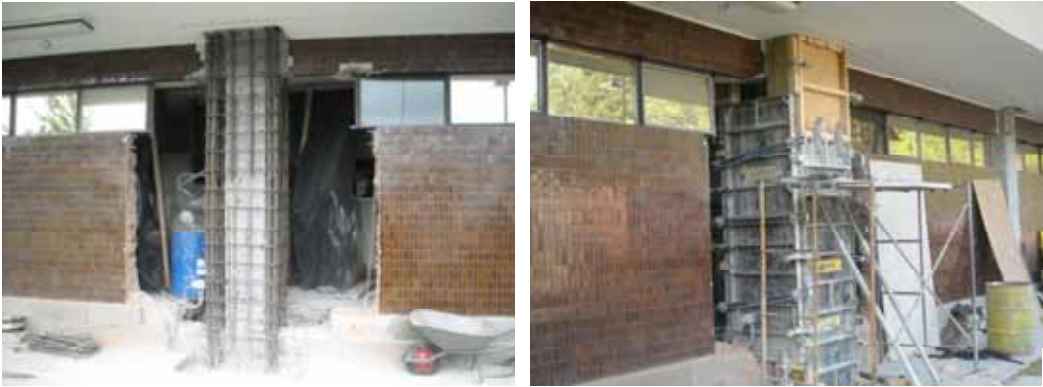
Figure 4.16 Retrofitting of the Odontology Building, University of Concepción

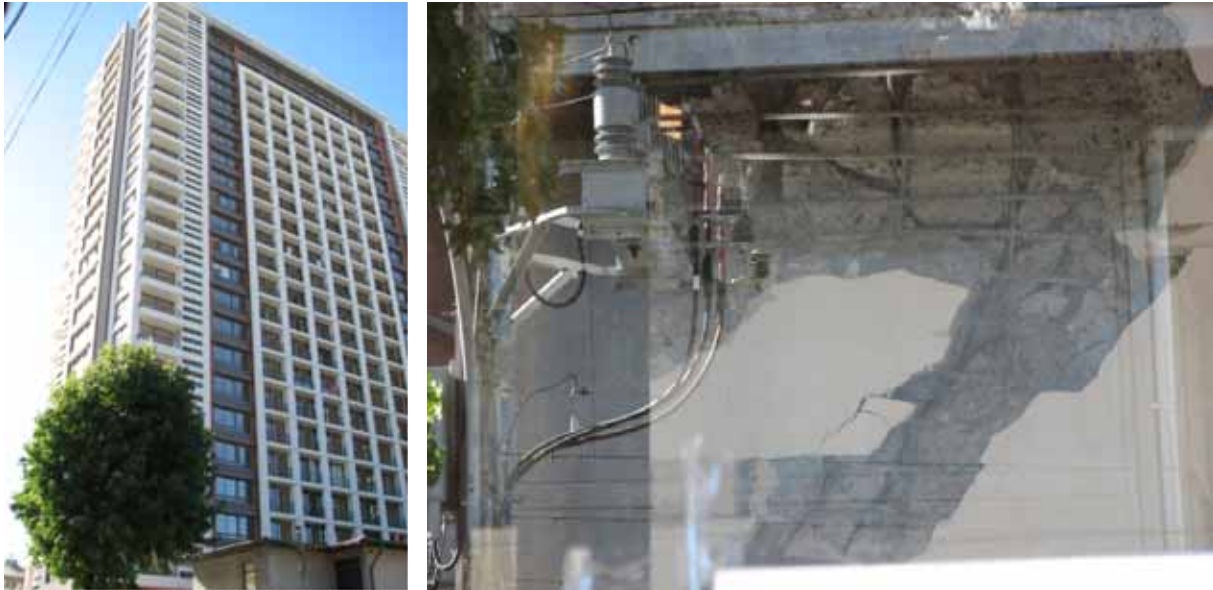
Figure 4.17 Severely damaged condominium high-rise building in Concepción

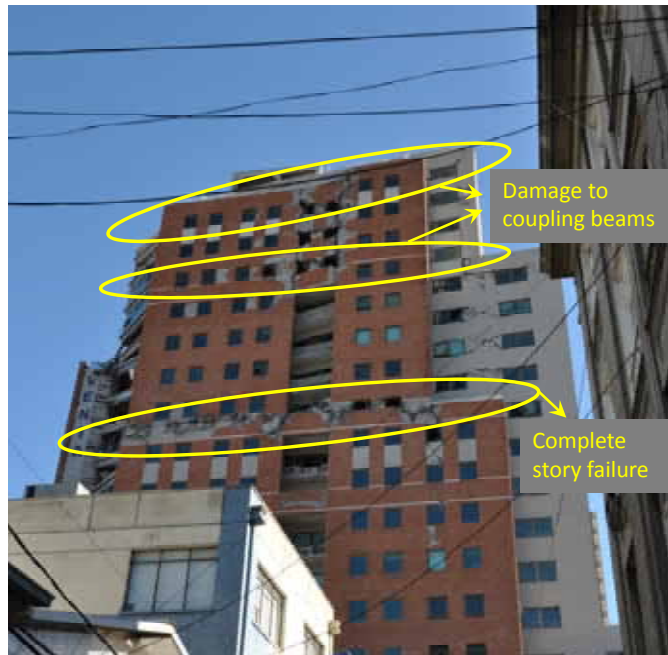
Figure 4.18 O'Higgins tower in Concepción suffered partial story collapses

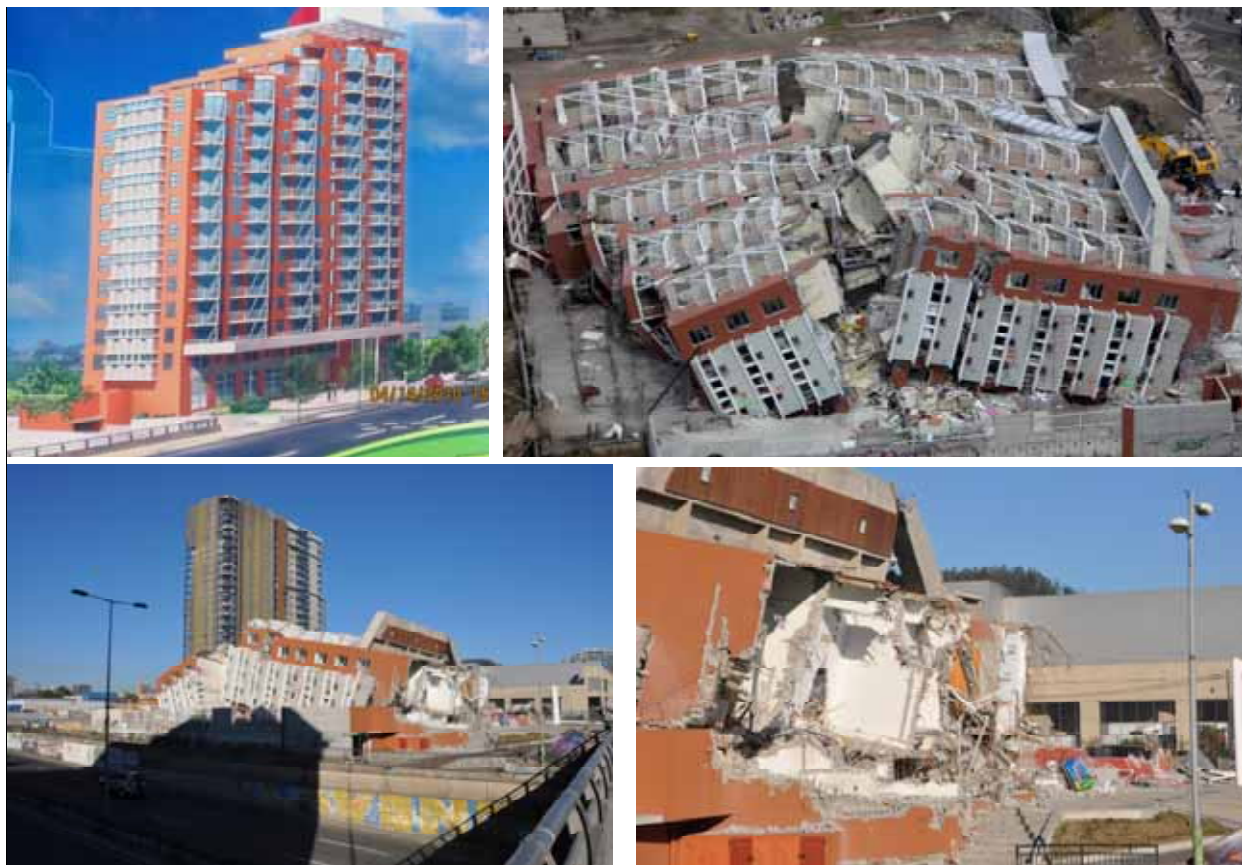
Figure 4.19 Alto Río condominium in Concepción, structure toppled on one side, and failure of bearing walls

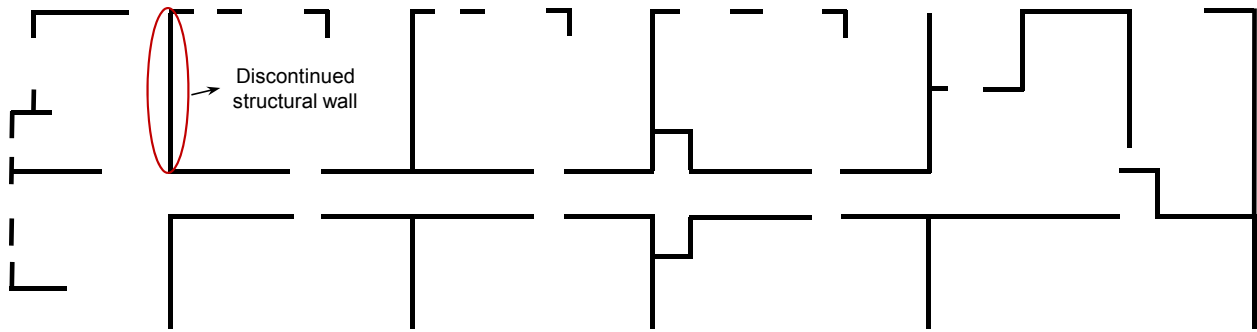
Figure 4.20. Sketch of plan view for Alto Río condominium (the sketch is based on the information provided in the reconnaissance report by the Los Angeles Tall Building Structural Design Council)

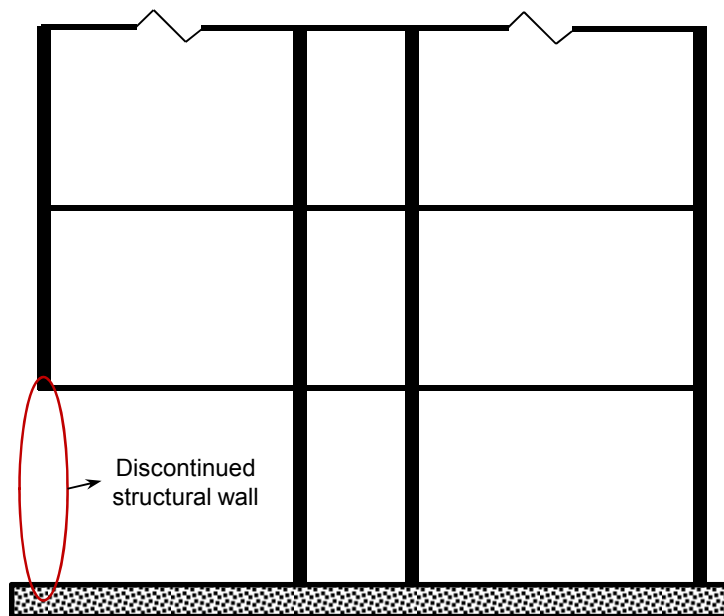
Figure 4.21. Sketch of elevation view for Alto Río condominium
