The Maule (Chile) Earthquake of February 27, 2010

Consequence Assessment and Case Studies

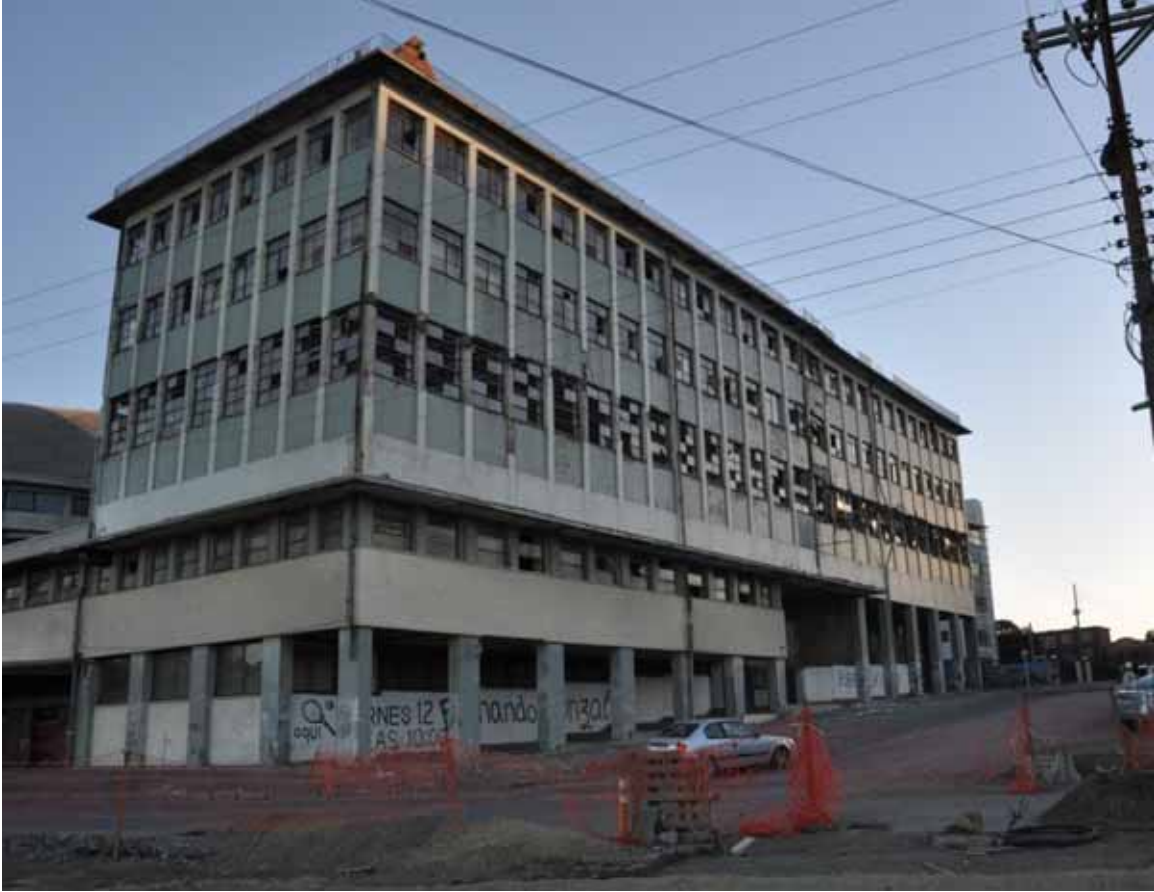
Figure 4.22 RC building near the port of Talcahuano damaged beyond repair

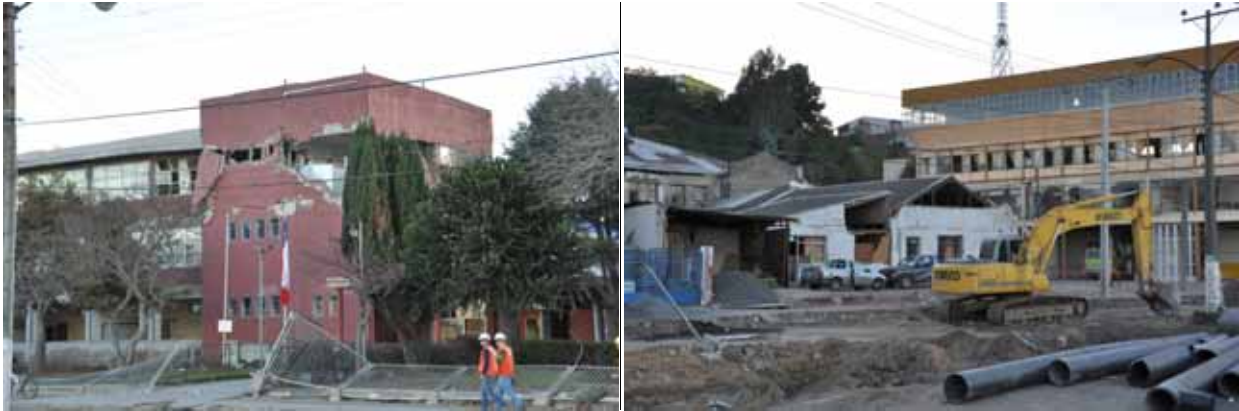
Figure 4.23 Buildings at the shorefront in Talcahuano damaged due to hydrodynamic loading

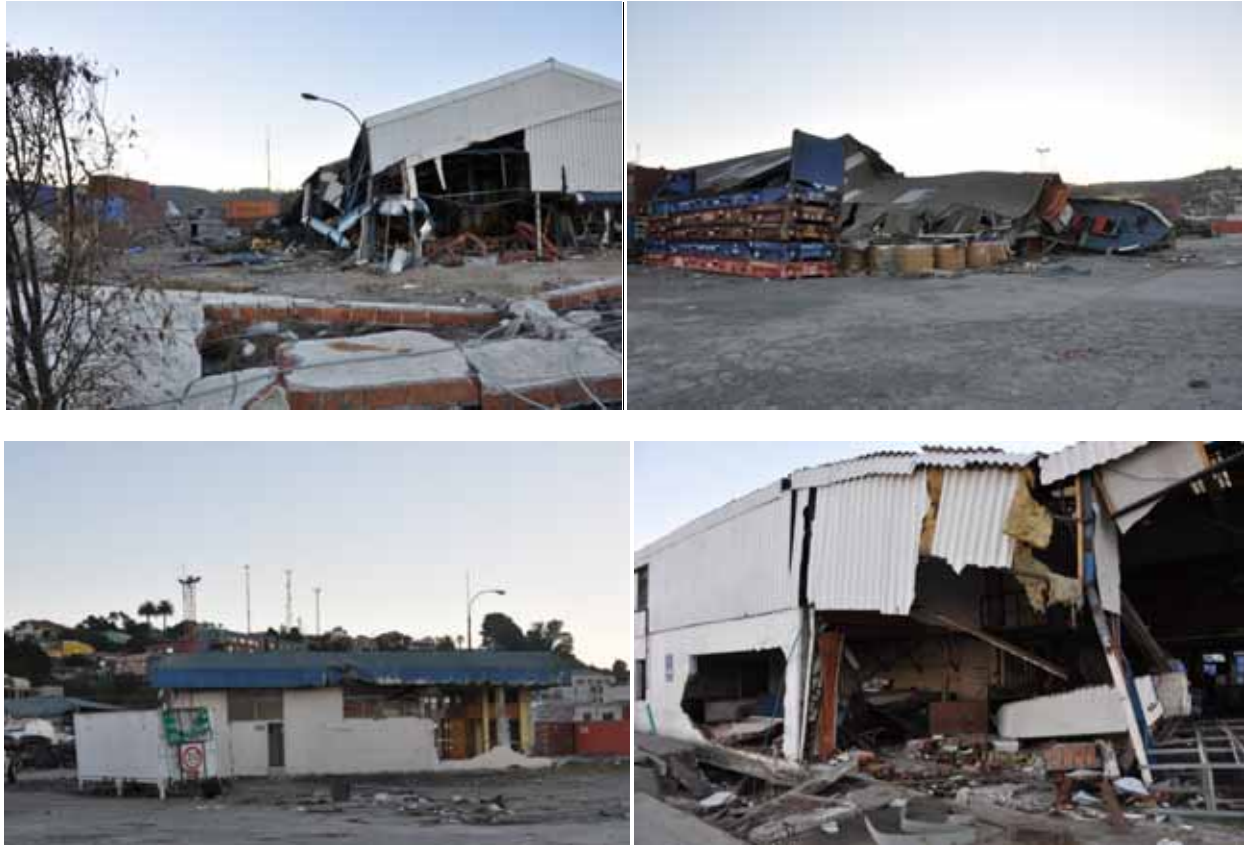
Figure 4.24 Damaged buildings of the Talcahuano port

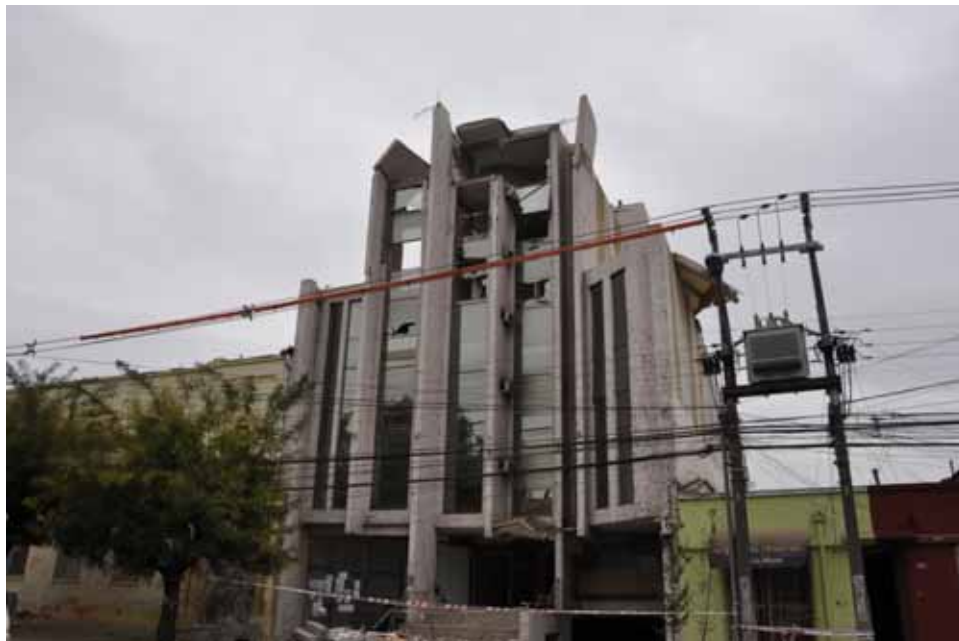
Figure 4.25 Edificio Aranjuez (6-story office building) was rendered nonfunctional due to nonstructural damage after the earthquake

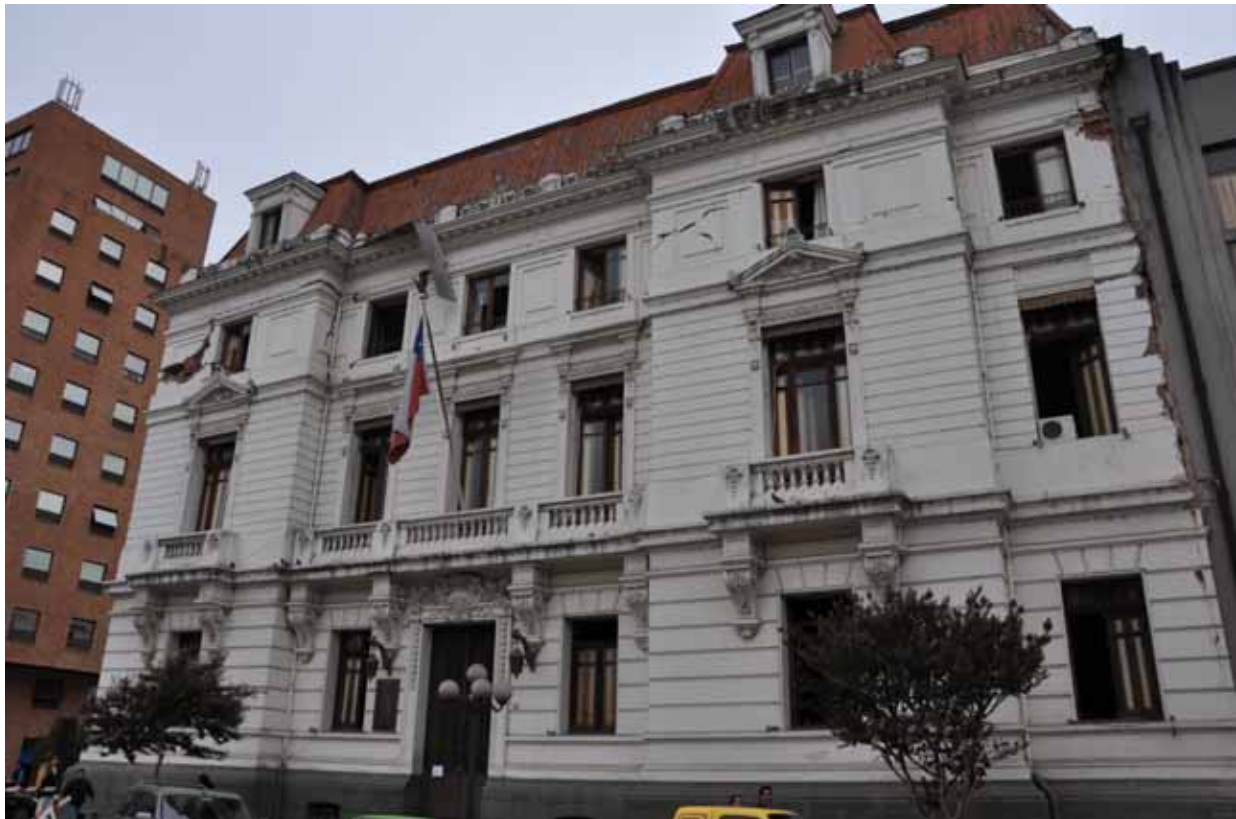
Figure 4.26 Edificio Intendencia Maule in Talca

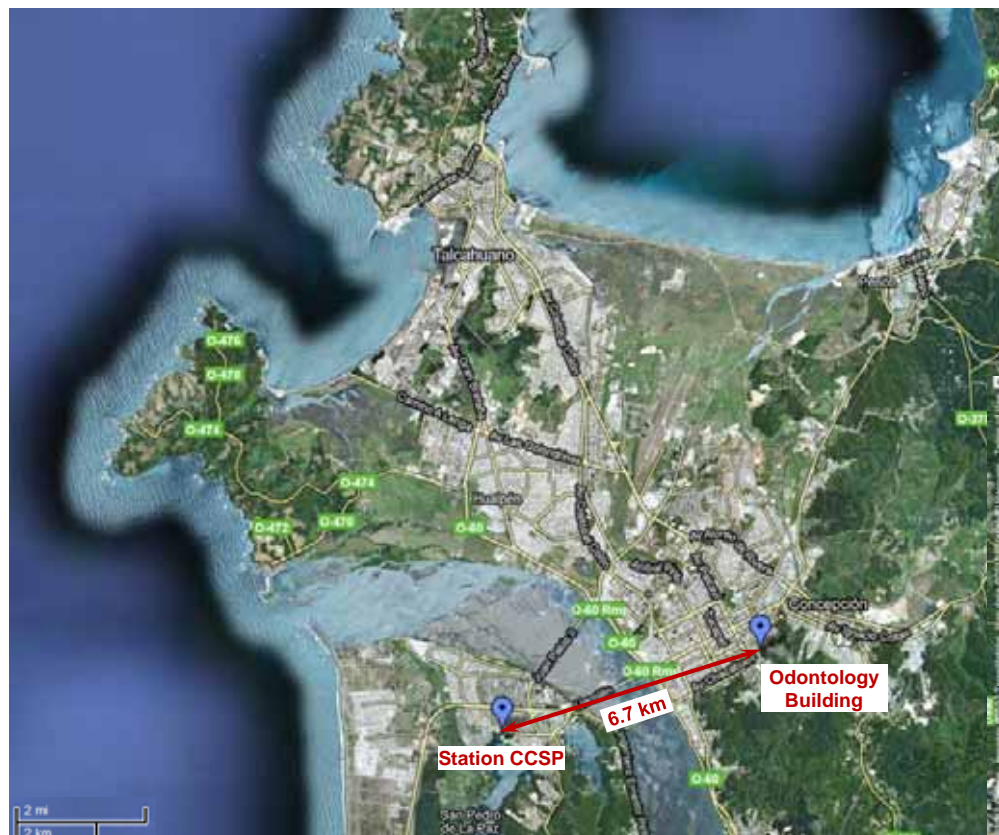
A typical floor plan of the structure is shown in Figure 4.30. The building has a rectangular shape with seven bays in x-direction and five bays in y-direction. Structural core-walls are provided at center of the building to resist the majority of the lateral loads. Except for minor differences in column dimensions of the exterior frames with five bays, the structure is symmetrical with respect to both x- and y-axes.

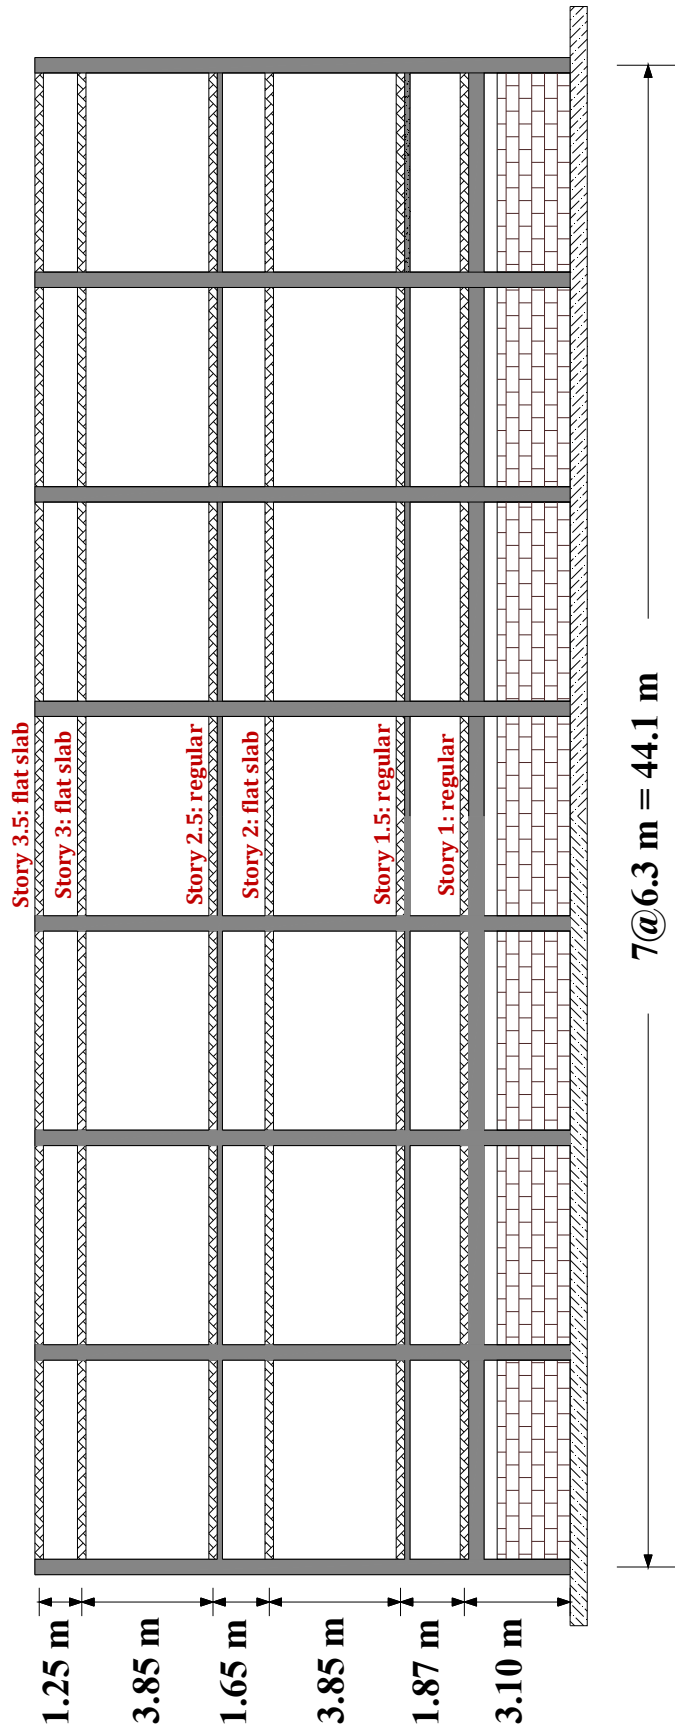
Figure 4.31 Elevation view sketch of the Odontology building

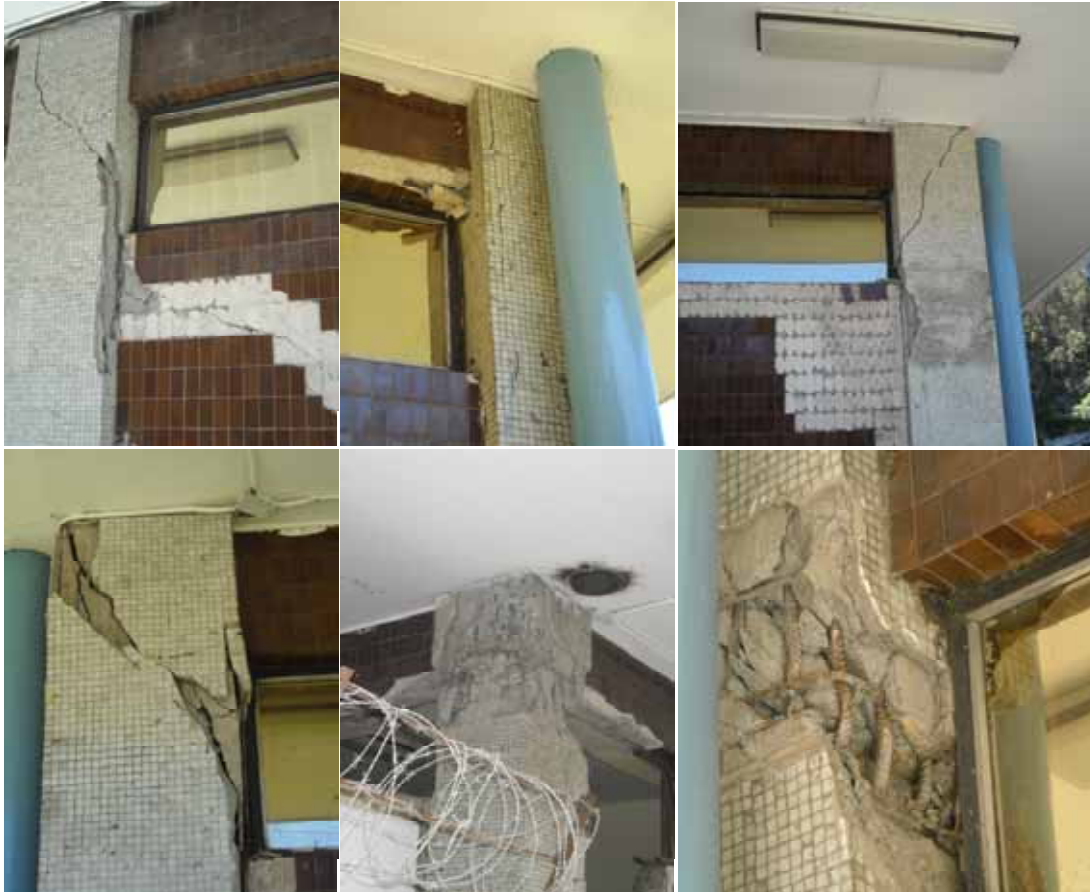
Figure 4.32 Short-column effect observed at the Odontology building

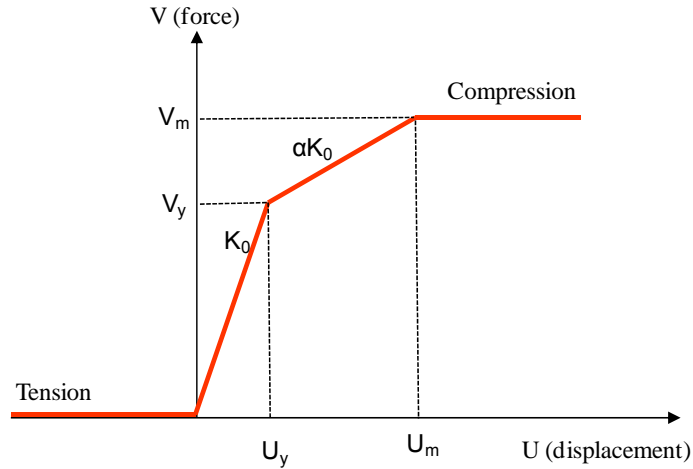
Figure 4.35 Hysteretic behavior of diagonal strut elements (Kwon and Kim, 2010)

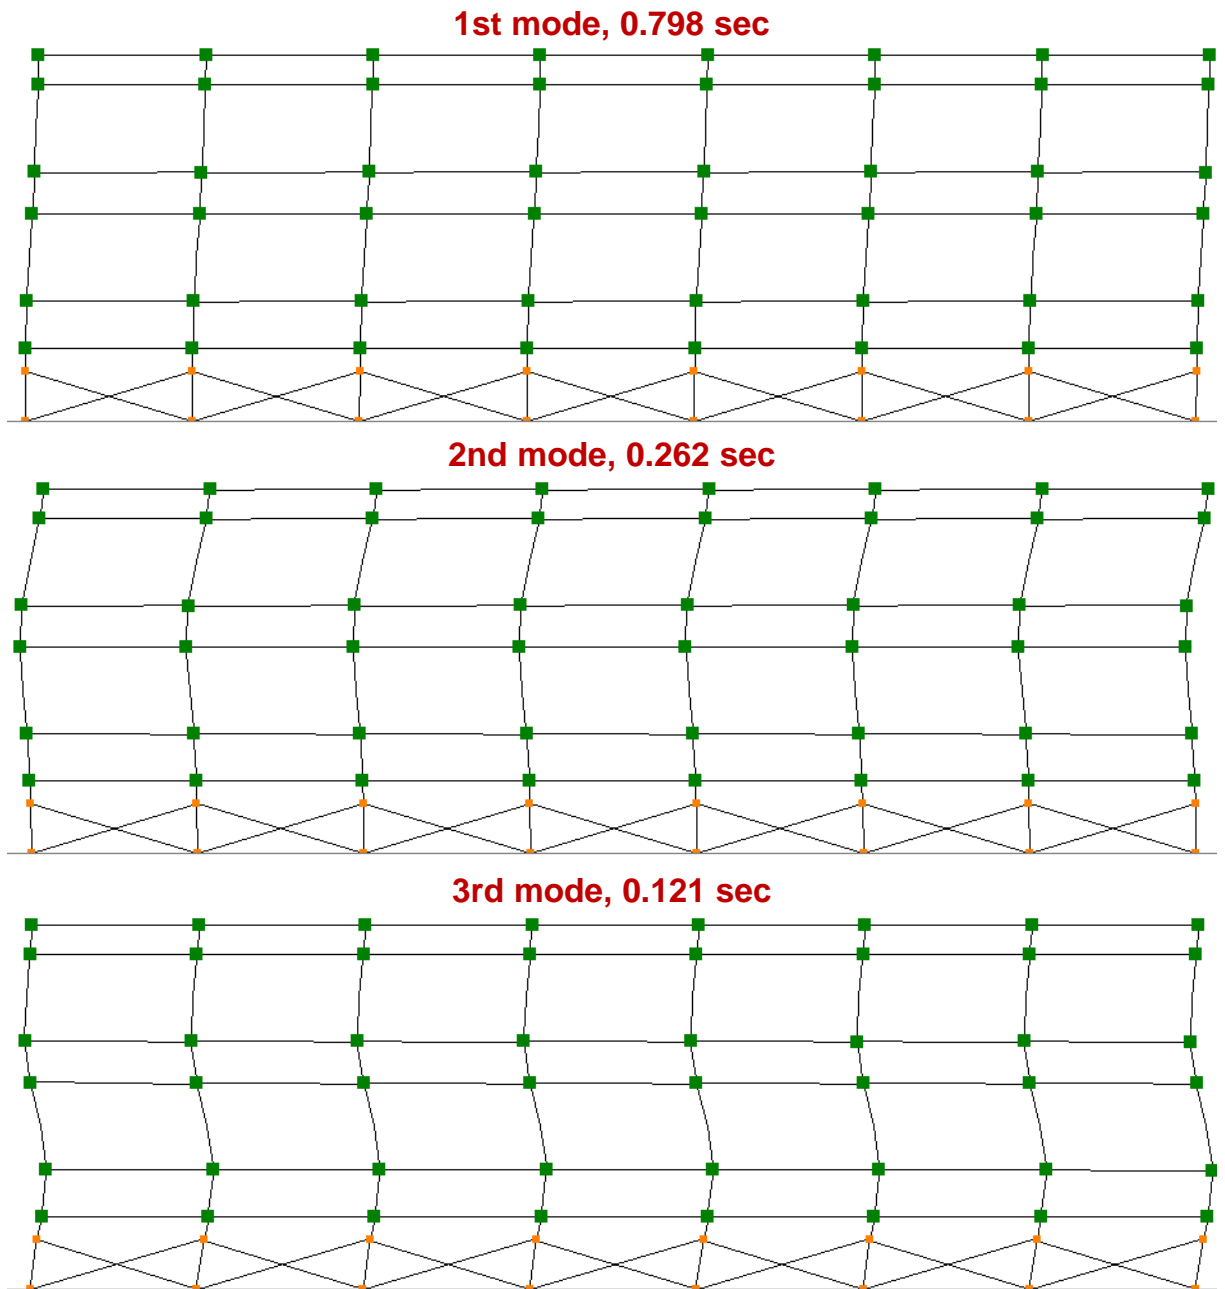
Figure 4.37 Mode shapes for the first three modes (frame with infill walls)

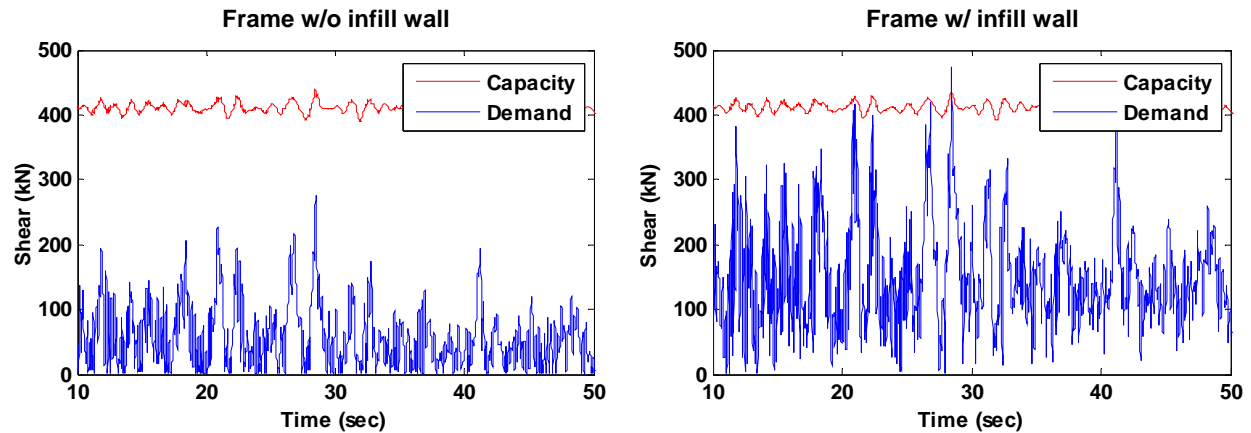
Figure 4.39 Comparison of shear capacity and demand for column 8, spectrum compatible mean record with seed CCSP

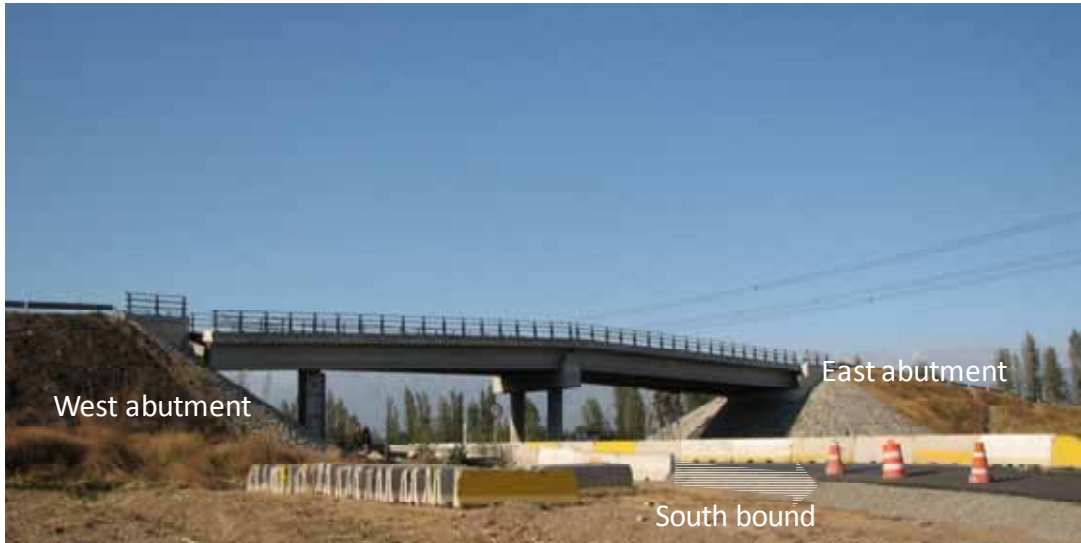
Figure 4.43 Rancagua Bypass

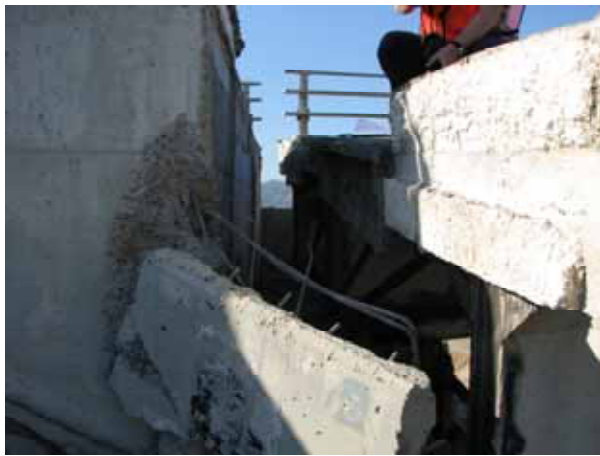
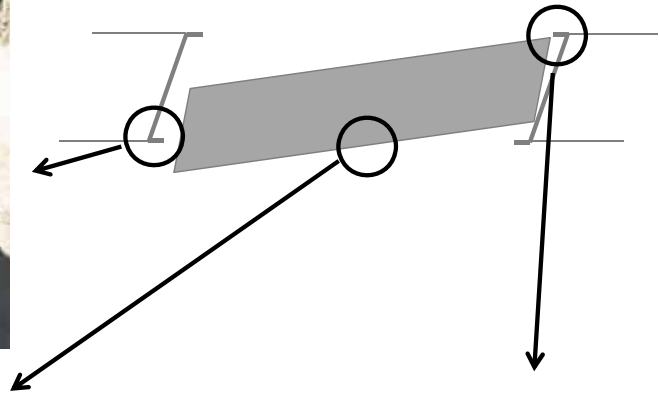
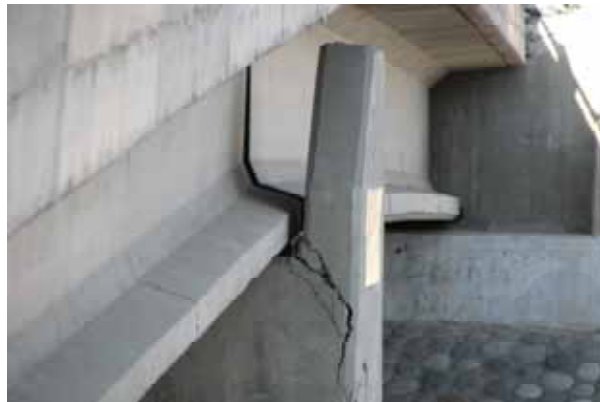
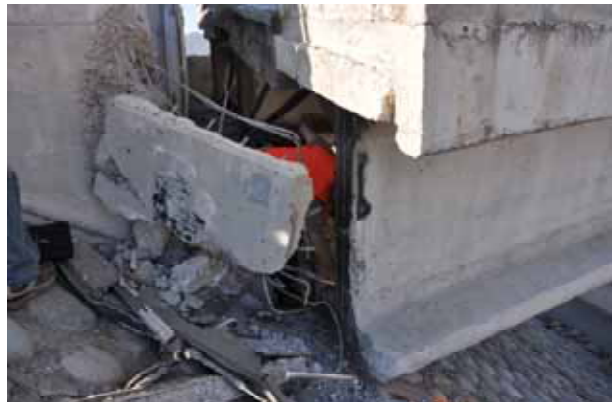
Figure 4.47 Failure of bridge shear keys

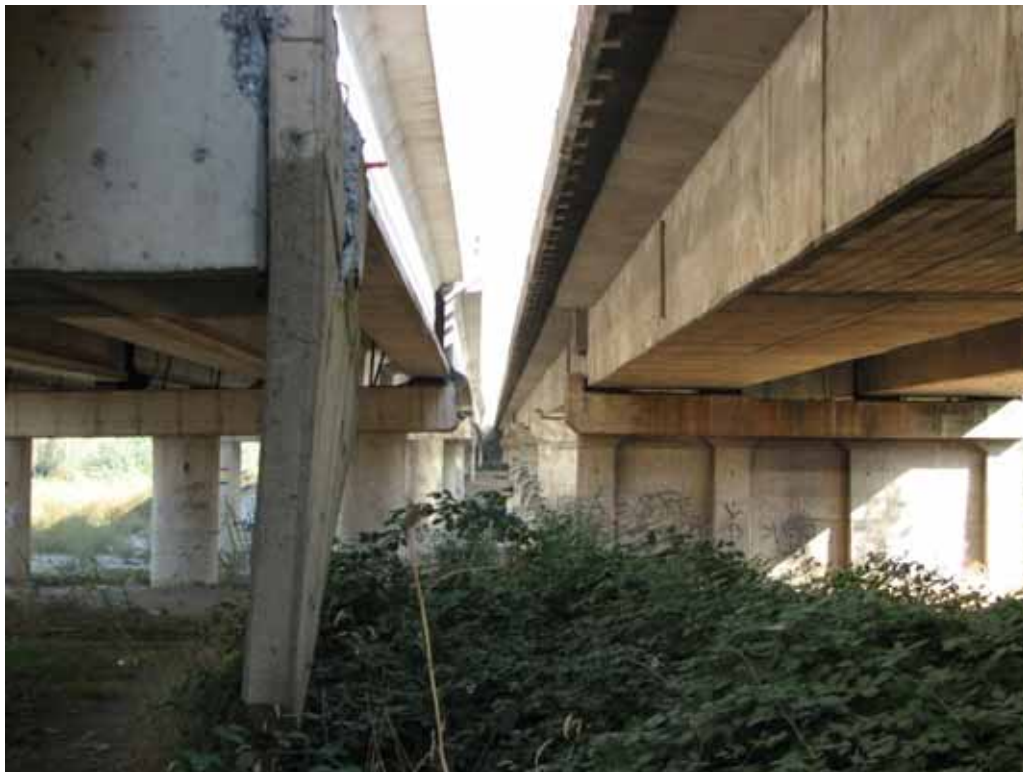
Figure 4.48 Perquilauquén Bridge

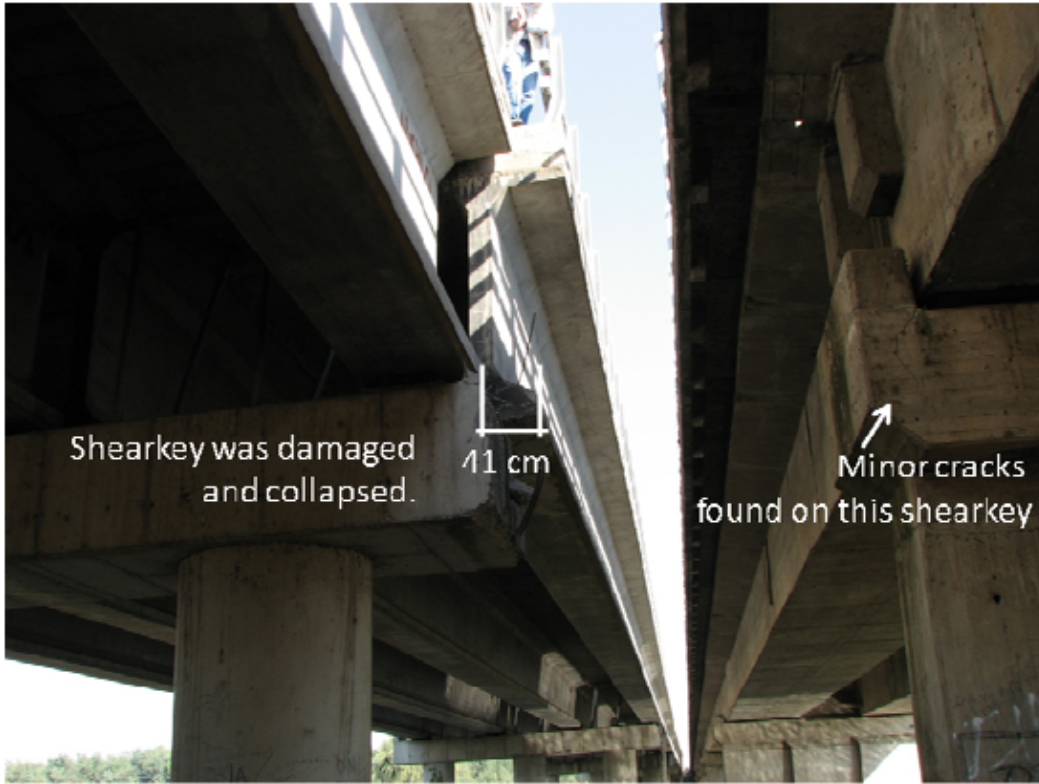
Figure 4.49 Displaced bridge superstructure and damage on shear keys

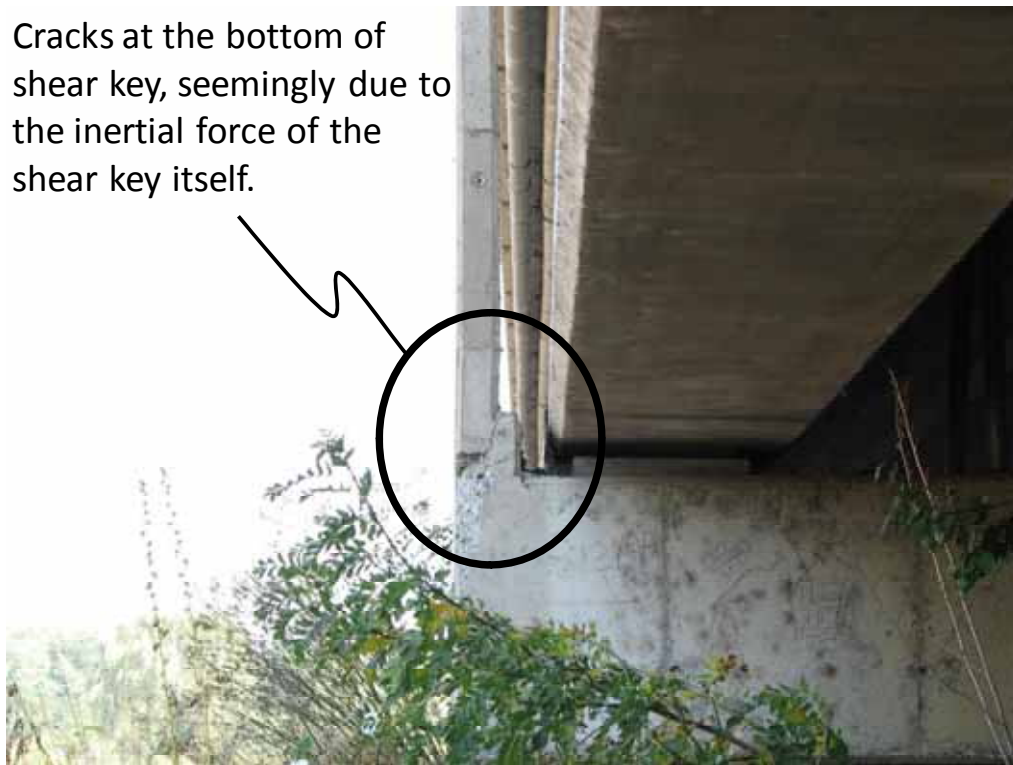
Figure 4.50 Damage at the bottom of a slender shear key

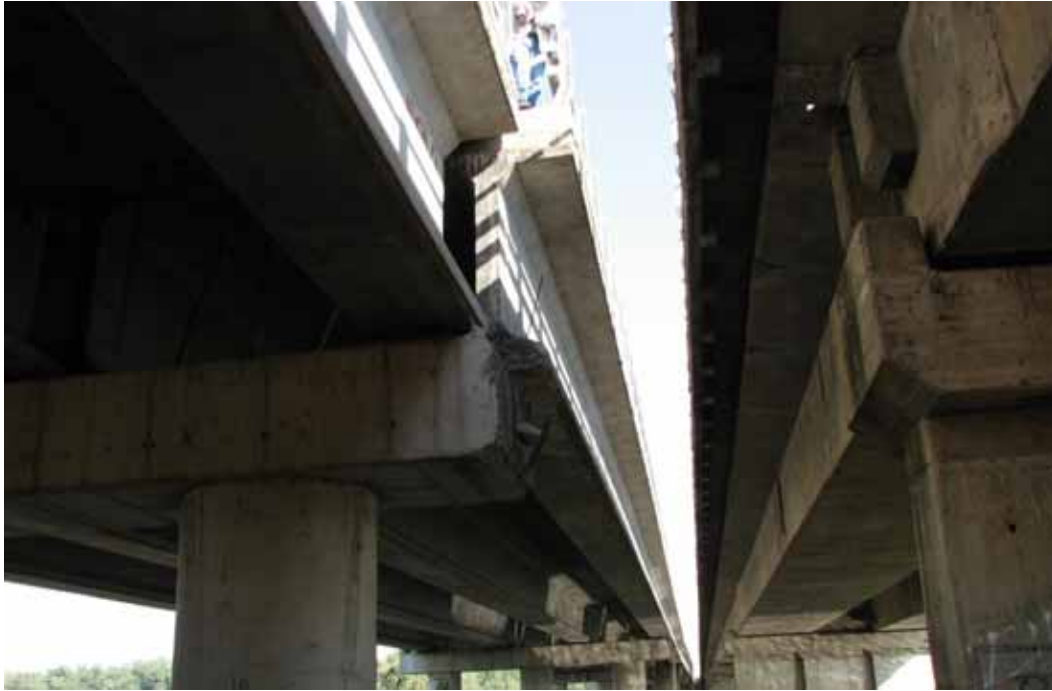
Figure 4.51 Bridge girder close to unseating

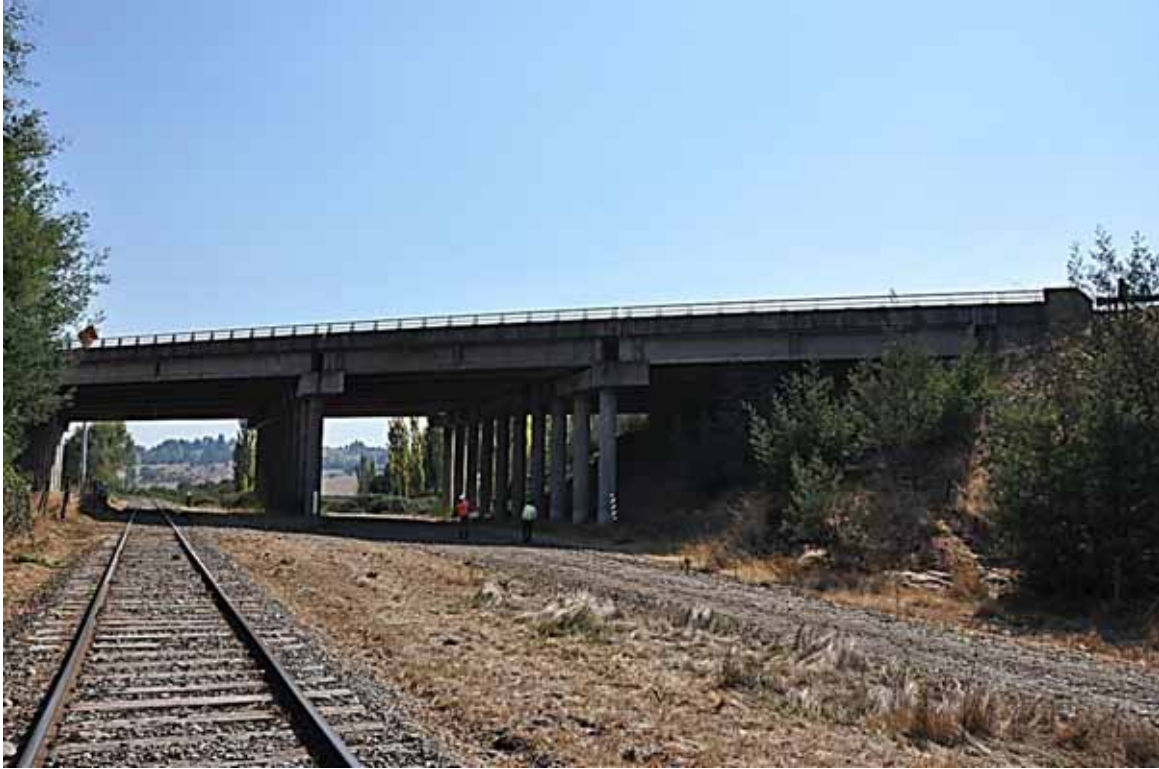
Figure 4.52 Paso Cladio Arrau

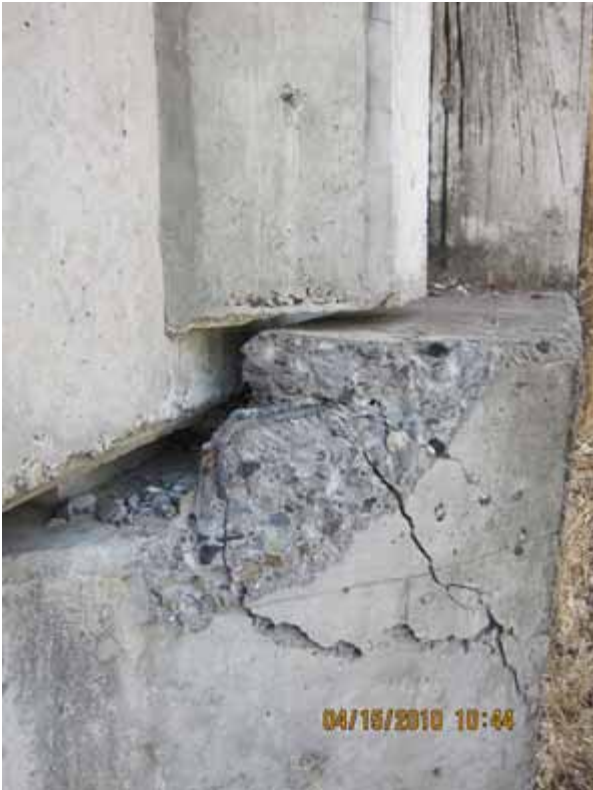
Figure 4.53 Damaged shear key at abutment

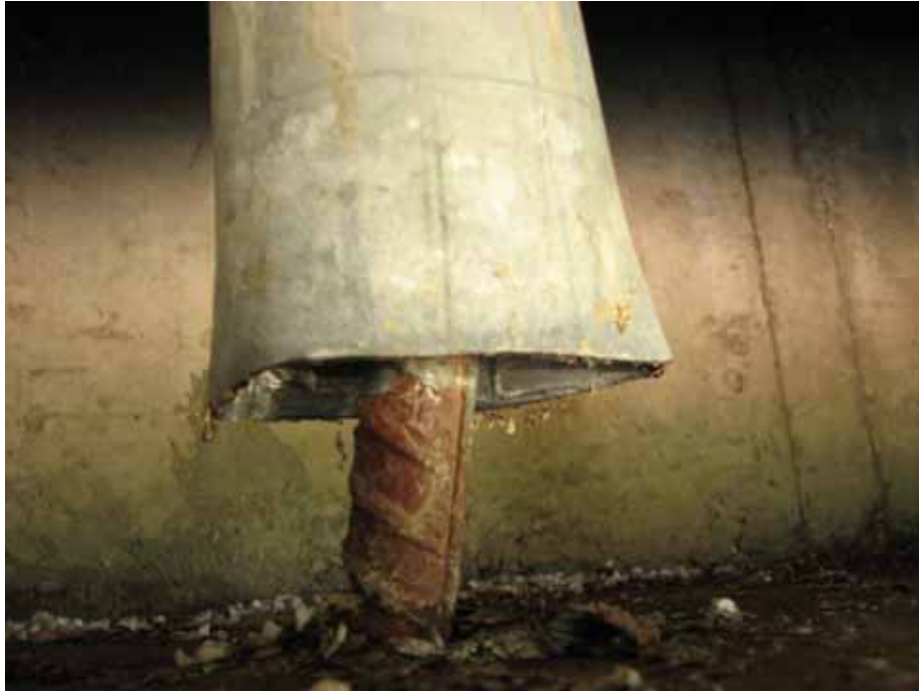
Figure 4.54 Yielded seismic restrainer and steel tube protecting the restrainer from the weather

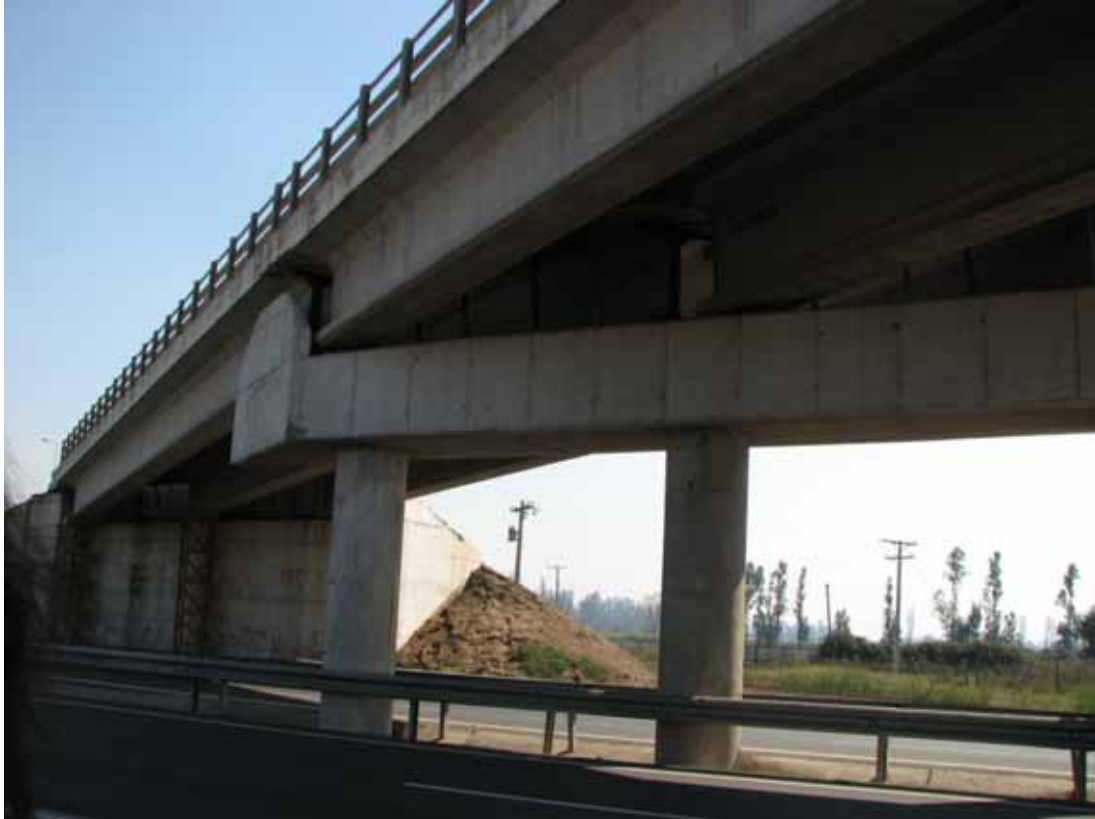
Figure 4.55 Route 5 overpass near Chillán

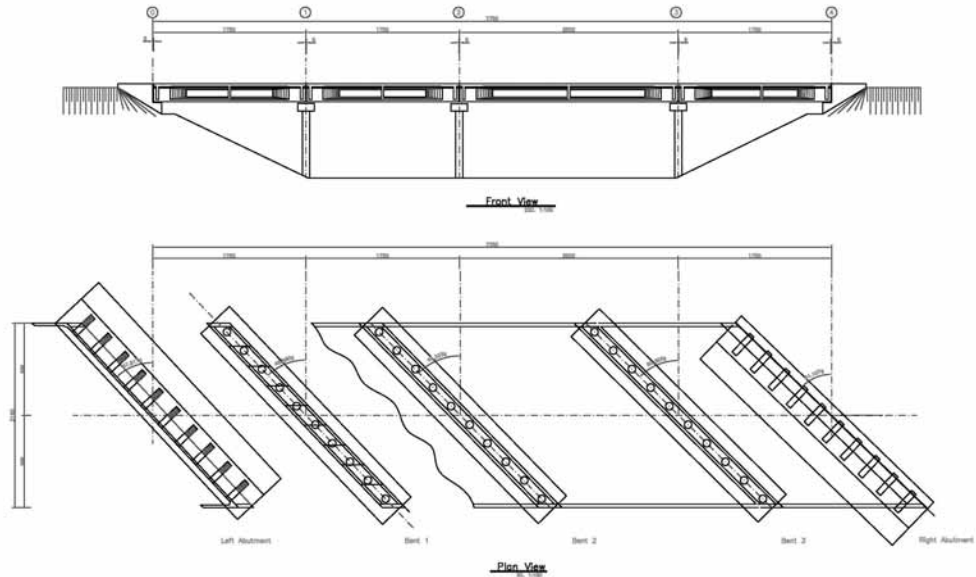
Figure 4.58 Configuration of bridge bents and abutments

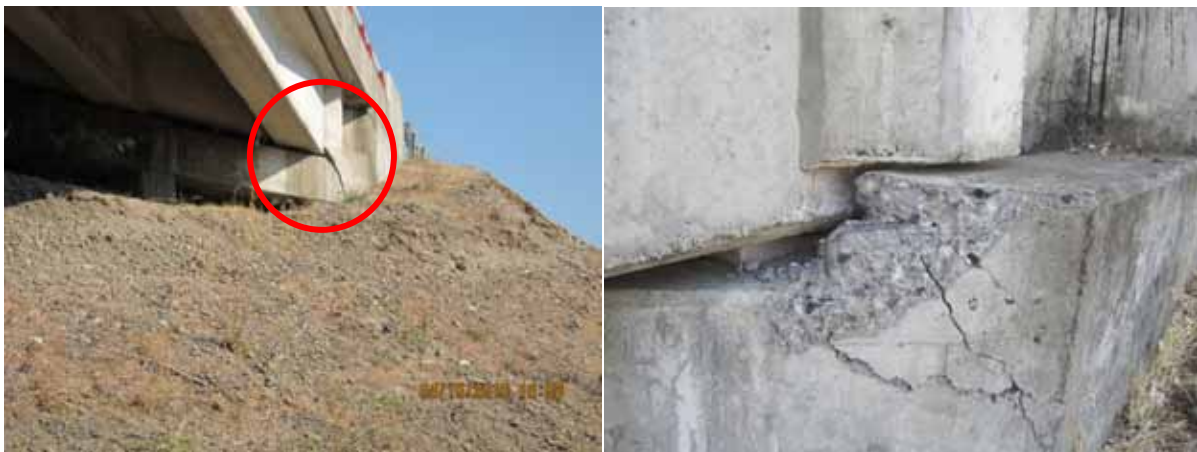
Figure 4.59 Failure of the shear keys

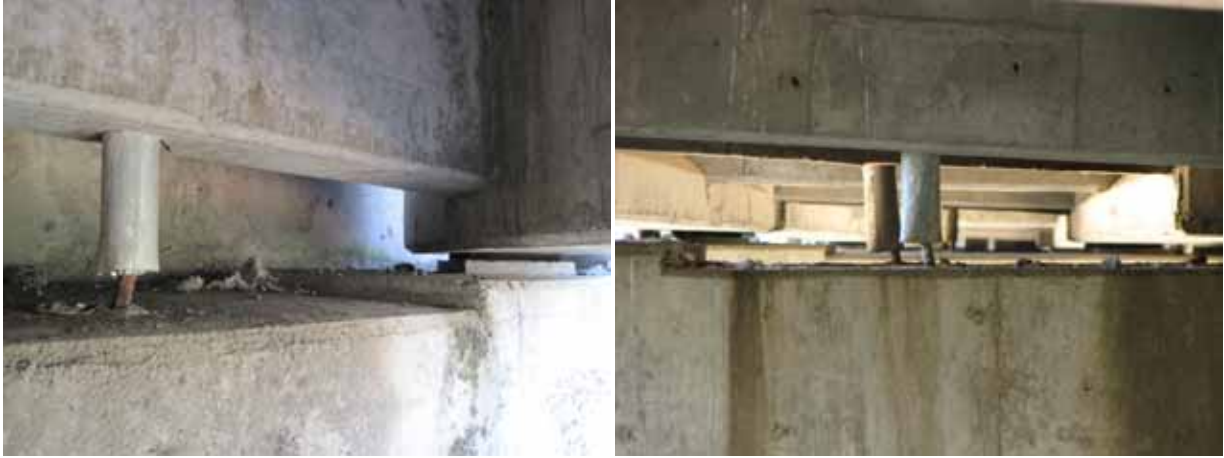
Figure 4.60 Yielded seismic restrainers

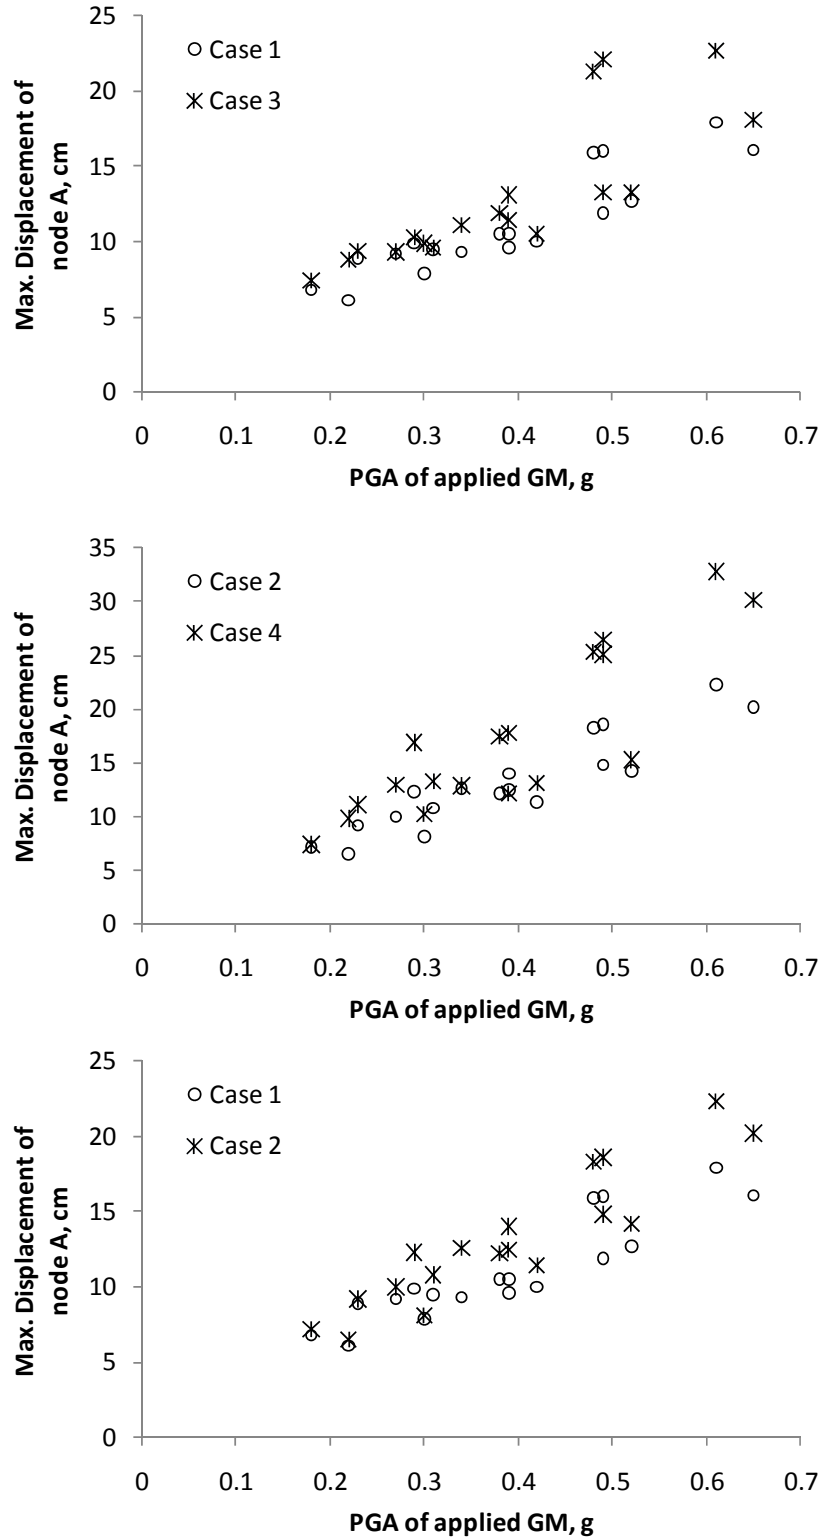
Figure 4.66 Maximum displacement of node A, *Top*: comparison of Cases 1 and 3, *Middle*: comparison of Cases 2 and 4; and *Bottom*: comparison of Case 1 and 2

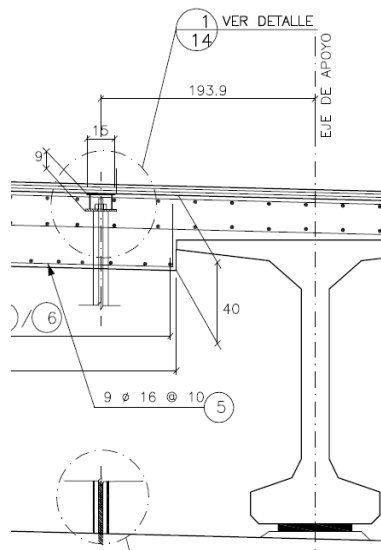
Figure 4.73 Details of the top anchorage of a seismic restrainer

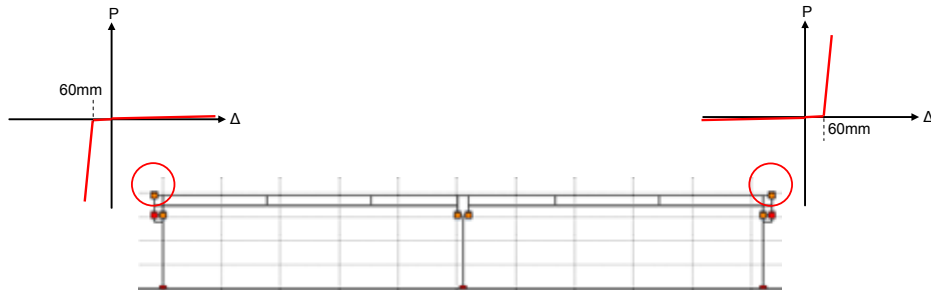
Figure 4.74 Numerical model of bent cap, elastomeric bearing, and seismic restrainer

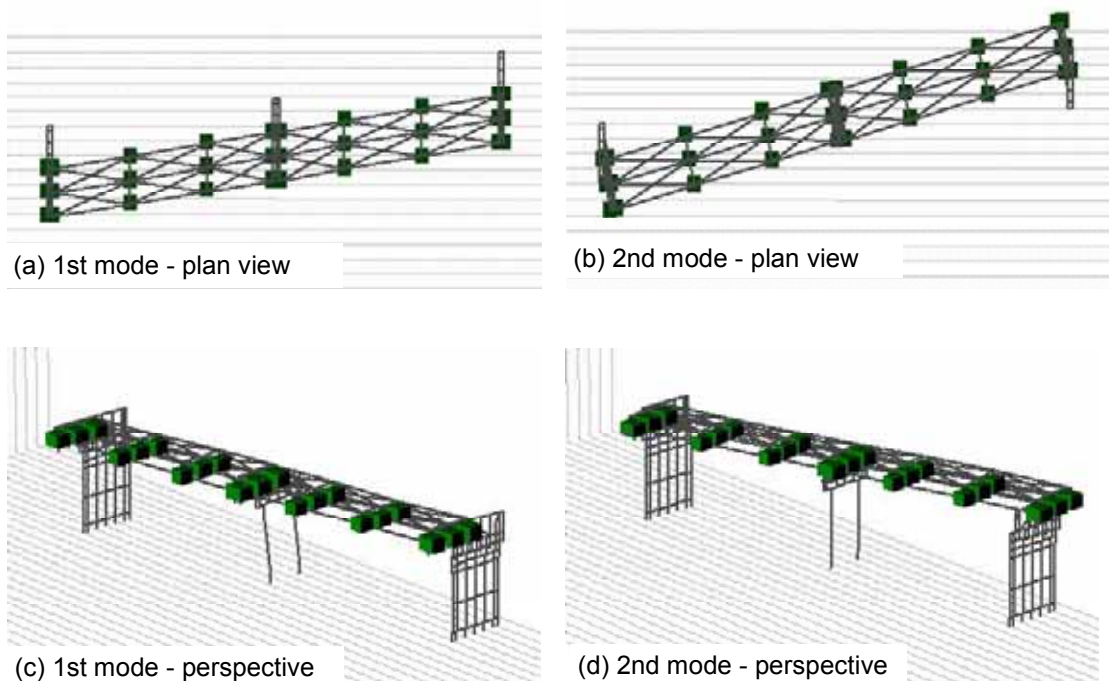
Figure 4.75 Mode shapes of the bridge

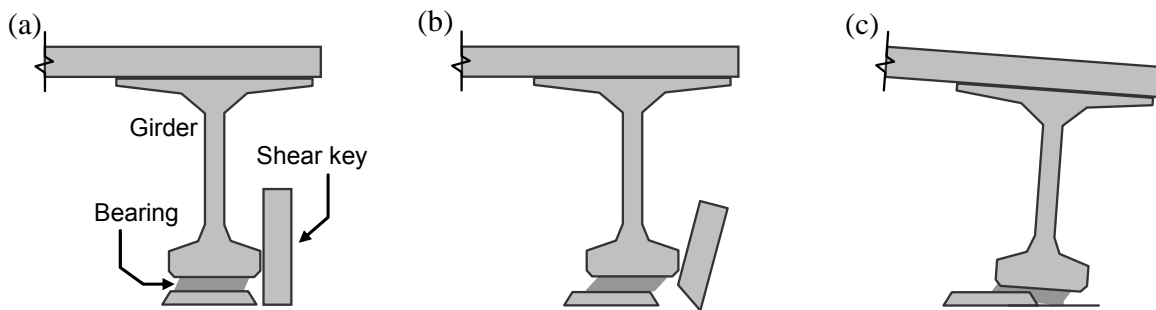
Figure 4.78 Girder slip on elastomeric bearing and bearing support

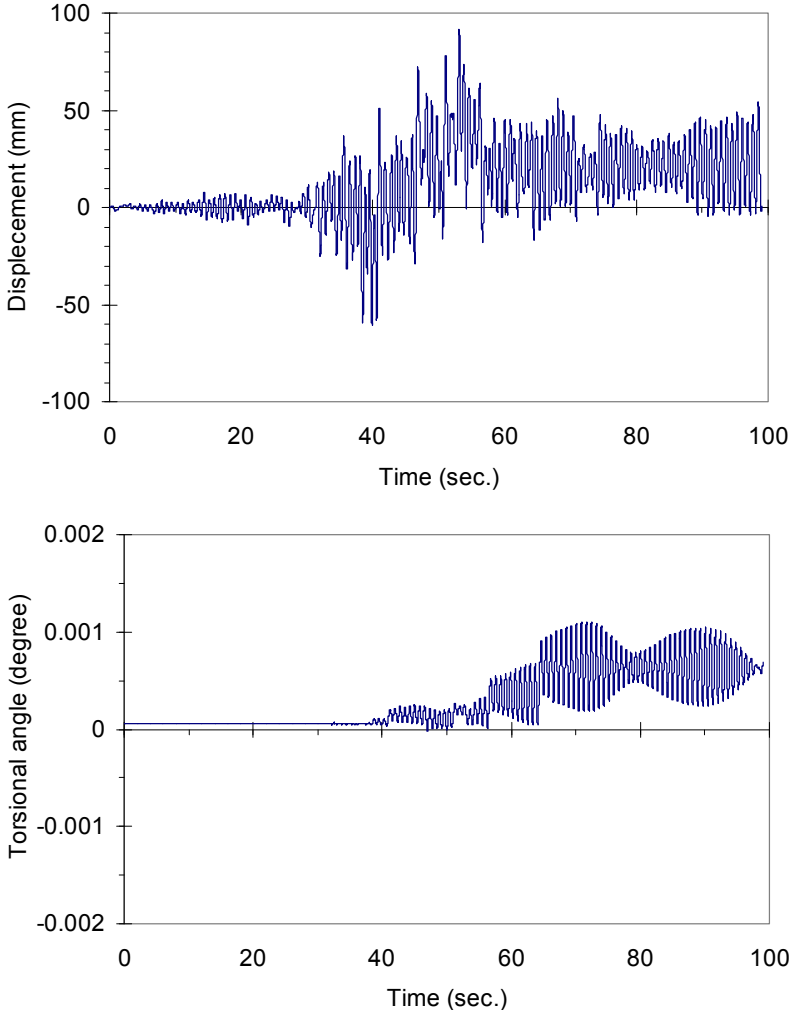
Figure 4.79 Selected dynamic response history results (response history by record: STL, EW component, mean $+0.5\sigma$)
