The Maule (Chile) Earthquake of February 27, 2010

Consequence Assessment and Case Studies

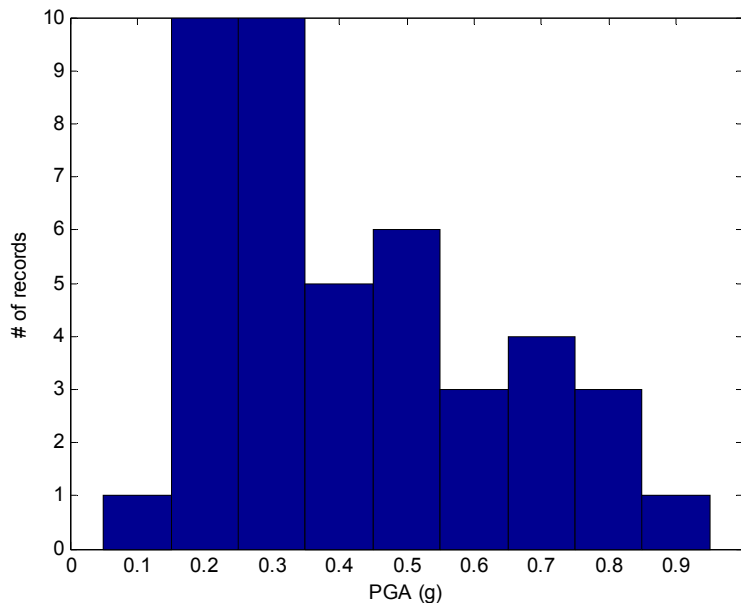
Figure 4.80 Distribution of the PGA of all records used in fragility analysis

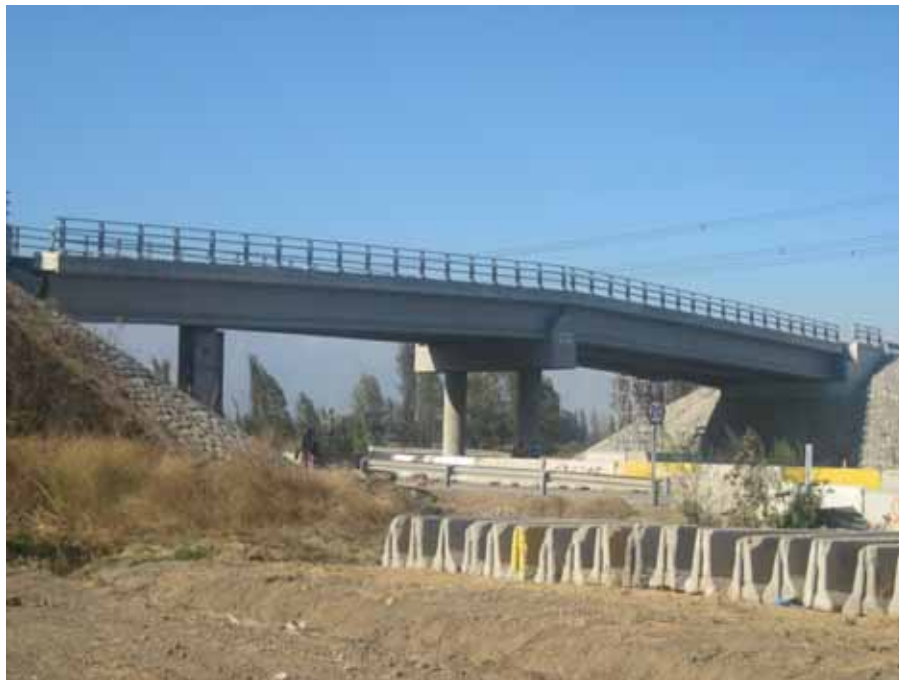
Figure 4.82 Case study overpass bridge crossing Route 5

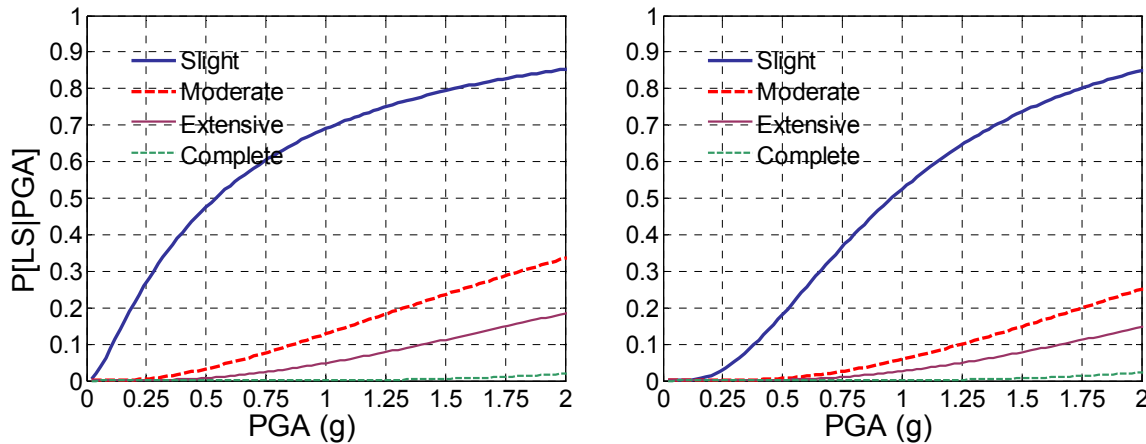
Figure 4.83 Seismic fragility curves in terms of different demand parameters (DP), *Left: DP is curvature ductility; Right: DP is max drift ratio.*

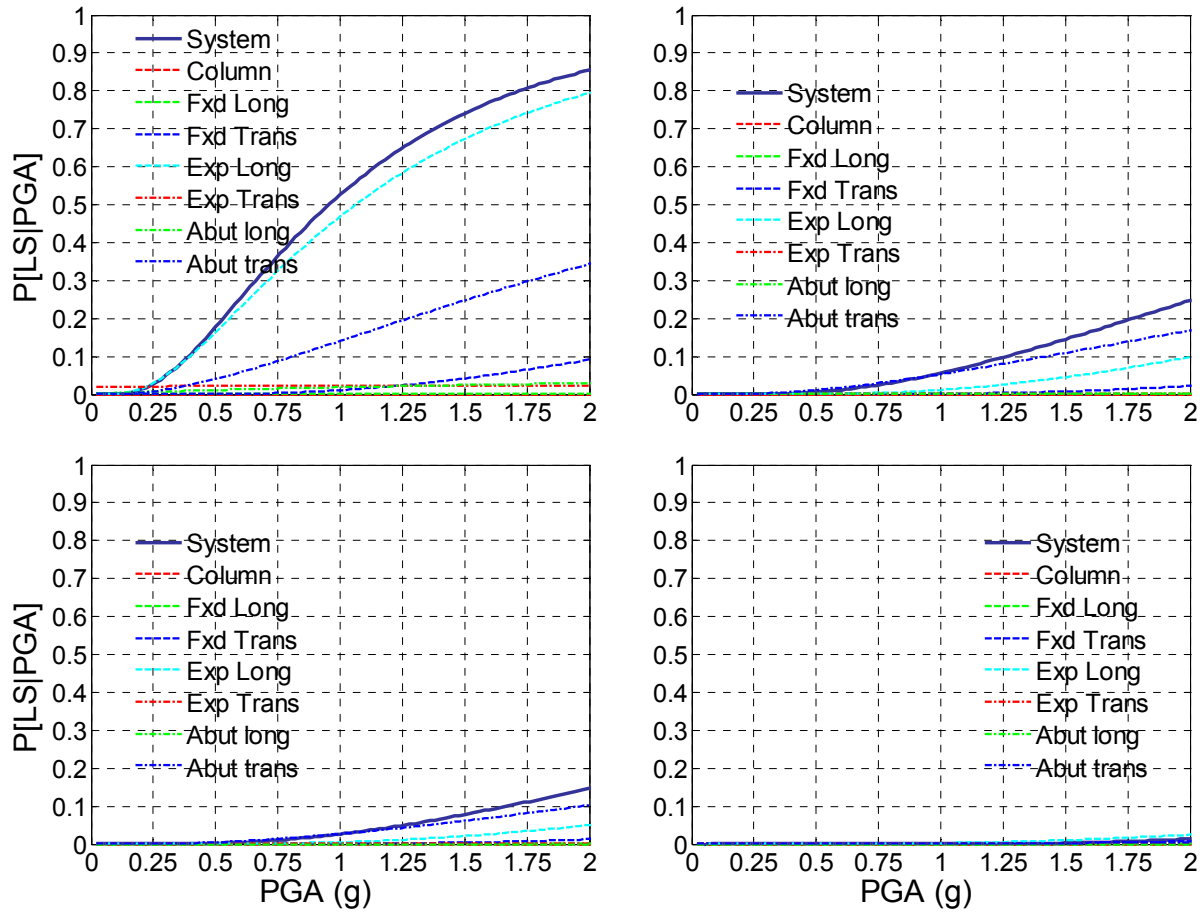
Figure 4.84 Seismic fragility curves of different structural components, *Top-Left*: Slight damage; *Top-Right*: Moderate damage; *Bottom-Left*: Extensive damage; *Bottom-Right*: Complete damage

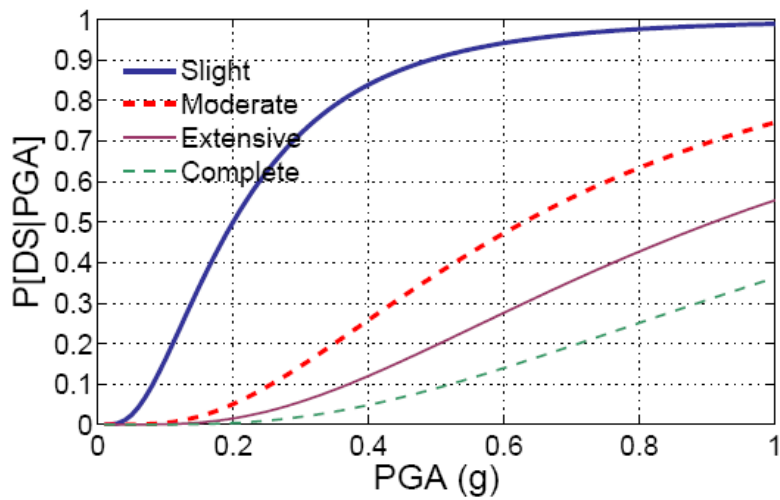
Figure 4.85 MSSS concrete girder bridge fragility curve for moderate seismic zones (Nielson, 2005)

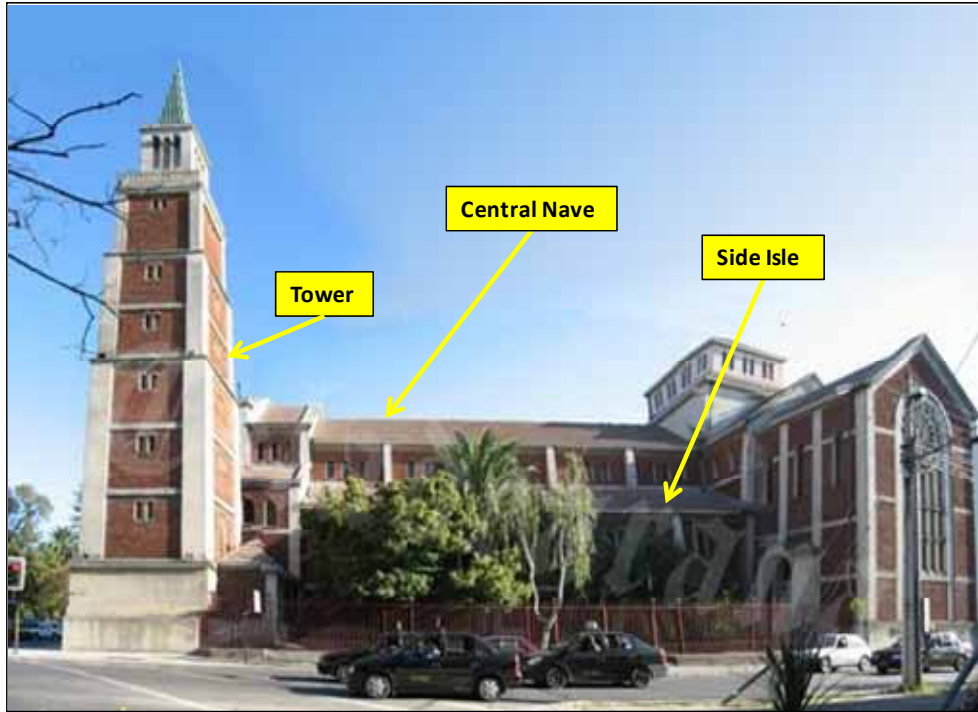
Figure 4.91 External view (side elevation) of the Cathedral before the earthquake

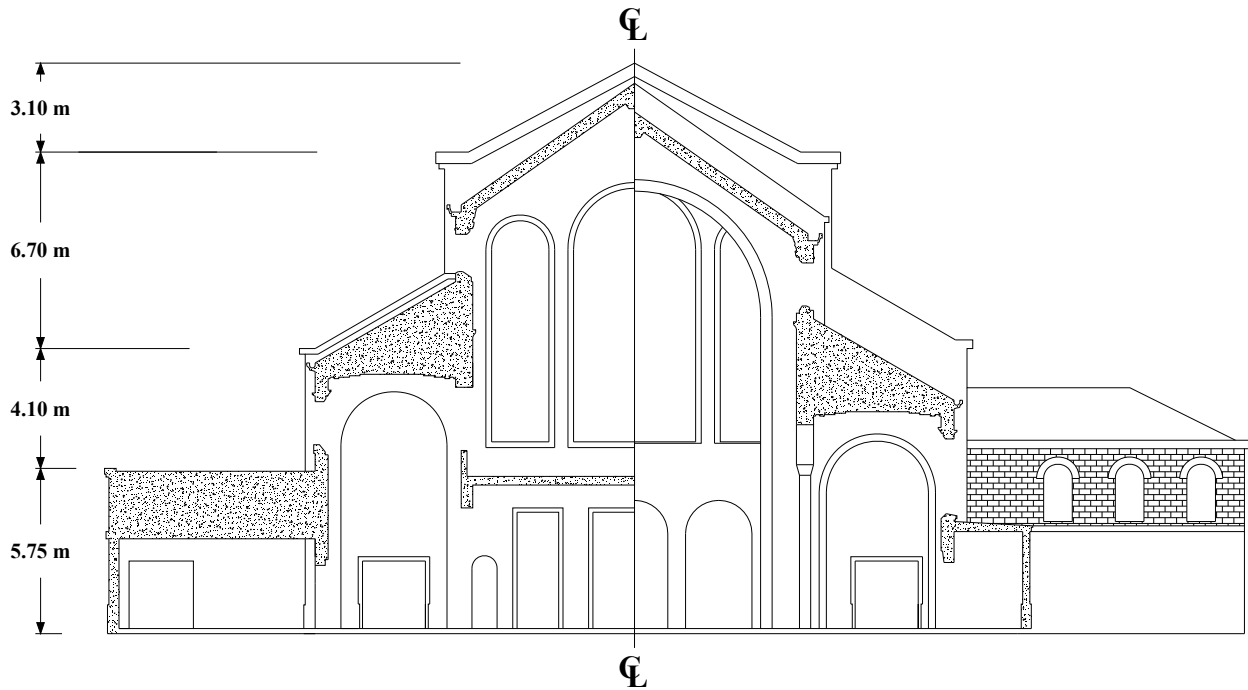
Figure 4.93 Front Elevation (recreated from design drawings)

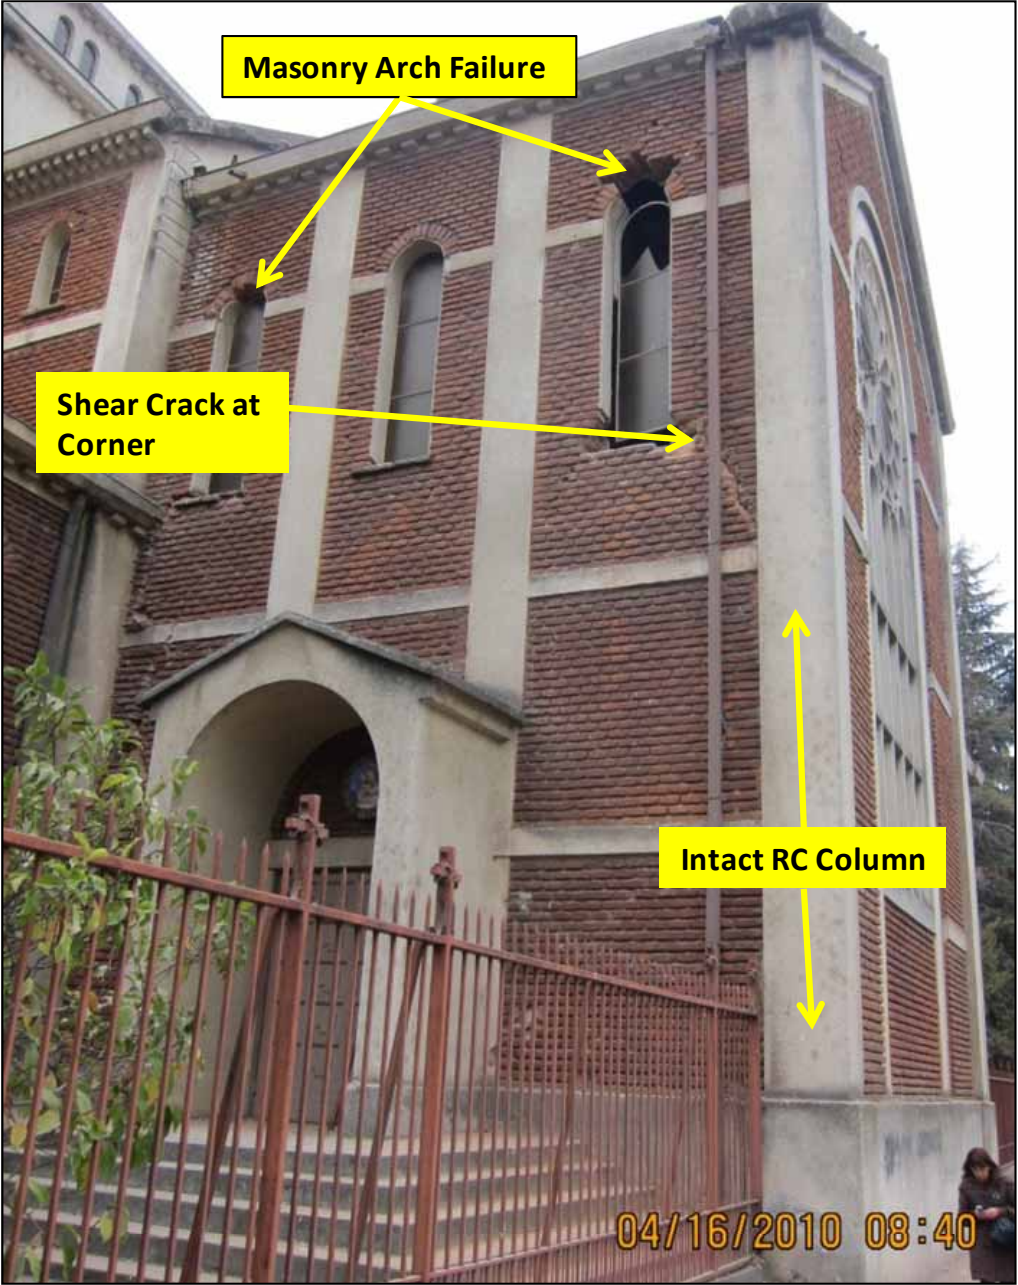
Figure 4.94 Exterior damage to masonry walls

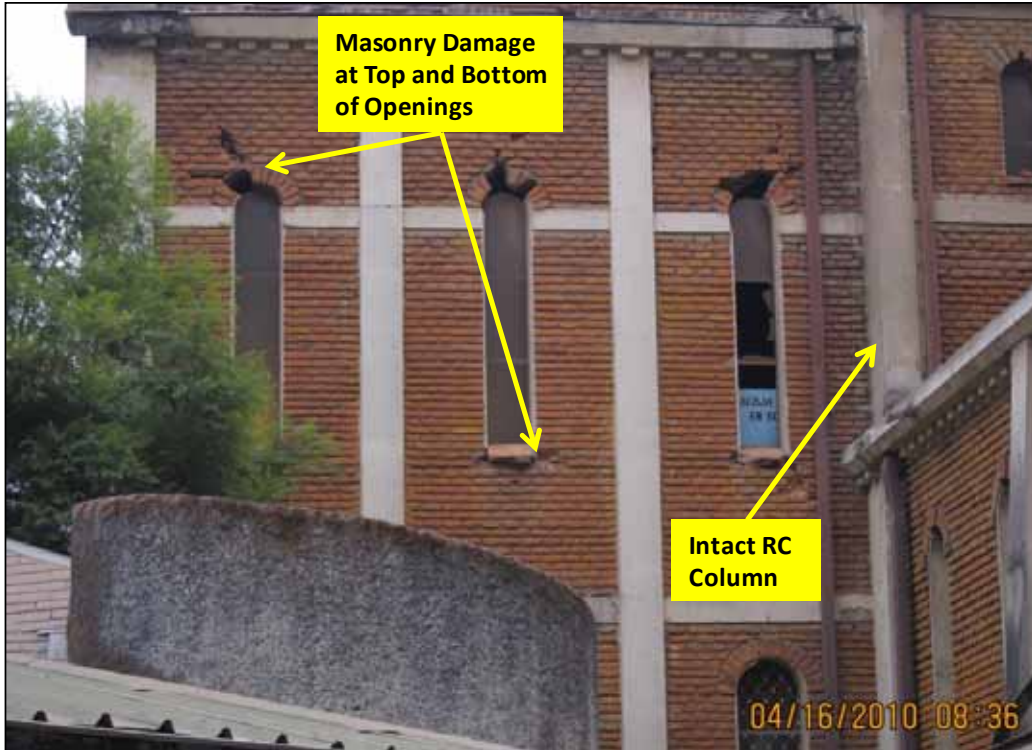
Figure 4.95 Exterior damage to masonry at corners of windows

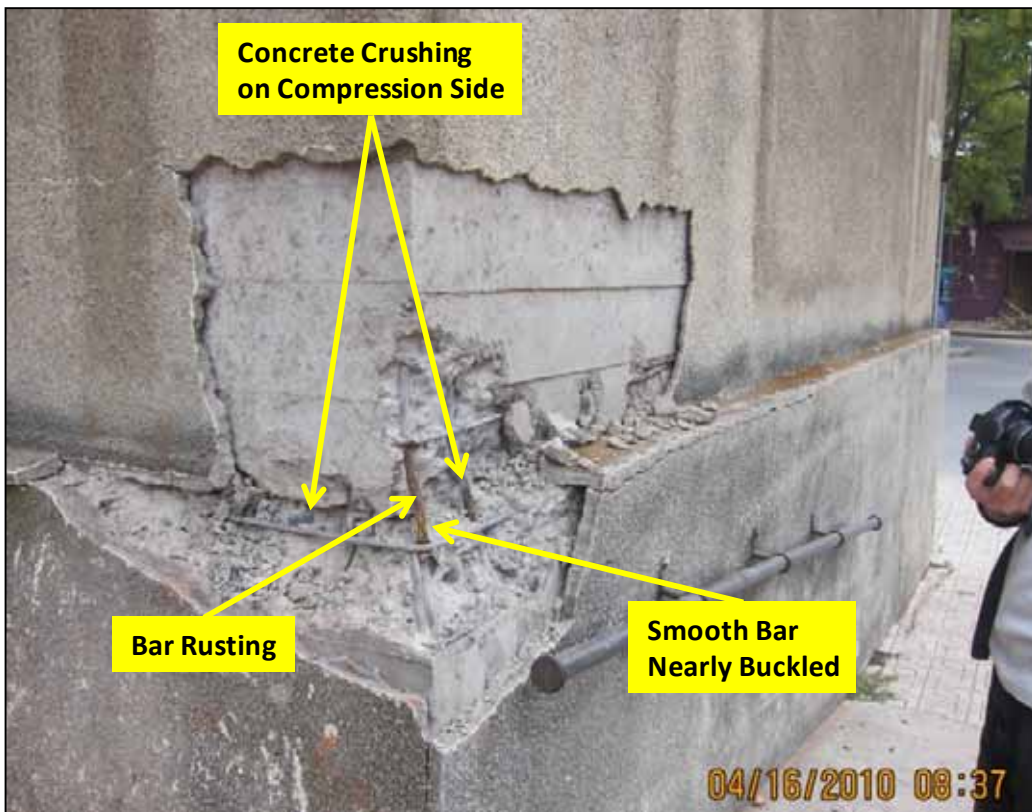
Figure 4.96 Compression-induced damage to exterior RC column

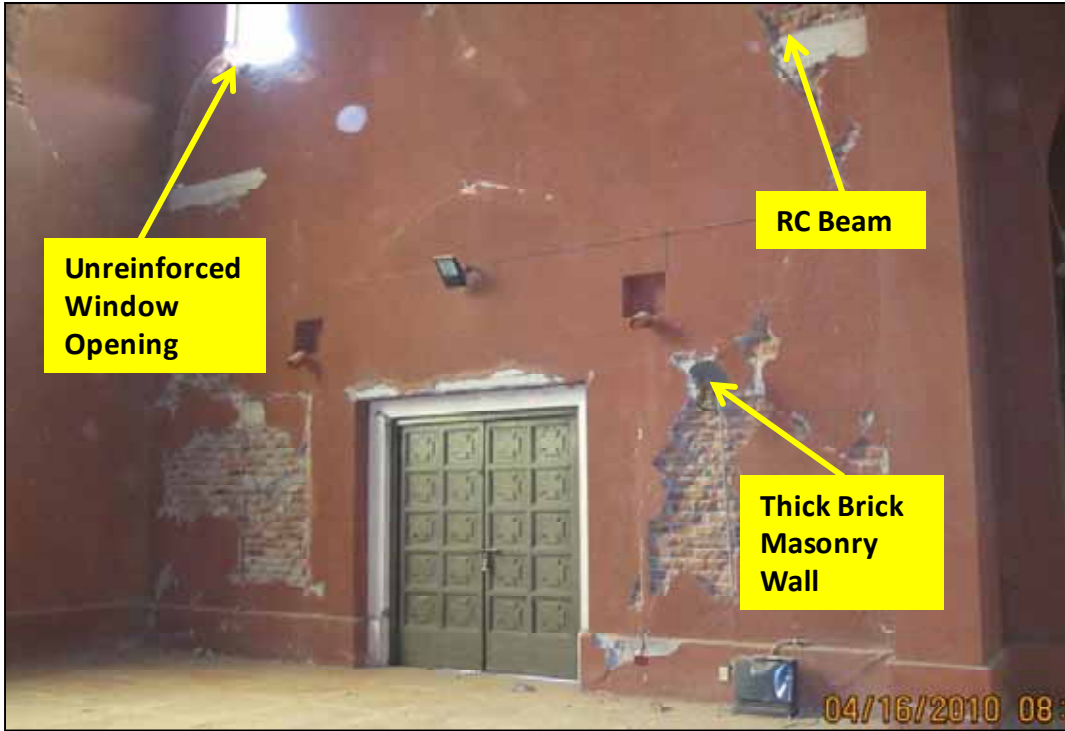
Figure 4.97 *Left:* Interior damage to masonry walls

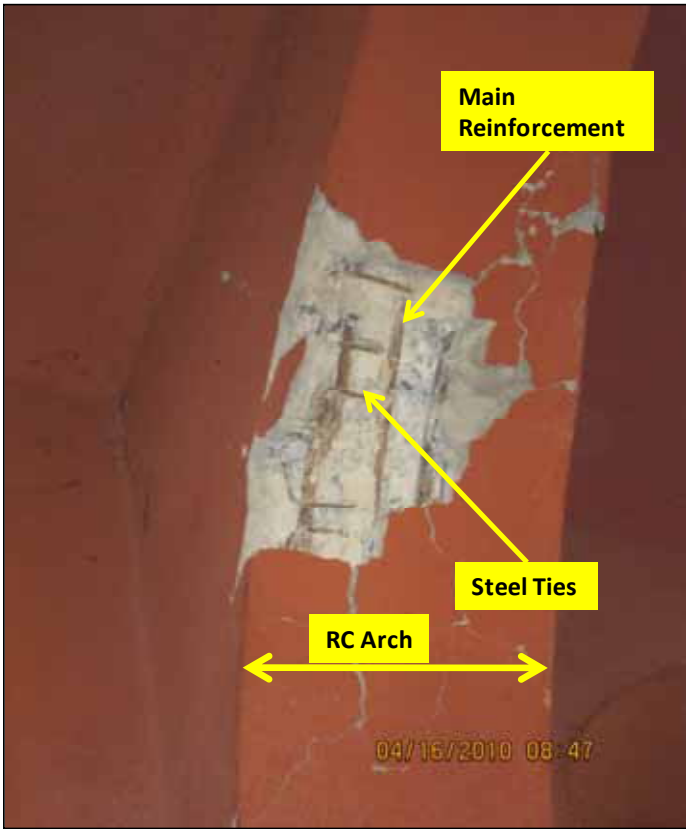
Figure 4.98 Interior spalling of RC cover – showing construction details

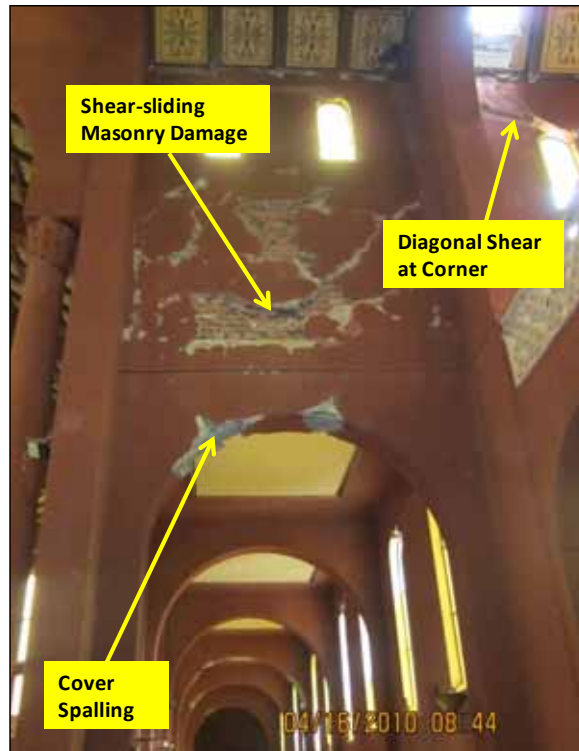
Figure 4.99 Side isles damage to RC arch and masonry wall

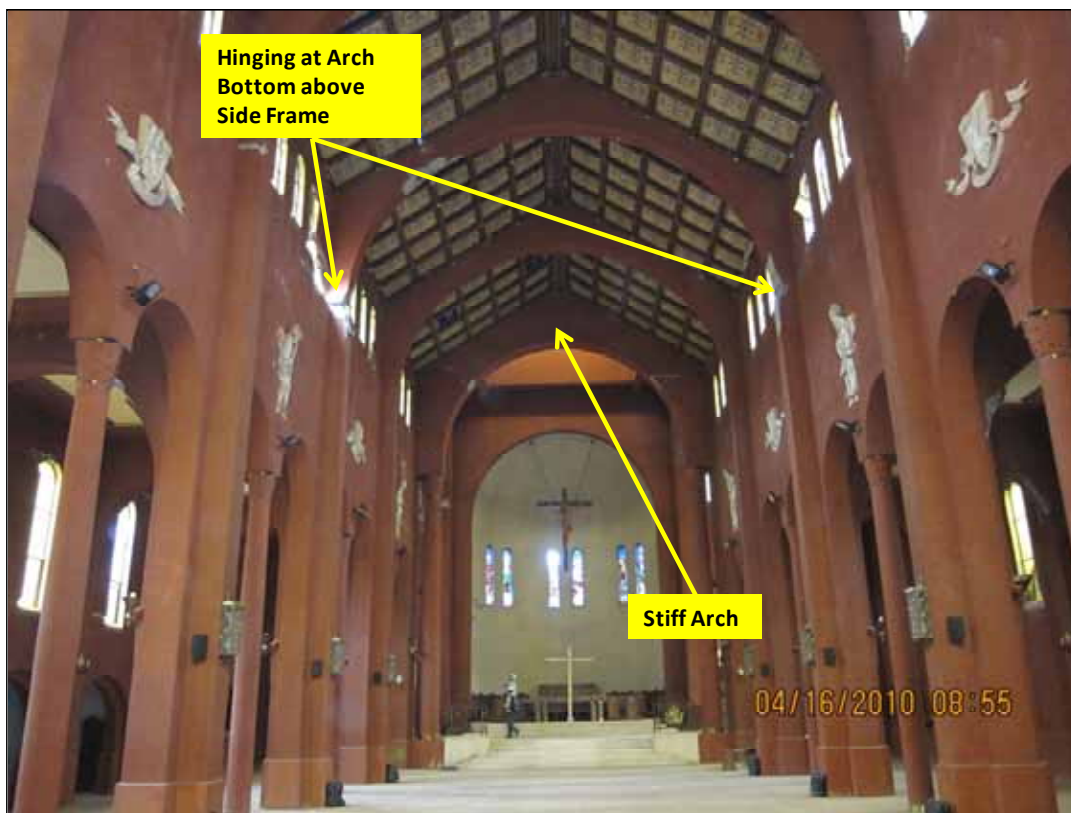
Figure 4.100 Interior damage to high columns at junction with side isles

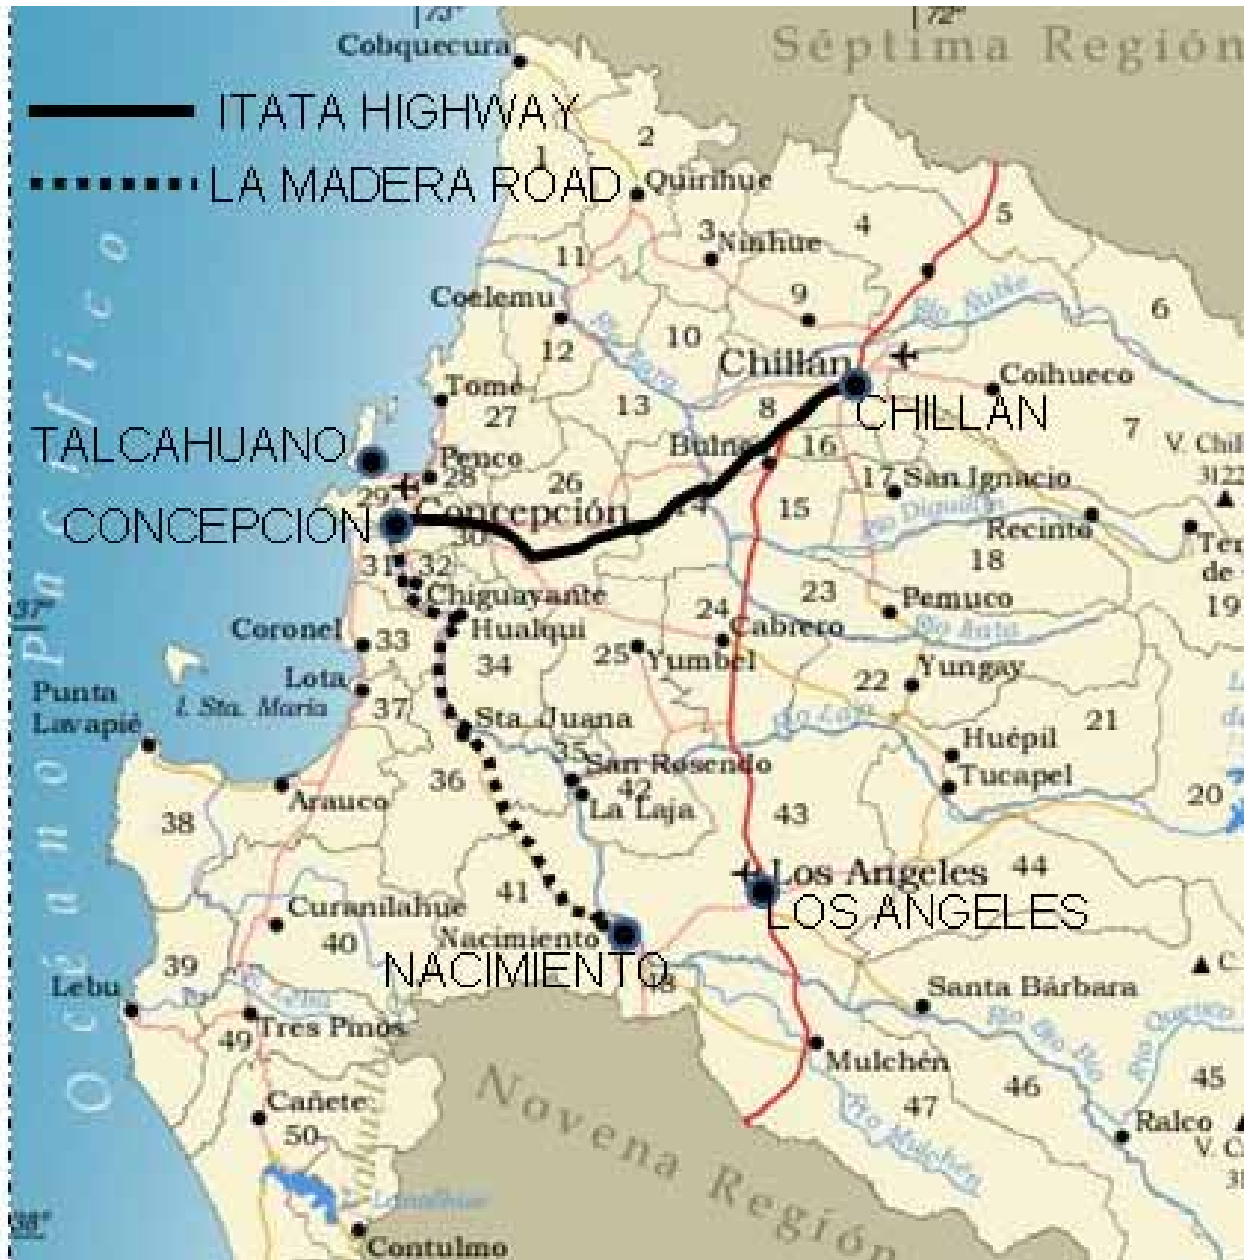
Figure 5.1 La Madera road and Itata highway networks surveyed

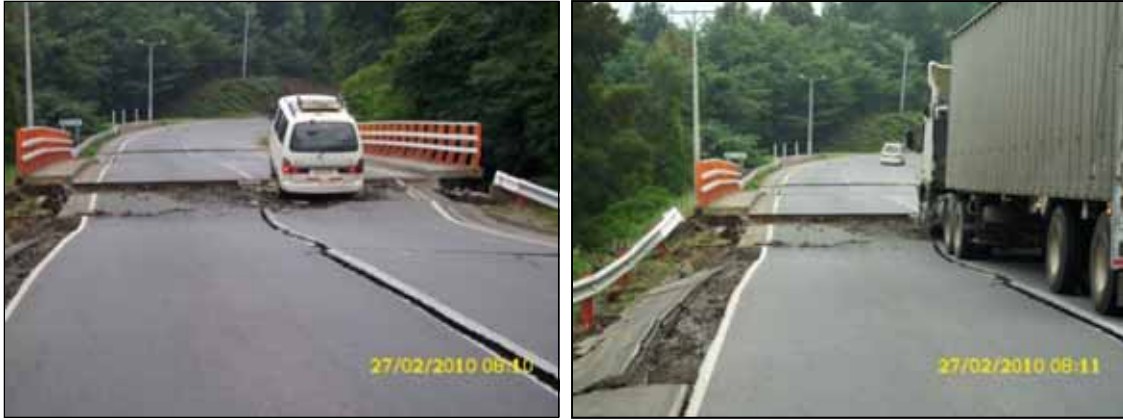
Figure 5.2 Typical bridge approach embankment-fill settlement

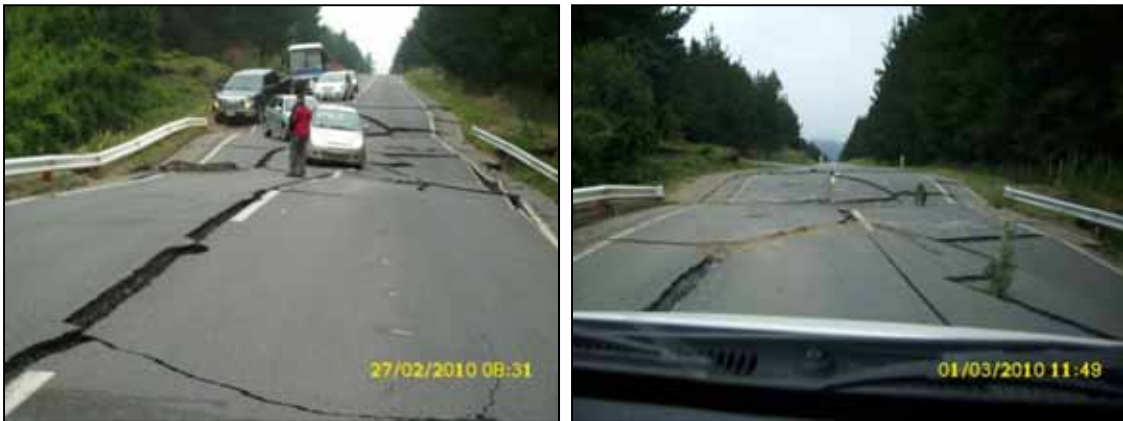
Figure 5.3 Sag vertical curve pavement failures

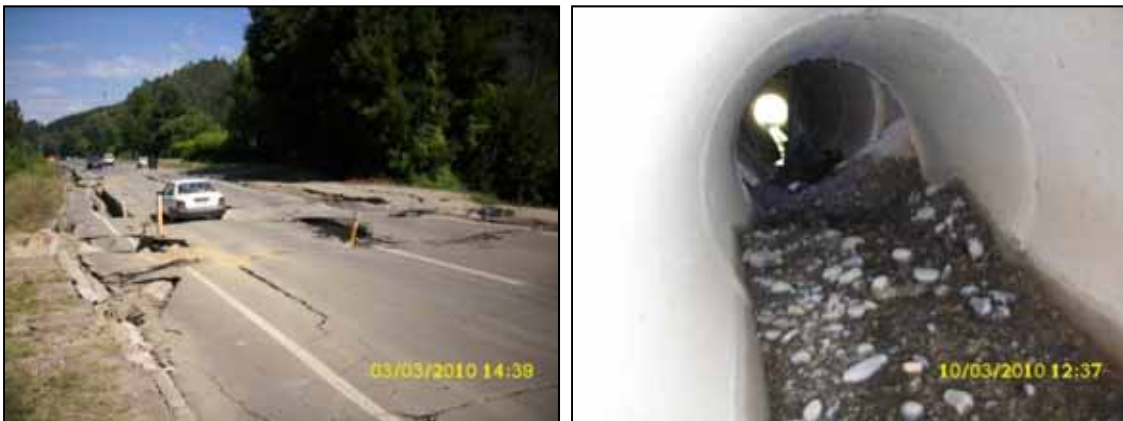
Figure 5.4 *Left:* under-drain fill settlement at the roadway surface; *Right:* collapsed drainage pipe

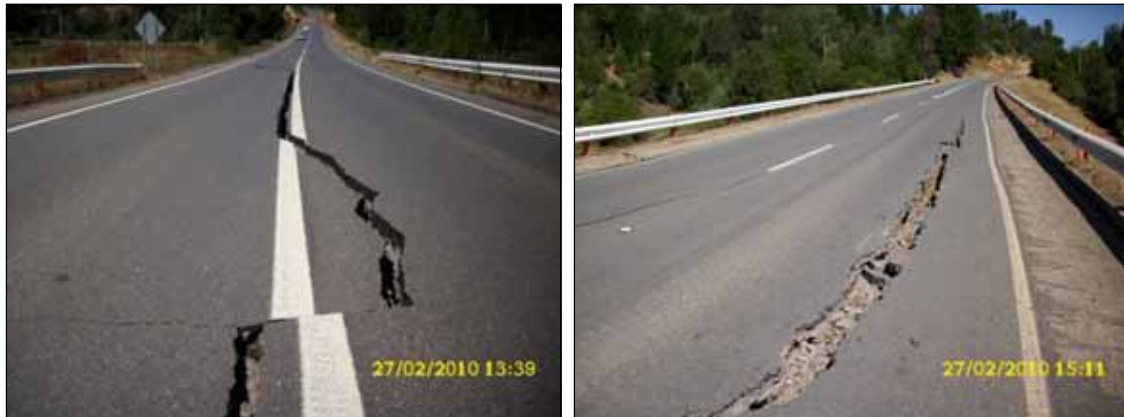
Figure 5.5 Pavement damage due to embankment slope stability and lateral spreading

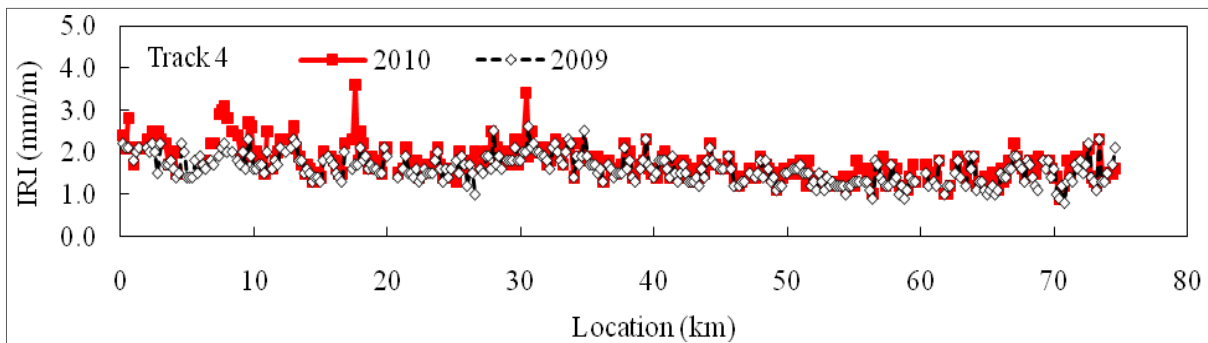
Figure 5.8 Longitudinal variations in IRI from 2009 to 2010 for Lane 4 of Itata highway

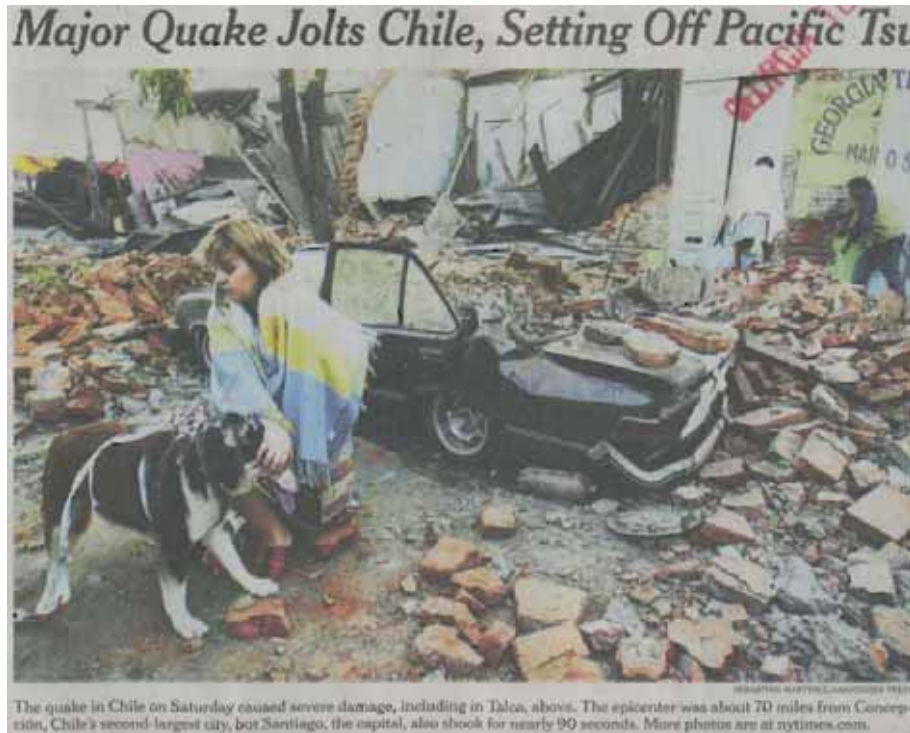
Figure 6.1 Front page New York Times article and photo on February 28, 2010—the day after the earthquake. While the photograph is of Talca, most of the article focused on the damage in Santiago and Concepción

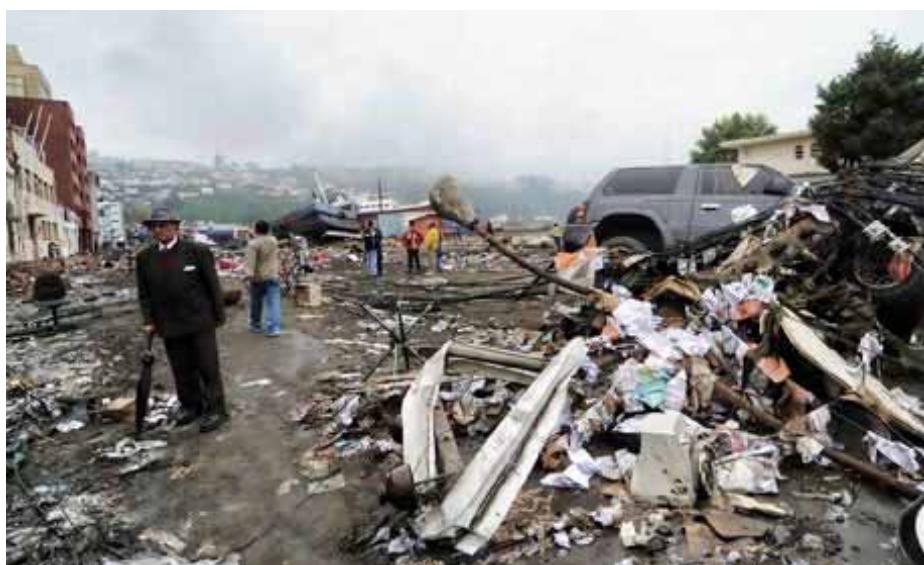
Figure 6.2 Photograph from cnn.com on February 27, 2010, Santiago damage

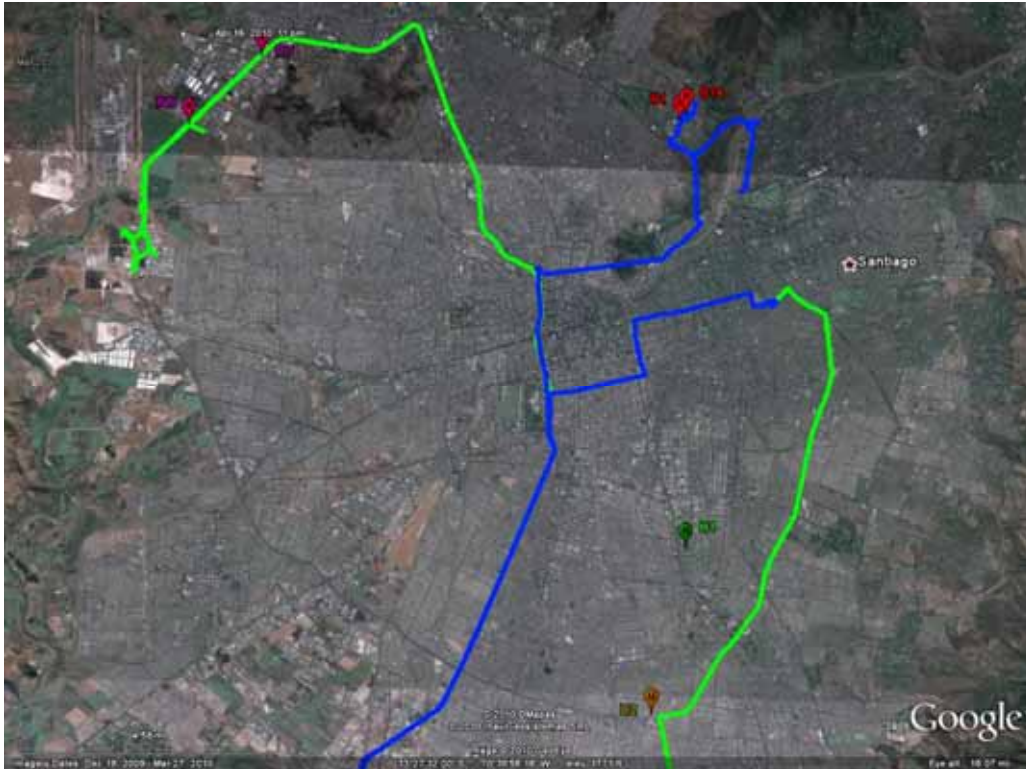
Figure A.1 Santiago region
