Performance of RC frames in 26.11.2019. Albania earthquake: effects of irregularities and detailing*

Ivan Milićević¹⁾, Marko Marinković¹⁾, Nikola Blagojević²⁾, Svetlana Nikolić-Brzev³⁾

ABSTRACT

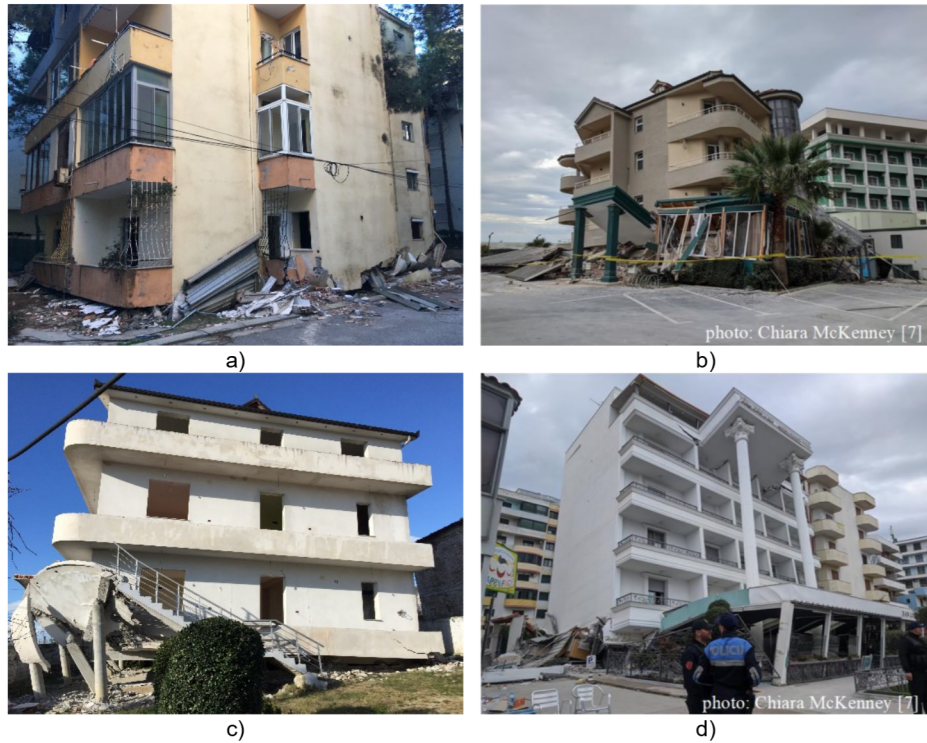
Examples of collapsed buildings in Albania due to the November 26 earthquake are shown in Fig. 3. The "soft storey" collapse was caused by a large difference in the lateral stiffness between adjacent floors-usually ground floors that were more flexible than upper floors. This behaviour is typical for flexible RC frame systems, which are common in Albania. Vertical irregularities were caused by unevenly distributed masonry infills in buildings, with open spaces at the ground floor level (garages, office space, shops, restaurants, etc.), while at the other floors there was a masonry infill (usually housing units). Due to presence of masonry infills and the resulting increased stiffness at higher floor levels, deformation demands on RC columns at open lower floors were significantly increased, which most likely resulted in structural damage and collapse. It should also be noted that Hotel Ljubljana (see Figure 3(d)) had three added floors (vertical extension). The other cause for significant damage of RC columns is their smaller dimensions compared to dimensions of RC beams, as shown in Fig. 6(a).

Figure 3. Examples of building collapses due to “soft storey” effect in the November 26, 2019

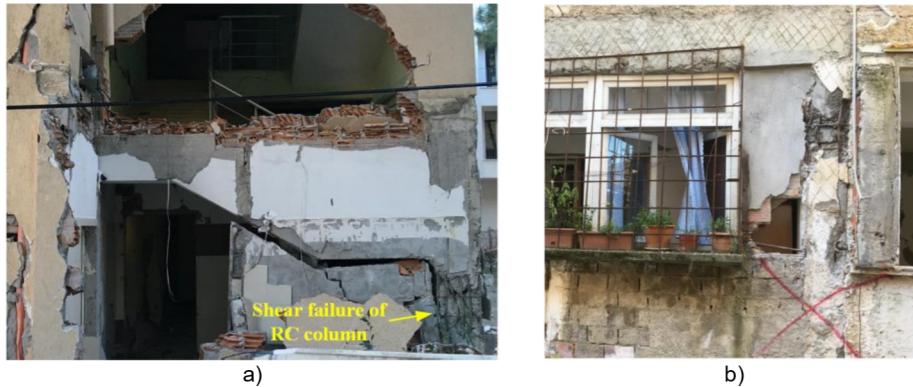
The "short-column" effect most often occurs when some parts of staircase (usually on intermediate landing) are supported by the RC columns or a partial masonry infill is constructed up to a certain height of the RC column due to openings (e.g. windows), acting as a lateral restraint along the column height. Damaged RC columns caused by this effect are presented in Figs. 4(a) and 4(b), respectively. Due to the lateral restraint of RC column provided by the staircase or the partial masonry infill, the column height is smaller. Shortening of RC column leads to increased localized stiffness and internal forces in the column itself (usually shear forces), for which RC column is usually not designed.

Figure 4. Examples of RC column damage due to “short column” effect in the Albania earthquake caused by: a) intermediate staircase landing, b) partial masonry infill due to openings

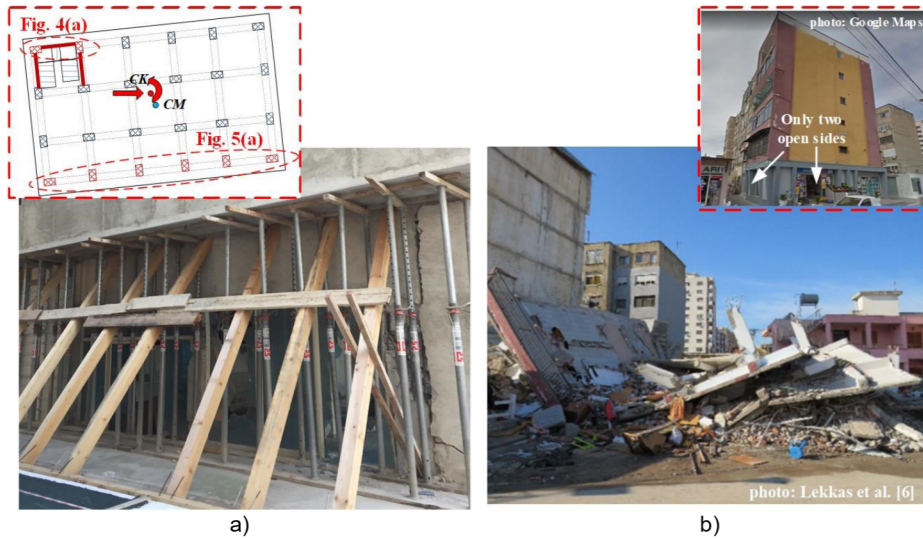
Fig. 5 shows significant earthquake damage and collapse of flexible structures due to torsional effects. The damage was caused by "secondary elements", specifically masonry infills and stairs, which are often neglected in seismic design practice. Fig. 5(a) illustrates the effect of shifting the position of the centre of stiffness of the structure due to the restrained RC columns at the stair support locations. Torsional effects caused an increase of forces in elements on the opposite side, and significant damage of the RC columns along the façade. The damage of an RC column which supports the staircase in this building is shown in Fig. 4(a). The building also had an open space at the ground floor. Fig. 5(b) shows the collapse of a corner building that had two adjacent open sides at the ground floor level with masonry infill walls along the other two sides. The ruins were cleared before the authors' reconnaissance, but it is believed that the collapse

was primarily due to inadequate detailing of RC members and torsional effects caused by a significant increase in stiffness on sides with masonry infill and an eccentricity of the centre of mass (CM) relative to centre of stiffness (CK).

Figure 5. Examples of damage and collapse of a building in Durres due to torsional effects: a) shifting of centre of stiffness due to the corner staircases, b) the influence of masonry infills

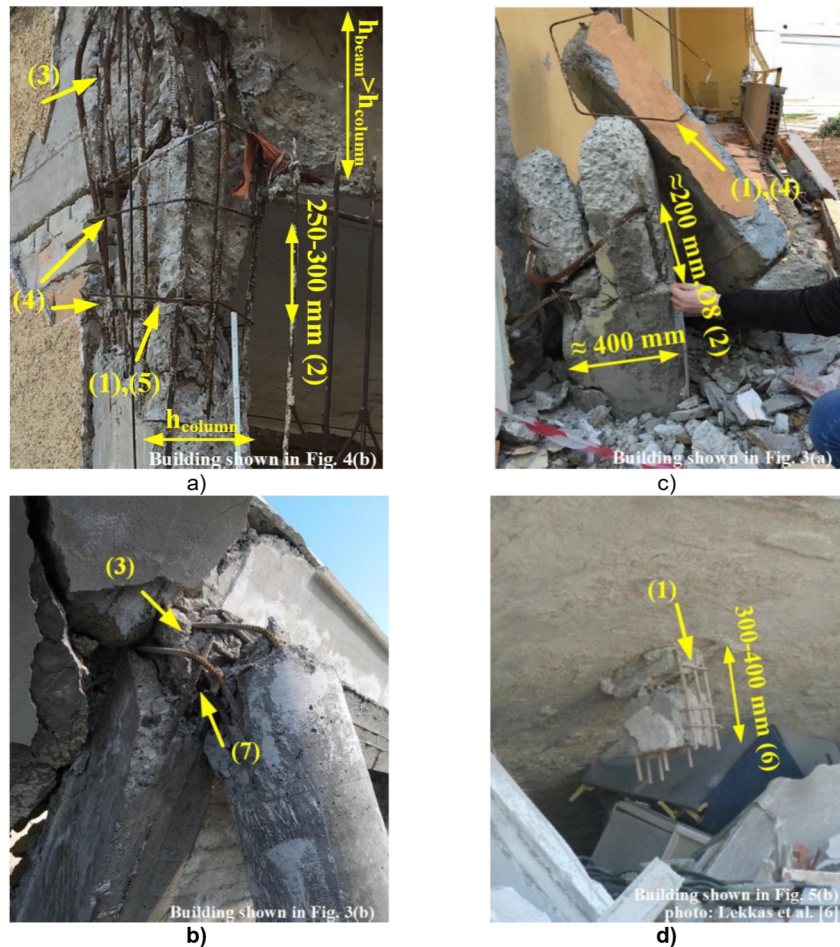
Apart from structural irregularities, several typical flaws in reinforcement detailing for the local ductility of the elements of RC frames (columns and beams), were observed in most of the damaged and collapsed buildings. Examples of these flaws are shown in Fig. 8. The authors believe that the most common detailing flaws were:

- (1) A single perimeter tie in RC columns in “critical” regions (according to [5], for RC columns with cross section dimensions larger than 30 cm, there should be at least 2 ties);
- (2) Widely spaced stirrups/ties in “critical” regions and/or outside the “critical” regions of beams and columns (according to [5], for IX seismic zone spacing of ties in RC columns should be less than 8 diameters of longitudinal bars or 10 cm);
- (3) Lack of or complete absence of stirrups in beam-column joint regions;
- (4) Ties with 90° hooks and insufficient anchorage length (according to [5], 135° hooks with straight part not shorter than 10 tie diameters are mandatory);
- (5) Ties with 6 mm diameter in RC columns (according to [5], for seismic zone IX diameter of ties should be at least 8 mm);

- (6) Insufficient lap splice length when (often 100% spliced reinforcement at one floor);
- (7) Insufficient anchorage length of longitudinal beam reinforcement (without hooks).

A few examples of highlighted detailing flaws are shown in Fig. 6.

Figure 6. Examples of inadequate detailing of reinforcement in RC columns and beams

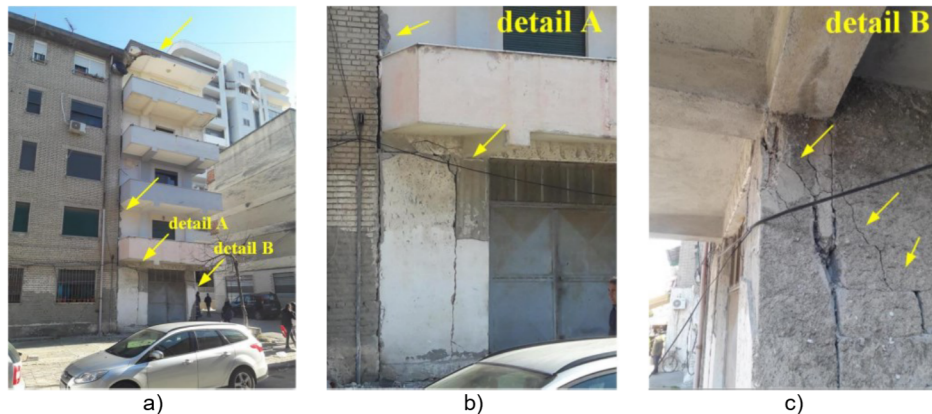
Several buildings suffered minor damage in the earthquake due to pounding, which was caused by insufficient width or absence of seismic gaps. An example of damage caused by this effect is shown in Fig. 7. In this case, the building experienced permanent inter-storey drifts. The interaction caused damage such as crushing of concrete cover (see Fig. 7(b)) and cracking of infill walls made out of concrete blocks as well as RC columns (see Fig. 7(c)) is the result of their interaction. This mechanism is explained in detail in [8].

Figure 7. Example of damage caused by pounding of adjacent buildings (a, b) and interaction between RC frames with infill walls (c)

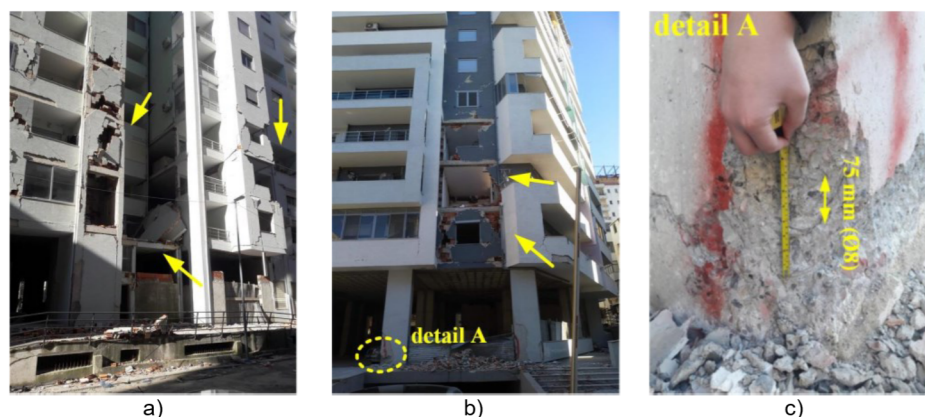
Most of the buildings that sustained significant damage or collapse during the November 26 earthquake were built between 1990 and 2010. Although the buildings built after 2010 also sustained damage in the earthquake, the level and extent of damage to the structural elements of these buildings were relatively small. The masonry infills suffered most of the damage. Although these (mostly tall) buildings had flexible RC frame structures, the authors believe that RC elements with large dimensions had a significantly higher load-bearing capacity compared to the masonry infills. Therefore, due to large inter-storey drifts at lower floor levels (typical for frame structures), only masonry infills experienced significant damage (see Figs. 8(a) and 8(b)).

Minor damage of RC elements can be attributed to adequate detailing of reinforcement for local ductility (see Fig. 8(c)).

Figure 8. Examples of damage to modern buildings with RC frame structure
