Geological Problems at Kerr Dam Lake County, Montana

GEOLOGIC PROBLEMS AT KERR DAM
LAKE COUNTY, MONTANA

A Thesis
Submitted to the Department of Geology
in Partial Fulfillment of the
Requirements for the Degree of
Geological Engineering

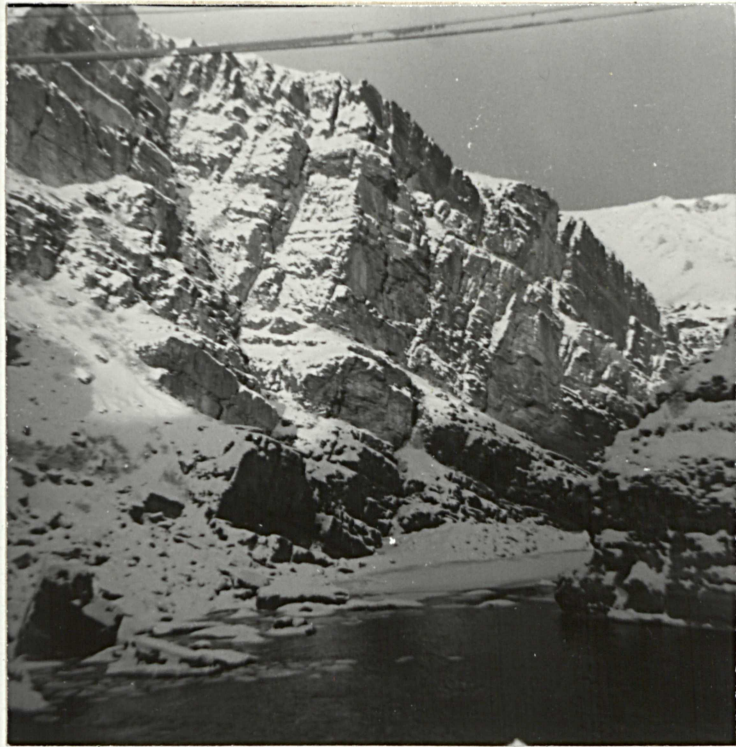
A - Photograph taken from the northeast corner of the powerhouse showing the strata dipping upstream to the east.

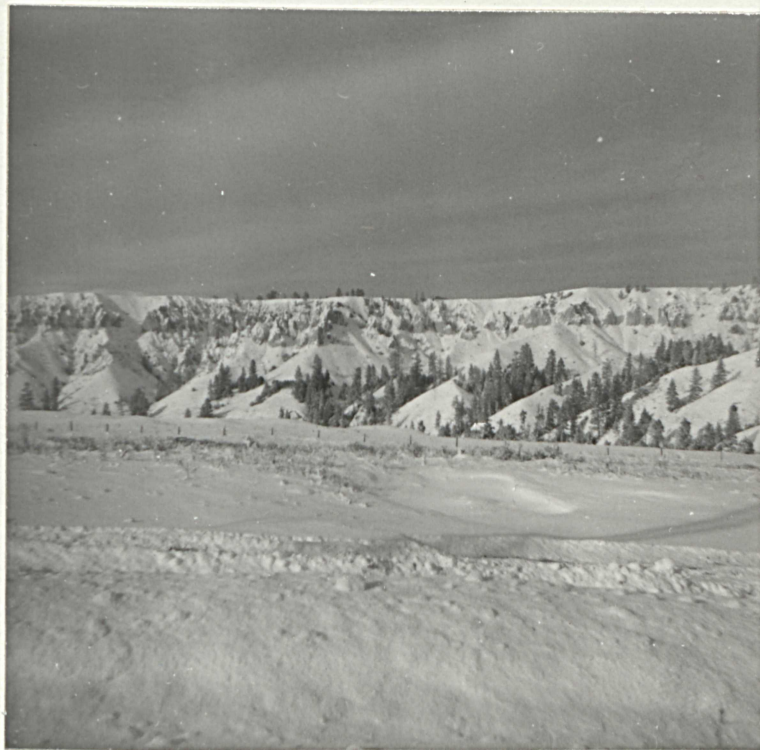
The area in which the dam lies is an "island" of pre-Cambrian Beltian age rocks, surrounded by Tertiary lake deposits. The immediate country is flat or very gently rolling and the Flathead River gorge (Photograph B, Plate I) is the only major topographic feature. The surrounding area is largely under cultivation, with wheat the most prominent crop.

B - Photograph of Flathead River gorge cut into Tertiary lake deposits showing deeply eroded banks and pinnacles left under a protective cover.

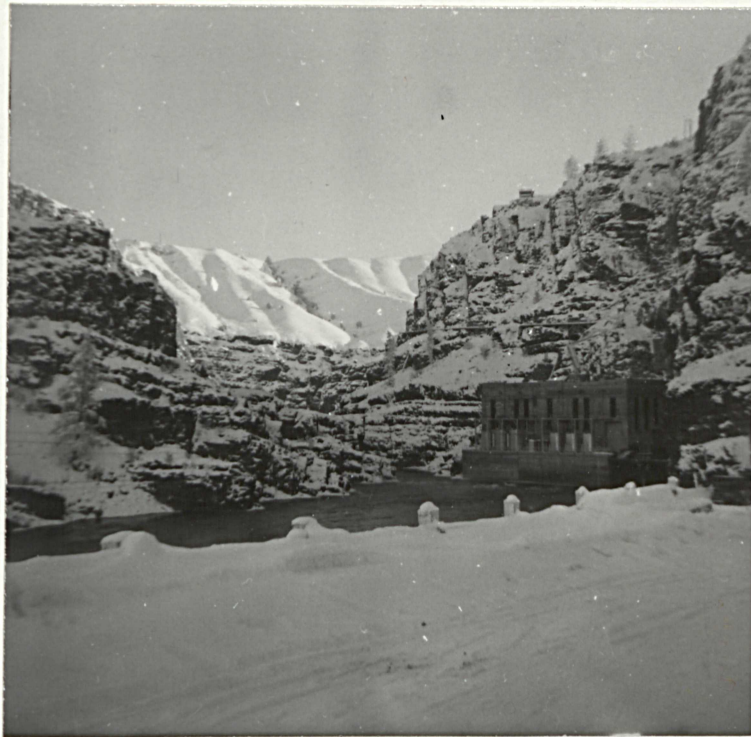
A - View looking towards the powerhouse, through the "island" of pre-Cambrian strata. Lake beds show in the background.

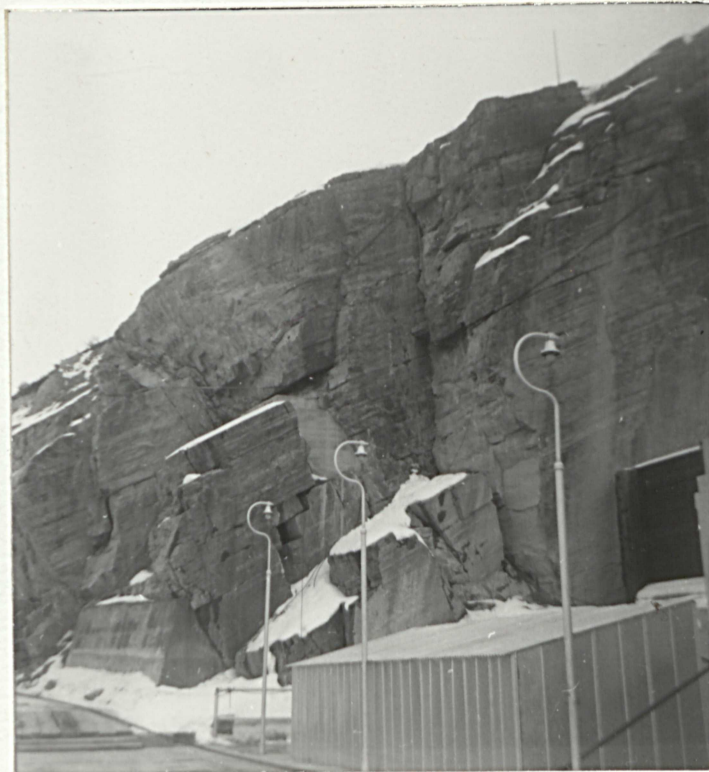
B - View of the blocks of strata still remaining in place, formed as the result of the three directional jointing.

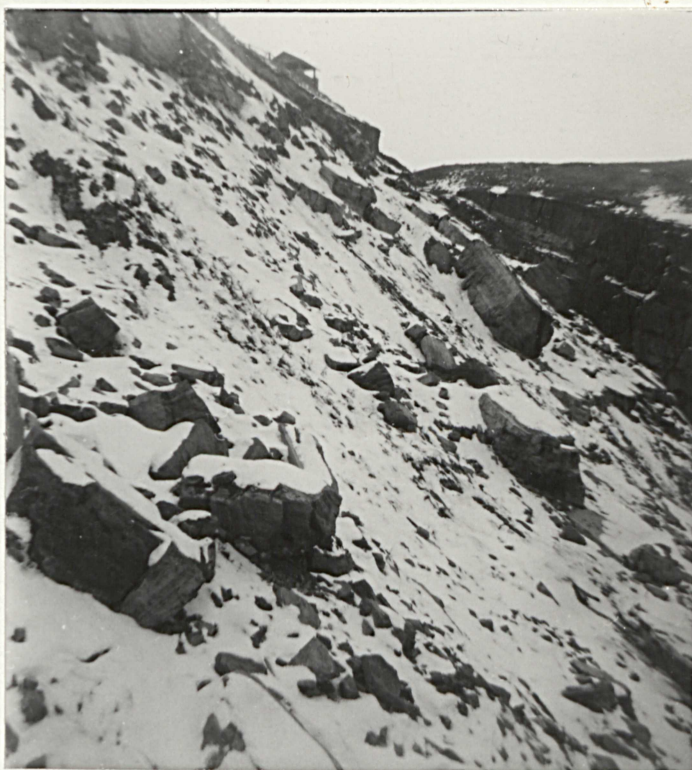
A - Photograph of the dislodged blocks lying on the dip-slope below the dam.

The main fault, striking approximately north and south, is very nearly normal to the bedding and is dipping to the west. The fault is a normal strike fault, closely paralleling the normal north-south joint pattern of the argillite beds. There are three well-defined sets of joint planes in the area. First is the fracturing along the bedding, second is a system of joints parallel to the dip, and a third, a system parallel to the strike. A contour map (Plate VI) shows the strike fractures in many places in the area. The jointing of the rocks has a tendency to allow large blocks to fall into the river gorge and subsequently become covered with gravel. Care was taken to interpret the cores from these large blocks, because there was a danger of falsely calling them bedrock. (Photograph A, Plate III, showing similar blocks lying on the slope)

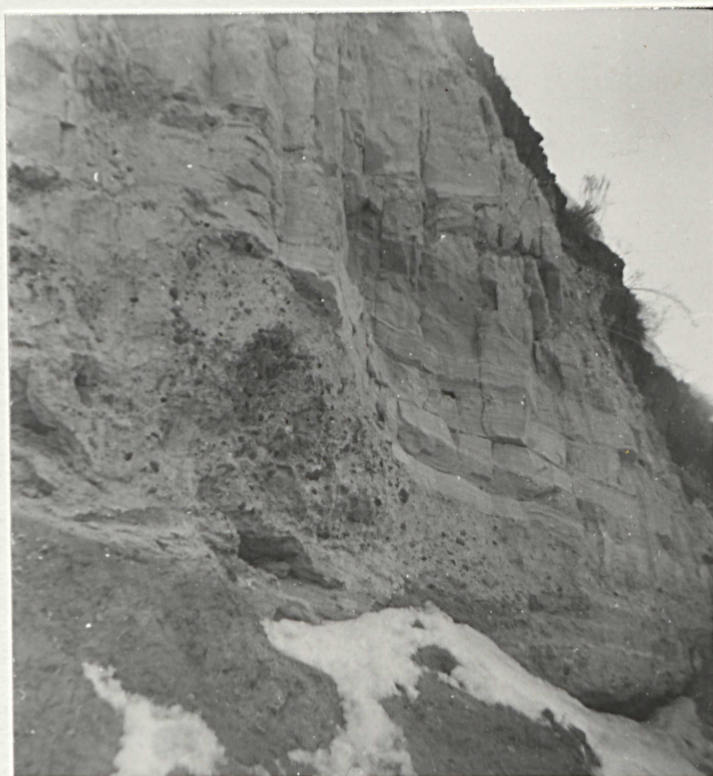
B - Close-up of the Tertiary lake bed deposits. Photograph taken in a road cut going down to the dam.

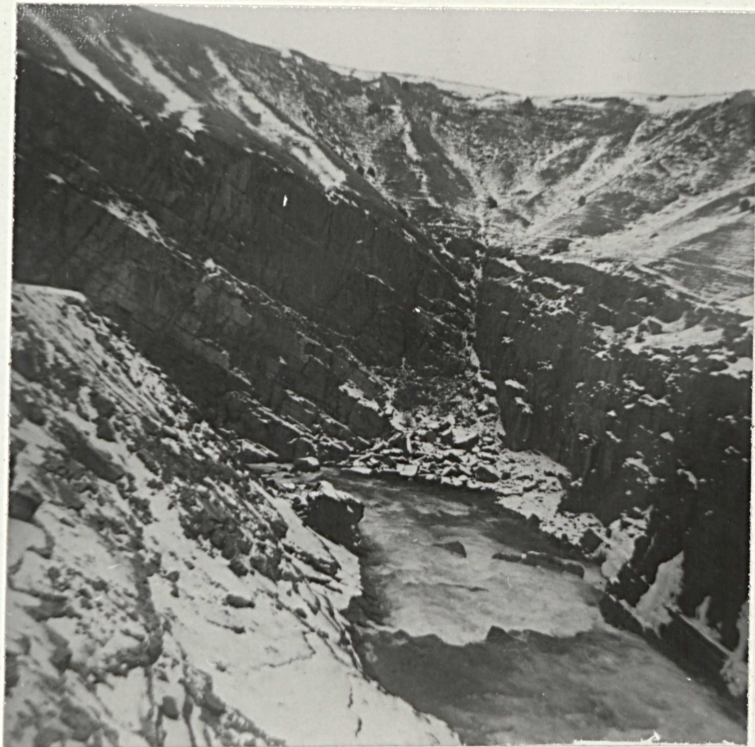
A - View down the gorge formed by the Flathead River along a large north-south fault. The trace of the fault may be seen at the point where the gorge makes a sharp bend to the left.

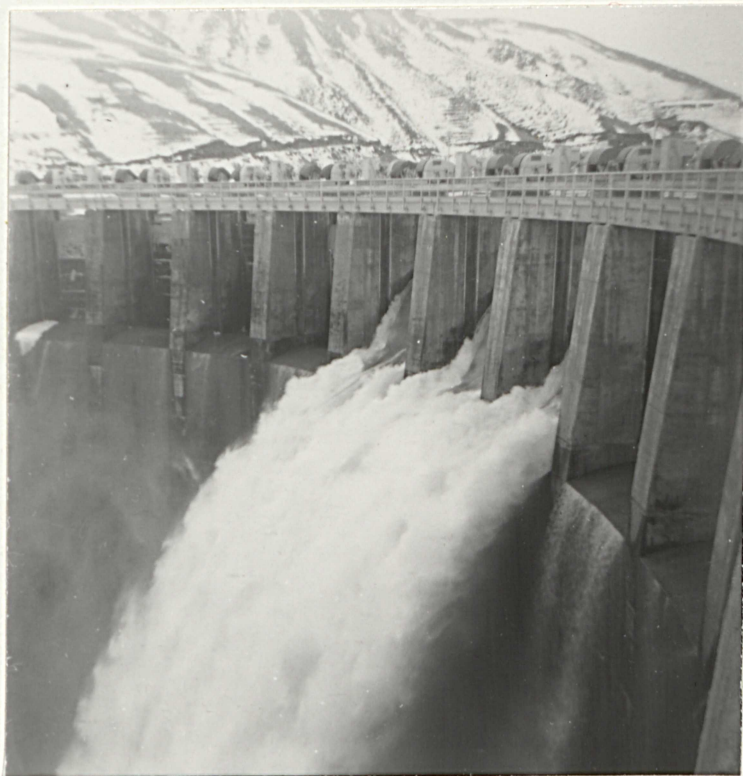
B - Kerr Dam from the downstream side showing a small overflow.

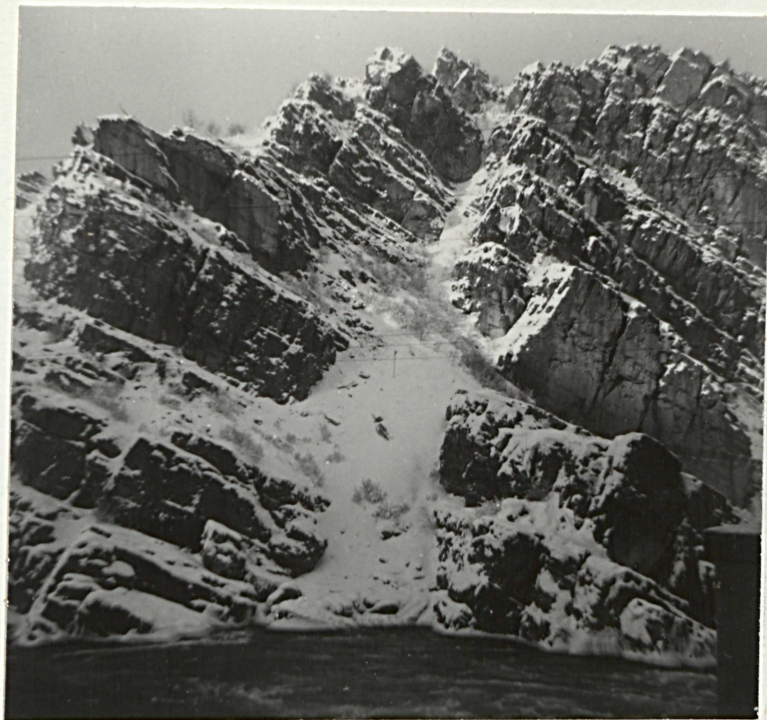
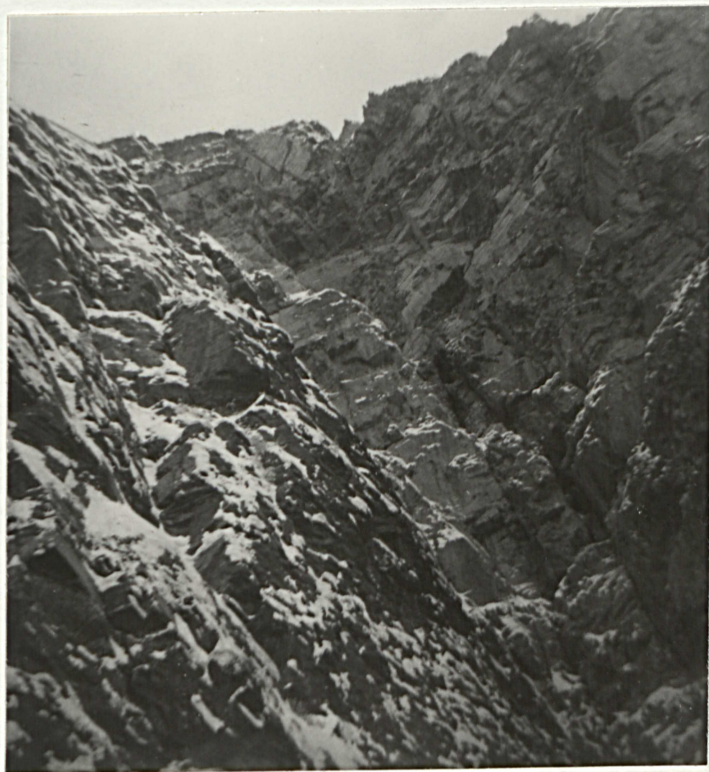
- A - View across the river from the powerhouse.
The trace of the fault is covered by the
heavier snow.
- B - Fault exposure on the south side of the river.
The camera was held nearly vertical to make
this photograph.

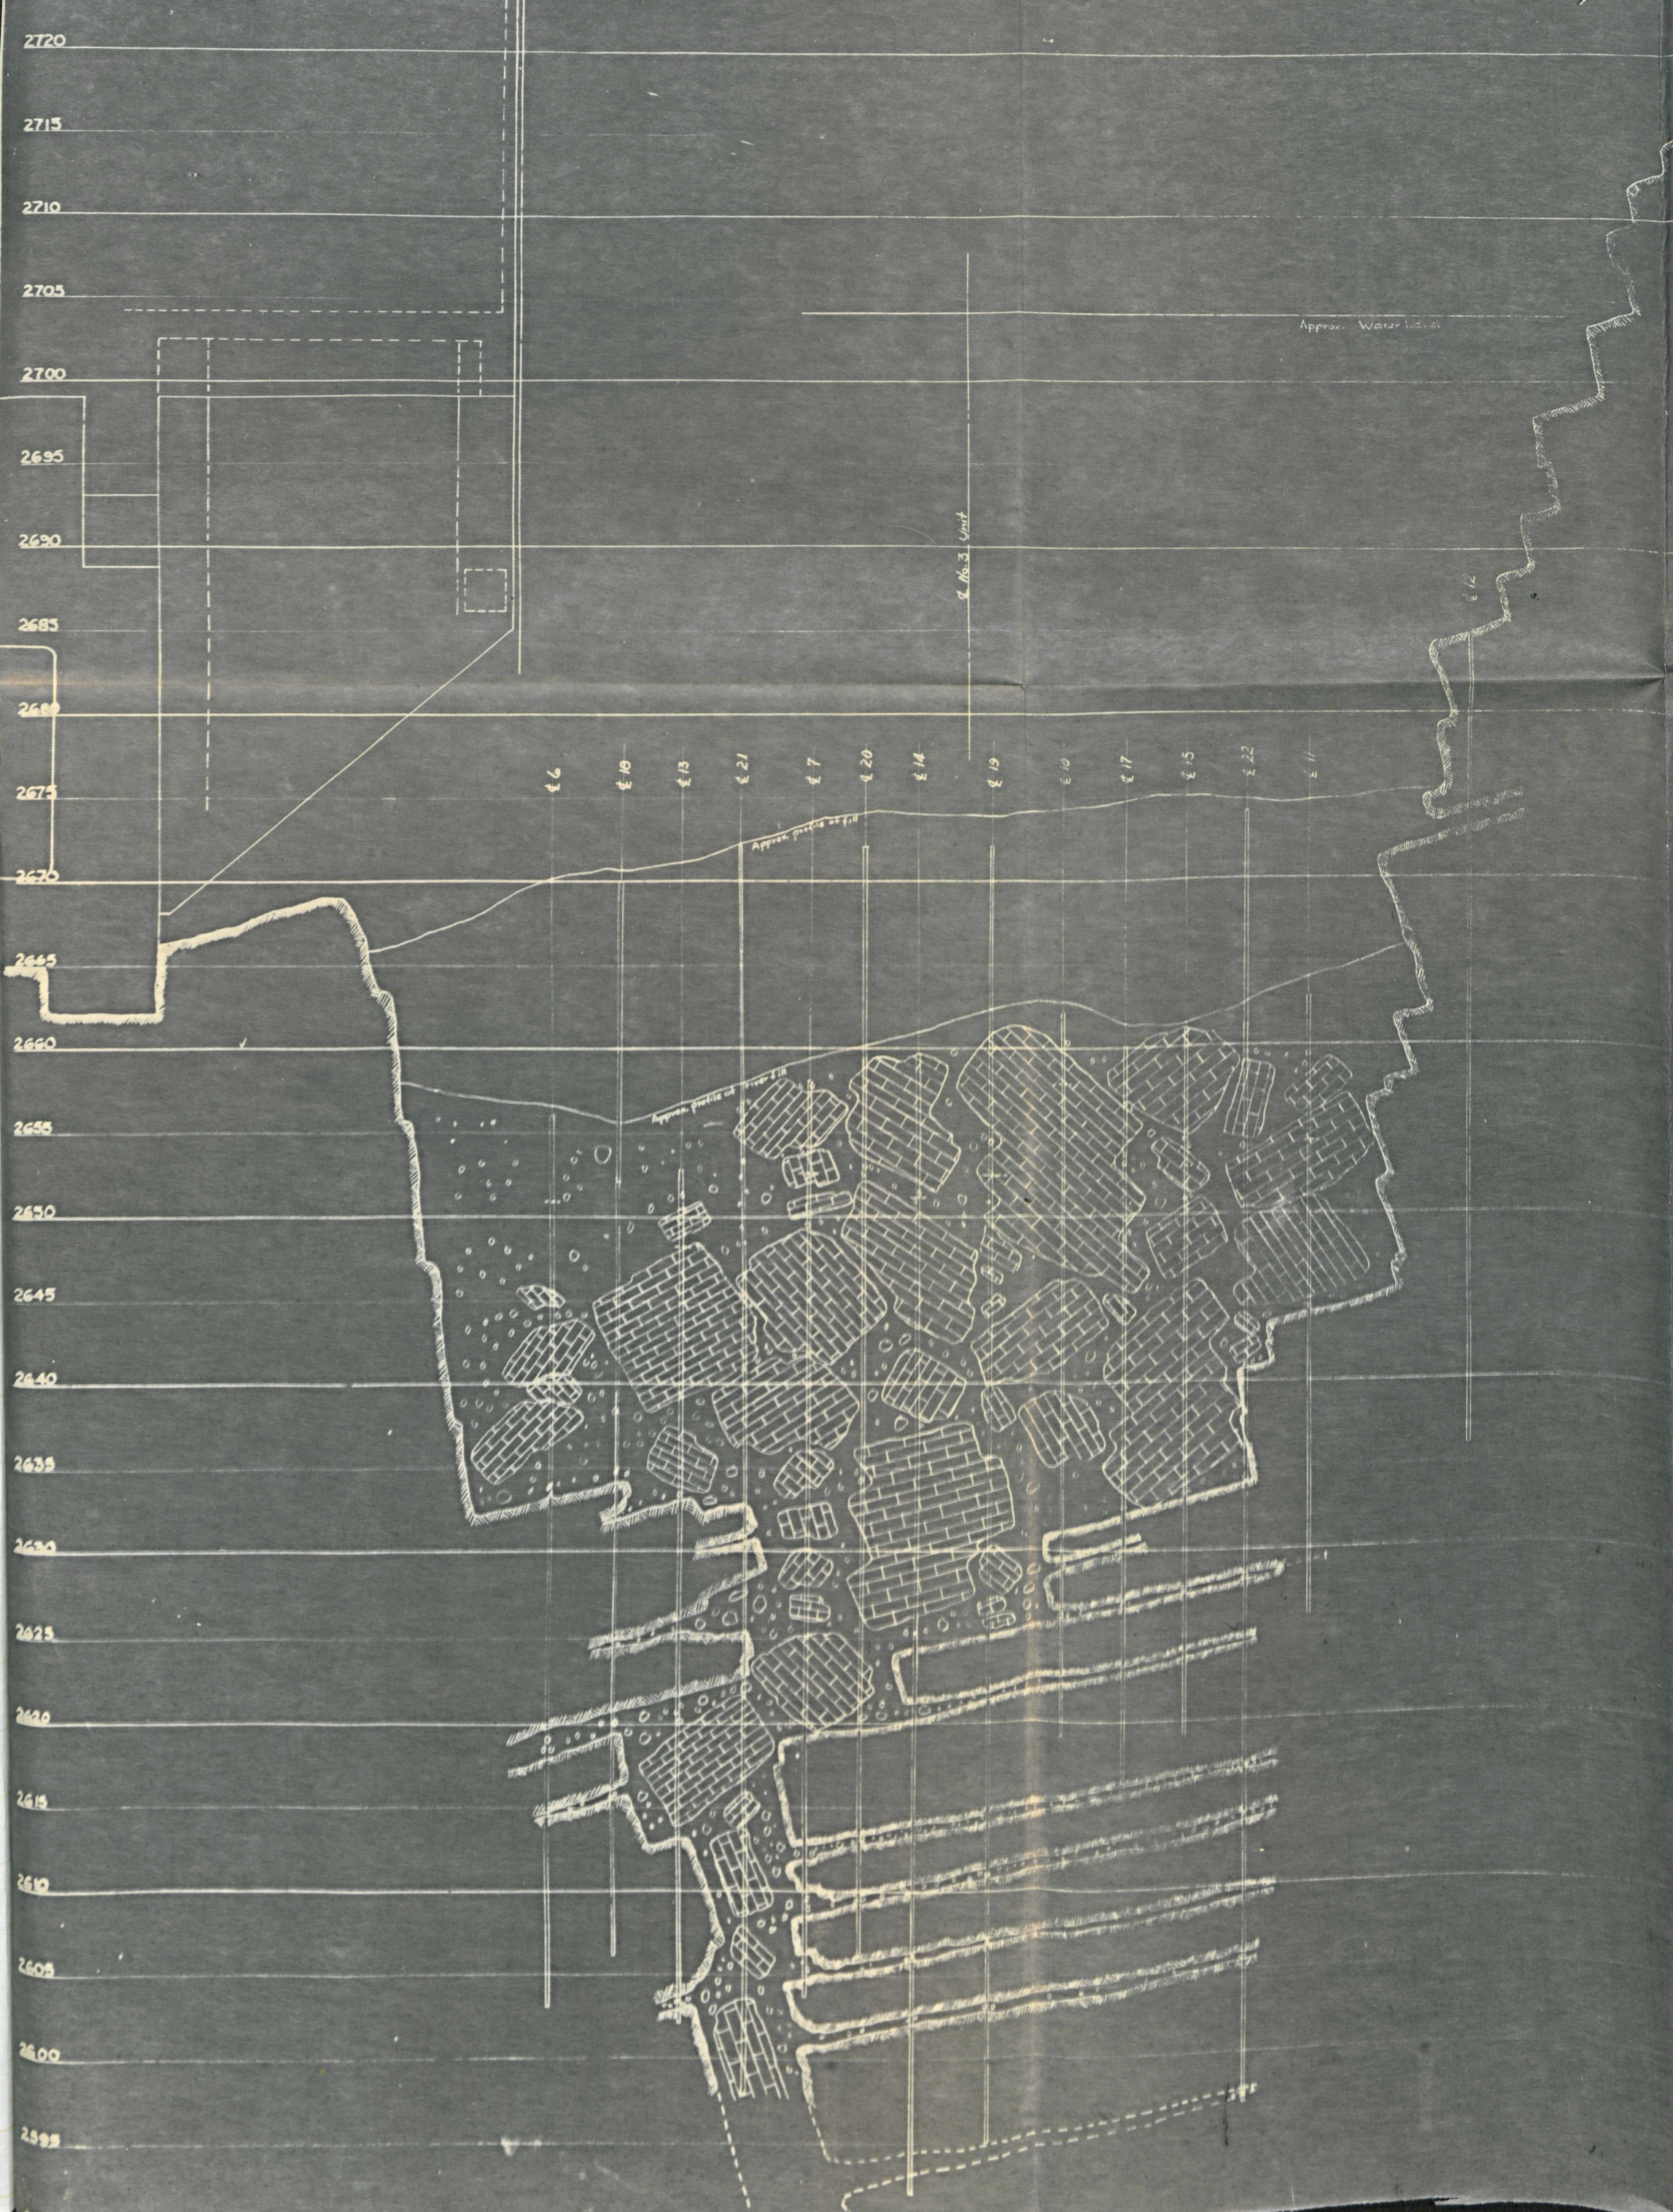
PLATE VIII

The gravel seams, when plotted on a section, followed the exact bedding angle for each particular section. On the front line of drill holes, seven and possibly eight gravel seams were encountered. (Plate VIII) The fault fissure, traced definitely to elevation 2640, narrowed considerably with depth. At some of the gravel seams, thin plates of quartzite were observed. By calculating the approximate location of an outcrop of one of these seams from the angle of dip of the strata and the depth of the seam according to the drill hole data, an outcrop was found. This outcropping bed was the same as the one found at about elevation 2640, and was within approximately seven feet of the calculated outcrop. The corresponding exposed bed had voids up to 5" thick and extending into the bedrock for six or more feet. Around the openings to these voids, there were plates of quartzite approximately 1/4 of an inch thick and 1/2 of a square foot in area. These voids, being above the present water level did not have a gravel filling, but it may be assumed that under conditions similar to those encountered in the holes, they would be filled with river gravel.

CONSOLIDATION OF THE RIVER FILL: Since the powerhouse will be constructed over the fill in the fault fissure, the fill had to be consolidated to such an extent that it would support the new structure. The drill holes in the area served as channels for the introduction of a grout mixture. The grout, a mixture of cement, fine sand, alfesil, and water, was forced into the holes under pressure. The resultant, a mixture of grout, gravel, and rock, forms a strong base for further construction. Further drilling and grouting continued until the grout stage was within a short distance of the top of the fill. A cofferdam will be constructed to hold back the river water while the foundations for the powerhouse addition are being excavated in the consolidated fill. The excavation will also serve as a check on the success of the grouting measures.

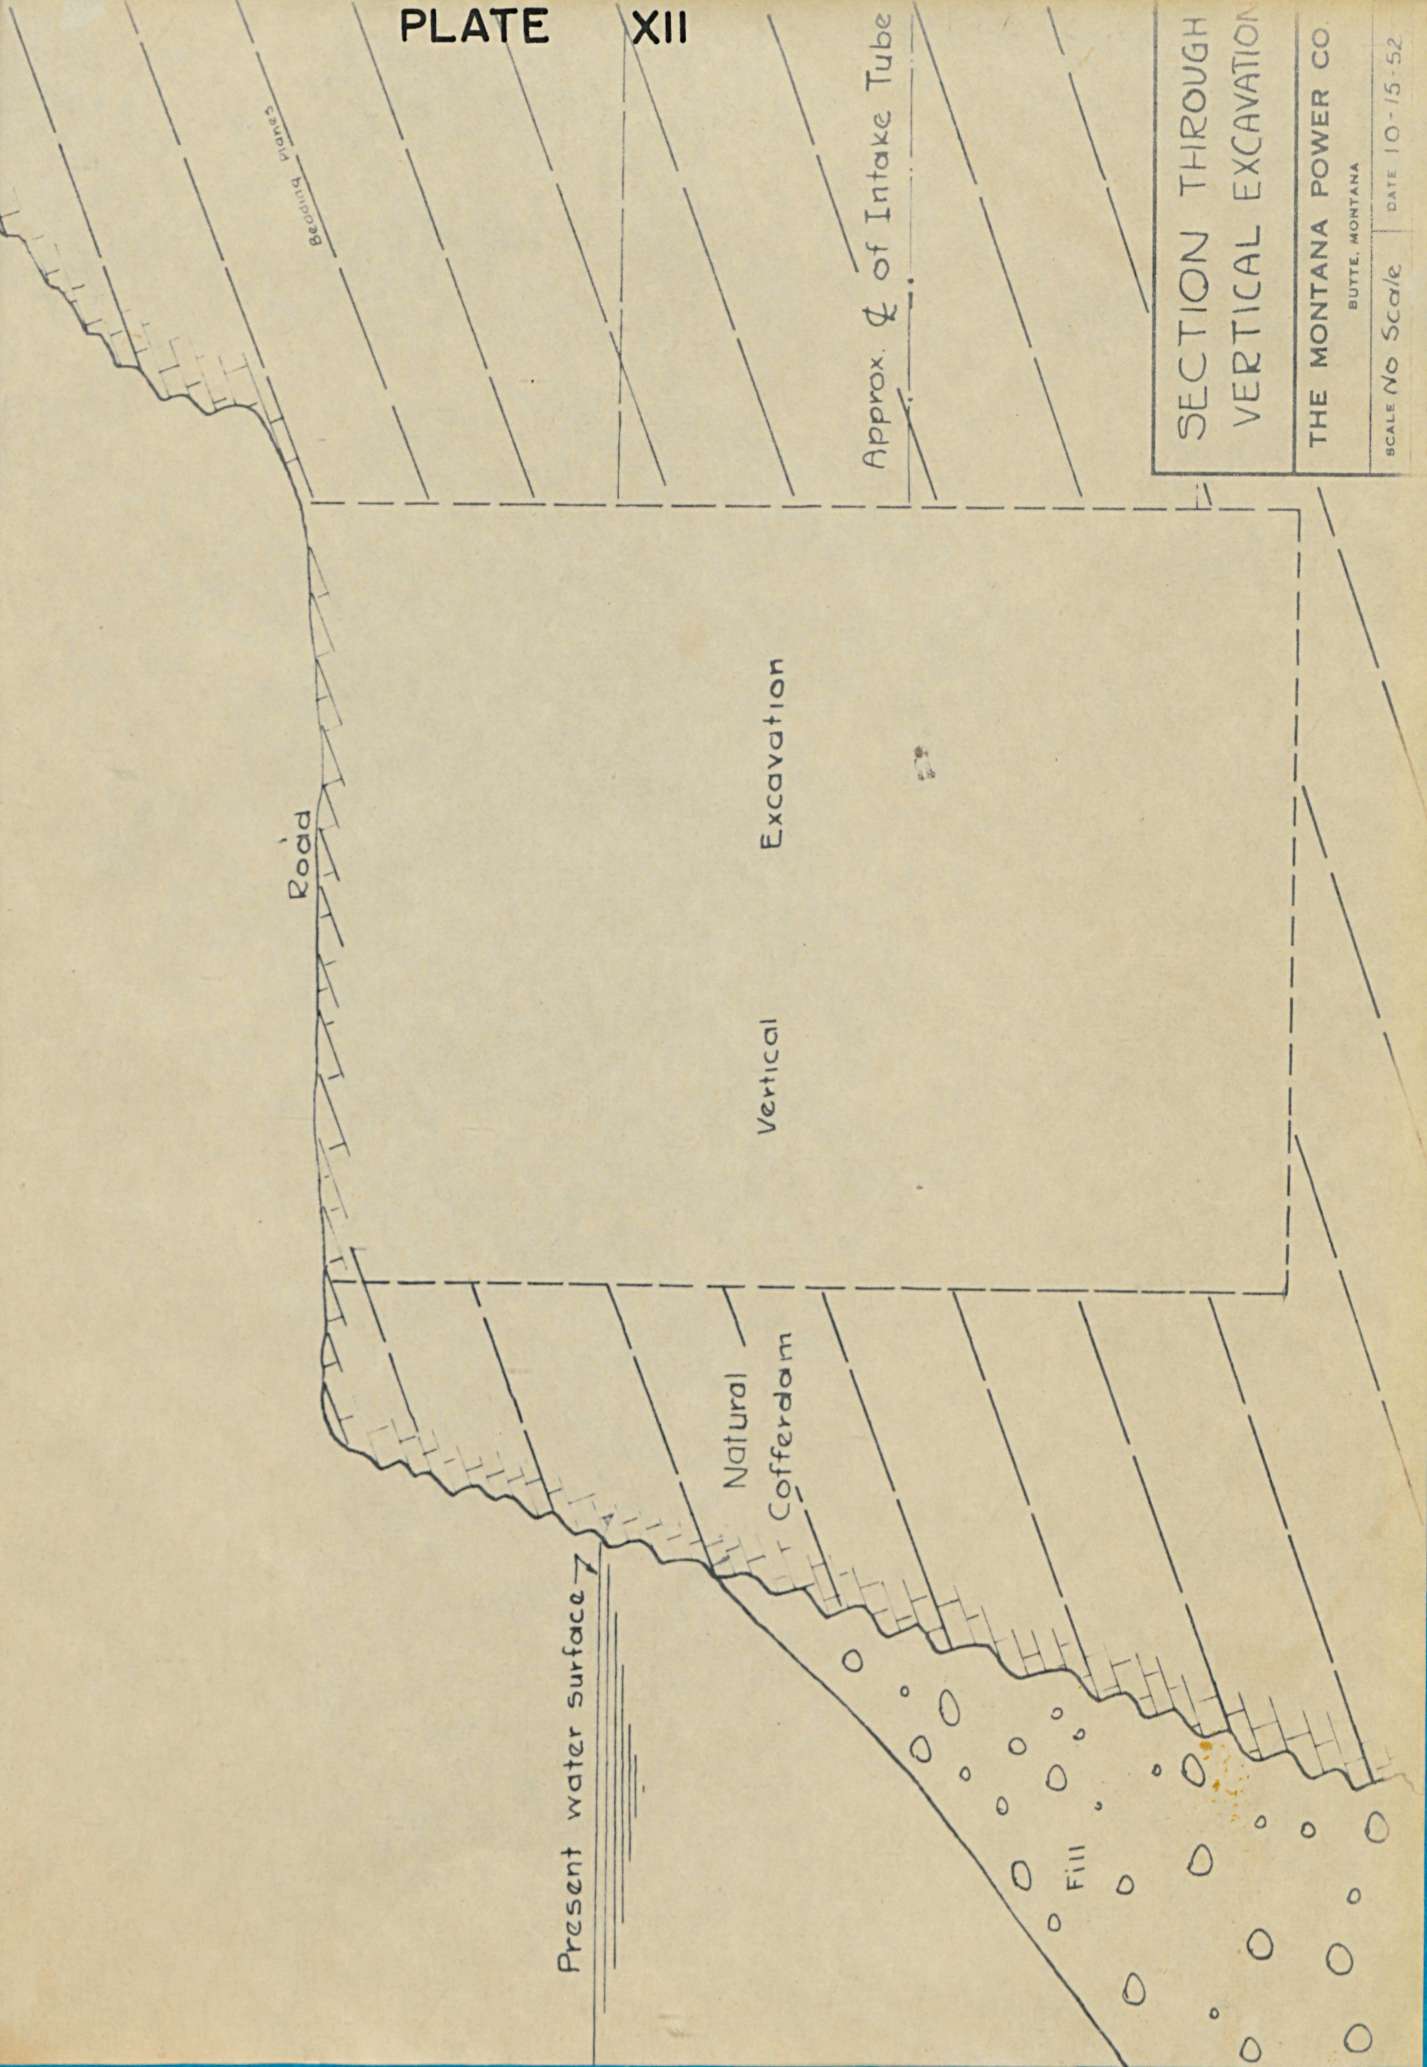
PLATE XII

Rather than lower the pond level during construction, a natural cofferdam, made by leaving a dam of the bedrock in place, will be tried. A vertical excavation or shaft will be made in the rock, then the horizontal tunnel will be driven from the bottom of this vertical excavation. The main problem is whether the inclined strata (Plate XII) will support the pressure of the pond, and also, whether the overlying strata will slide into the vertical excavation. With the strata dipping into the excavation, the beds above the excavation may not be competent enough to resist the gravitational forces acting upon them. Once the tunnel was started, and the portal and abutments installed, the beds would have something to rest against.

If the overlying beds show a tendency to slide, and it is entirely possible that they may, the author suggests a series of rock bolts, similar to those now being used to replace, under certain conditions, timbering in some mines. These rock bolts could either be anchored into a competent bed that lies below the bottom limits of the vertical excavation (Plate XII), or they could be used

to tie a number of beds together and gain strength in that way. Since there may be two tunnels driven, there would be ample space between the two tunnels to drive the anchor bolts below the bed at the bottom of the excavation. During blasting, these bolts would further strengthen the strata in case there was a further inclination of the beds to slide.
