Monitoring and Documenting the Performance of Stormwater Best Management Practices

**Center for Neighborhood Technology
with Hey and Associates**

TR-048

April 2012

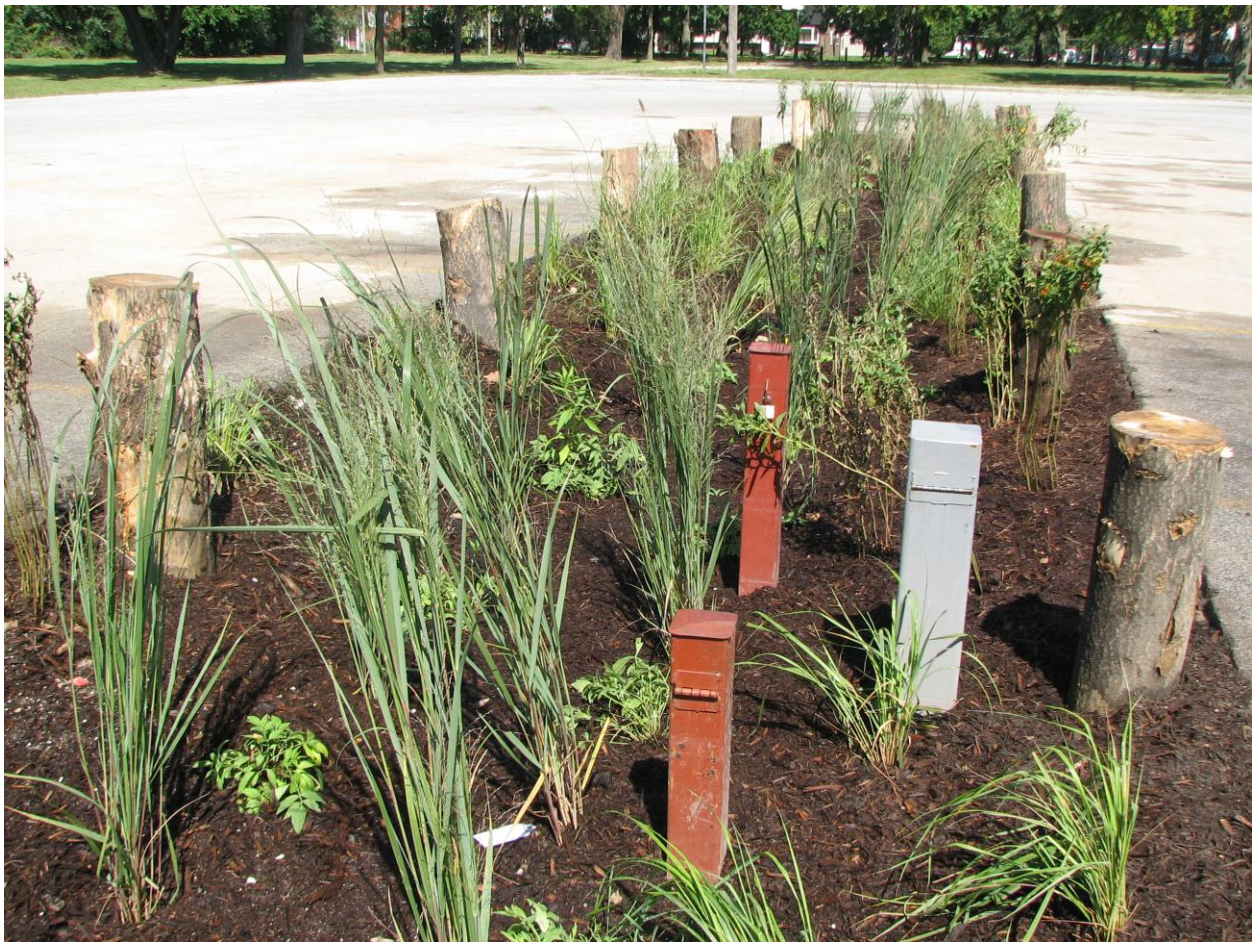
The bioswale at Our Lady Gate of Heaven had been monitored during 2007 and 2008, and additional monitoring was recommended as the ISTC project commenced. Instrumentation was installed and monitoring was conducted between December 1, 2009, and March 31, 2010.

Figure 1: Details of the Bioswale at Our Lady Gate of Heaven Parish, including three monitoring wells

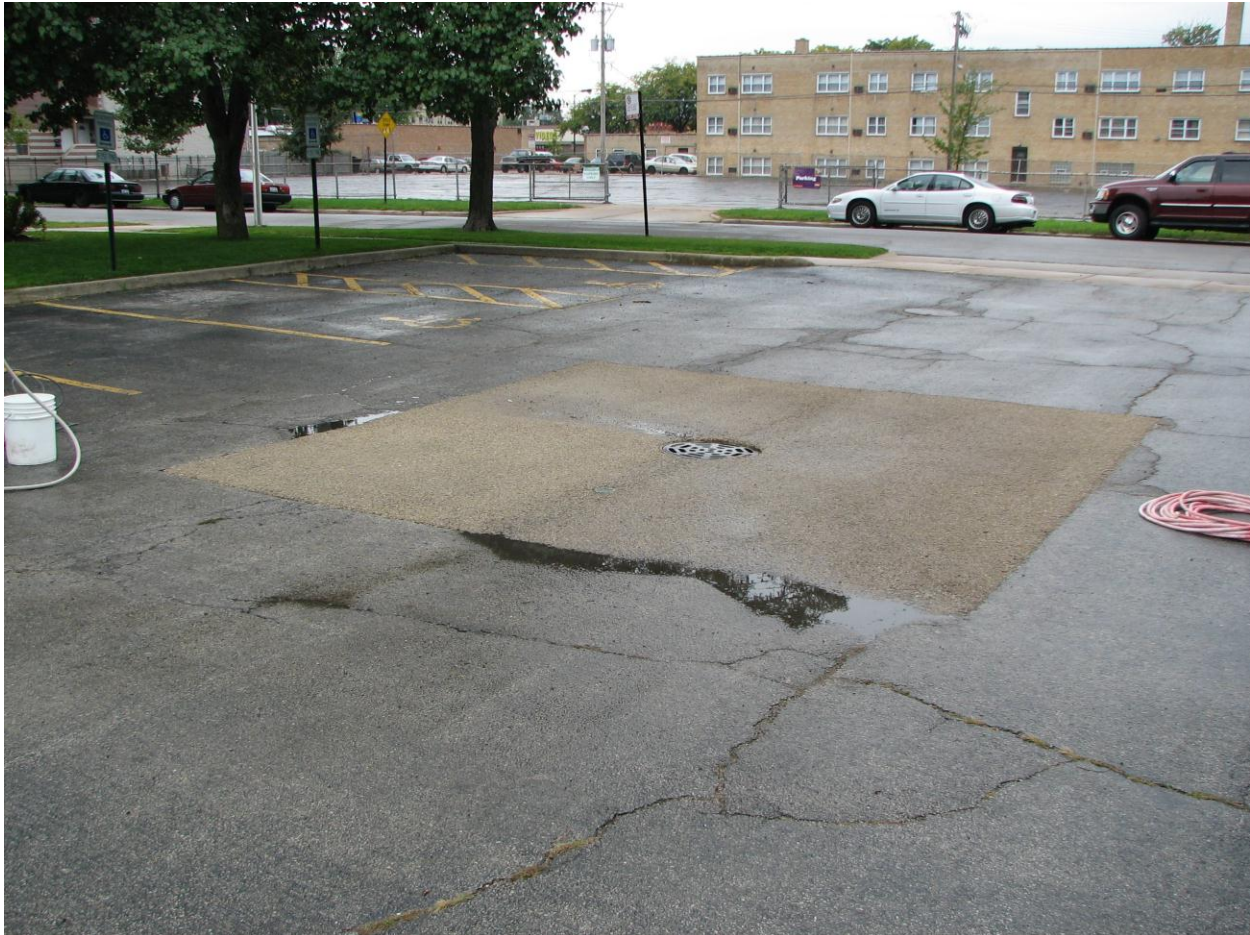
The additional sites that were suggested for monitoring in the March 2008 proposal to the ISTC included two permeable concrete patches that had been installed at St. Margaret Mary Parish during 2007 (Figure 2). The instrumentation was installed in the permeable concrete patches and monitoring was conducted between July 21, 2009, and March 18, 2010.

Figure 2: A Permeable Pavement Patch at St. Margaret Mary Parish

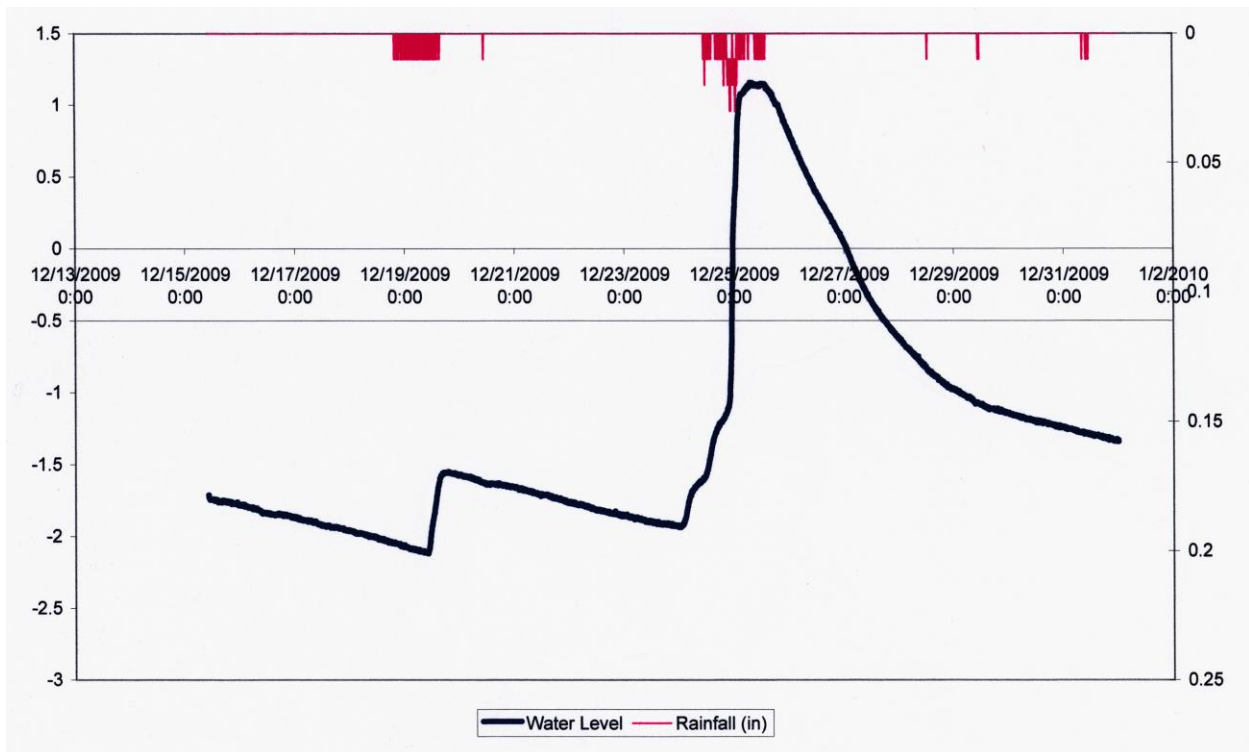
The objective of the monitoring at Our Lady Gate of Heaven Parish was to compare the performance of the bioswale during the winter months of 2009/2010 with the performance during the sampling conducted during the fall of 2007 and the spring and summer of 2008. The data collected between December 15, 2009, and February 9, 2010, indicated that the winter conditions did not negatively impact the performance of the bioswale. Figures 4 and 5 show the rise in water levels in the bioswale during two cold-weather rainfall events. The rates of decline in the water surface are an indication of the average infiltration rate within the soils. The infiltration rate of the bioswale was determined to be 2.70×10^{-4} cm/s (0.38 in/hr), which is well within the infiltration rates documented during warmer months of 1.42×10^{-4} to 5.68×10^{-4} cm/s (0.2 to 0.8 in/hr). Additionally, as had been observed during the summer months, the infiltration rate of the swale during the winter months was limited by the infiltration rate of the subsoils and not of the engineered soils or aggregate, indicating that frozen surface conditions do not negatively impact the infiltration rate of the bioswale.

Figure 4: Precipitation and Water Levels in the Bioswale, December 2009

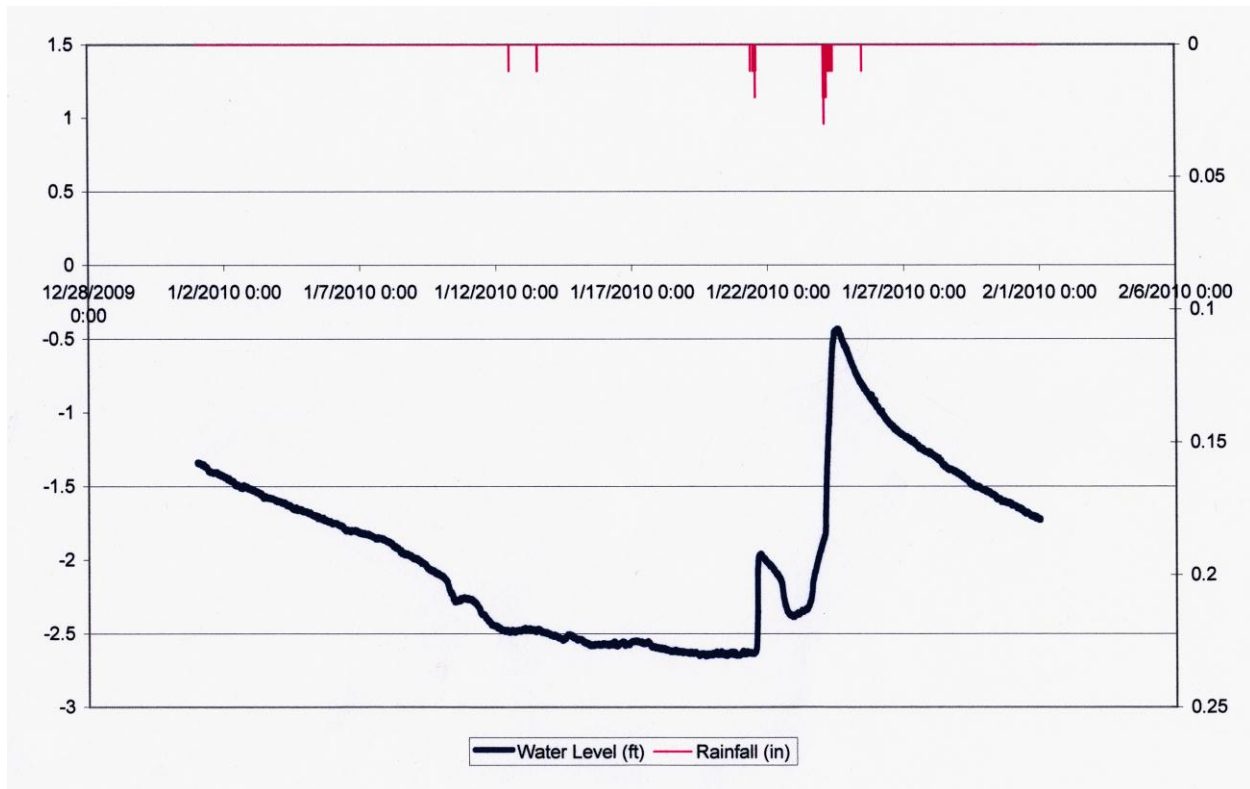
Figure 5: Precipitation and Water Levels in the Bioswale, January 2010

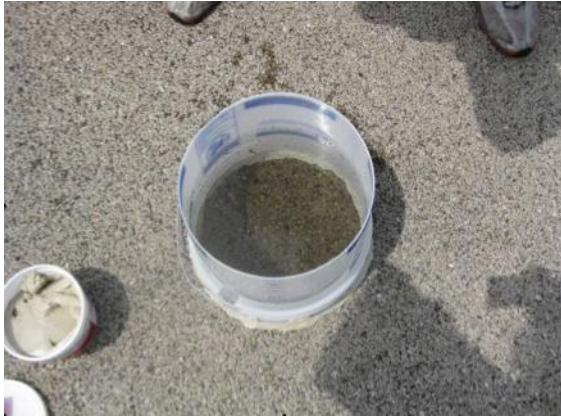
On July 21, 2009, the infiltrometer was positioned upside down in the southwest corner of the east permeable concrete section and in the northeast corner of the west permeable concrete section. At both locations, the infiltrometer was sealed to the pavement using plumber's putty (Figure 6). The infiltration rate was to be determined by filling the infiltrometer with 15 cm (6 in) of water and documenting the time it took for 10.2 cm (4 in) of water to infiltrate into the pavement (drawing down of water level from 15.2 cm to 5.1 cm [6 to 2 in]). The infiltrometer would then be re-filled with 15.2 cm (6 in) of water and allowed to drain down to 5.1 cm (2 in) for a second time and the time documented. This step was to be repeated until the time to draw down from 15.2 to 5.1 cm (6 to 2 in) was constant (indicating steady state infiltration have been achieved). The testing water was City of Chicago water obtained from St. Margaret Mary's Activity Center.

Figure 6: Infiltrometer at Permeable Pavement at St. Margaret Mary Parish

However, during the testing, the methods were altered because the infiltration rate was significantly less than anticipated. As planned, the infiltrometer was filled to 15.2 cm (6 in) with water. After three hours, the water in the infiltrometer in the east section had only drawn down to 7 cm (2.75 in) and after two hours, the water in the infiltrometer in west section had only drawn down to 8.6 cm (3.375 in). As such, the test in the east section was stopped after three hours and the test in the west section was stopped after two hours. Using these results, the infiltration rate of the east permeable pavement section was determined to be 7.7×10^{-4} cm/s (1.08 in/hr) and the west permeable concrete section was determined to be 9.3×10^{-4} cm/s (1.31 in/hr). These infiltration rates were significantly less than what is expected for permeable concrete. For example, infiltration testing conducted on the permeable concrete green alley located at 10300 South Avenue G in Chicago indicated infiltration rates of 0.112 cm/s to 0.305 cm/s (157.9 in/hr to 429.3 in/hr). As such, it was recommended that the permeable concrete sections at St. Margaret Mary be cleaned prior to future infiltration testing. The permeable concrete sections were power washed in late summer 2009.

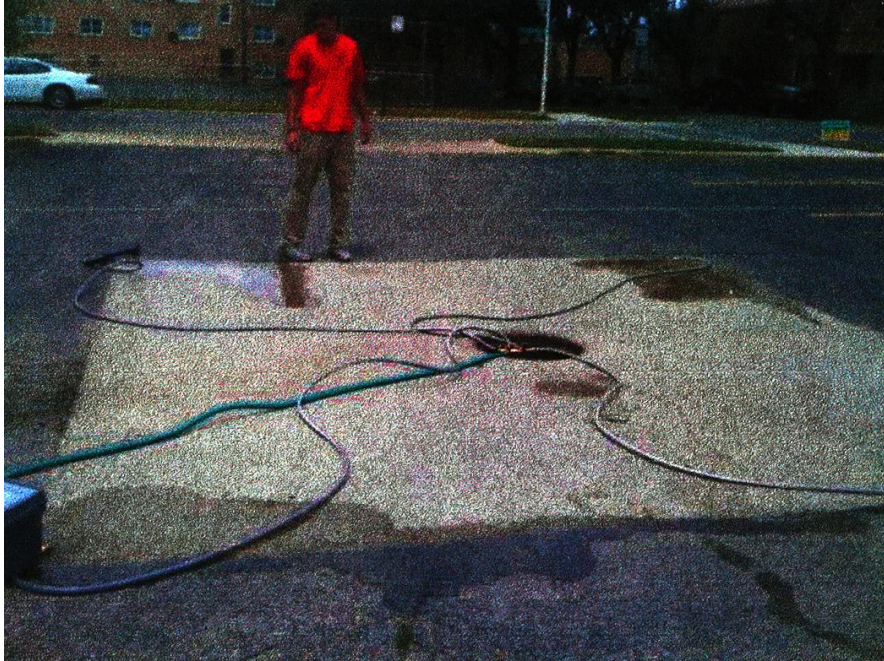
Figure 7: Configuration of Hoses on West Permeable Pavement Section

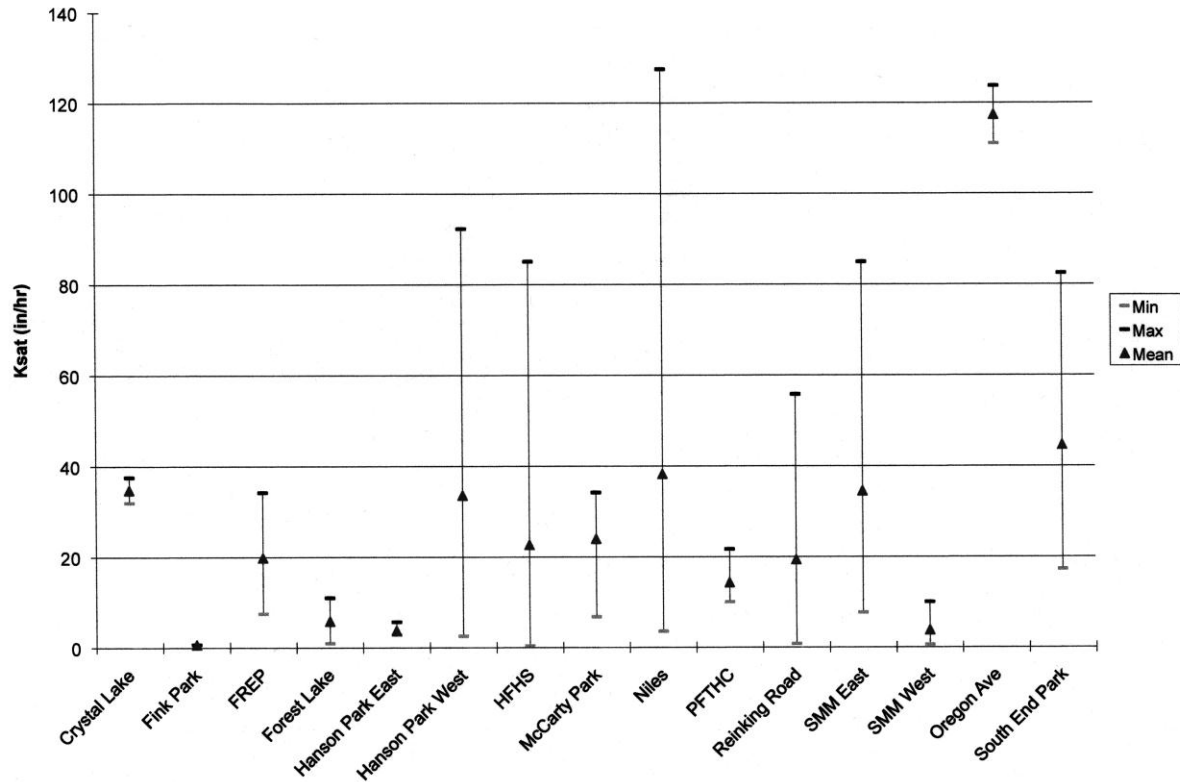
Figure 8: Average, Minimum, and Maximum K_{sat} Values by Site (in/hr)

The Oregon Avenue site had the highest mean K_{sat} value of 8.36×10^{-2} cm/s, which correlated to a surface infiltration rate of 301 cm/hr, or 118.52 in/hr. The K_{sat} values at Oregon Avenue ranged from 7.91×10^{-2} to 8.81×10^{-2} cm/s (111.4 to 124.1 in/hr). The K_{sat} values measured at Oregon Avenue represented the 2nd and 3rd highest K_{sat} values of the 55 tests. The exceptionally high K_{sat} values at this site can likely be attributed to the high organic content of the recently placed (spring/summer 2010) engineered soils utilized in the rain garden. During field testing, the soils were observed to be extremely loose which did not allow the MPD infiltrometer to firmly seal with the surface soils, thus potentially allowing water from the infiltrometer to leak laterally through the soils and overestimate infiltration rates at this site.
