# MONITORING OF PLAYA CALDERA AND COASTAL STRUCTURES WITH UNMANNED AERIAL VEHICLES (UAV)

GEORGES GOVAERE<sup>1</sup>, RONALD VIQUEZ<sup>1</sup>, HENRY ALFARO<sup>1</sup>, DIEGO CORNEJO<sup>1</sup>

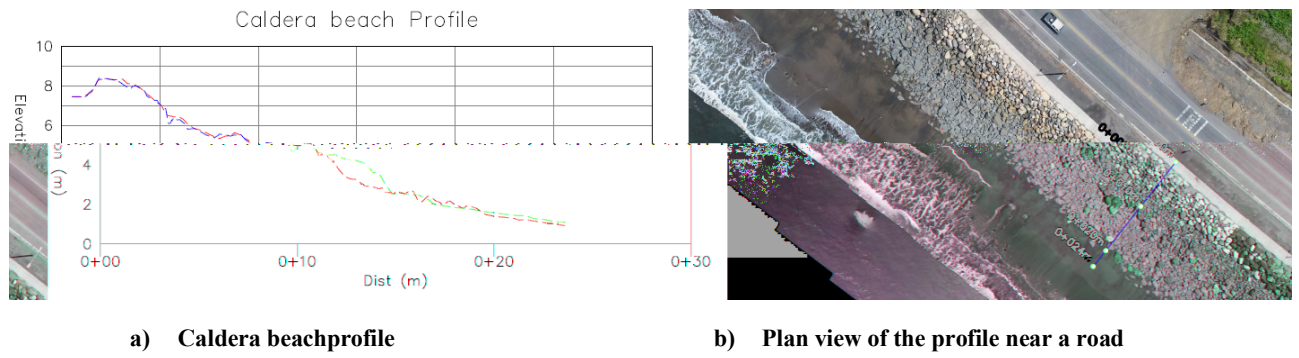
During August 2017, there was a significant storm in the Pacific coast of Costa Rica, corresponding to one of the largest registered by an IMARES buoy measuring surges since 2015. For this event, the buoy registered a significant wave height of 3.7 m and a peak period of 17.66 s (August 14, 2017 at 5 am). Since photogrammetric surveys are carried out monthly, it was possible to detect the damage caused after the storm contrasting before and after results. The latter showed a material loss of up to 0.75 m in a section of beach profile according to a previously traced profile in the zone of most impact (Figure 4a). In that image, red color represents the beach profile measured in July, and blue color represents the beach profile measured in August after the storm.

The storm effect was also detected in the orthophotography generated. Rock absence and displacement were detected. Changes suffered in this area of the beach put the existing road at risk, because they allowed waves to cause a greater impact. A volume calculation, showed that there was a loss of approximately 2000 m<sup>3</sup> of material, between sand and rocks, in the stretch of the beach that is usually seen most affected when storms occur, which corresponds to an area of 1.0 hectare, approximately (Figure 4b).

Figure 4. Caldera beach cross profile comparison, before (red) and after (blue) storm.

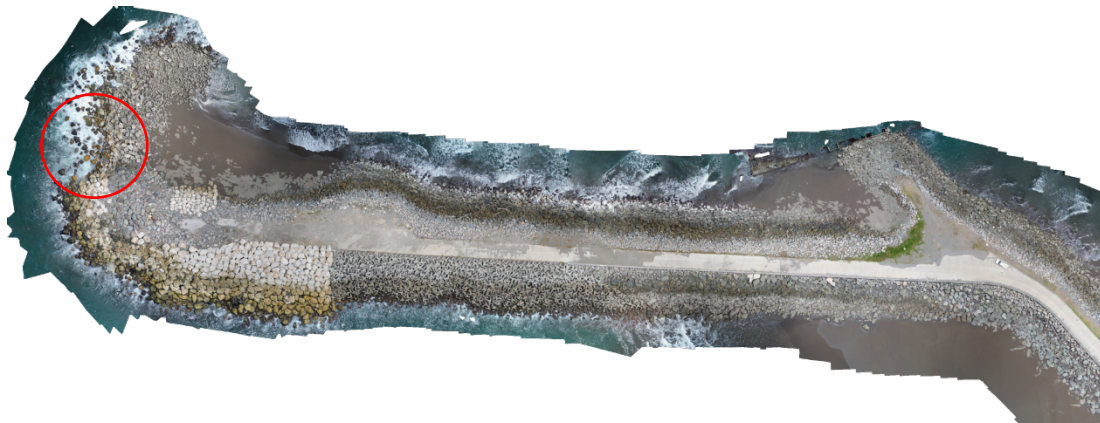
In the breakwater of the port of Caldera no damage of the structure was detected. However, in an accumulation of rocks adjacent to the hill, product of a previous damage, it was possible to document the movement of rocks and dolos, as indicated in the red circle in figure 5. These movements can be appreciated in greater detail in Figure 6, where the before (a) and after (b) conditions are shown. The red box shows an initial position of the rocks and the blue box the rearrangement of them after the storm, showing a generalized displacement of these elements. Both images were taken at low tide.

Figure 5. Caldera Port Breakwater heads damage.

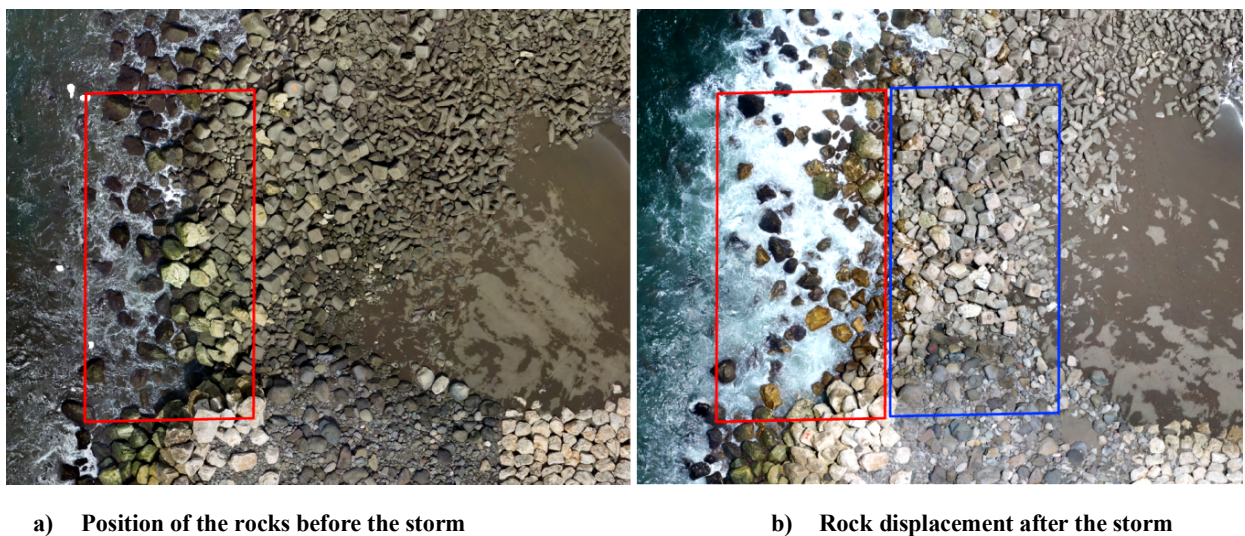
Figure 6. Damage suffered on breakwater's head, the red area show a control zone before and after the storm and the blue one the place where stones and dolos pile up after the storm.

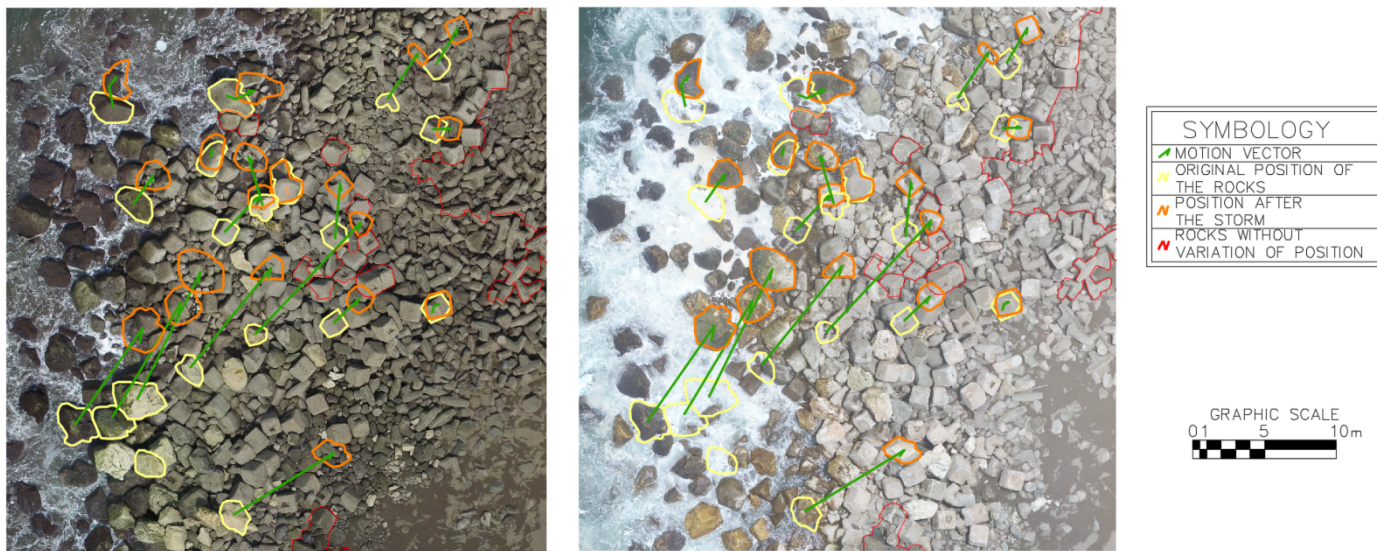
An overlap analysis of the orthophotos was performed, and it was detected that large elements moved with a

predominant northwestern direction (Figure 7). The magnitude of the movement reached 8 meters with respect to the position previous. The image shows the original position in yellow and the final position of rocks in orange indicating the direction and magnitude of displacement with a green arrow.

Figure 7. Displacement of rocks in the breakwater's head before and after a storm.

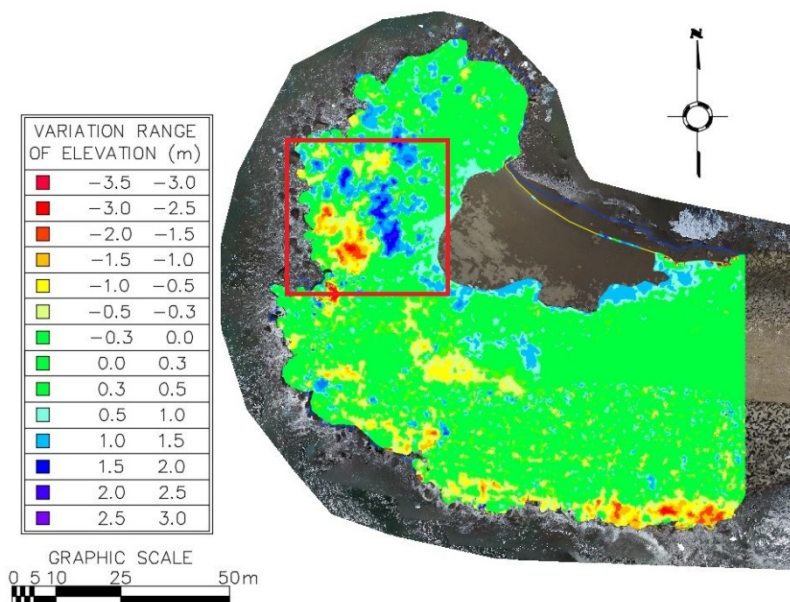
The variation of the elevations by the movement of rocks and dolos, can be observed in Figure 8, where a 0.3 m movement is considered as invariant in magnitude. Red and yellow colors represent decreases in elevation and blue colors increase in this variable. With this figure is possible to make a validation of what was observed with the movement to the northeast of the rocks, since in the central sector of the hill is possible to see the red colors and to the northeast of this point the blue ones.

Figure 8. Elevational change of elements in the breakwater after the storm.

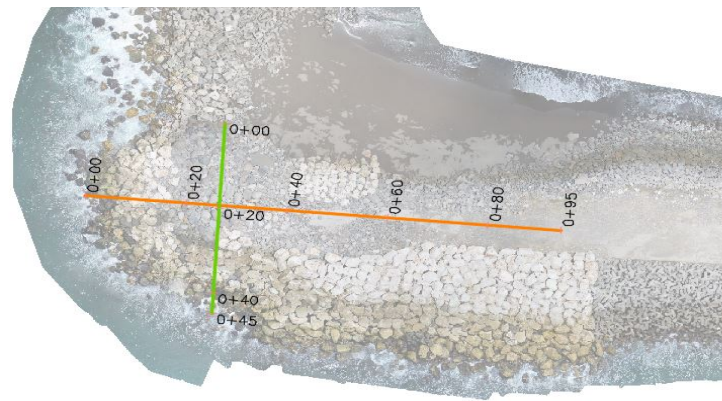
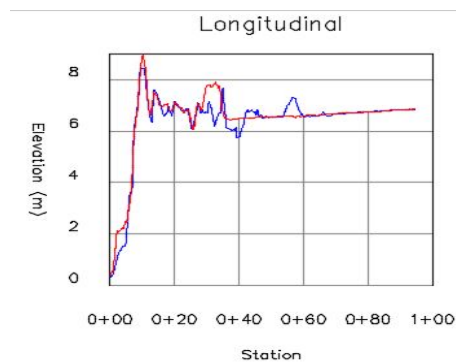
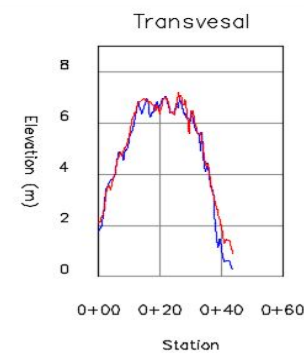
Although the movement of rocks and dolos can be appreciated, Figure 9 shows that the slope did not change drastically, especially on the slope. This result would have been difficult to assess using conventional methods since the density of the points taken is lower than that obtained by UAV methods. The interpolation of the levels for the creation of a digital model of terrain would have had lower resolution and less resemblance reality.

Figure 9. Breakwater profile changes
