A case study for scientific research prior to conservation of marine metal artefacts

van der Stok-Nienhuis, J.; Kuiper, E.; Beentjes, T.; Joosten, I.; van Eijck, L.; Zhou, Z.; van Bommel, M.

Journal of Archaeological Science: Reports

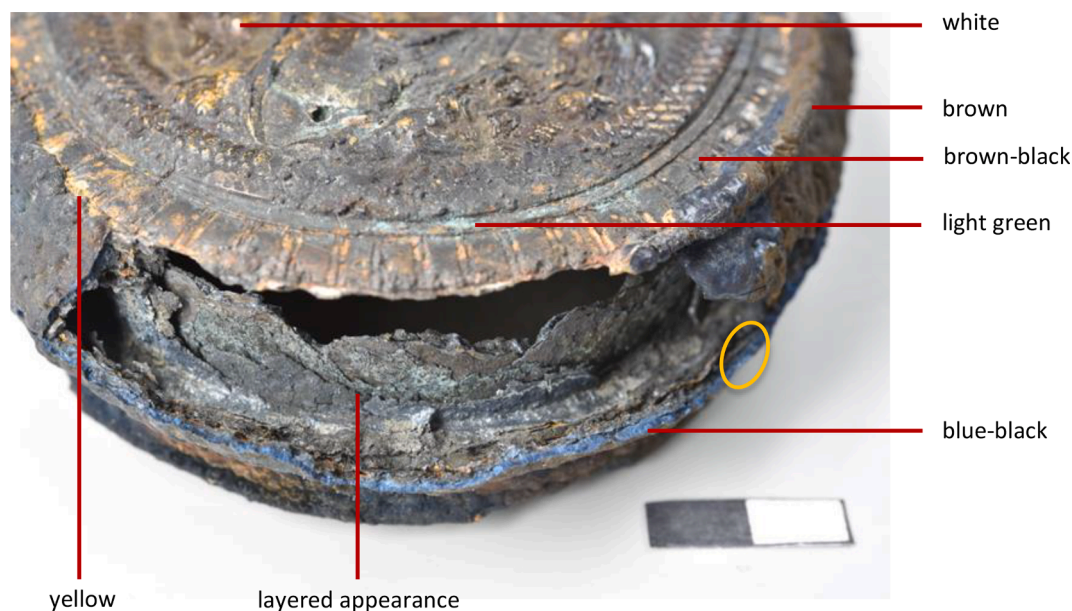
Fig. 2. Damaged area of the box, showing the internal sheet metal structure with a layered appearance. Different corrosion colours are seen. The yellow circle illustrates the most plausible location of the fragment used for the cross-section (see Fig. 5).

Previous to or during its recovery from the seabed the object was badly damaged in especially one area (Fig. 2; bottom area in Fig. 1a).

This gave the opportunity to visually examine part of the interior of the box. On the inside of the D-shaped side, an internal sheet metal structure can be observed, which exhibits a layered or laminar structure. This morphology is markedly different from the plaquettes, where a relatively smooth surface outlines the well-visible decorations.

This damaged area has enabled the identification of a hollow structure of the D-shaped side (Fig. 2), and the X-ray images clarify that this area is hollow along the entire perimeter of the box (Fig. 6, D) and several larger and smaller cracks are seen, indicative for mechanical instability. Also, the internal sheet metal structure is present along the perimeter.

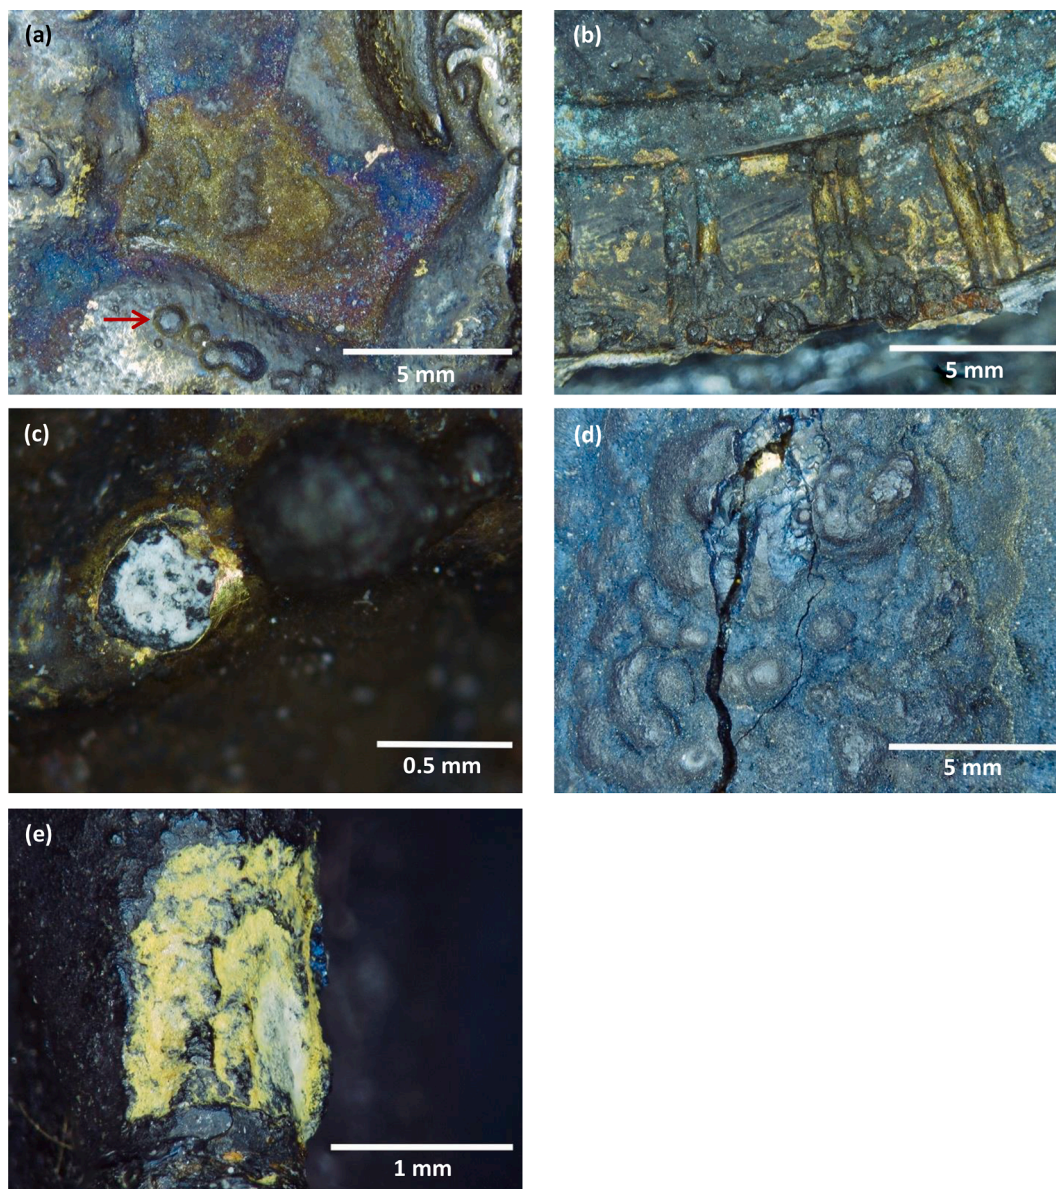
Fig. 3. Corrosion colours and morphologies as seen on the oval box. (a) Relatively thin layer, varying from brass yellow to brown to black, with an iridescent purplish tarnish. The red arrow indicates a pustule; (b) light green corrosion on top of the gilding layer; (c) white powdery corrosion inside a damaged pustule, here seen with gilding on top of the pustule; (d) thick, blue-black corrosion, likely with pustules; (e) yellow material.

Different types and degrees of corrosion are observed. The decorations on the gilded metal substrate of the plaquettes and gadrooning are (partly) obscured by a relatively thin corrosion layer. The corrosion varies in colour from brass-yellow to brown to black, sometimes with an iridescent purplish tarnish (Fig. 3a). XRD results show that both covellite (CuS) and chalcopyrite (CuFeS₂) are present on the surface (see Fig. SOI 2.2), which may exhibit the same range of colours as those seen on the box (Fig. 3a), depending on their layer thickness. Both compounds are commonly found on maritime finds (Scott, 2002, 227). To a lesser extent, light green corrosion is visible on the faces of the box as well (Fig. 3b). At the moment, the nature of the compound is unknown due to the lack of reliable XRD results, but a copper-containing corrosion form is expected because of the green colour. All over the plaquettes and gadrooning, small pustules can be seen, varying in size from 100 µm to 4 mm (Fig. 3a, red arrow). Also, on several locations on both plaquettes, spots of white, powdery material can be seen and microscopic research indicates that this material invariably occurs on the inside of a damaged

pustule (Fig. 3c). Either $Zn(SO_4) \cdot 4H_2O$ (boyleite) or a zinc chloride compound ($Zn_2Cl_2H_{14}O_{16}$) are possible matches according to XRD (see Fig. SOI 2.3) and both are white. Their plausible presences may be an indication of a chemically unstable corrosion compound.

confirmed by XRD). The blue-black areas appear blue in cross-section (Fig. 2) and inside and through the cracks, the gilding layer can be distinguished (Fig. 3d). Pustule-like features are present here as well, but it is unknown whether these originate from decorative features of the original metal or whether it is comparable to the pustules seen on the faces. The typical blue colouration seen with the unaided eye, combined with the XRD results, indicates that this compound is covellite.

Another coloured material can be seen on the box, preferably along the edge of the gadrooning: yellow (Fig. 3e). As described in section 2, colouring treatments were regularly carried out after amalgam gilding. As this yellow compound could be a remnant of a pigment intentionally

As mentioned in section 4.1, yellow material is visible on multiple locations on the box. In the colouring treatment after gilding, the use of iron oxide as pigment is described in historical sources. SEM-EDS analyses show that sulphur, iron and oxygen are present, as well as traces of copper and zinc, in multiple samples (see Fig. SOI 4.9 and Fig. SOI 4.10). With XRD, no corresponding compound matches can be found (see Fig. SOI 2.5). The powder-like morphology in combination with the absence of an iron oxide phase leads to the conclusion that the yellow material is a corrosion product, adhered to the brass of the box.

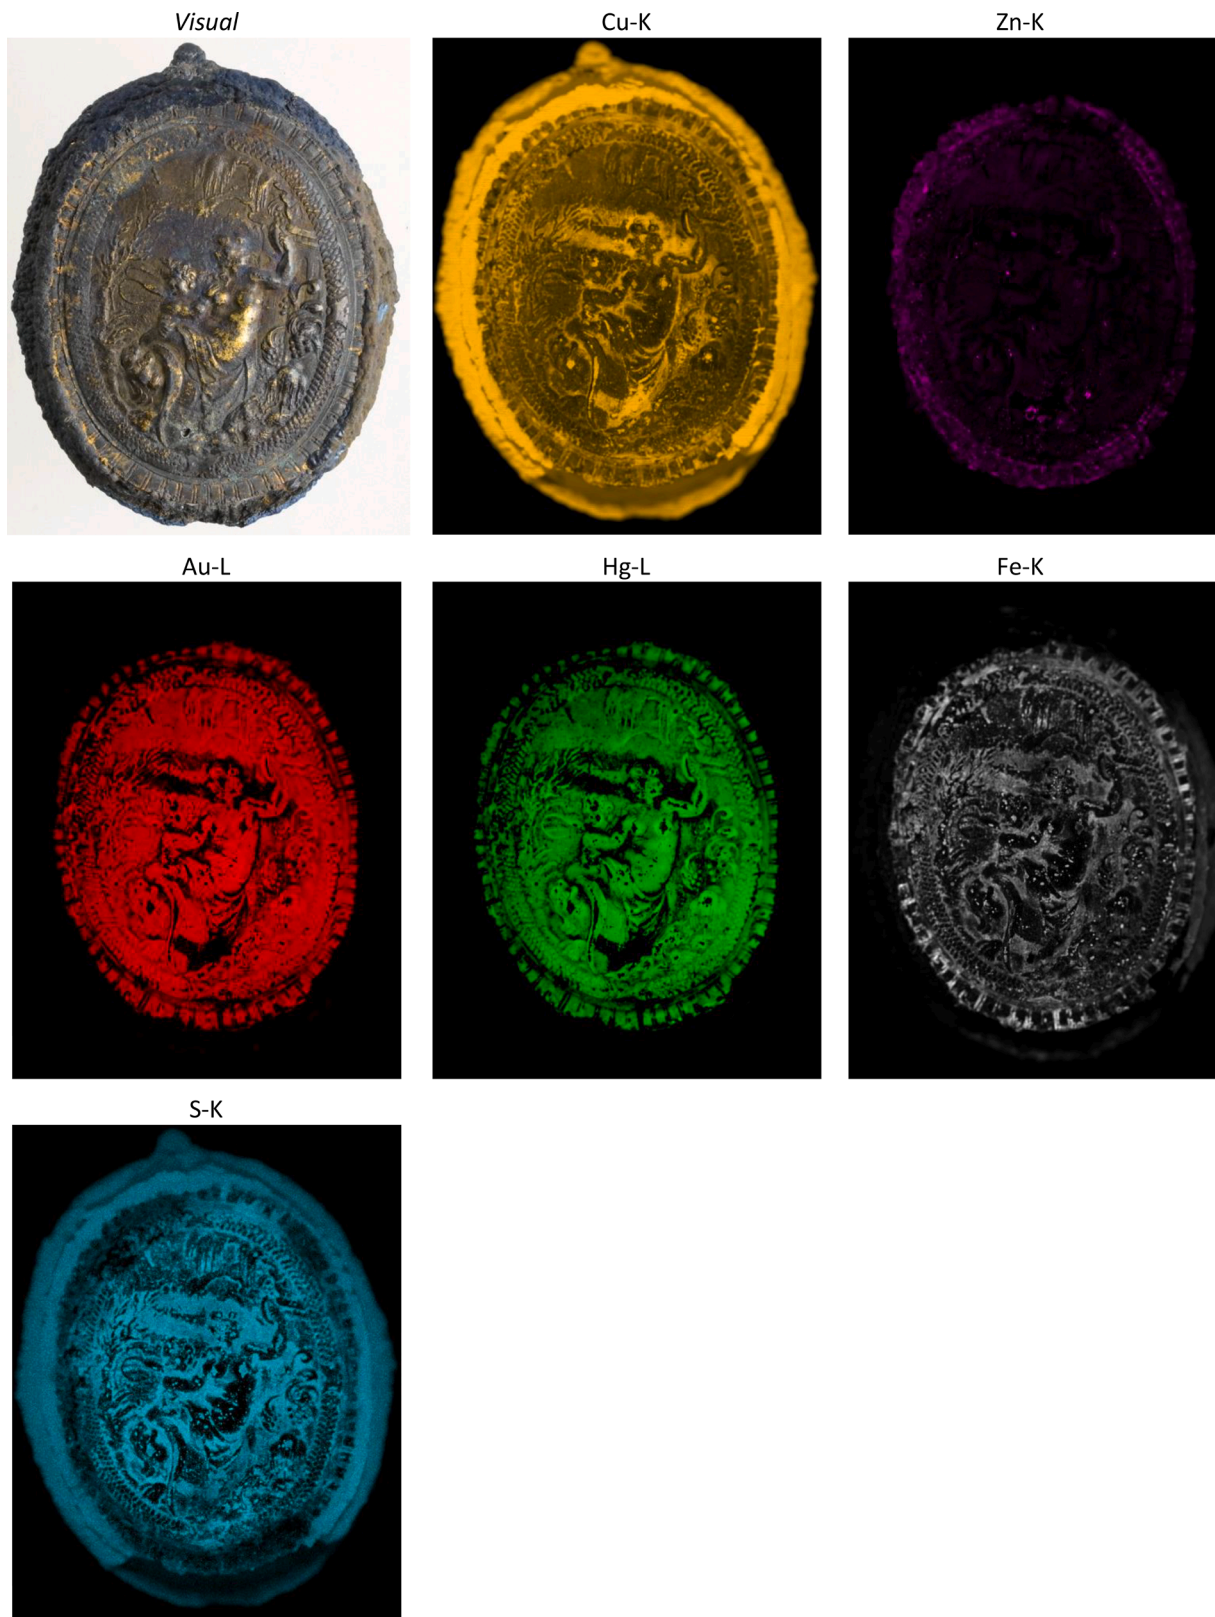
Fig. 4. Elemental XRF-maps of the entire face of the box with Venus, showing the distribution of the major elements. Lighter areas correspond to higher elemental concentration.

To provide an overview of the distribution of chemical elements along the surface of the box, macro-XRF was applied to the decorated faces and the results of the major chemical elements found on the Venus-side are shown in Fig. 4.

Copper is omnipresent on all parts of the face and on the side of the box, while zinc is locally present, especially in the gadrooning. Locations with relatively high zinc content correspond to areas with white powdery corrosion as described in the previous section. Both the heavily corroded side of the box and low-relief areas of the surface are rich only in copper, iron and sulphur, while gold, mercury and zinc are notably absent there (black areas in Fig. 4). This suggests that Cu, Fe and S are part of the corrosion that is also visibly different with the naked eye (blue-black at the side and brown-black on low-relief areas, see Fig. 2). This is in accordance with XRD results (section 4.1). The high-relief areas mostly consist of Au and Hg, for which nearly identical images were produced. Even though a slight peak overlap between both elements should be taken into account, this confirms that the object was

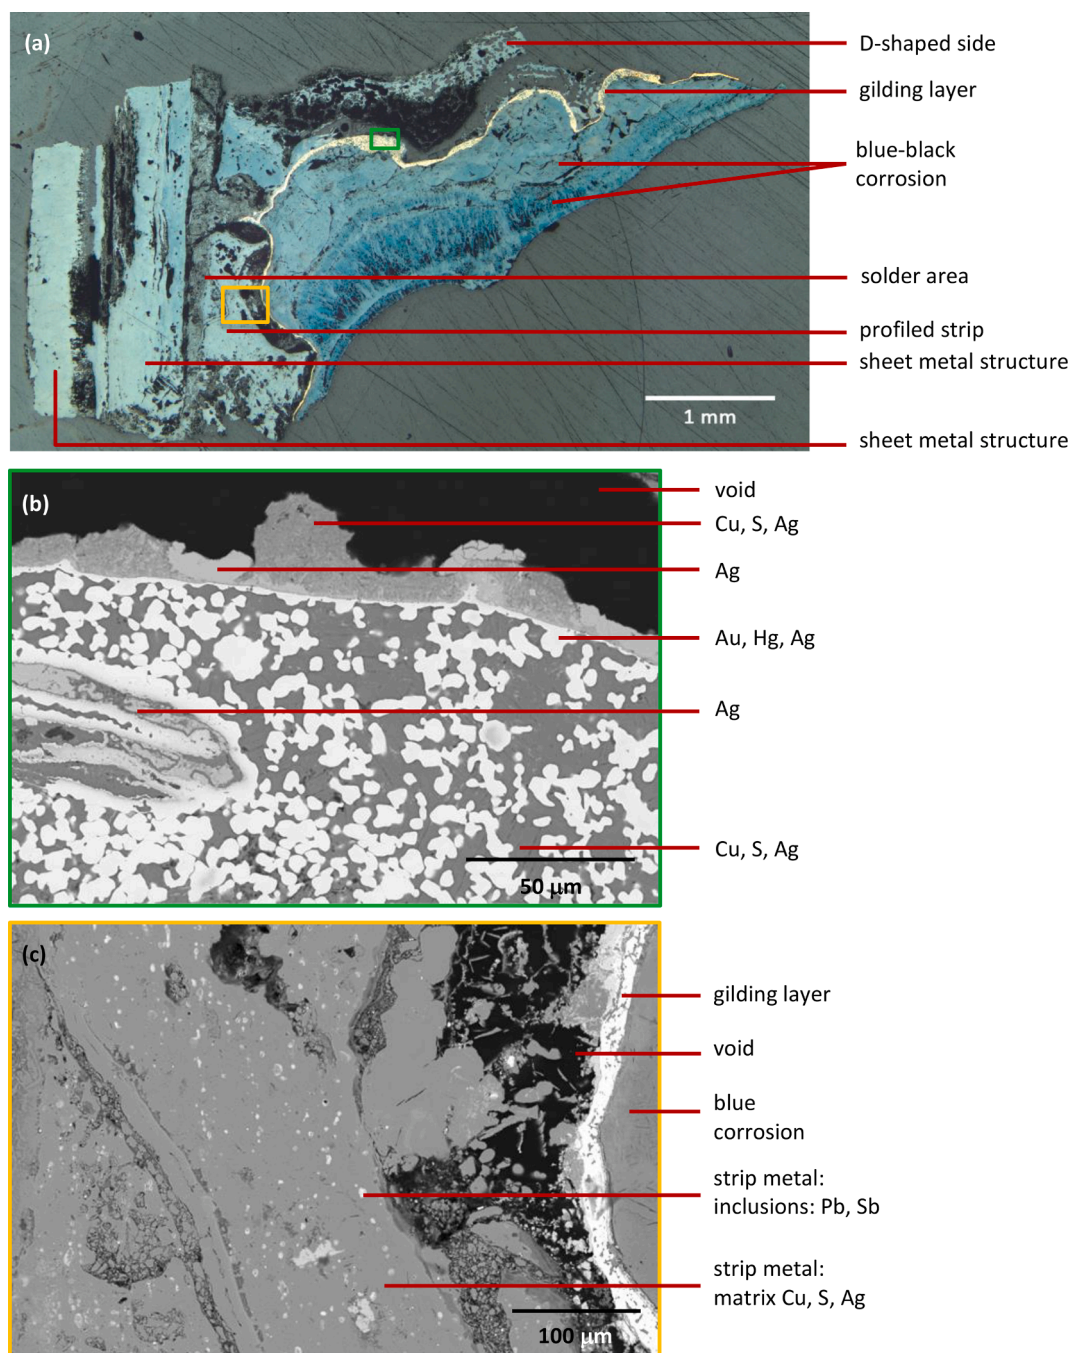
Fig. 5. Embedded cross-section (see Fig. 2). (a) Optical micrograph showing multiple constructional parts of the oval box. In green, the area shown in (b) is indicated, in yellow the area shown in (c); (b) backscatter electron image showing the entire cross-section of the gilding layer, revealing gold (Au) particles (white) with traces of mercury (Hg) and silver (Ag) dispersed in a copper (Cu)- and sulphur (S)-rich layer (grey). Silver-rich areas are present both inside the gilding layer and between the D-shaped side and the gilding layer (light grey); (c) backscatter electron image showing a corroded brass (Cu, Zn) matrix with inclusions containing lead (Pb) and antimony (Sb).

A fragment was found detached from the box and its origin could be reconstructed with high certainty, see Fig. 2. An embedded cross-section of this fragment was studied by OM and SEM-EDS. A clear gilding layer with a thickness varying between 10 and 100 μm is found in between a dark-coloured matrix and a blue-green layer (Fig. 5a).

SEM-EDS analyses (see SOI 4 for more details) of the gilding area (Fig. 5b) show the layer is composed of gold-rich areas (white), containing traces of mercury and silver, dispersed in a matrix of copper and sulphur (grey). The presence of mercury and the globular morphology is consistent with the process of amalgam gilding on copper (Anheuser, 1999, 24, 34). A relatively thick layer with undeformed gold-rich areas (Fig. 5b) is the result of the application of a large amount of amalgam paste that is not subsequently burnished, while a thinner, more compact layer is a typical result after burnishing (Fig. 5c). The copper-based matrix in which the gold-rich areas are dispersed is most likely an infill that has formed during corrosion of the brass box during its presence in the marine environment. The microstructure and composition (Fig. 5c) of the dark-coloured vertically oriented parts as analysed with SEM-EDS (see SOI 4 for more details) lead to the conclusion that these parts are corroded brass components, which belong to the interior sheet metal structure and profiled decoration strip. The blue layer could be identified with SEM-EDS as a layer consisting of copper, sulphur and traces of iron, consistent with the XRD results on the exterior of the box: chalcopyrite (CuFeS_2) and covellite (CuS). The presence of trace amounts of silver in nearly all phases present in the entire cross-section indicates that silver is present in the alloy materials in the form of traces in the copper matrix and/or inclusions.

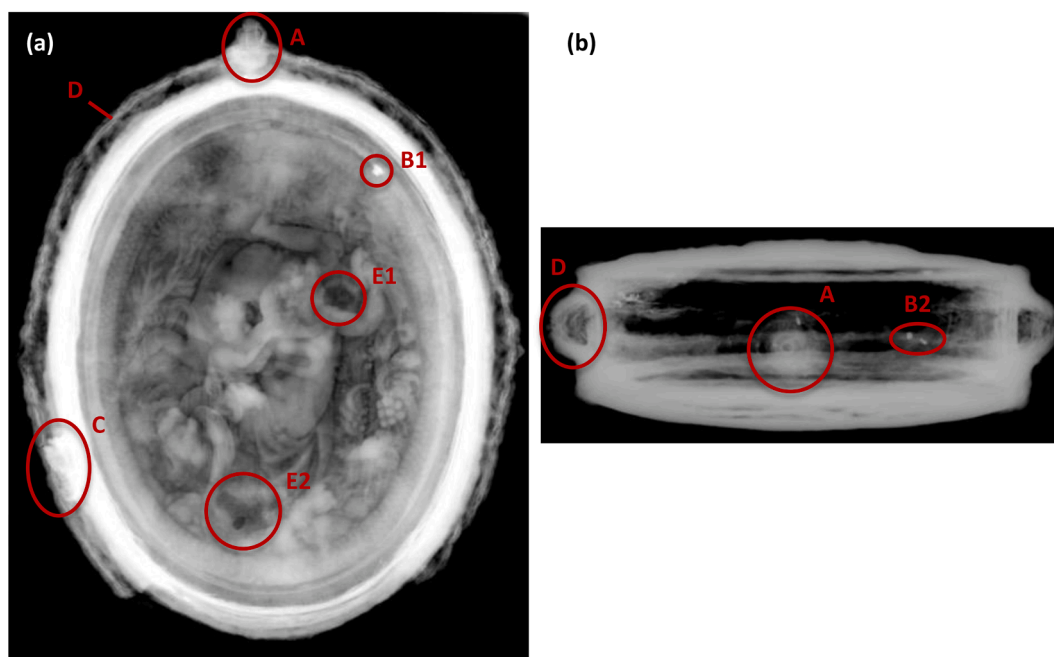
Fig. 6. X-ray images of the oval box. (a) Frontal view; (b) short-side view. A: knob; B: possible uncorroded alloy; C: adhered fragment from another silver object; D: hollow D-shaped side; E: possible old repair.

Area A shows the internal structure of the protrusion on one of the short sides of the box. It can be identified as a knob, that could either be a suspension part or that could have been used to open and close the box. Boxes of this type have usually a tight-fitting lid (*press-fit*), sometimes even without a hinge. If a hinged mechanism is used, the opposite side of the box has usually a small knob that can be pressed to open the lid. A

Small white spots and more stretched patches are visible on the interface between plaquette and gadrooning (Fig. 6a, area B1, ~20 mm diameter) and at the base of the D-shaped side (Fig. 6b, area B2, ~15 mm diameter), which can be interpreted either as soldering residues, possibly lead or silver, as gold residue from gilding or as a relatively large amount of copper alloy. These areas are not distinguishable by neutron tomography. Since the presence of lead would have led to visible voids in reconstructions based on the used neutron tomography set-up, this material can therefore be eliminated. The observation that these areas have the same grey value as their surroundings also indicates that large amounts of gold and silver can be ruled out. But, unexpectedly, the gilding layer could not be clearly distinguished from the base metal (=non-ferrous metal, neither precious nor noble), even though its presence is confirmed by other techniques. The voxel size of the NT set-up is ~150 μm^3 , while the gilding layer is estimated to have a thickness up to 100 μm (see section 4.2), leading to apparent invisibility with NT. Therefore, the chemical composition of the patches is still inconclusive.

A fragment of another object from the shipwreck is adhered to the Leda-side of the box at location C, which can be seen with the unaided eye. The high brightness of this area in the radiographs suggests a material with a relatively high density compared to copper, which is confirmed by XRF where a high concentration of silver is measured.

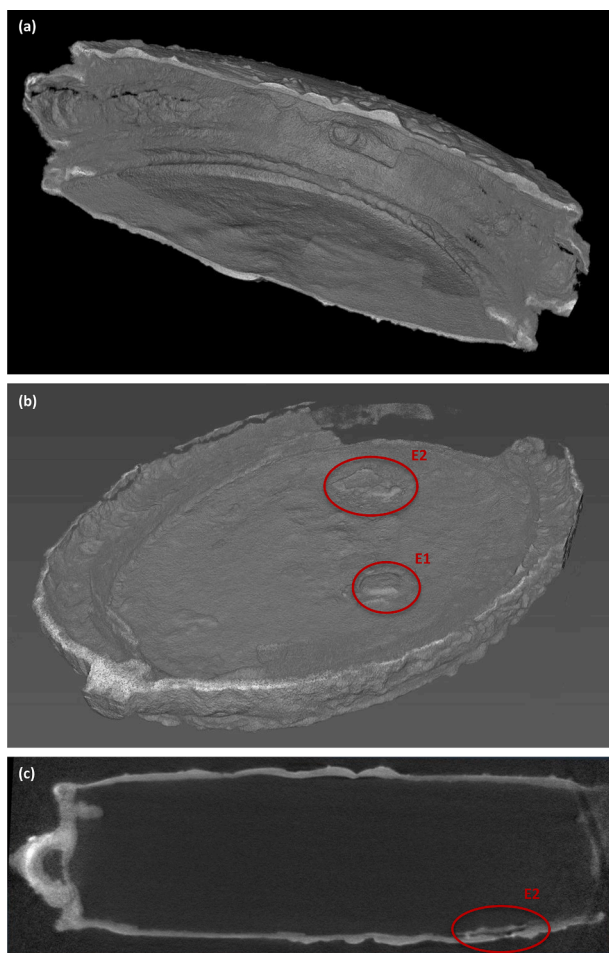
Fig. 7. Reconstructions made from neutron tomography. (a) Interior of the box showing the possible opening mechanism with the Venus-side on top; (b) the bottom side of the Venus-plaquette, showing a smooth outline, indicative of casting. Two old deformations can be seen as well (areas E1 and E2, see Fig. 6); (c) virtual section along the longitudinal axis of the box, with the Venus-plaquette shown on top and the one with Leda on the bottom.

Fig. 7a shows that the possible opening mechanism is now incomplete, with the knob (see Fig. 6) located at the left of the rectangular opening. This shape suggests perhaps the use of a spring system with the steel spring now completely disappeared, probably due to corrosion.

From the reconstructions made from NT, it can be deduced that the backs of the plaquettes roughly follow the form of the decoration (Fig. 7b), and the thickness measures about 2–3 mm, consistent with manufacturing by casting. The gadrooning and other sheet metal structures are embossed, based on their shape and thickness (~1 mm). This is in agreement with the observation of different corrosion morphologies on the different box components (section 4.2).
