Description of Gasket Failure in a 7 Cell PEMFC Stack

Attila Husar, Maria Serra, Cristian Kunusch*

Institut de Robòtica i Informàtica Industrial, Parc Tecnològic de Barcelona. Edifici U
C. Llorens i Artigas, 4-6, 2a planta, 08028 Barcelona, España

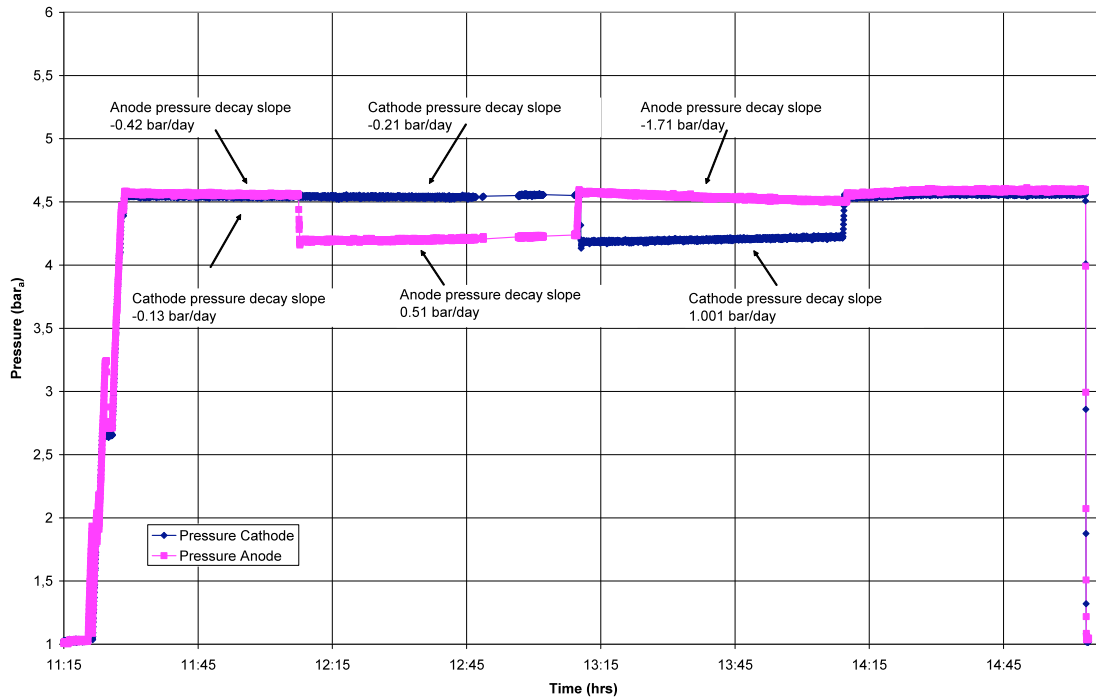
In the morning, an overboard leak check was done on the stack using nitrogen on the anode and air on the cathode. A leak check was needed because on the previous run the pressure on the anode side could not be maintained. However, there were no other signs of failure. The procedure for the pressure decay leak check is as follows: a flow of nitrogen and air is applied to the stack, the system is pressurized to 4.5 bar_a , then the inlet and outlet to the stack are closed and the system left alone for a given amount of time. The pressure decay leak check is presented in figure 3. It was done in three sections. The first section of the test was done with anode and cathode pressures at the same value (4.5 bar_a). The second part of the test was done with the cathode pressure left at 4.5 bar_a and the anode pressure reduced to 4.2 bar_a . The final part of the test was carried out in reverse order. The

anode pressure was increased back up to 4.5 bar_a and the cathode pressure was reduced to 4.2 bar_a. The slope of each section of the test is indicated on the graph. Figure 3 shows an increasing slope of the lower pressure side of the membrane indicating that gas from the higher pressure side of the membrane is crossing over to the low pressure side. The exact rate is unknown because a true crossover leak check was not done on this stack due to the lack of equipment. No combustion occurred during the leak test because nitrogen was being used on the anode.

Fig. 3. Pressure decay leak check of stack at ambient temperature with air on the cathode and nitrogen on the anode

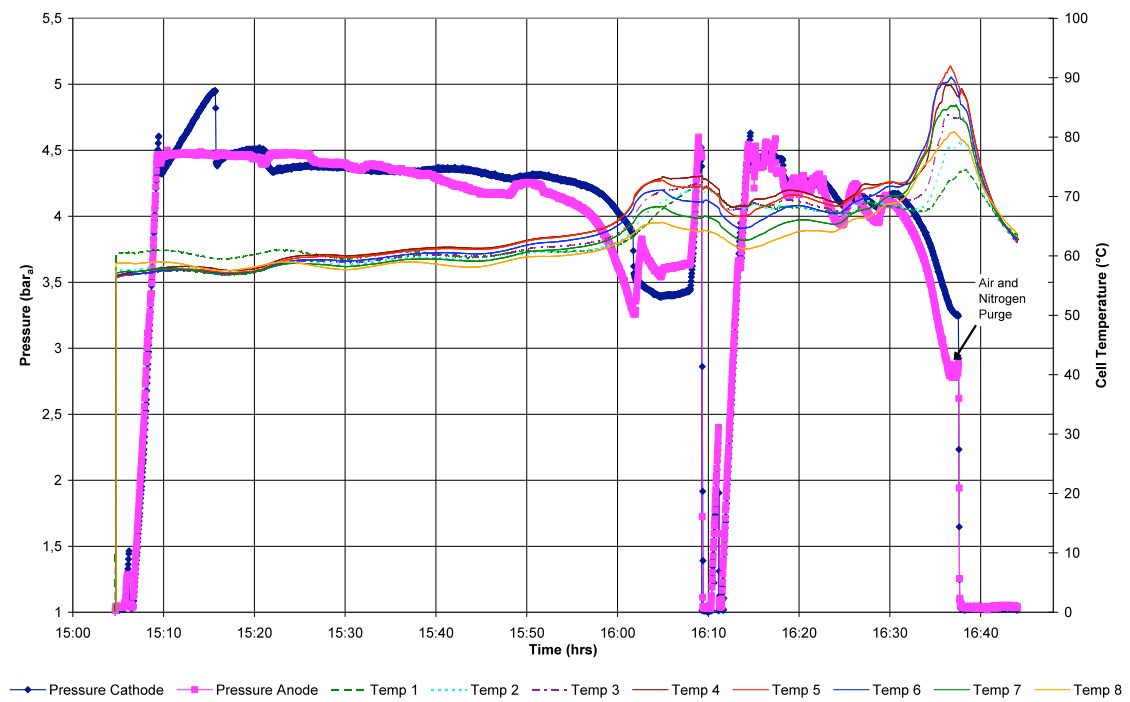
The stack temperature was the indicator that led to the final shutdown of the stack. The stack was being operated with oxygen and hydrogen and no humidification. The stack temperature reached 90°C without current or resistance heaters enabled. The hot point in the stack was in the middle cells, which read a temperature of 91°C. The pressure in the stack could not be maintained. Both of these symptoms indicated a crossover leak and combustion. So the stack was purged with nitrogen, and declared inoperable.

The data for these final hours with respect to pressure and temperature is shown in figure 4, which shows spikes in temperature as the pressures decayed. The cell temperature measurements were taken at eight different points throughout the stack located in the bipolar plates in between each cell. For simplicity purposes they were called measurements 1 through 8, where measurement 1 is located between the end plate and cell #1, where cell #1 is the first cell the gasses encounter when they enter the stack.

Fig. 4. Pressure of the reactant gasses vs. cell temperature during the last hours of operation. *H₂/O₂, no humidification??*

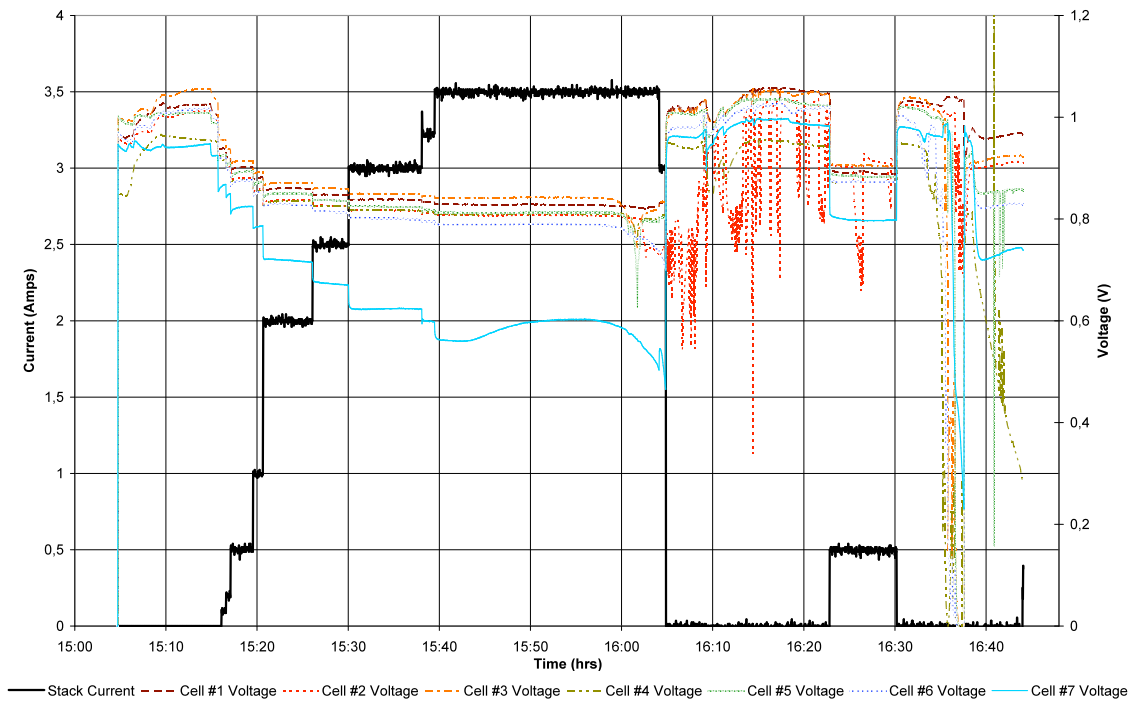
Figure 5 depicts the stack current versus the individual cell voltages, which indicate that after the current was reduced to 0 at around 16:05, the open circuit voltages became very unstable especially that of cell #2.

Fig. 5. Stack current vs. individual cell voltage during the last hours of operation, H₂/O₂, no humidification and a gas pressure??

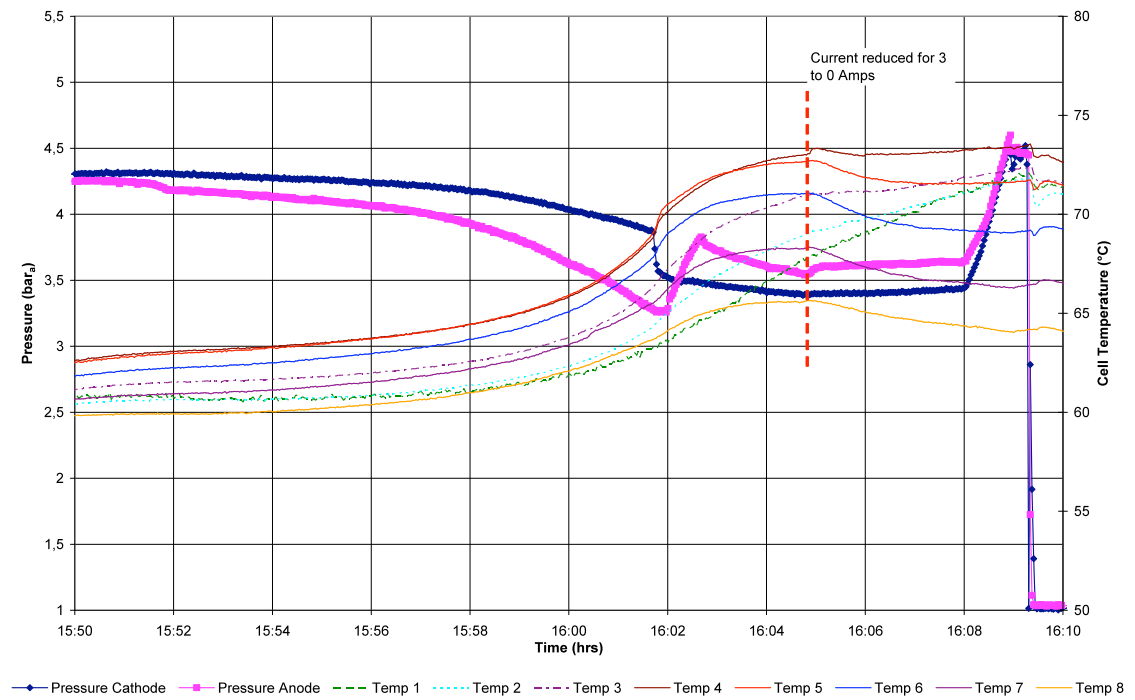
In figure 6 the time between 15:50 and 16:10 is examined with respect to pressure and cell temperature. When the load was removed from the stack at 16:05 the temperature measurements 4 to 8 started to decline as was expected. However, the temperature measurements 1 to 3 continued to increase. This temperature rise showed signs of a breach possibly in cell #1 and/or #2.

Fig. 6. Zoom of fig 4 between 15:50 and 16:10. Increase in temperature in cells #1 and #2 with no electric load or external heaters on the stack and an anode reactant pressure higher than the cathode pressure when the load was removed

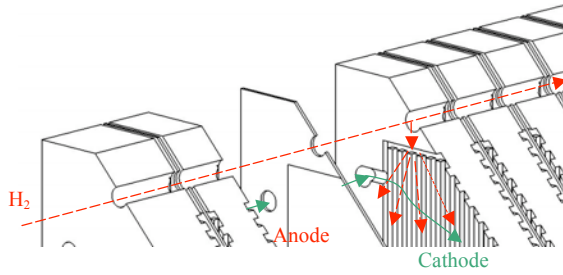
Figure 7 explains how a breach in one cell affects the flow of the reactant gases when the pressure of the anode is higher than the cathode. Hydrogen enters directly into the breached cell and combusts in the catalyst layer, therefore increasing the temperature for just that one cell.

Fig. 7. Flow of the reactant gases when there is a breach in the seal at the anode inlet port that goes into the cathode flow field. Anode pressure is higher than the cathode's

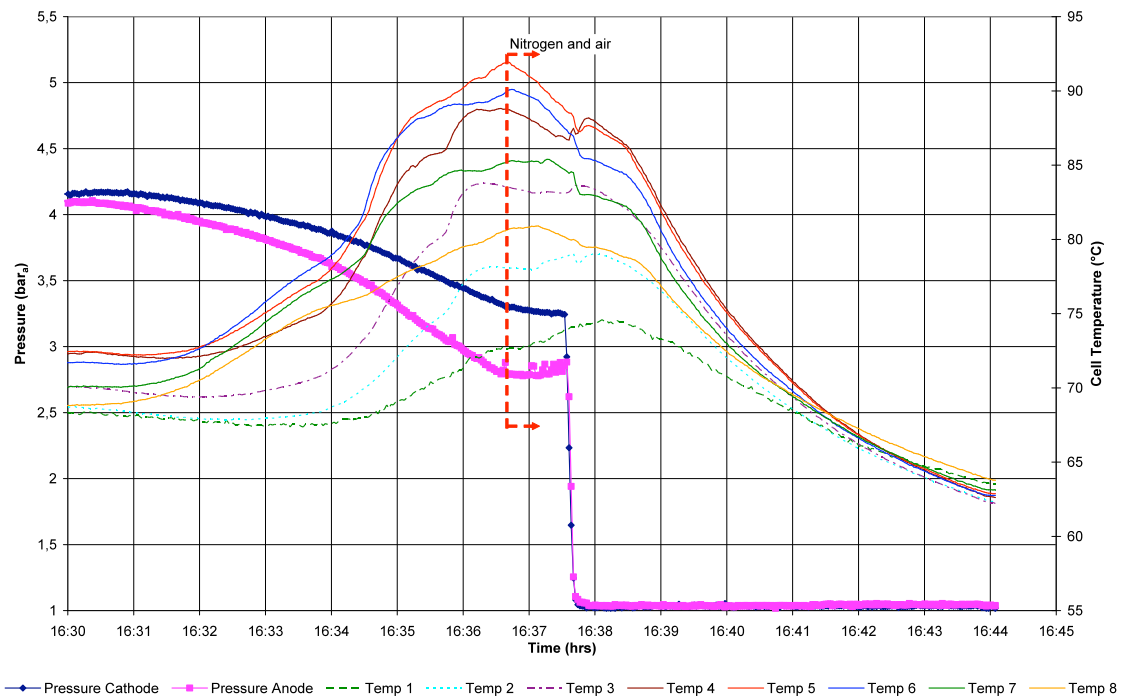
In figure 8 the time between 16:30 and 16:45 is examined with respect to anode and cathode pressure and temperature. Initially both pressures were equalized, however the anode pressure started to decline more rapidly than the cathode because hydrogen was being consumed at twice the rate of the oxygen due to combustion which, in turn, caused more oxygen to be forced into the anode inlet port thus, increasing the rate of combustion in the cells located after the breach. Once the nitrogen purge was initiated on the anode and air purge on the cathode the pressures began to stable out and the cell temperatures decreased. Shortly after, the pressure was reduced to atmospheric and the stack was declared inoperable.

Fig. 8. Zoom of fig. 4 between 16:30 and 16:45. Cathode pressure is higher than the anode's and the hot spots in the stack are from cell #3 to #6 indicating that the oxygen was entering into the hydrogen stream through the inlet port

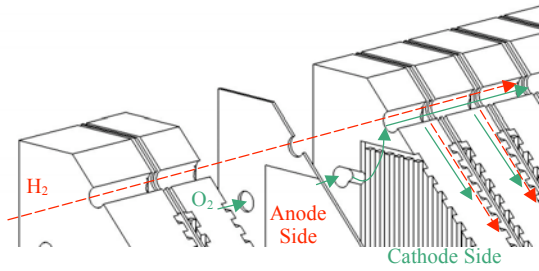
Since the breach is reversible it should permit the oxygen to enter into the anode inlet port if the cathode pressure was higher than that of the anode as shown in figure 9. Therefore, the oxygen breach should only affect the subsequent cells.

Fig. 9. Flow of the reactant gases when there is a breach in the seal at the anode inlet port. Oxygen is entering into the anode inlet port. Cathode pressure is higher than the anode's

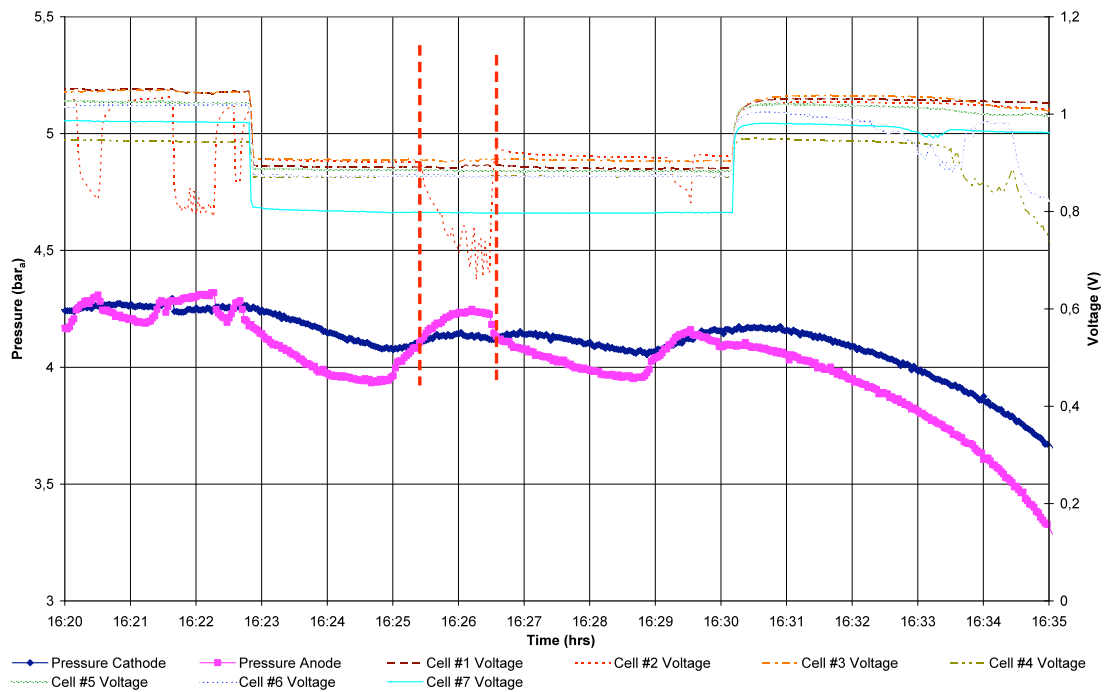
Cell #2 in Figure 10 showed a unique behavior when the anode pressure was higher than the cathode pressure. The cell lost about 20 mV and became unstable. Then, when the anode pressure was decreased to be lower than the cathode's the cell stabilized. This indicates that there was hydrogen crossover in cell #2.

Fig. 10. Temporary instability of cell #2 when the anode pressure is higher than the cathode's. Hydrogen enters directly into the cathode flow field of the cell

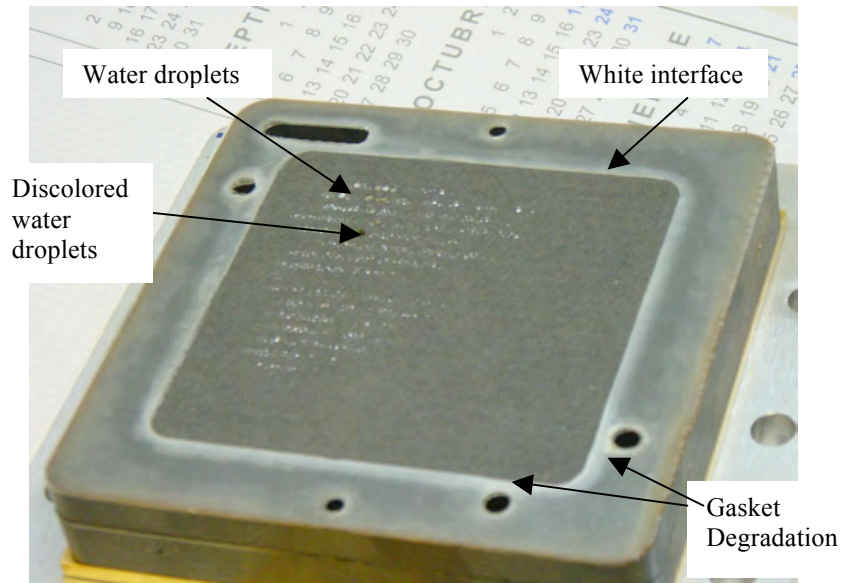
Upon opening the stack it was clear that it was cell #2's cathode side gasket that had failed. Figure 11 shows the cathode gasket and GDL for cell #2 while still attached to the bipolar plate. The interface between the gasket and the GDL is an off white color indicating degradation.

Interestingly, this was the only cell that had water droplets on the gas diffusion layer and a few of the droplets were brown in color which is a sign of contamination possibly from combustion on the cathode side.

Figure 11. Cathode GDL and gasket of cell #2 before it was removed from the bi-polar plate

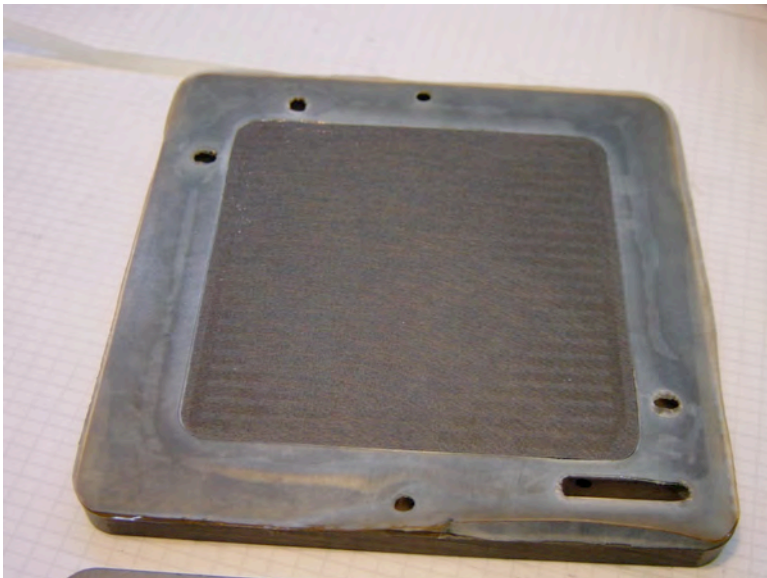
Figure 12 illustrates what a good cell with no degradation of the gasket should look like.

Figure 12. Cell # 5 gasket and diffusion layer which showed no degradation

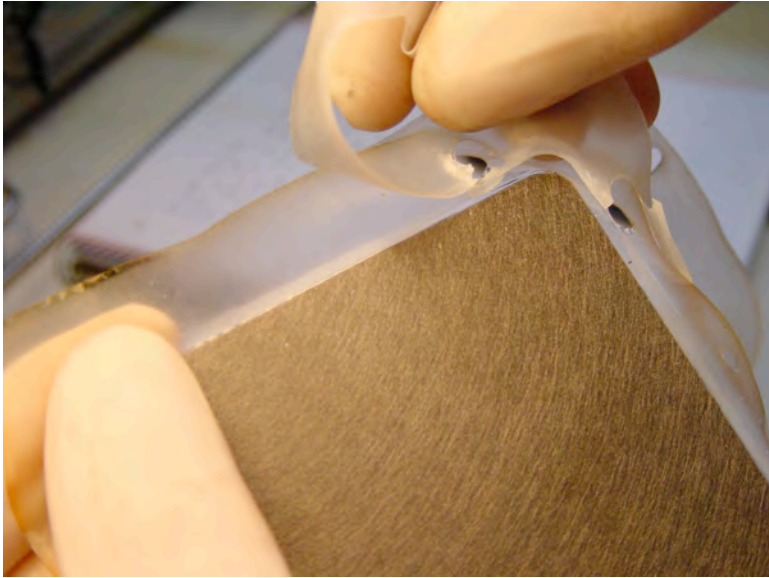
When the gasket and MEA were peeled off of the anode side of the bi-polar plate it revealed that there was severe degradation of the gasket material around the anode inlet port towards the GDL as shown in Figure 13. There was also some degradation around the cathode inlet. This degradation occurred on the cathode gasket.

Figure 13. Cell #2 cathode gasket degradation

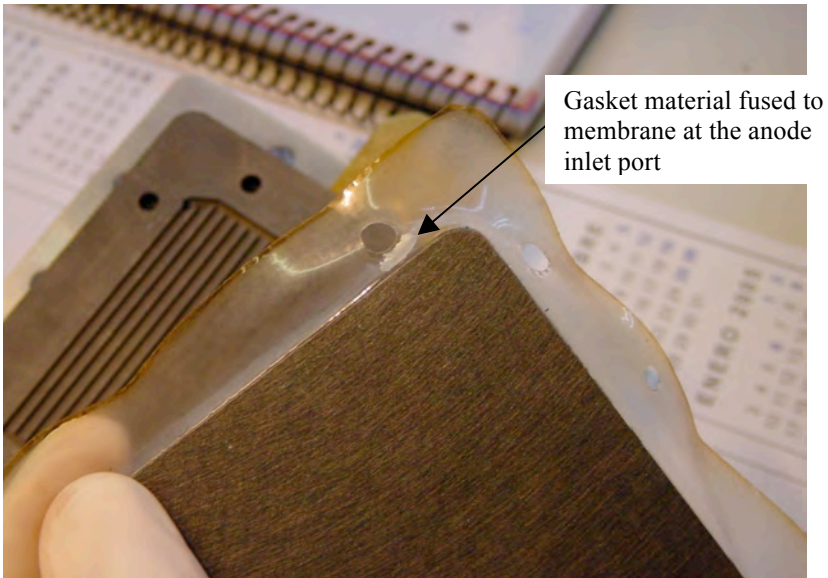
Finally, when the gasket was totally detached from the membrane it was discovered that a piece of the gasket material was fused to the membrane at the anode inlet port as seen in Figure 14. This could be explained by the high

temperature reached due to combustion that caused the gasket material to disintegrate and fuse to the membrane.

Figure 14. Gasket material left on the membrane at the anode inlet port and on the cathode side of the membrane

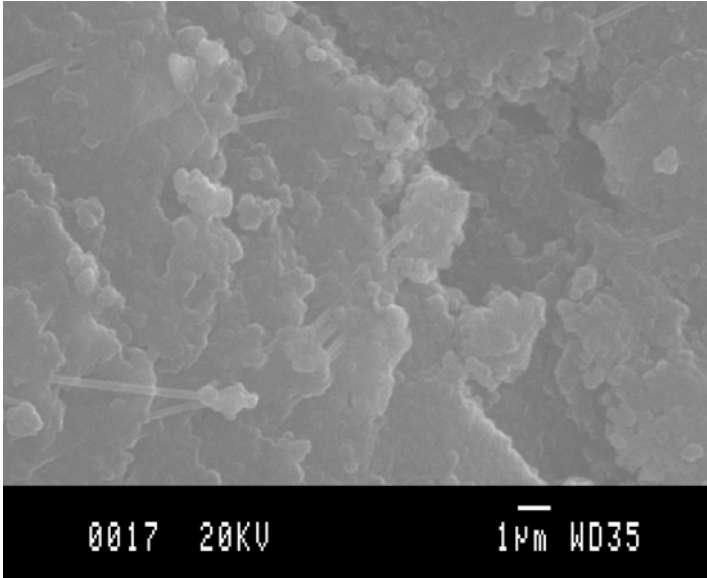
Figures 15 & 16 show images of the silicon gasket material taken with the scanning electron microscope. In figure 15 the silicon gasket material was exposed to combustion from cell #2, and figure 16 shows what the same material looks like under regular conditions.

The MEAs from cells #2 and #4 were also examined. An X-Ray Energy Dispersing Spectroscopy was performed on both MEA samples which indicated the presence of both platinum and silicon. The platinum was expected because it is used as a catalyst. However, the silicon indicated a possible contamination of the MEA.

Fig. 15. Silicon gasket material that was exposed to the combustion from cell #2

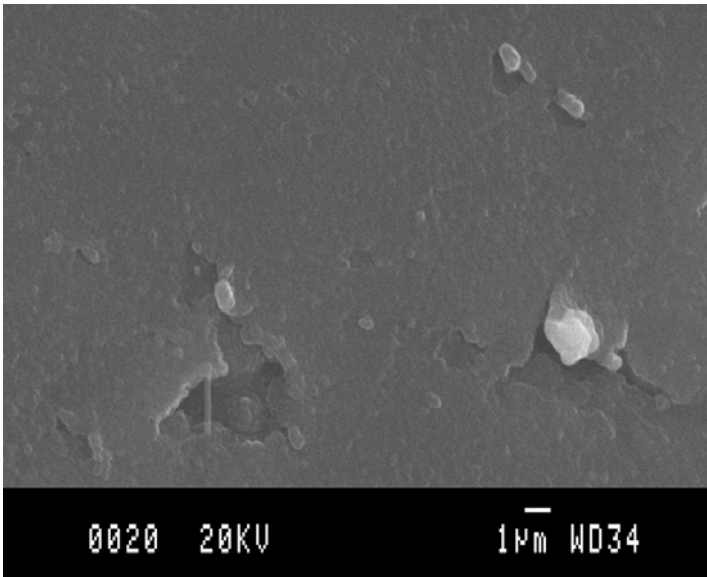
Fig. 16. Silicon gasket material that was not exposed to the combustion from cell #4
