East Stoke: The Archaeology of the Old Church of St Mary

This is the second of two reports relating to research and fieldwork at the site of the Old Church of St Mary, East Stoke (see Hewitt, Russell and Manley 2009). These investigations were undertaken in conjunction with the East Stoke Heritage and Archaeological Group. This paper presents the results of limited non-intrusive archaeological fieldwork.

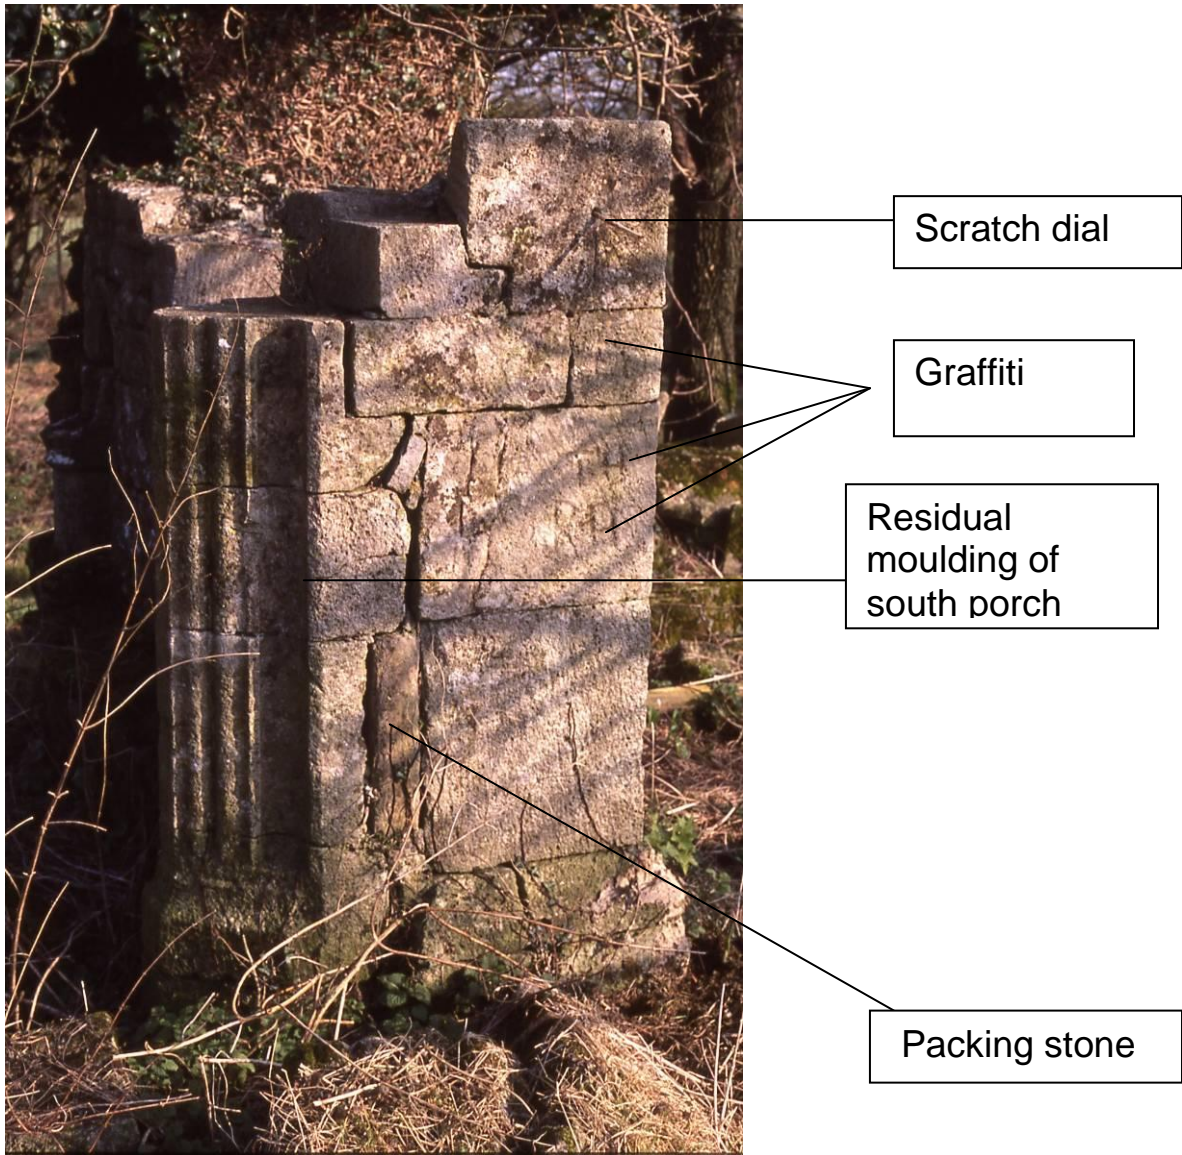
The visual survey revealed that the south elevation of the porch, east of the entry arch, shows signs of reconstruction. Close to the ground is a slab-like stone that seems to be out of place in a vertical position (Figure). Furthermore, it is a limestone of a slightly different hue to other component stones of the porch. This, together with apparent re-cutting lines of the stone blocks immediately above it, suggests that the porch had been re-assembled having formerly graced a previous site, perhaps either of the monastic

The south face of the east porch wall has an unpublished scratch, or mass dial upon its surface, incised into a single limestone block (Figure 3). Mass dials are pre-Reformation features and so this example is likely to be contemporary with the erection of the porch in the 15th or 16th centuries (Friar 1996, 437-8). If the porch was imported from another site then this scratch dial is a fairly late example because it is perfectly positioned for its purpose and it is not a re-used feature. In common with many dials of its type, the East Stoke example comprises an incised horizontal line (220mm) that passes through a central hole (ca 25mm diameter) that also served as the socket for the gnomon. The socket is the starting point for 6 (possibly 8) radiates arranged in protractor fashion and spaced at approximately 15 degree intervals. Each radiate is of ca 110mm length. At a point roughly midway between the fourth and fifth radiates from the left, and ca 600mm beneath them, a peg hole has been impressed into the mortar between two stone blocks. Clearly, this peg hole is part of the dial and probably indicates the time at which mass was to be performed.

Carved into the stone block immediately below the scratch dial are the letters ED, the largest of the letters being 75mm in height. The incisions are of both letters are approximately 15mm in width. One block further down has been incised with two further sets of letters: TH and, immediately beneath, RH. The style and size of engraving is much the same as the ED above which suggests that all three may be contemporary. However, the letter R is by far the most pronounced at 120mm in length. A date for the graffiti cannot be determined but all of the letters are indicative of an unskilled style that would not be out of place from the late 19th century through to the mid twentieth century.

Figure 3: *Southeast wall of south porch showing features as described. The porch sits on a plinth finished in a single sunken chamfer (Child 2008: 39).*

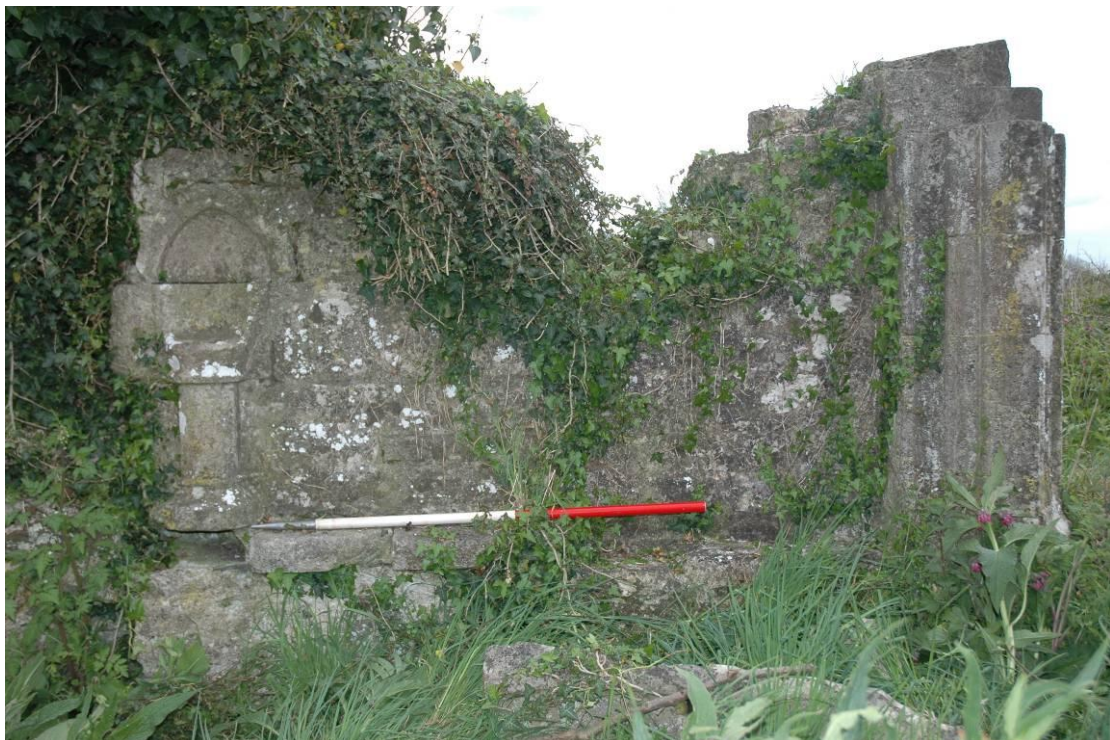
In common with other church porches of the 15th or 16th centuries, the south-east interior of the porch contains a holy water stoup at the point where the latch of the nave door would have been. This example is constructed from three limestone blocks, of the same geological origin as the porch. It has a chamfered arched head with an octagonal base underneath which a flat stone has been removed. The central pillar is cylindrical and has annulets at either end. The bowl is incomplete, about 50% of it having been broken away.

However, sufficient of the bowl remains as to suggest that originally it was circular and of ca 250mm depth.

The porch also contains stone bench-seating. On the east wall this feature remains almost complete but there are traces of it on the west side too. This seating would have been for the use of the Church Wardens and other parochial worthies (Figure 4). Above and centre, the remaining wall dips downwards. This was the position of a quatrefoil window that has vanished since it was recorded by the Royal Commission (1970, 274-5). The creeping incursion ivy is self-evident.

Figure 4: *Interior east wall of the south porch showing the relative locations of the stoup (left) and the stone bench. The dip in wall above indicates the former position of the quatrefoil window. Ivy (*Hedera helix*) is firmly rooted into the top of the fabric.*
