Dhimish, Mahmoud and KETTLE, JEFF (2021) Impact of Solar Cell Cracks Caused During Potential-Induced Degradation (PID) Tests. IEEE Transactions on Electron Devices. ISSN 0018-9383

Impact of Solar Cell Cracks Caused During Potential Induced Degradation (PID) Tests

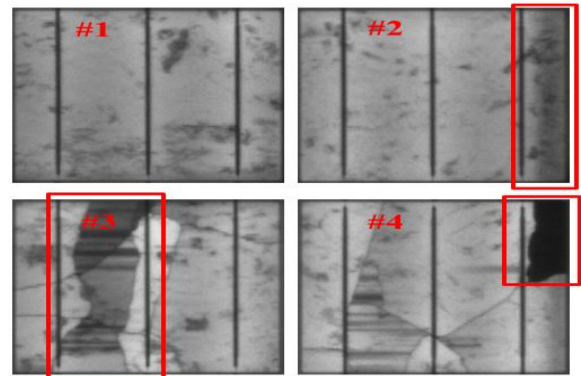
We have examined several solar cell samples categorizing different cracks shapes on distribution as well as structural defects. The EL image of the tested cells is shown in Fig. 4. According to Fig. 4(b), the solar cell sample (#1) is affected by minor defects/cracks across the cell. It was evident by previous research that such cracks do not reduce the output power of the solar cell. While solar cell samples (#2 and #3) are affected by cracked areas along with dark areas (labelled by the triangle), this type of crack has not been fully understood, and there is no information on whether it could lead to PID in the solar cell.

The last solar cell sample (#4) is affected by a breakdown region (labelled by the triangle). There are some proposals in the literature on whether this area can lead to PID or breakdown in the busbar; however, experimentation results have not yet been proclaimed. Hence, our results on examining these defects in the solar cells would significantly contribute to understanding the variations of the cracks along with their relationship with solar cell PID.

Fig. 4. (a) EL image of the PV module before the dismantling process, (b) After the dismantling process, the EL image of the tested solar cell samples, the first sample (#1), has a minor defect/crack across the cell. In contrast, samples (#2 and #3) are affected by a dark area with additional cracks in the cell. The last sample (#4) is affected by a breakdown region, as evidence by the solid black area.

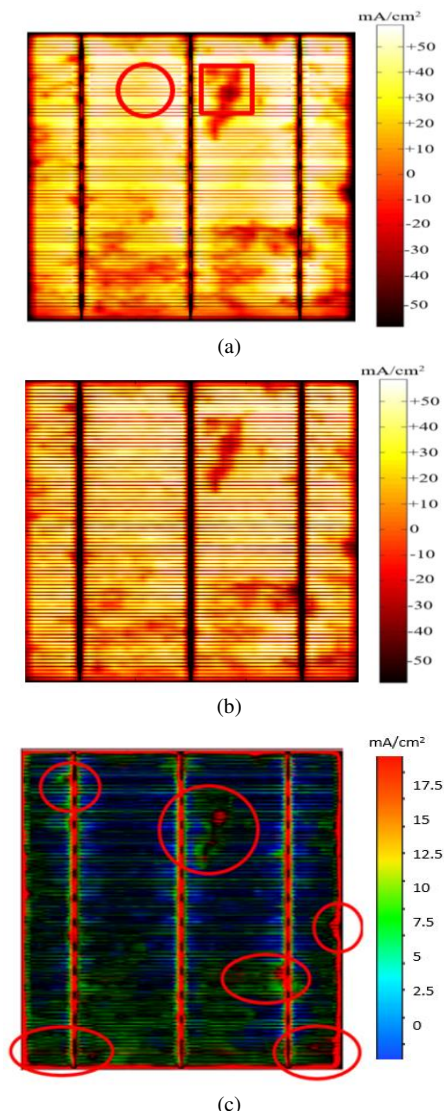
The image of the J_{sc} before and after the PID test is shown in Fig. 6(a) and Fig. 6(b), respectively. The difference between the before/after images is shown in Fig. 6(c). The most significant defects/cracks in the solar cell sees the biggest drop in J_{sc} . For example, on, the area labelled by the circle has no losses in the J_{sc} , 38 mA/cm². However, for the cracked/fractured area, labelled by the rectangle, the J_{sc} drop is approximately equal to -10 mA/cm² (27% relative reduction). This would correspond to a hotspot in an operational PV module, potentially leading to greater module defects as time progressed.

Following the observation of sample #1, minor cracked/defective areas in a solar cell are unlikely to cause a major and immediate PID. This consequence was concluded by observing that the pattern of Fig. 6(a) and Fig. 6(b) are almost equal. There are moderate differences between the J_{sc} before and after the PID, as shown in Fig. 6(c). We have labelled the key areas that exhibit a reduction in (leakage) current after the PID testing was completed. The blue regions in Fig. 6(c) correspond to a negligible change in degradation (no difference in the J_{sc}).

Fig. 6. J_{sc} for Solar cell #1. (a) before the PID test, (b) after the PID is completed, (c) Difference in the J_{sc} before and after the PID test.

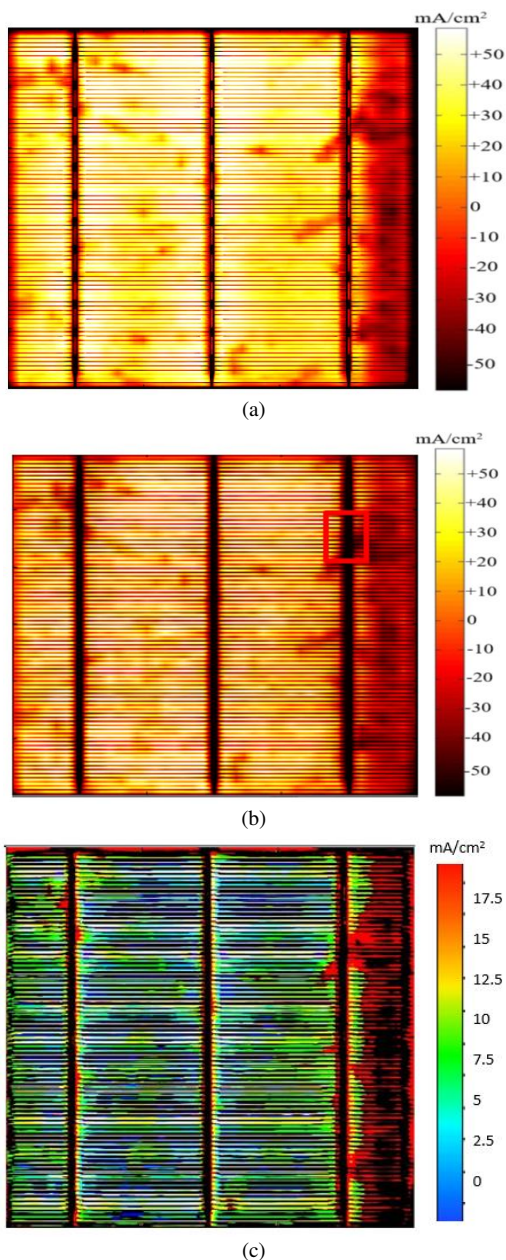
Now consider the behavior of solar cell sample #2, where the LBIC images before the PID test began is shown in Fig. 7(a). The dark area on the right-hand side of the solar cell clearly exhibits a drop in the J_{sc} . In agreement with the earlier data, the J_{sc} reduced significantly after the PID test was completed (Fig. 7(b)). Remarkably, the images indicate that the dark area is likely to be causing a more severe PID to the cell. There is a noticeable expansion of the dark regions across the right-hand side where the original EL image has an initial dark area.

The difference between the J_{sc} before and after the PID test is shown in Fig. 7(c). There is a significant drop in the current on the right-hand side of the solar cell, which is the same area that had the initial shading/defect. This confirms that such dark areas in the original EL images can be classified as high-risk regions for PID degradation in solar cells.

Fig. 7. J_{sc} for Solar cell #2. (a) before the PID test, (b) after the PID is completed, (c) Difference in the J_{sc} before and after the PID test.

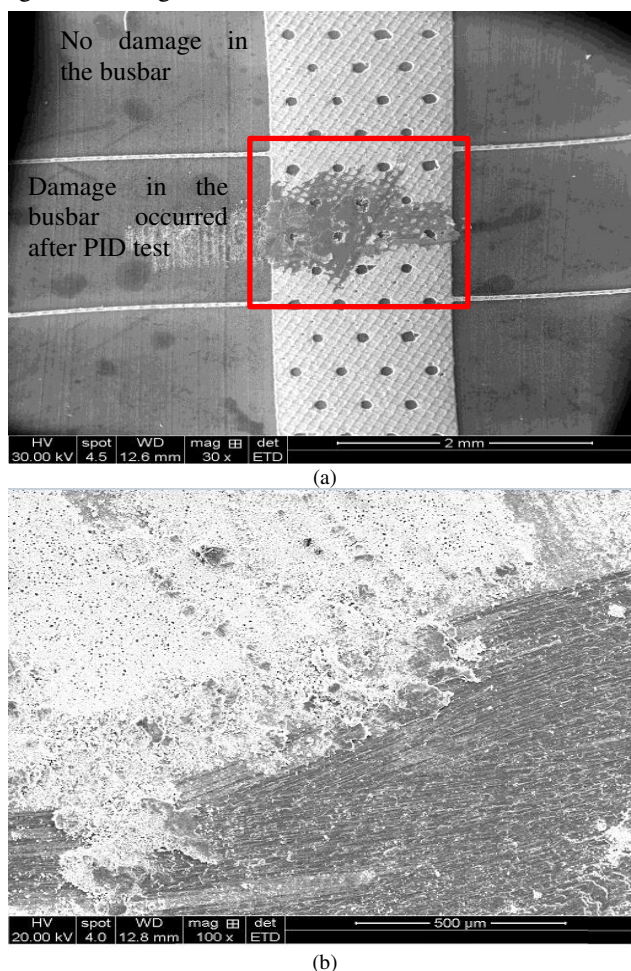
We have taken the SEM image of the labelled area in Fig 7(b) for further examination. The output image of the inspection is shown in Fig. 8(a). We have witnessed that after performing the PID test, the dark area (potential crack) damaged the busbar, this is evident by the front surface view.

In Fig. 8(b), we have observed at the back surface of the busbar. The PID test initiated further damage to the rear surface of the solar cell sample. There are a number of ‘pits’ in the contacts and material migration from the contact areas. As a result, we prove that it is likely to have a critical PID for a solar cell that comprises entirely/partially dark regions in the original EL image.

Fig. 8. SEM for solar cell #2. (a) front surface, (b) Back surface.

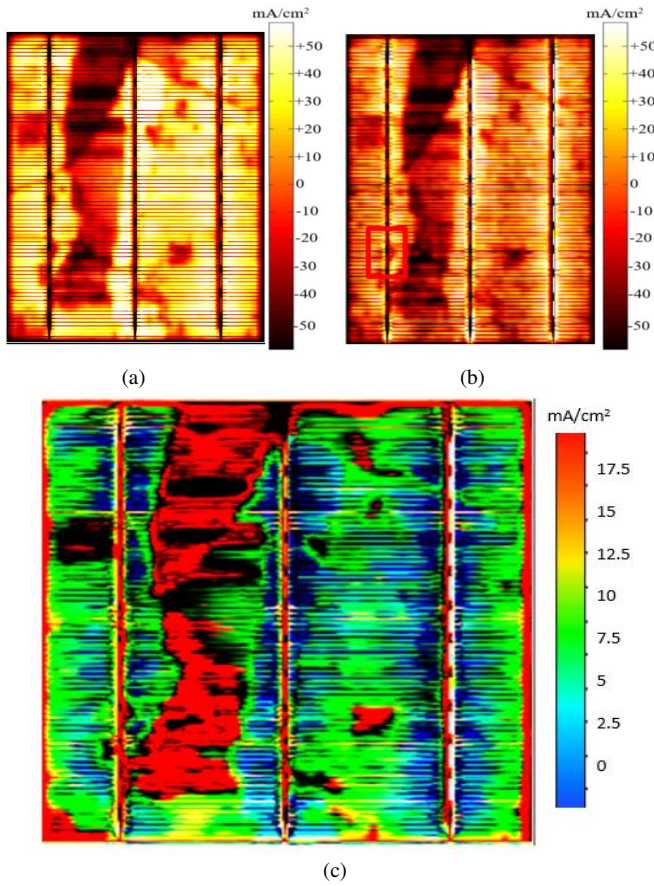
Now, considering solar cell sample #3 which was also imaged before and after PID testing. The J_{sc} before the PID test is shown in Fig. 9(a), whilst after the PID test is performed, a large reduction in the J_{sc} was observed, particularly in the dark area on the left-hand side of the EL image, and in the LBIC image, which is shown in Fig. 9(b).

The difference between the J_{sc} before and after the PID test is shown in Fig. 9(c). We can remark that there is negative current (leakage) in the areas where the dark (crack) is present. This result reinforces our earlier conclusion that cracks can lead to greater decreases in current density, indicative of regions where the solar cell operation has completely broken down. Hence, hotspots are expected to appear these locations if the cell is operated under field conditions, which would lead to further degradation.

Fig. 9. J_{sc} for Solar cell #3. (a) before the PID test, (b) after the PID test is completed, (c) Difference in the J_{sc} before and after the PID test.

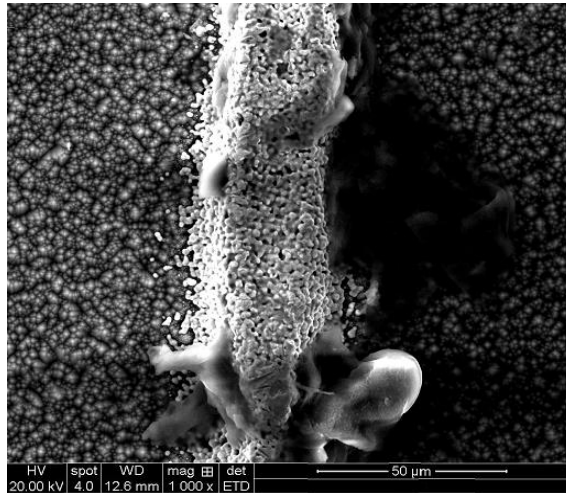
In contrast, we have further investigated the labelled area in Fig. 9(b), using an SEM. The result of the SEM inspection is displayed in Fig. 10. By inspection of the busbar's metallic (solder) joint to the solar cell surface, it is evident that the solder has migrated and deformed around the solder joint. This microscopic observation leads to understand why some solar cells, after PID tests, demonstrate significant decreases in the output current; clearly these changes lead to the development of hotspots and open circuits forming at the solder joints.

Fig. 10. SEM image for the front surface of the labelled area in Fig. 9(b).

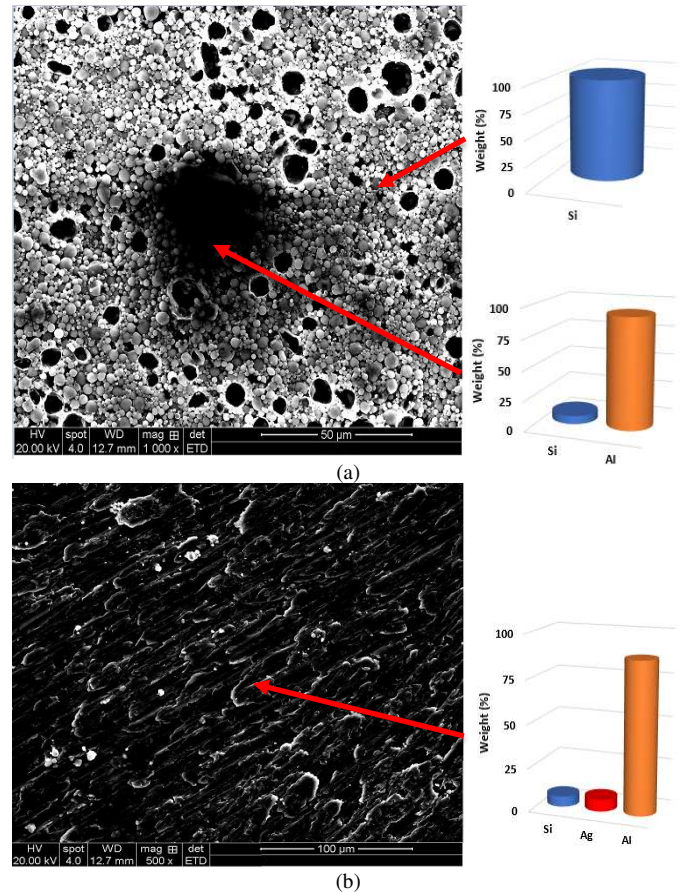
The breakdown areas were analyzed using a SEM. For example, the output SEM image for A1 is shown in Fig. 13(a). It appears that the crack has initiated a significant breakdown in the cell (the black area in the middle of Fig. 13(a)) and hundreds of similar potential breakdown blocks in the surrounding area. The white areas in the image represent as Silicon using Energy-dispersive X-ray spectroscopy (EDX). In comparison, the black area corresponds to aluminum (Al), indicating that a large defect in the solar cell, and the solar cell rear contact (made of Al) is only visible. Additionally, the SEM image for A2 is shown in Fig. 13(b); only 6% silicon was found in this area, along with 7% silver (Ag) due to the expansion of the busbar material and 87% of Al. Accordingly, this part of the solar cell has a complete breakdown, not generating any photocurrent.

In reviewing the abovementioned observations, the breakdown area in the solar cell sample #4 leads to a drop in the J_{sc} after the PID test was completed and a further breakdown area adjacent to the initial breakdown. These observations suggest the following:

Fig. 13. (a) SEM image for the front surface of area A1, (b) SEM image for the front surface of area A2.
