DAC REHABILITATION

GRAPHICAL SURVEY, DIAGNOSIS AND PROPOSALS FOR INTERVENTION OF “GUARDIA Y CUSTODIA” OF “EL POLVORÍN”

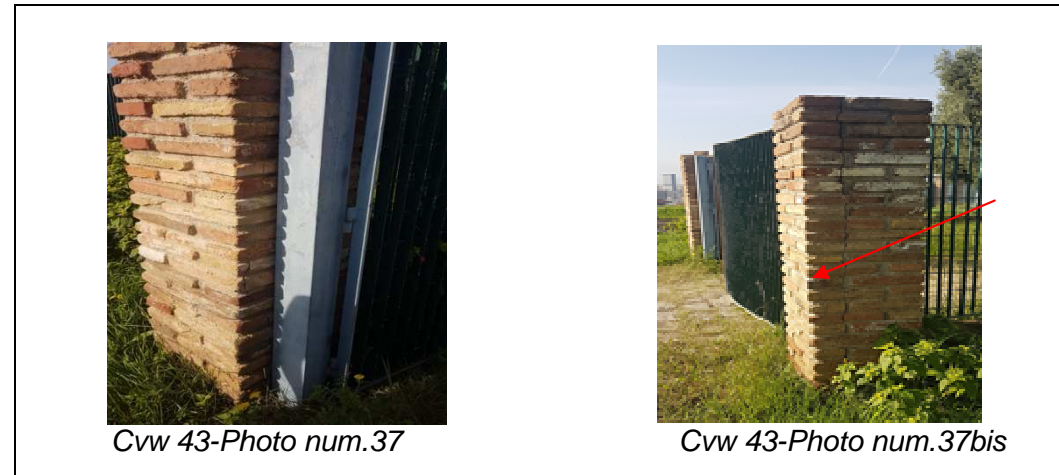
- Lost left outer wall of section in the lower part. (File nº9).

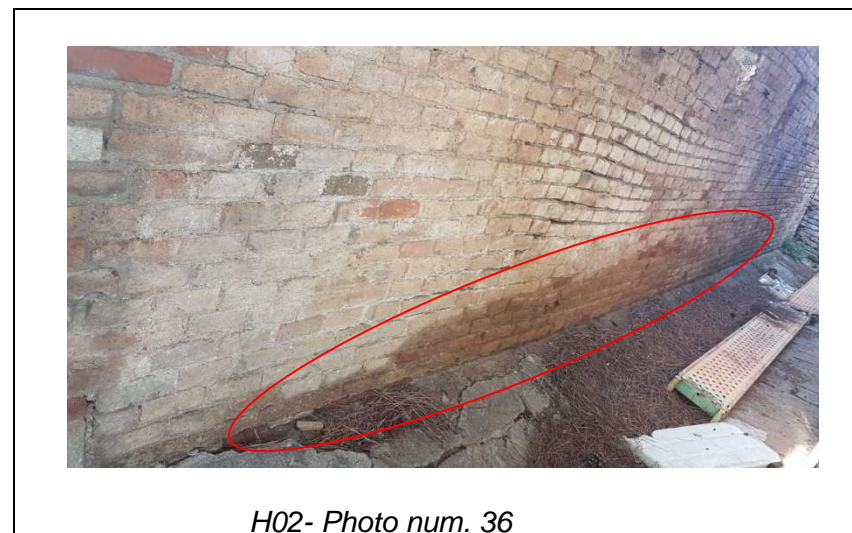
- Humidity in the perimeter wall that surrounds the building on the south side in the intrados. (File nº10).

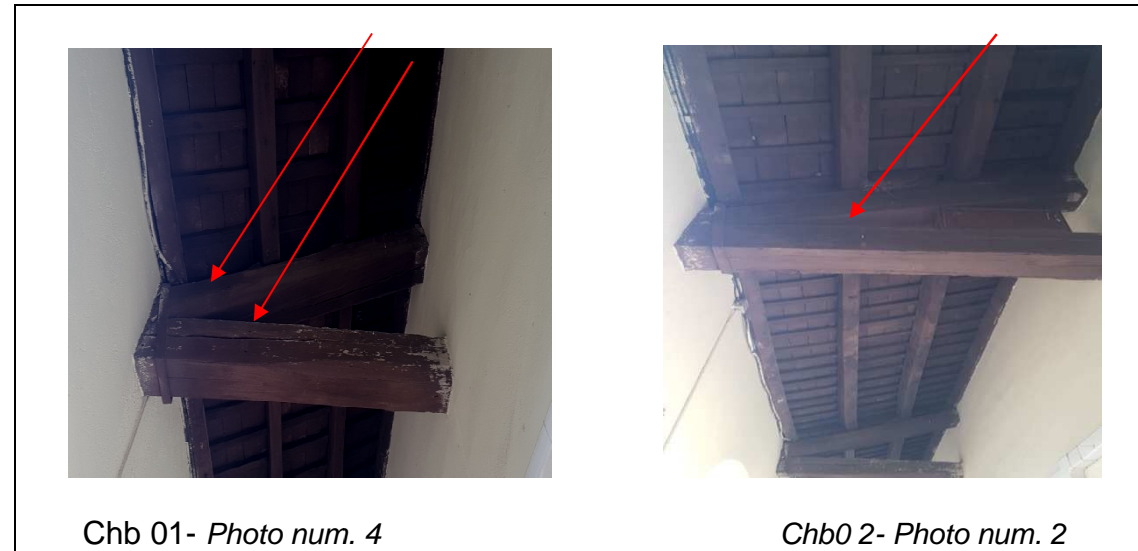
- The majority of the trusses present cracks in the longitudinal direction, of variable dimensions according to the truss, of different length and thickness in each and different situation in the section. (File nº13).

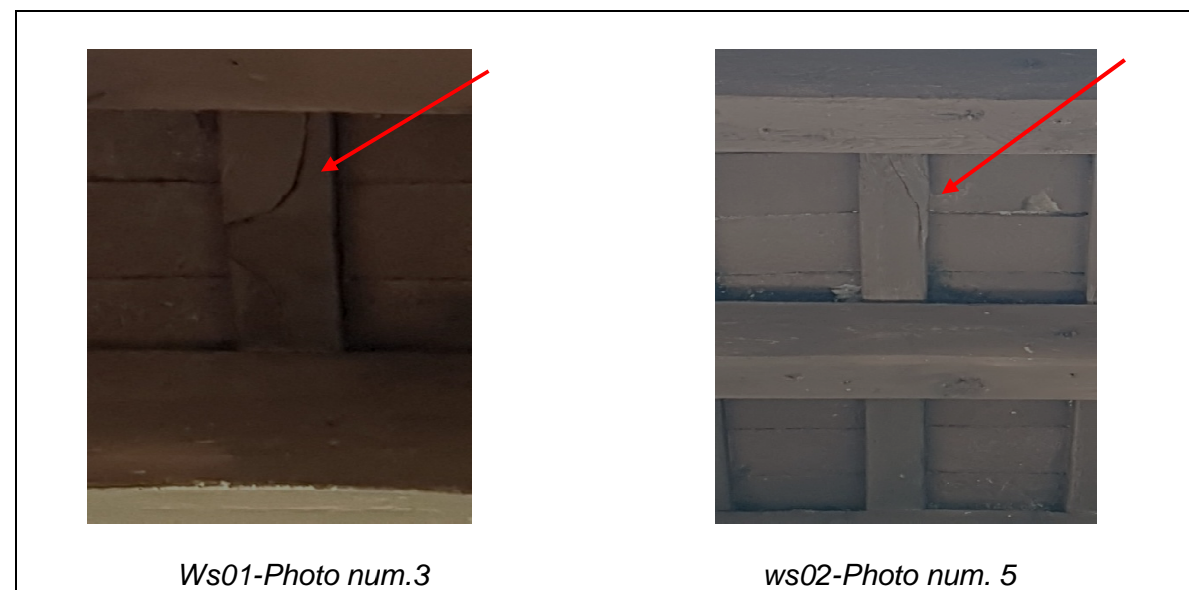
- Cracks in curvilinear form between the concentric layers of the growth rings that occur in the wood slats of the framework. (File nº14).

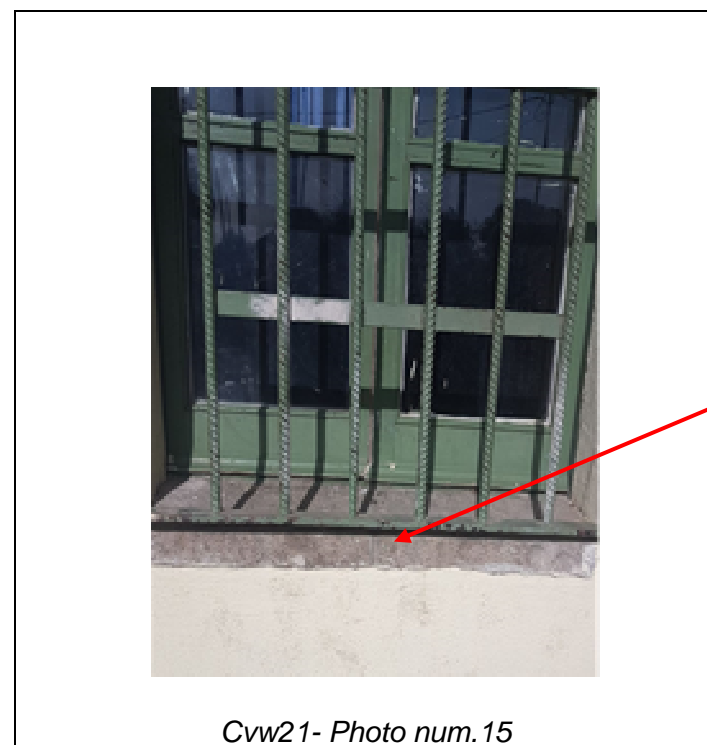
- Crack in the sill open in the middle formed by block of stone (File nº19).

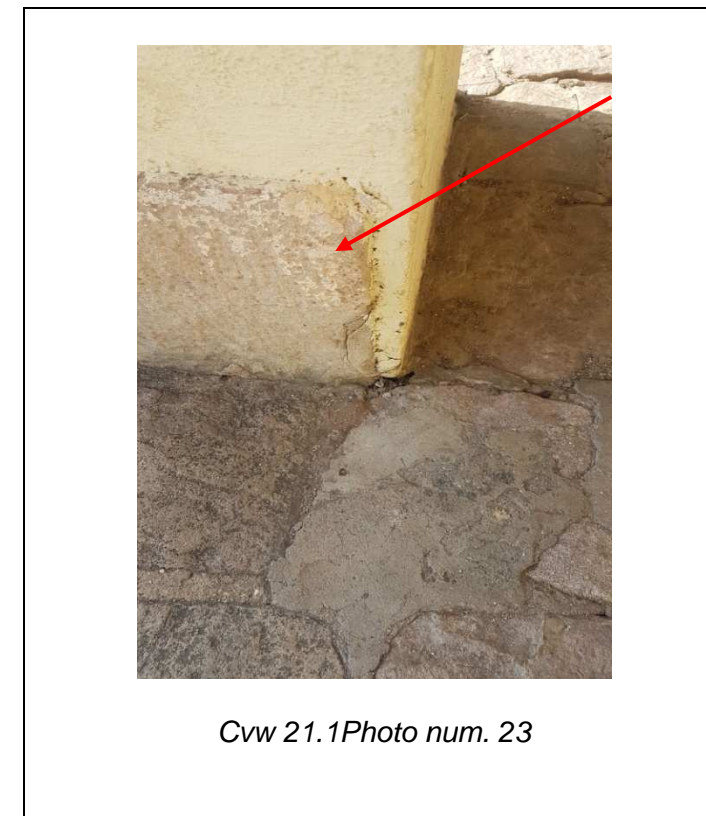
- Various vertical cracks in the pillar, in the lower part the base formed by a block of masonry carved by three of its faces, photos 23, 13 and 42 (File nº21).

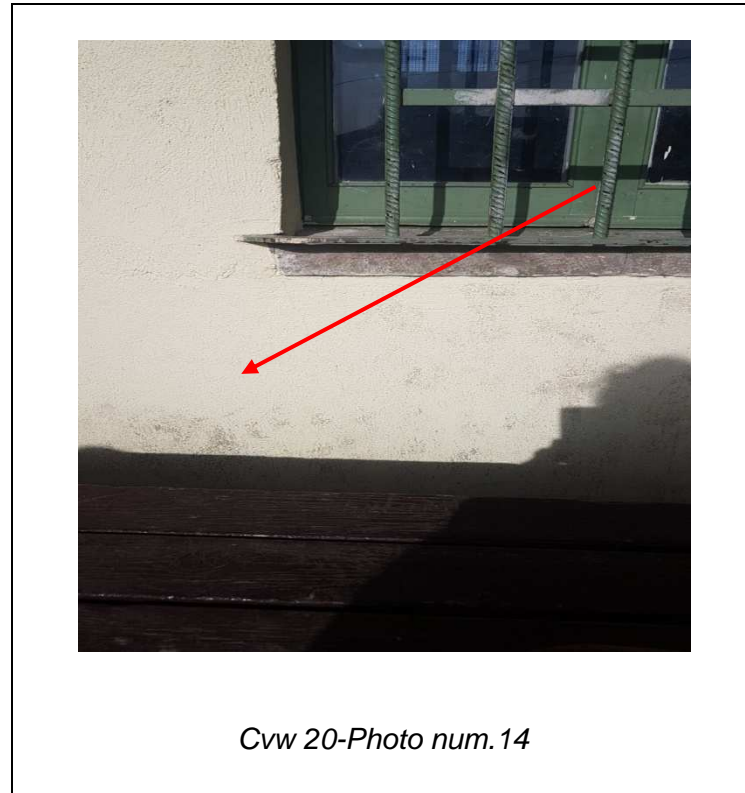
- Fissures in singular points in the windows (File nº22).

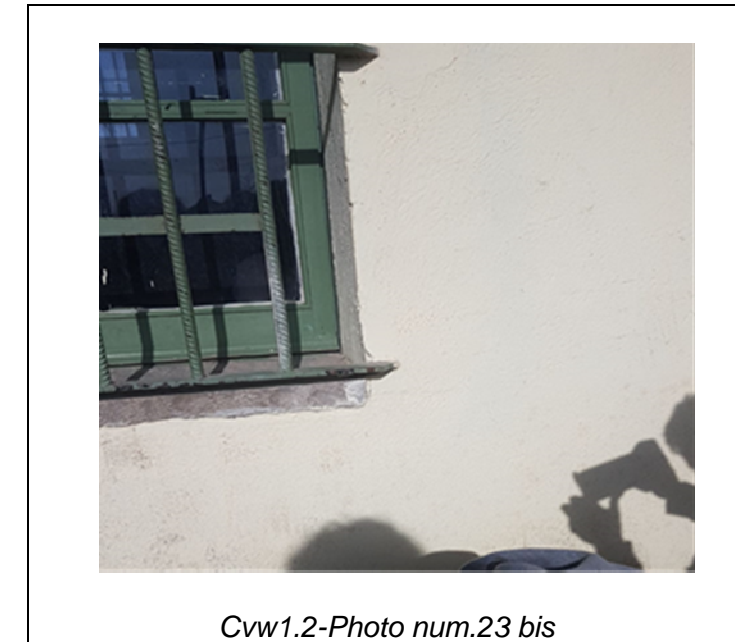
- Crack that comes out at the weakest point of discharge that is the bottom window (File nº 24).

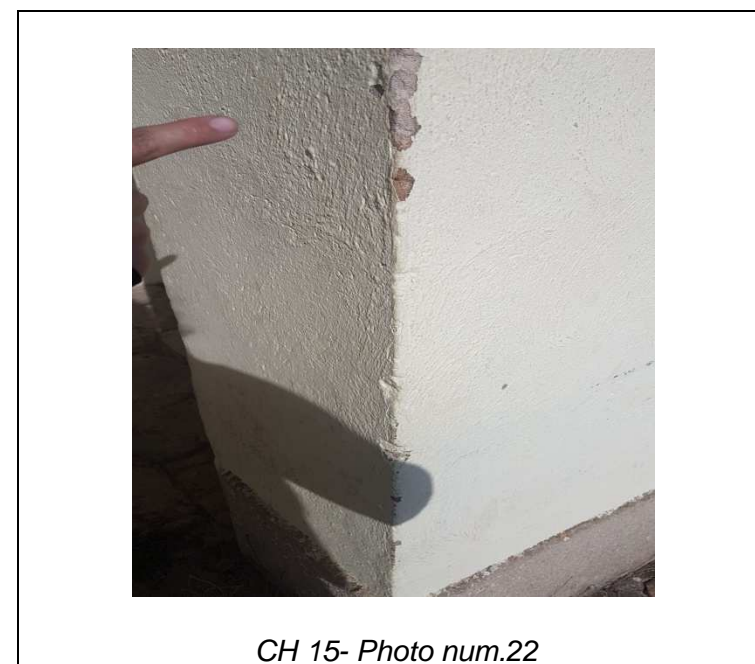
- The covering has fallen and the support material is seen in this case the masonry wall taken with mortar. (File nº 23).

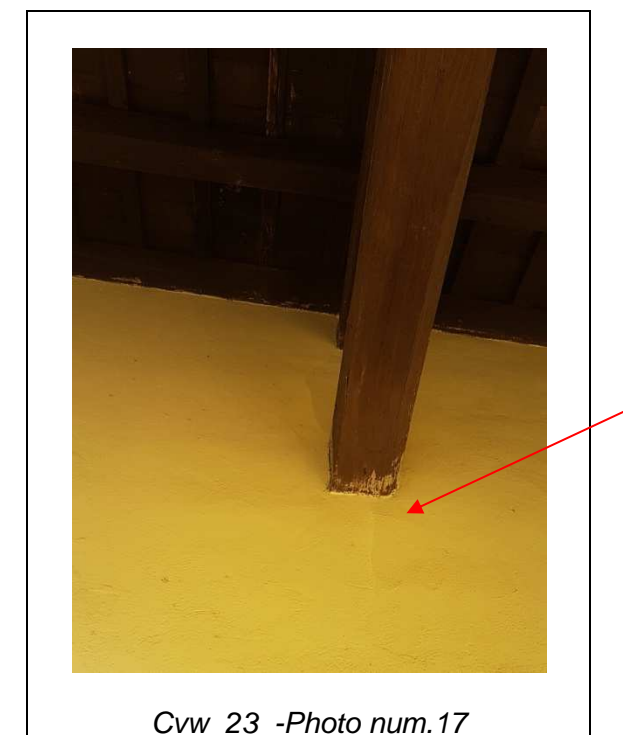
- Fissures and cracks leave the union of the truss with the tie and the pair with the masonry wall in photos 25 and 23 (File nº25).

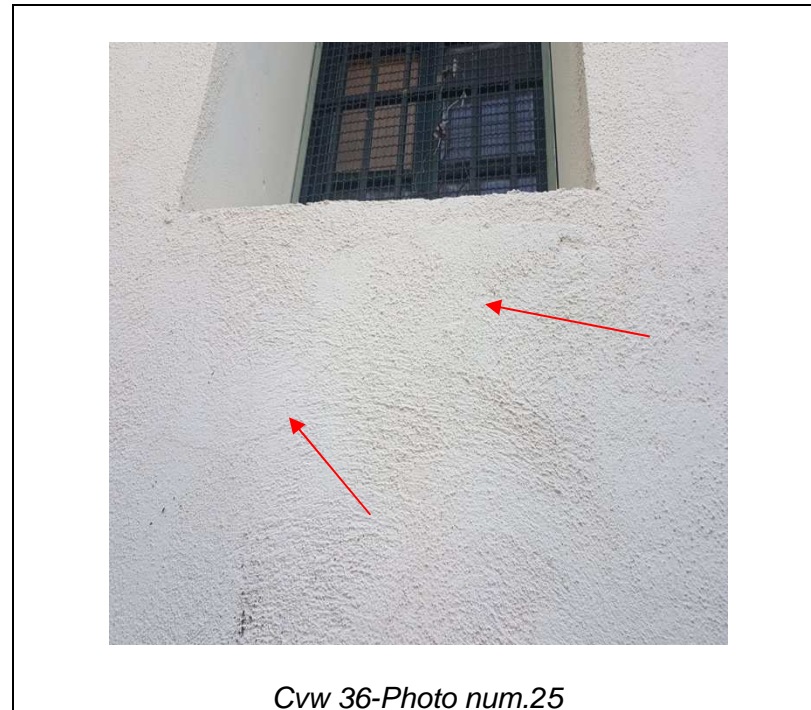
- Various descending cracks in the rear facade under the windows. (File nº26).

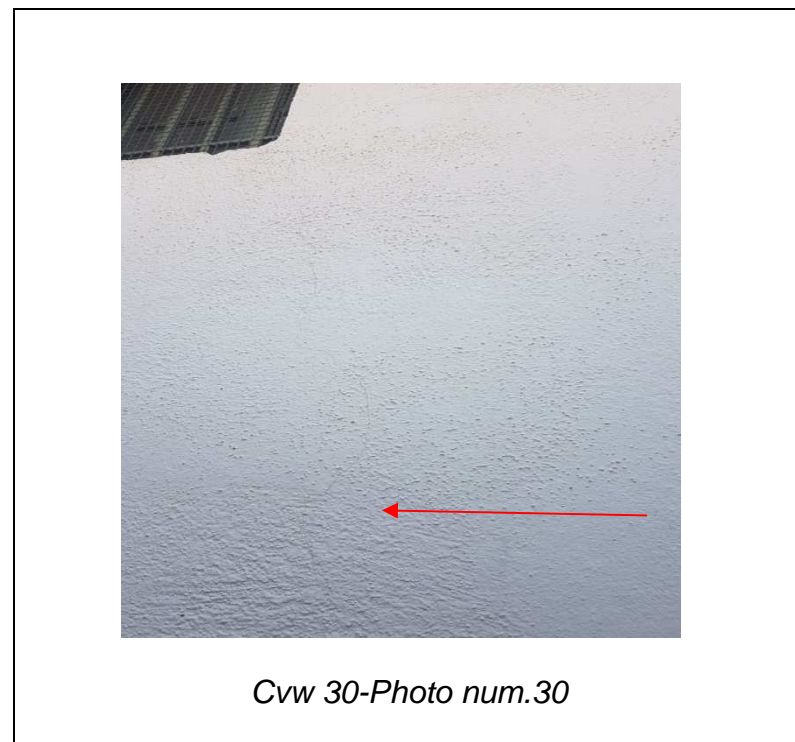
- Multiple vertical fissures on the inside of the entire facade in the photos 24, 25, 26, 27, 28, 29,30, 31, 32,33 y34 (File nº27).

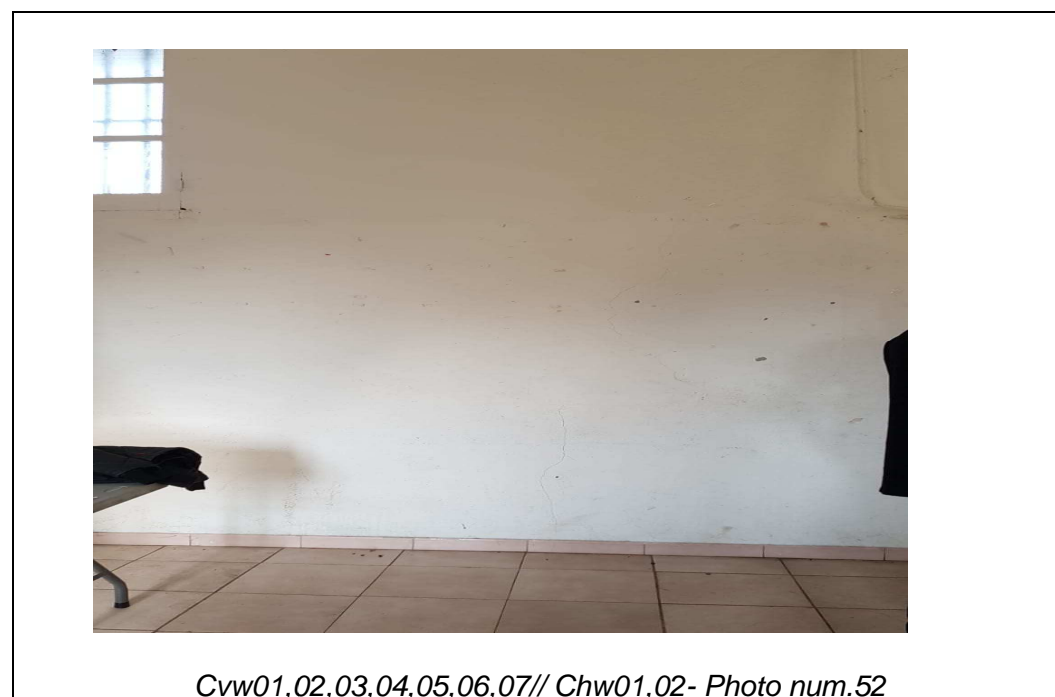
- Multiple fissures in the upper part of the vertical wall, it is seen that a moisture treatment has been carried out by capillarity, projecting cement mortar into the wall in order to waterproof one meter from the floor. (File nº32).

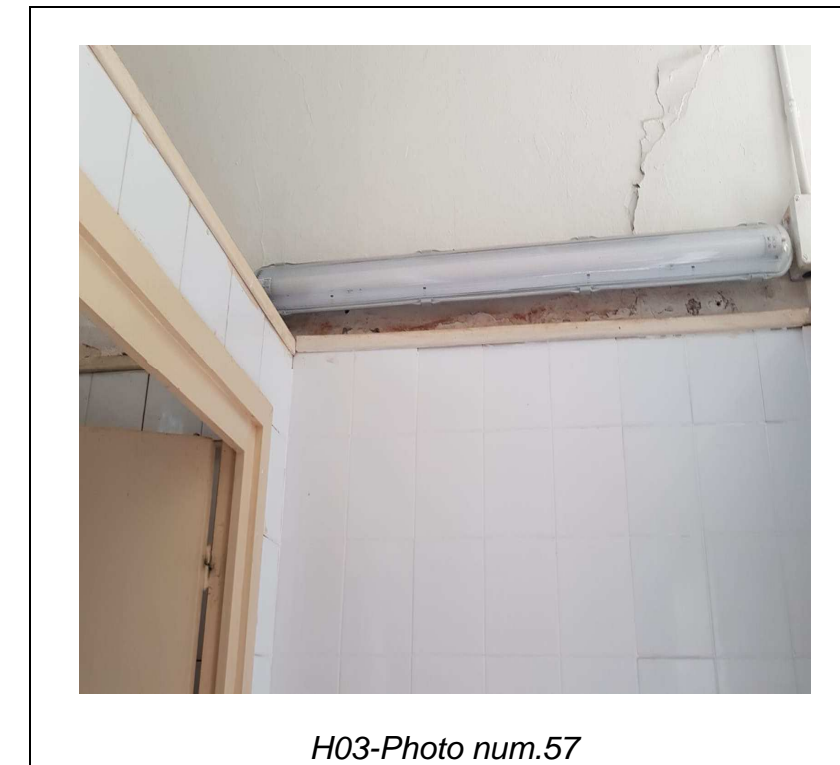
- Accidental humidity in linear and horizontal form in the vertical wall, of the structural wall in washbasins (File nº33).

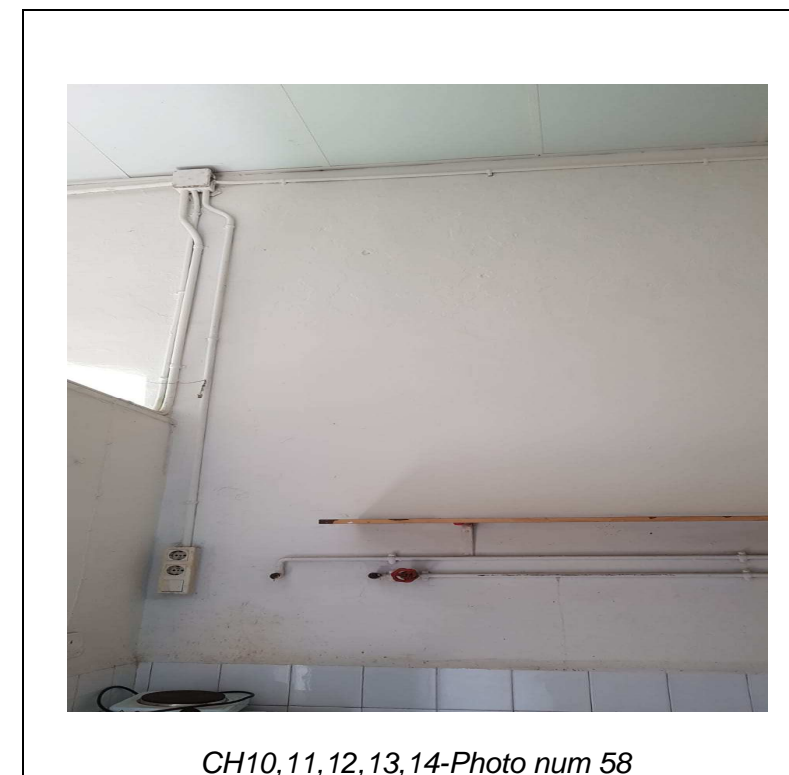
- On the inside face of the wall there are several cracks in the lower part of the window in the masonry wall. (File nº38).

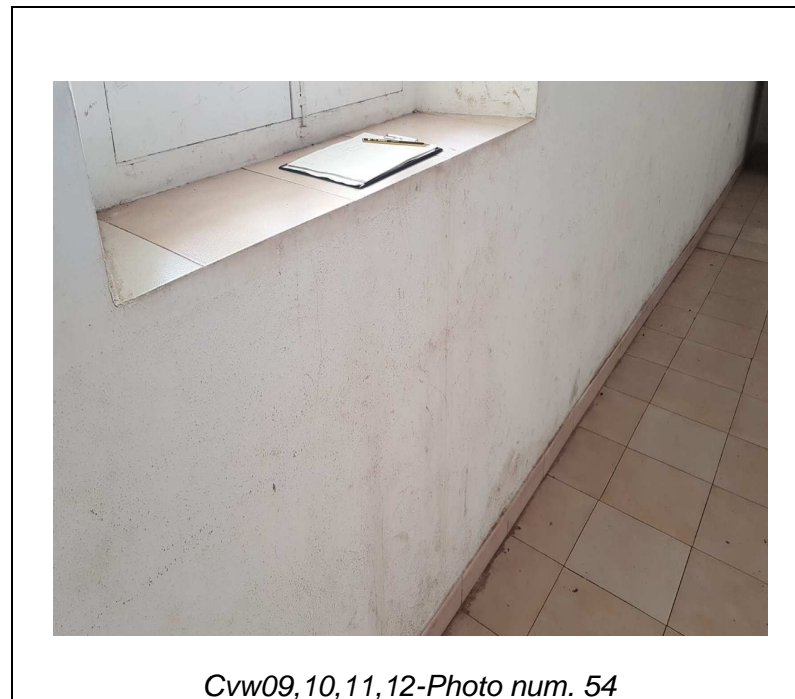
- On the inside face of the facing the covering has fallen leaving the masonry wall with mortar. (File nº.39).

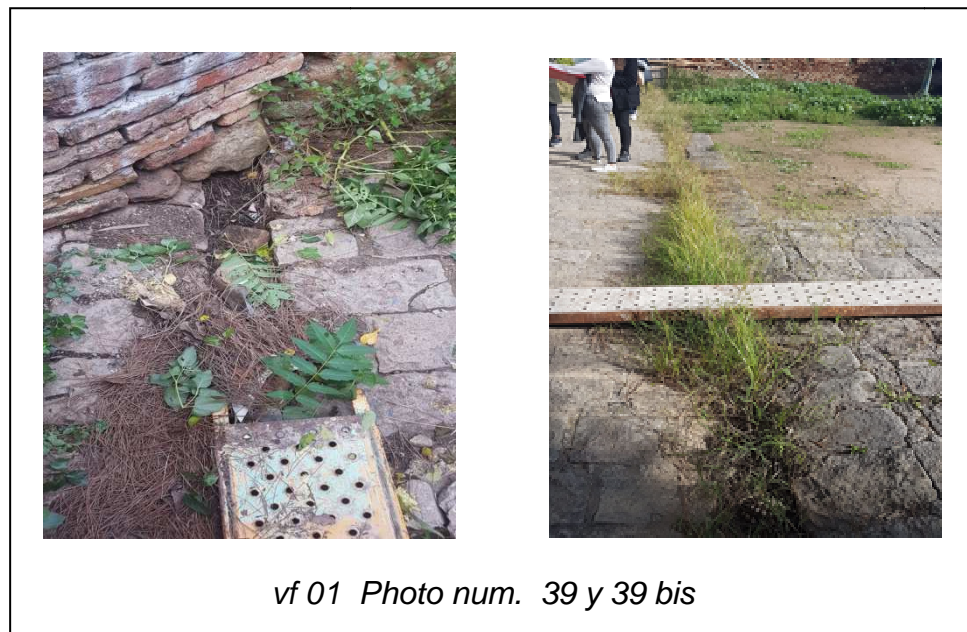
- Outer chest exterior side side broken. (File nº41).

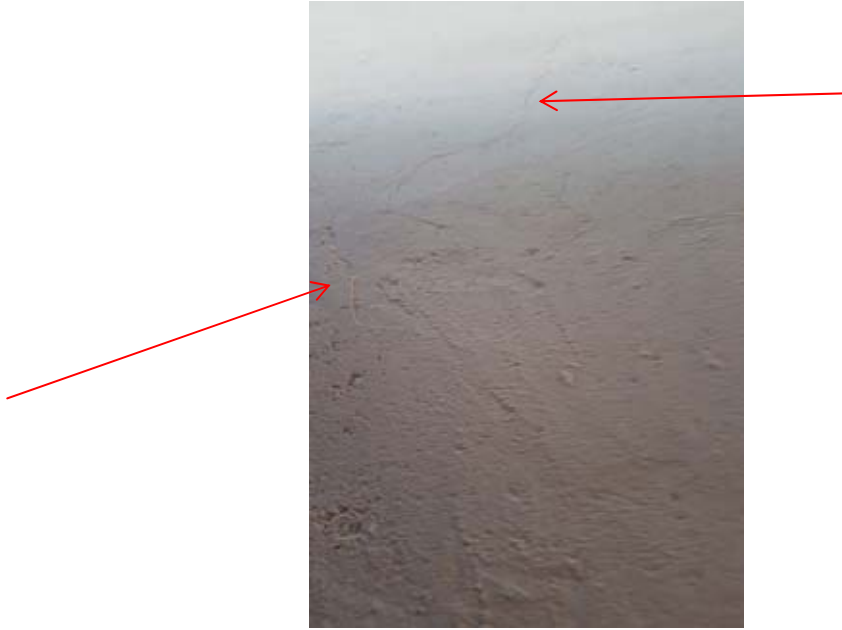
Several vertical fissures are observed in the lateral walls in the near area between the facade and the roof.		
			Analysis and possible causes		
			<p>A possible cause could be the deformability that the mortar presents in front of the pieces of masonry, it produces an elongation of the same in the direction perpendicular to that of the application of the load. Under excessive vertical loads, the mortar is crushed, subjected to local tractions to the pieces in horizontal direction, and produce their vertical cracking.</p> <p>Another cause would be by movements of the cover, elastic type, which being too attached to the façade introduces tractions and shear stresses that break it.</p>

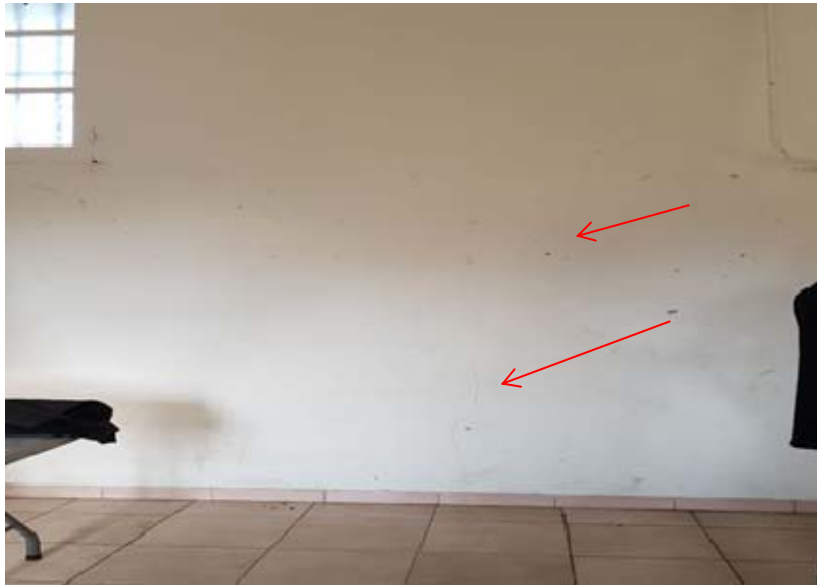
Multiple fissures are observed in the upper part of the vertical wall, it can be seen that a moisture treatment has been carried out by capillarity, projecting cement mortar into the wall in order to waterproof one meter from the floor.
	<p>Analysis and possible causes</p> <p>The possible cause is the deformability that presents the mortar against the masonry pieces, it produces an elongation of the same in the direction perpendicular to that of the application of the load. Under excessive vertical loads, the mortar is crushed, subjected to local tractions to the pieces in horizontal direction, and produce their vertical cracking.</p>
	<p>Possible interventions and actions</p> <p>Injections is a repair system for cracks less than 0.05 millimeters thick, applicable to walls of concerted masonry consisting of introducing a pressurized liquid in order to completely fill the gap between the lips of the opening. Said liquid, when hardening and adhering to the material, returns the continuity to the damaged element.</p>

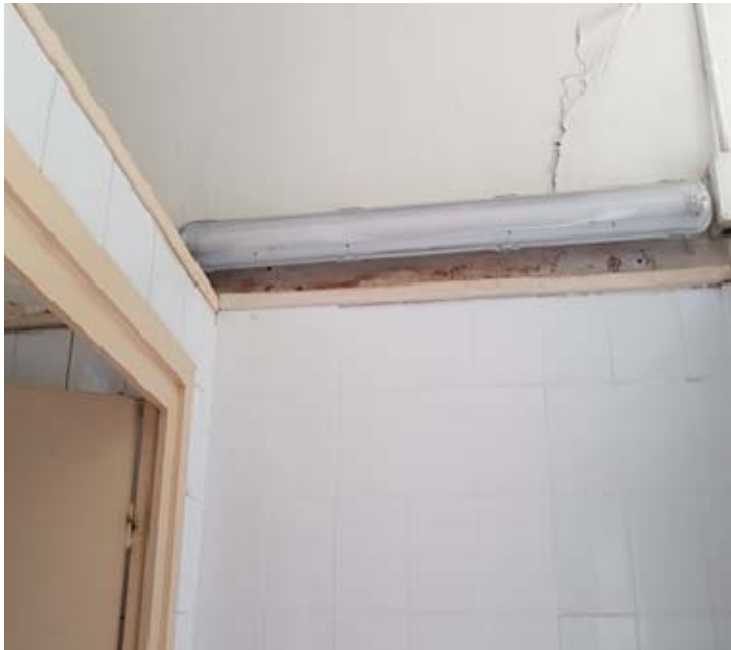
Accidental humidity is observed in a linear and horizontal way in the vertical wall, of the structural wall in washbasins.		
			Analysis and possible causes		
			The possible cause is the loss of water through pores in the pressure pipe and also affects the volume changes of the wall, causing local failures and loss of the load capacity of the mortar..		
			Possible interventions and actions		
			The first thing will be to change the broken piece. The introduction of slack is fundamental in the encounter with structural elements.
