Engineering Failure Analysis

Failure investigation of a solar tracker due to wind-induced torsional galloping

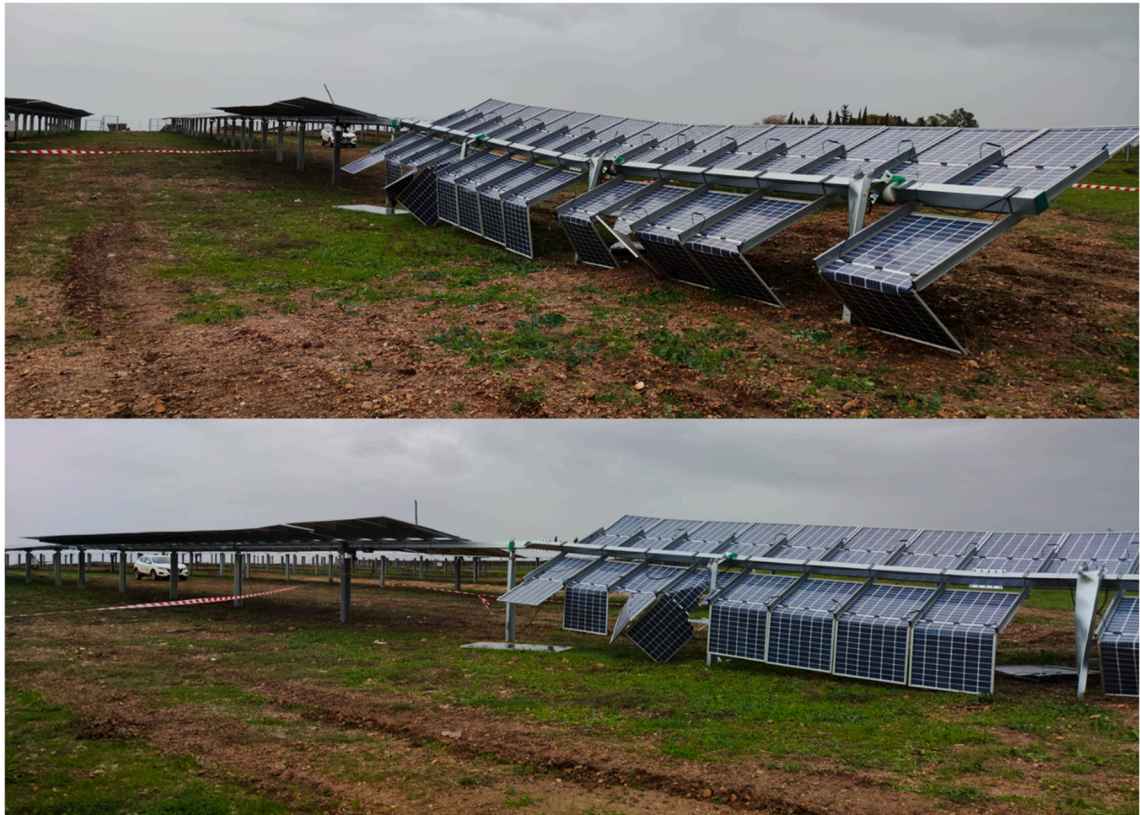
After a windy day, the solar tracker was found completely broken, as it can be observed in Fig. 3. It is seen that almost half of the tracker has rotated about 300 degrees from the initial position (0 degrees). Some PV modules are missing and others are broken. Furthermore, the supporting pillars 6, 7 and 8 (see Fig. 2) are completely bended. In Fig. 4 it is observed that the PV Modules near the pillar 5 and their supports are separated from the axis bar. In addition, it is seen that the axis bar that goes from motor pillar to pillar 5 is completely deformed in the junction with the other bar. This is the first sign that shows that the solar tracker was subjected to a high torsion force.

Fig. 3. Damaged solar tracker.

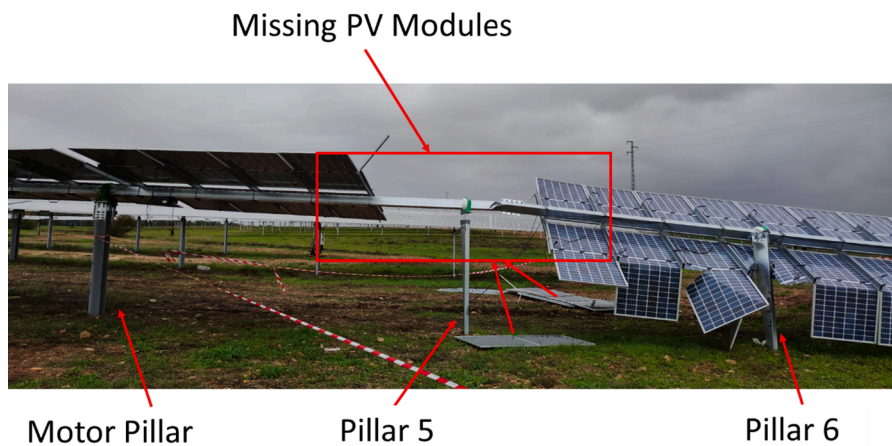
Fig. 4. Detail of the PV Modules near the pillar 5.

5. Four PV Modules were found separated from the axis near pillar 5, which leads to think that they suffered the maximum torsional stress. In addition, their frames were found broken.

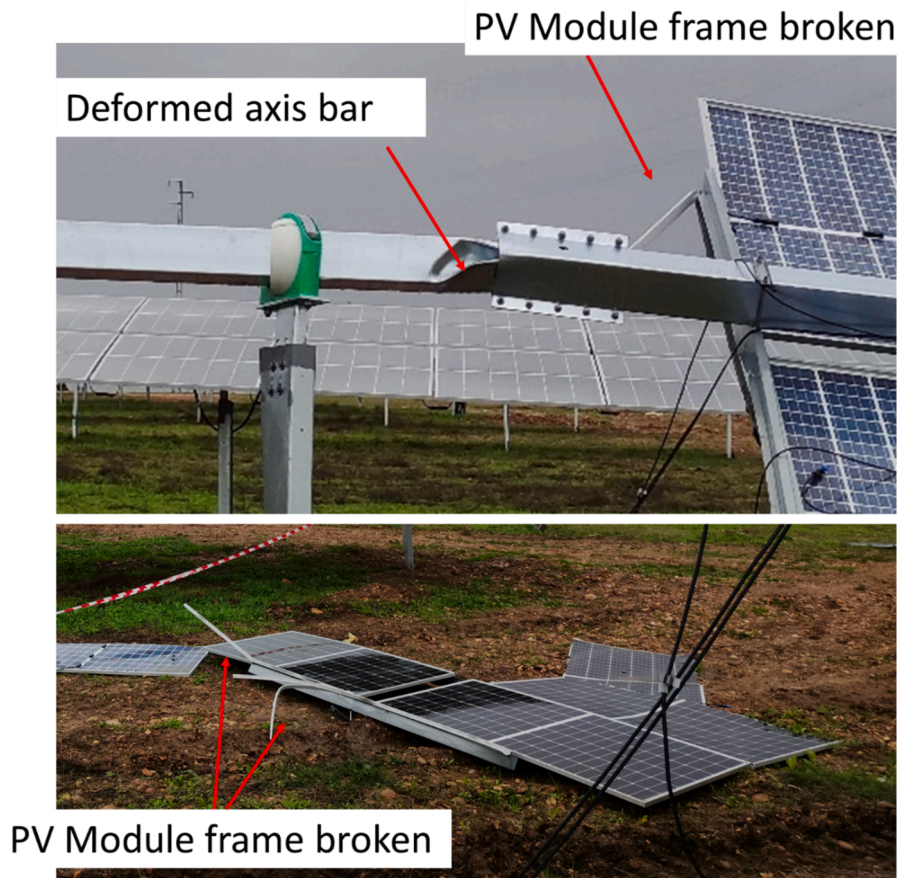
Looking with more detail into the area where the PV Modules are separated from the rest (Fig. 5), it is observed that the photovoltaic material is intact in the PV Modules found on the ground, but their frames are broken. This means that they were subjected to a high force that was able to bend the frame of those modules and separate them from the rest. In the same picture, one can see that the

deformation in the axis bar is due to a high torsion producing plastic deformation. The way of how this bar is deformed discards any possibility of failure due to fatigue and points to a possible failure due to torsional galloping.

Fig. 5. Detail of the deformed axis bar and the broken PV Module frames.

6. The axis bar junction near those modules was totally deformed, which means that the maximum torsional stress was located also in this zone.
7. Once those modules were separated from the axis bar due to the high torsional stress, the structure was divided into two parts which could further concentrate the torsional galloping effects on the damaged part.

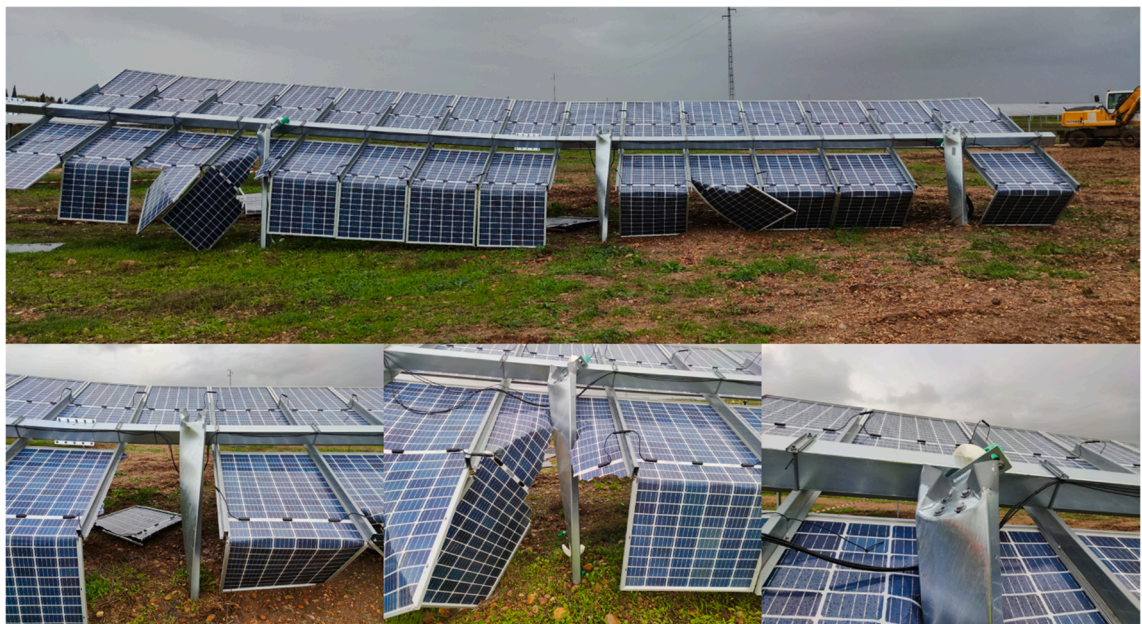
The rest of the PV modules that are still united to the axis bar are folded or broken because they hit the ground during the whole rotation of the axis. In Fig. 6 it is observed that only one row of PV Modules is bended at the junction between their supports and their frames. Furthermore, those modules that coincide with a pillar are totally destroyed due to the crash with them. The pillars present a large plastic deformation. This picture suggest that the whole solar tracker was deformed torsionally in clockwise direction (looking the axis bar from the tip shown in Fig. 6).

Fig. 6. Detail of the bended and broken PV modules.

8. The structure rotated 300 degrees, deforming pillars 6, 7 and 8 and colliding the PV modules of the right row with the ground. In the collision with the ground, those PV modules were deformed and the ones that coincide with a pillar were destroyed.

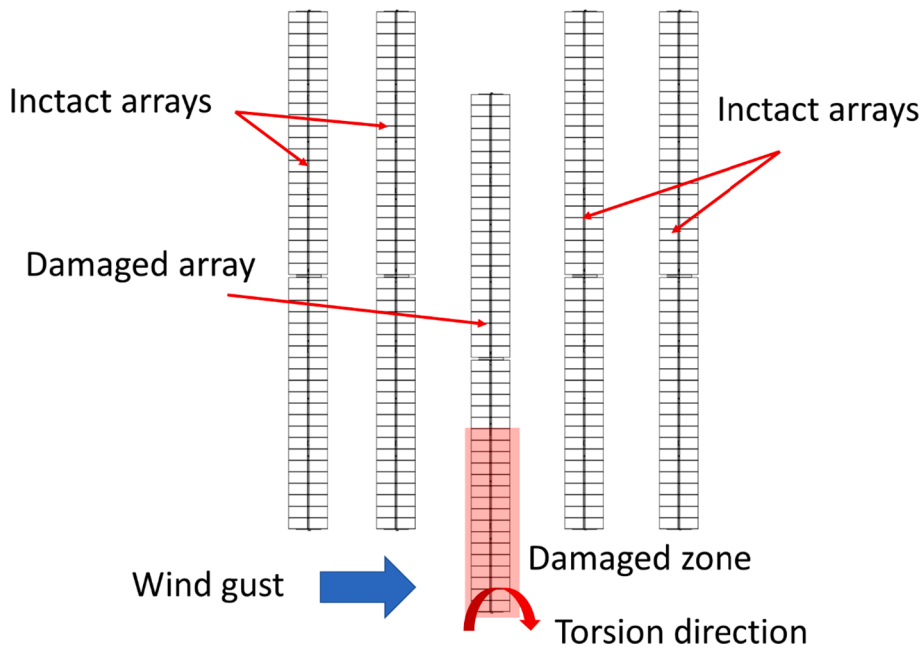
Fig. 7. Disposition of the damaged solar tracker in the solar plant.

The damaged solar tracker has a special disposition in the solar plant (see Fig. 7). In the damaged part of the tracker there is not any other solar tracker upstream or downstream, which means that this part is directly subjected to the wind, without any obstacles before or after the tracker. This means that the torque due to the wind in this zone could be higher than in the rest of the tracker. Considering this fact and analyzing the damages presented in Fig. 3 to Fig. 6, the possible causes of the damage can be explained as follows:

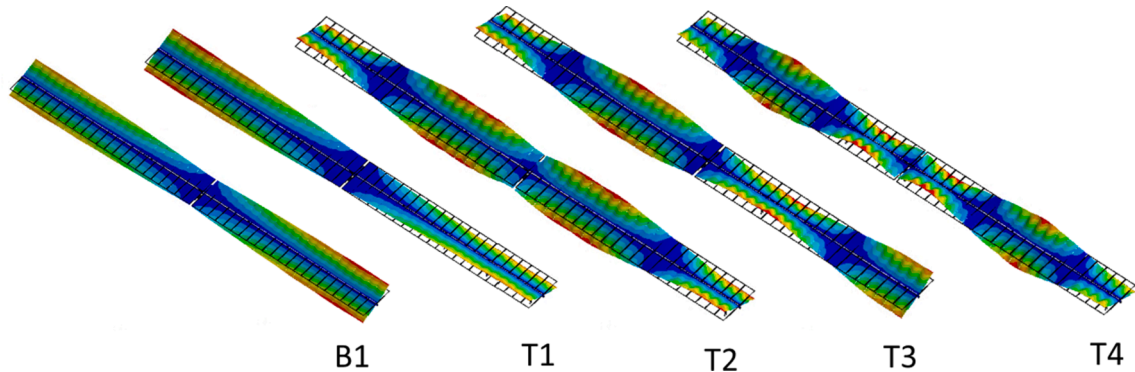
Fig. 9. Mode-shapes of the solar tracker. Normalized displacement (Red maximum, blue minimum).

First, a modal analysis was carried out to identify the natural frequencies and mode-shapes of the solar tracker. The natural frequencies found are summarized in Table 2 and their corresponding mode-shapes can be seen in Fig. 9. The mode-shapes have been classified as bending modes (B) and torsional modes (T). Only one bending mode is found at low frequency while several torsional modes are obtained in the range 0–5 Hz. The torsional modes appear with more nodal lines when increasing frequency. As explained in the introduction section, the first torsional mode (T1) is the one that is usually excited during the torsional galloping.

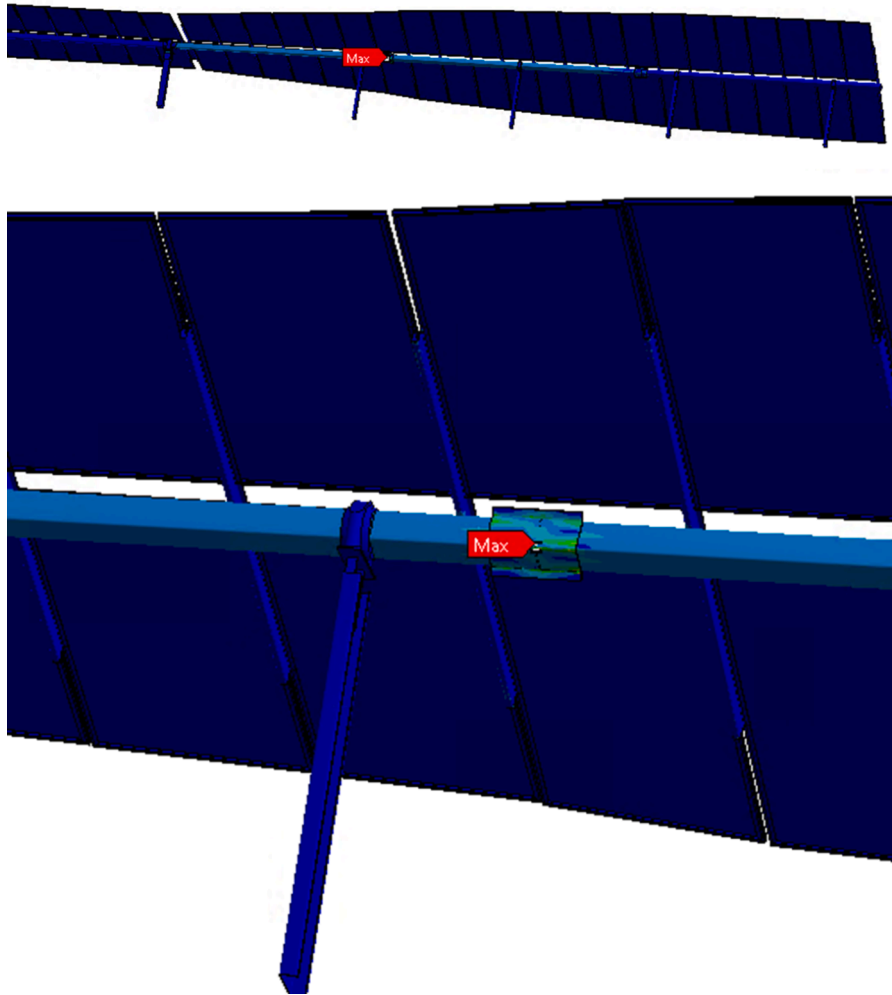
Under these circumstances, the maximum stress was found at the shaft joint, and concretely in the nearest union of the pillar motor (see Fig. 11). This is the same union piece that was found completely deformed in the field (Fig. 5). Looking at the stress, piece by piece of the structure, one can find the maximum stresses in those parts where each piece was broken. Fig. 12a shows the stress in the PV supports and the maximum is located in the union with the axis bar near Pillar 5, fact that explains why the PV Modules were found separated from the axis bar in the field. The PV Module frames present also the maximum stress (see Fig. 12b and c) in that zone where they were completely bended (Fig. 6).

Fig. 11. Maximum stress in the solar tracker. Normalized stress (Red maximum, blue minimum).

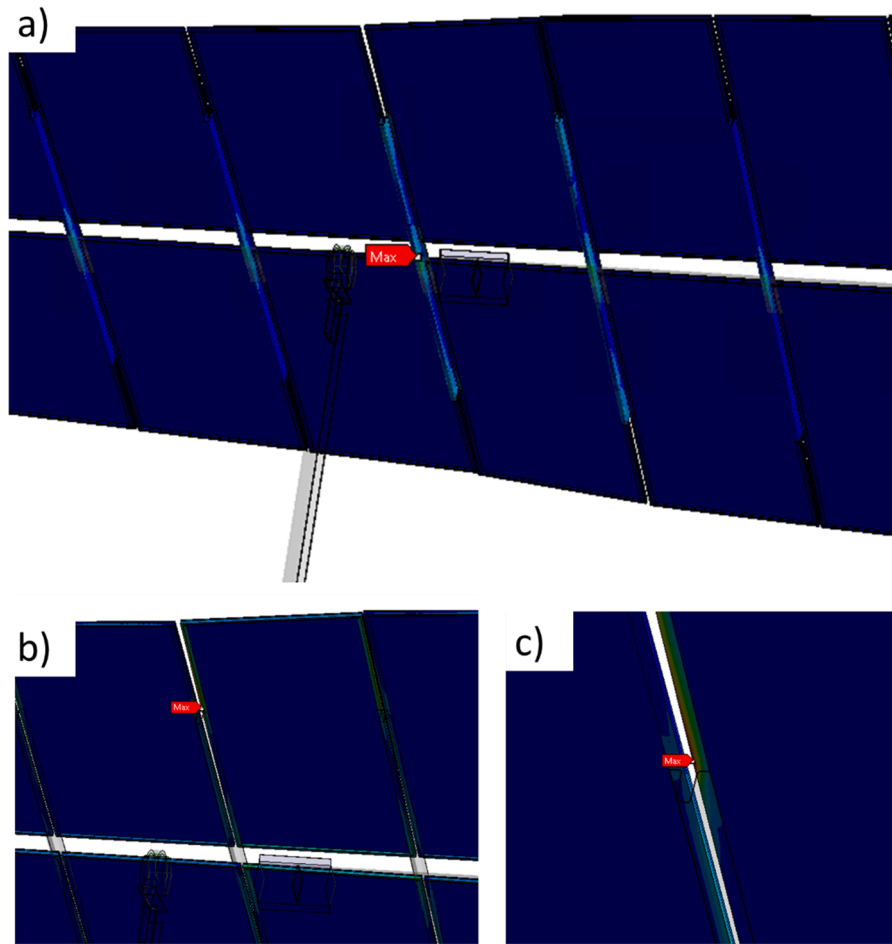
Therefore, the numerical simulation confirms the initial hypothesis presented in section 3.3, determining that the weakest pieces under a torsional galloping phenomenon are shaft joints, the PV supports and the PV Module frames. Moreover, the disposition of the solar trackers in the plant (Fig. 7) makes the wind force to be higher at the damaged zone, leading to a torque moment like the one applied in the simulation. Furthermore, the torsional deformation of the panel and the maximum stresses found in the simulation coincides with the shape of the first torsional mode-shape (T1), demonstrating that the torsional galloping phenomena occurred.

Fig. 12. a) Stress in the PV supports. b) Stress in the PV module frames. c) Detail of the stress in the PV module frame. Normalized stress (Red maximum, blue minimum).
