30th International Conference on Flexible Automation and Intelligent Manufacturing (FAIM2021)  
15-18 June 2021, Athens, Greece.

## Studying the ZnO formation in coated steel wire ropes for the automotive industry

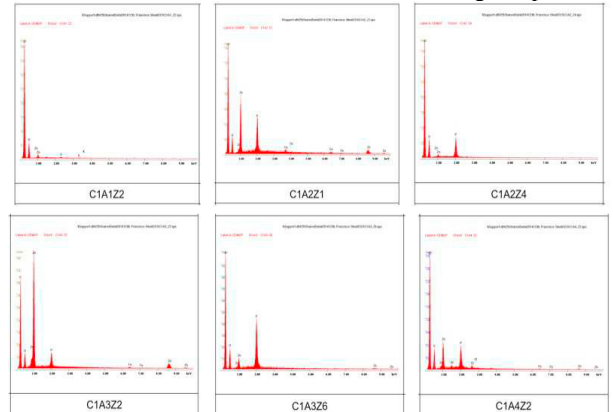
Fig. 19. Analyses of different areas containing C providing from the cable 1.

The presence of some stains reveals the persistent presence of C. However, sometimes, the C appears accomplished by phosphorus and other elements in very small contents. A deeper analysis was performed in order to realize where the C appears isolated or accomplished. Regarding the spectra in Fig. 19, it can be seen that P is not detectable on sample providing from area 1, but it is common in all the remaining samples.

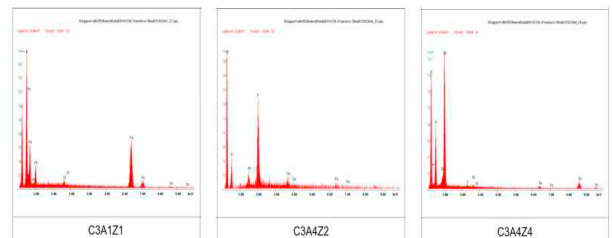
Fig. 20. Analyses of different areas containing C providing from the cable 3.

Fig. 20 depicts the spectra corresponding to areas 1 and 4 of the cable 3, because areas 2 and 3 do not present particles rich in C. These spectra allow realize that there are different kinds of dark particles (stains) in the same area, some of them containing P, whereas others contain just C or C and other elements in very small contents, such as Ca and/or Cl. Both in cable 1 and 3, area 1 does not present any P content allowing conclude that area 1 seems to be preserved from P content, whereas the other areas seem to contain different kinds of dark particles, providing from the internal polymer tube or resting from the lubricant used during the cable production.

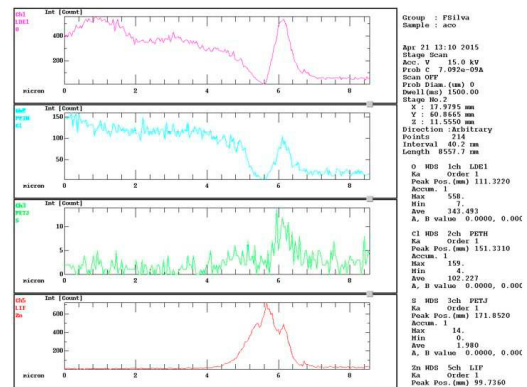
Fig. 25. EPMA analyses from the external to the steel substrate and isolating the intensity and area where each element.

the left side of the graphics as the external wax and the right side as the steel substrate, Fig. 25. Each channel was linked to a specific element: cyan to the O, blue to the Cl, green to the S and red to the Zn. The Cl and O are clearly presented on the external wax. After that, the Zn becomes visible and the S, Cl and O become newly visible in the interface between coating and substrate. This allows to conclude, under the coating, there are harmful products capable of triggering the ZnO nucleation reaction.
